Demonstrative Exhibits Summary

Shipyard PCB Uses and Sources

PCB Data Confirm SWM/BAE Shipways as PCB Source

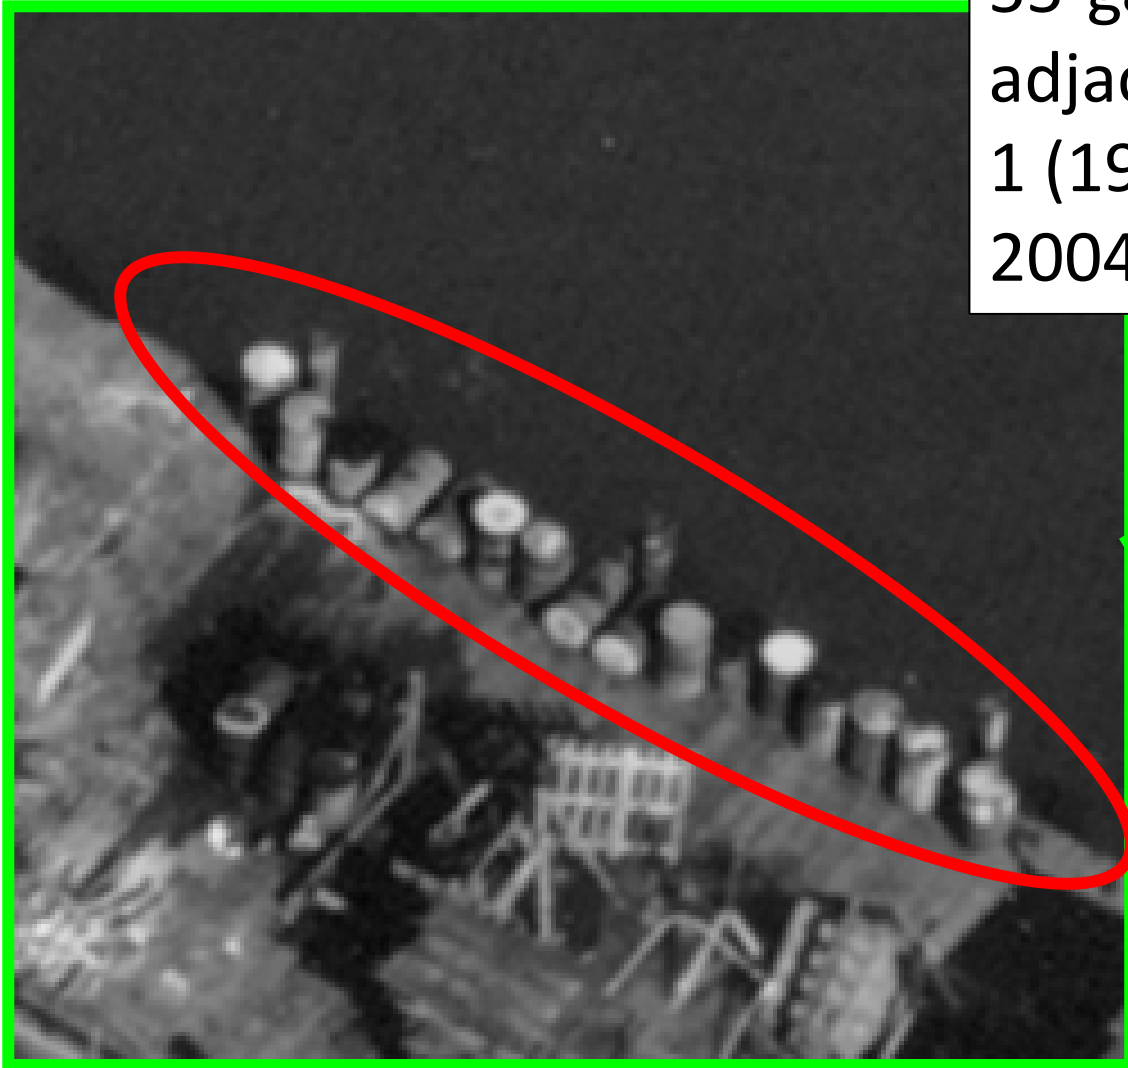
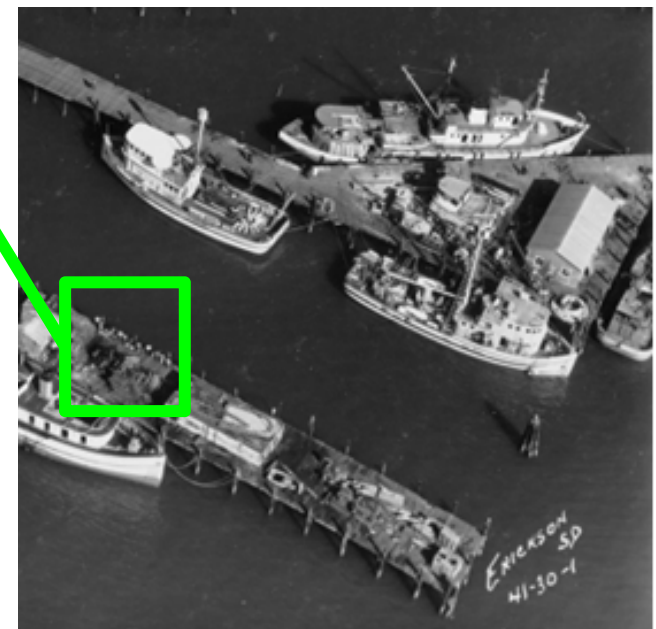
55-gallon drums located adjacent to water on Pier 1 (1941; Booth et al., 2004)

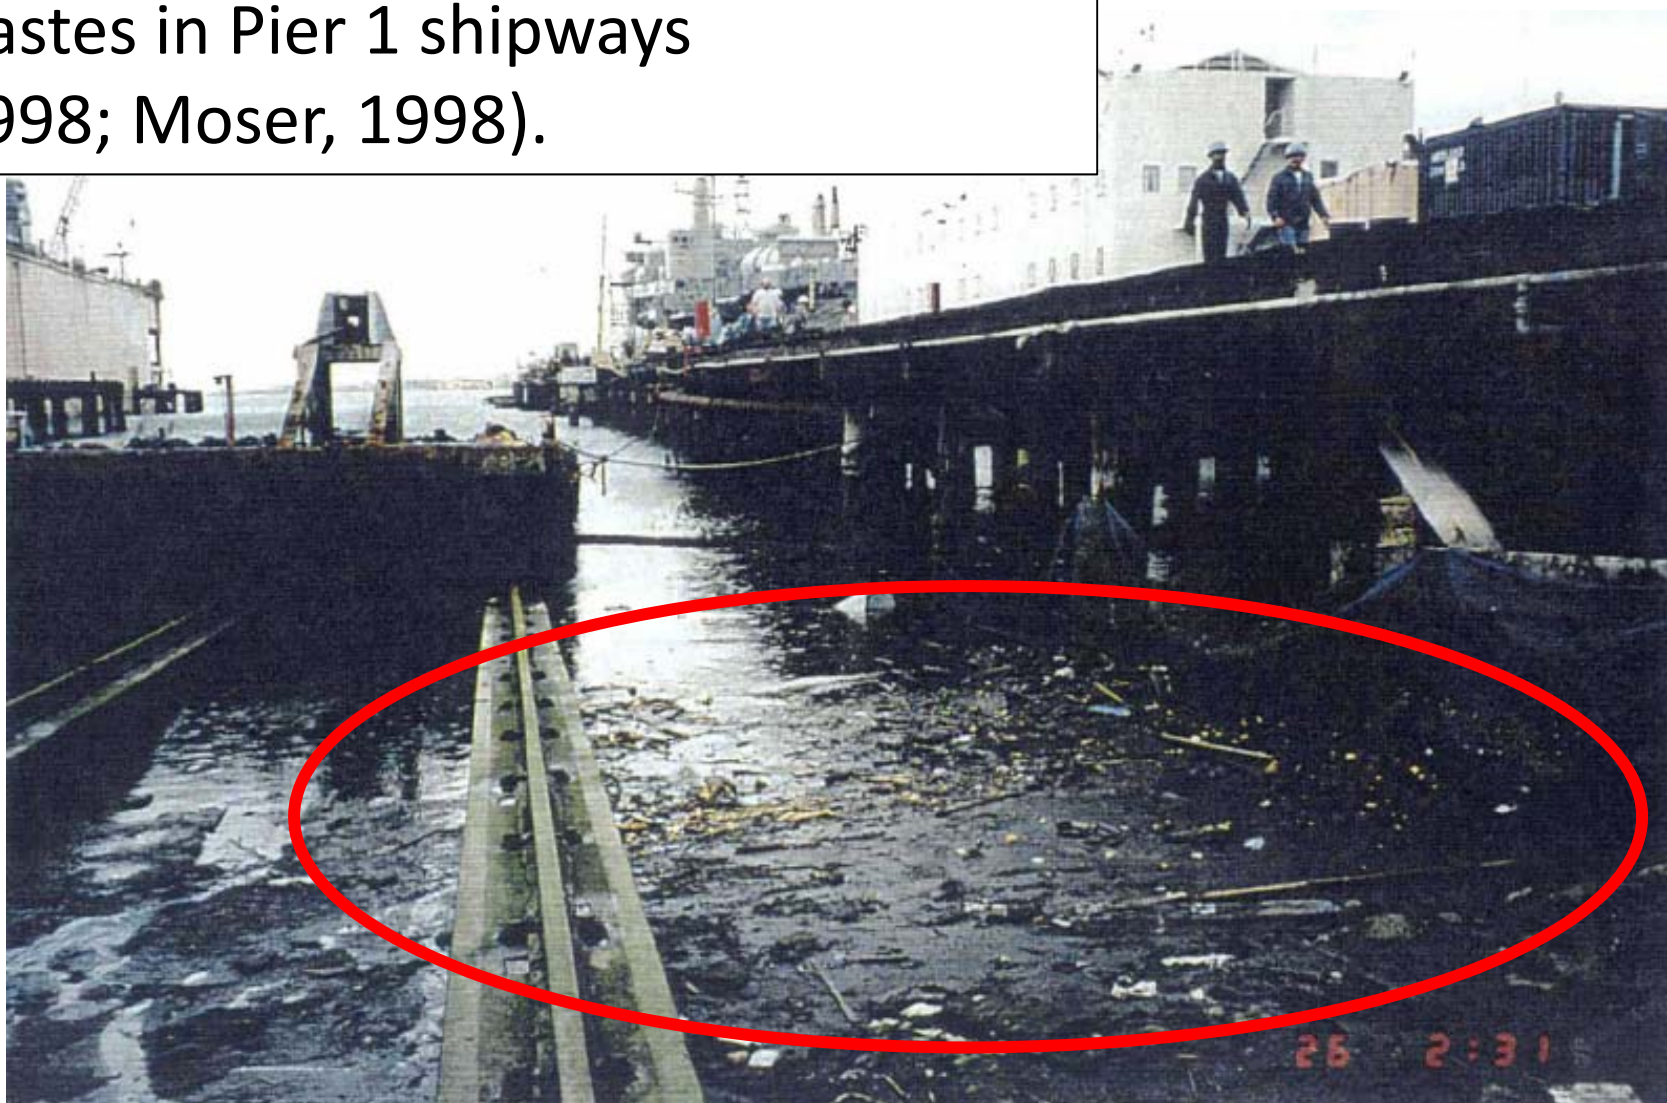
Wastes in Pier 1 shipways
(1998; Moser, 1998).

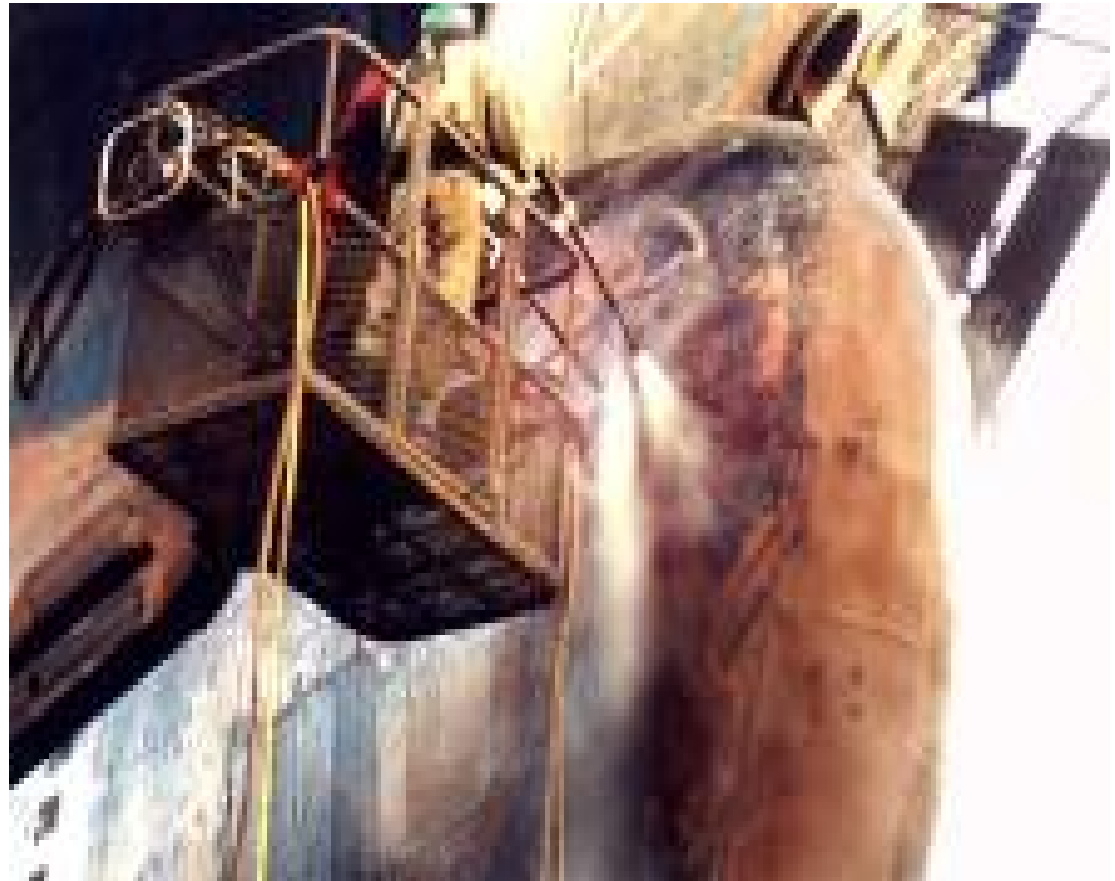
Widespread Shipyard PCB Use in Marine Paint

- 1971 inventory of pervasive use of PCBs in shipyard marine paint in Southern California, including San Diego (Young and Heesen, 1974)

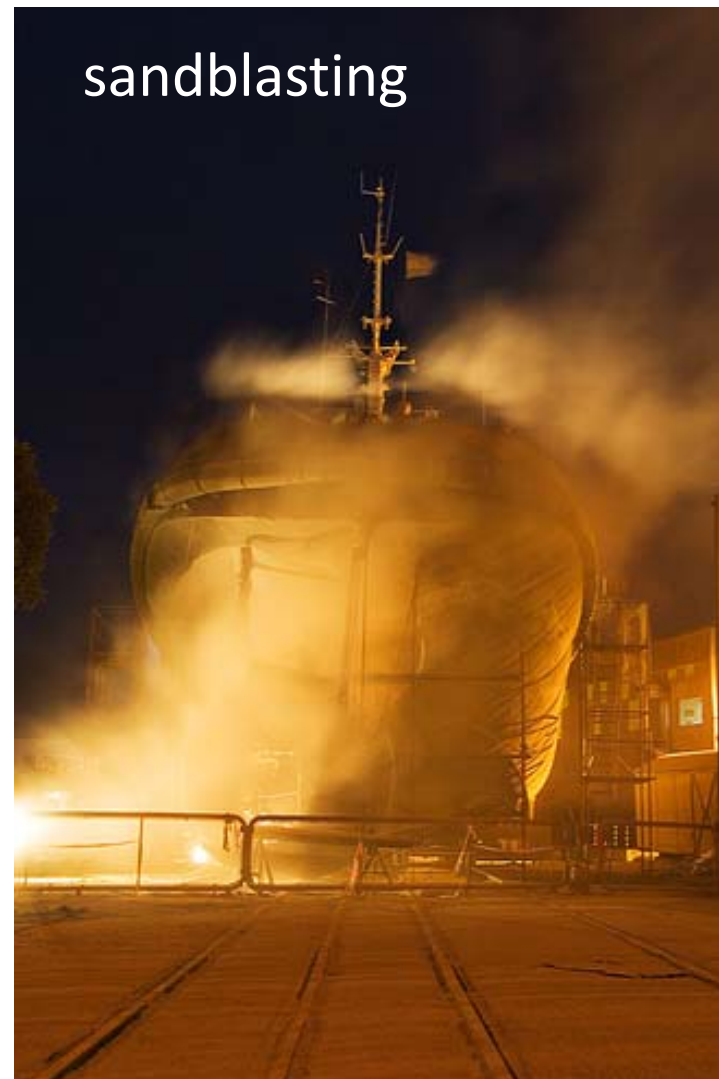
Direct Releases of Paint to Shipyard Site Sediment

- Circa 1971, CRWQCB estimated that 5-10% of sandblasting material discharged to San Diego Shipyard Site, a mass of **~200-300 tons annually** (CRWQCB, 1972)
- During spray painting of ships in San Diego shipyards, 5-30% of paint is lost to the environment (USEPA, 1974)

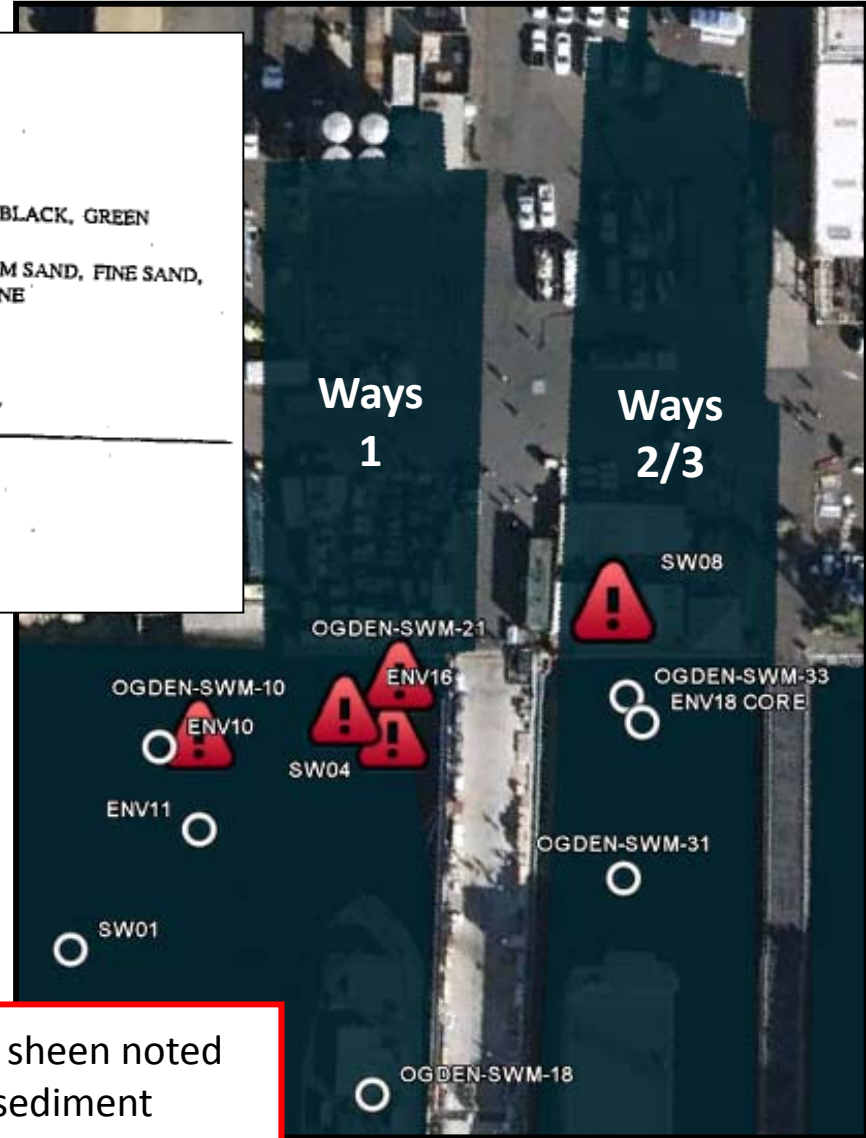
Does retrieval of core cause an OIL SHEEN?
 YES / NO
+ Top 2 feet only

Oil sheen noted
in sediment
cores
