**GEOLOGY AND SOILS EVALUATION SHIPYARD SEDIMENT  
ALTERNATIVE ANALYSIS CONVAIR LAGOON**

**GEOLOGY AND SOILS EVALUATION  
SHIPYARD SEDIMENT  
ALTERNATIVE ANALYSIS  
CONVAIR LAGOON  
SAN DIEGO, CALIFORNIA**

May 27, 2011  
Project No. 106997002

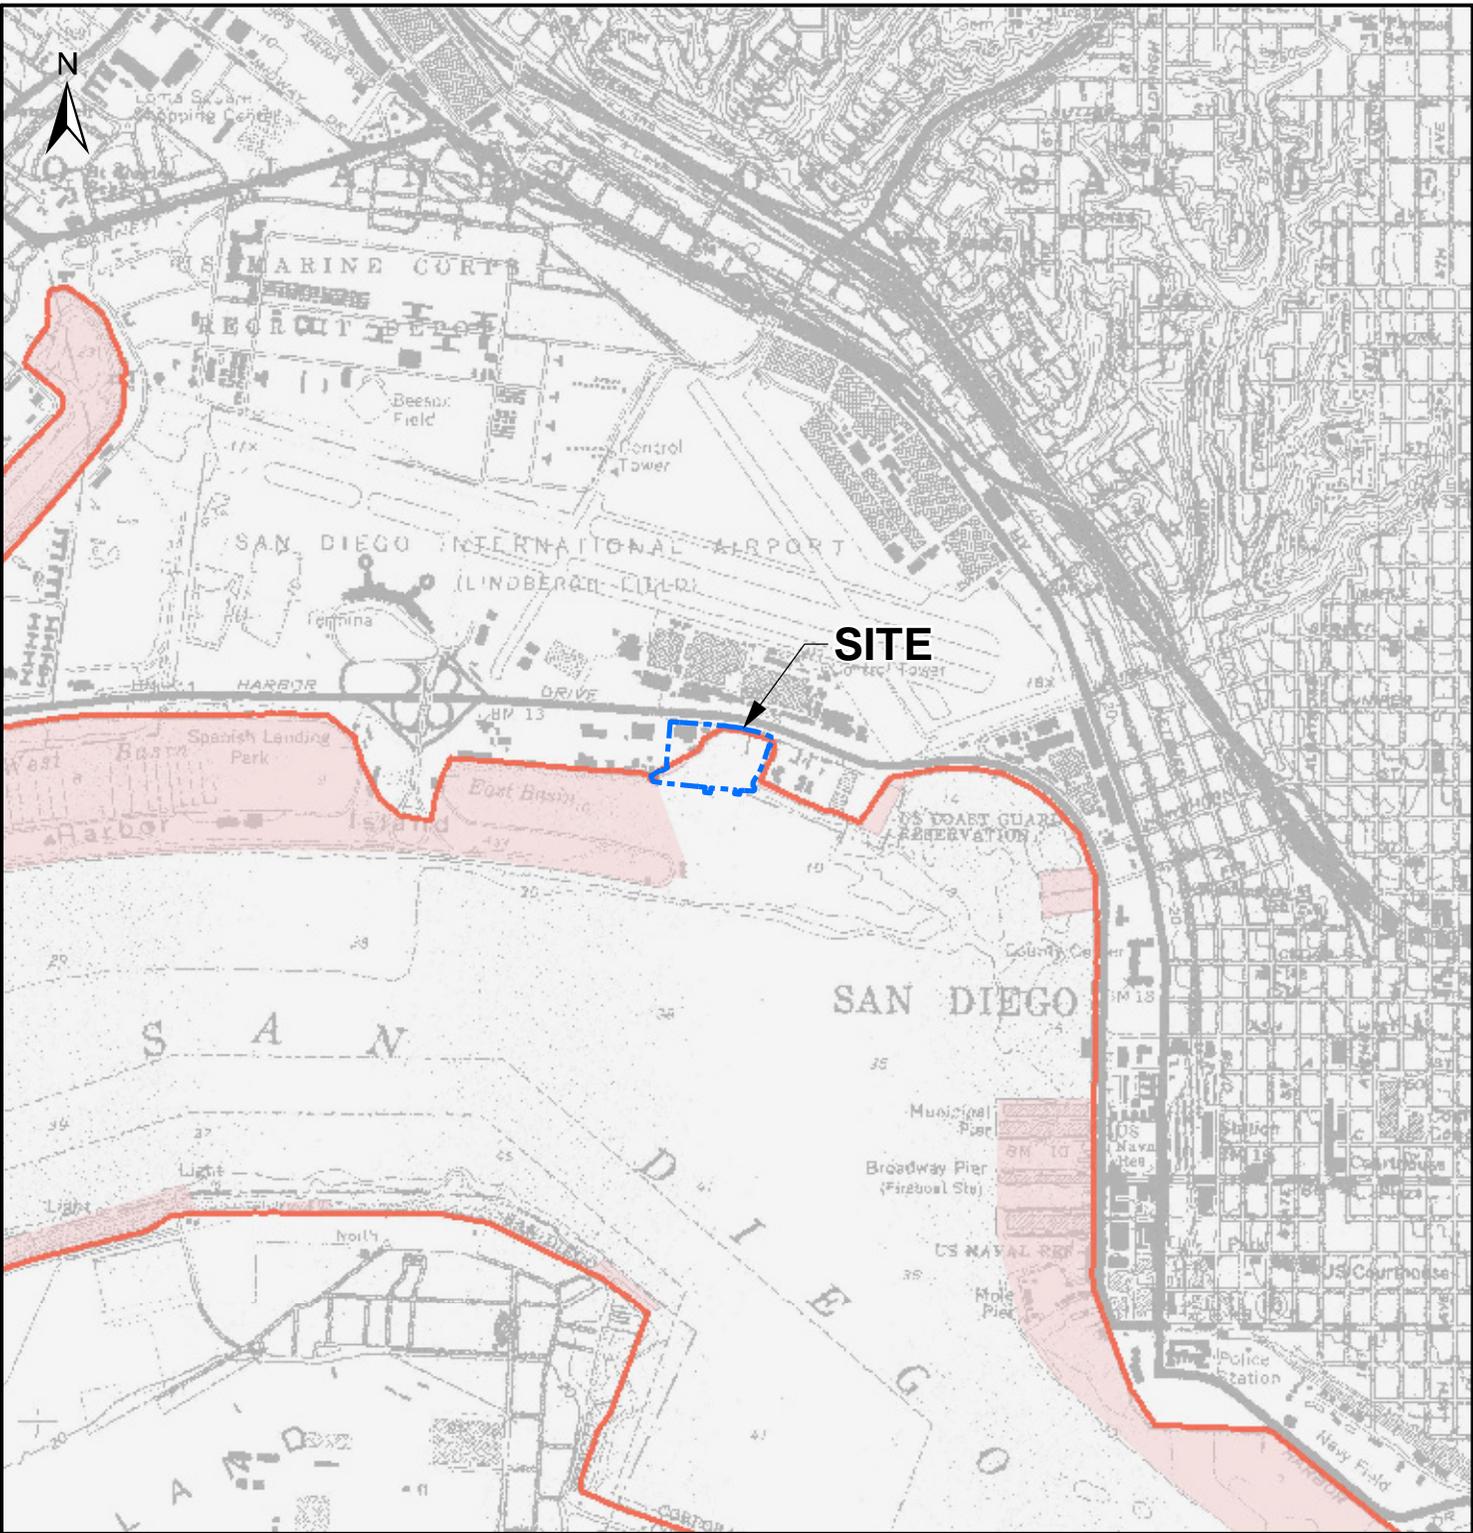
SOURCE: Base - TSUNAMI MAP FOR EMERGENCY PLANNING; State of California - County of San Diego, USGS 7.5 Minute Topographic Quadrangle - Point Loma, CA - June 1, 2009.
