# Demonstrative Exhibits Summary

# Shipyard COC Sources

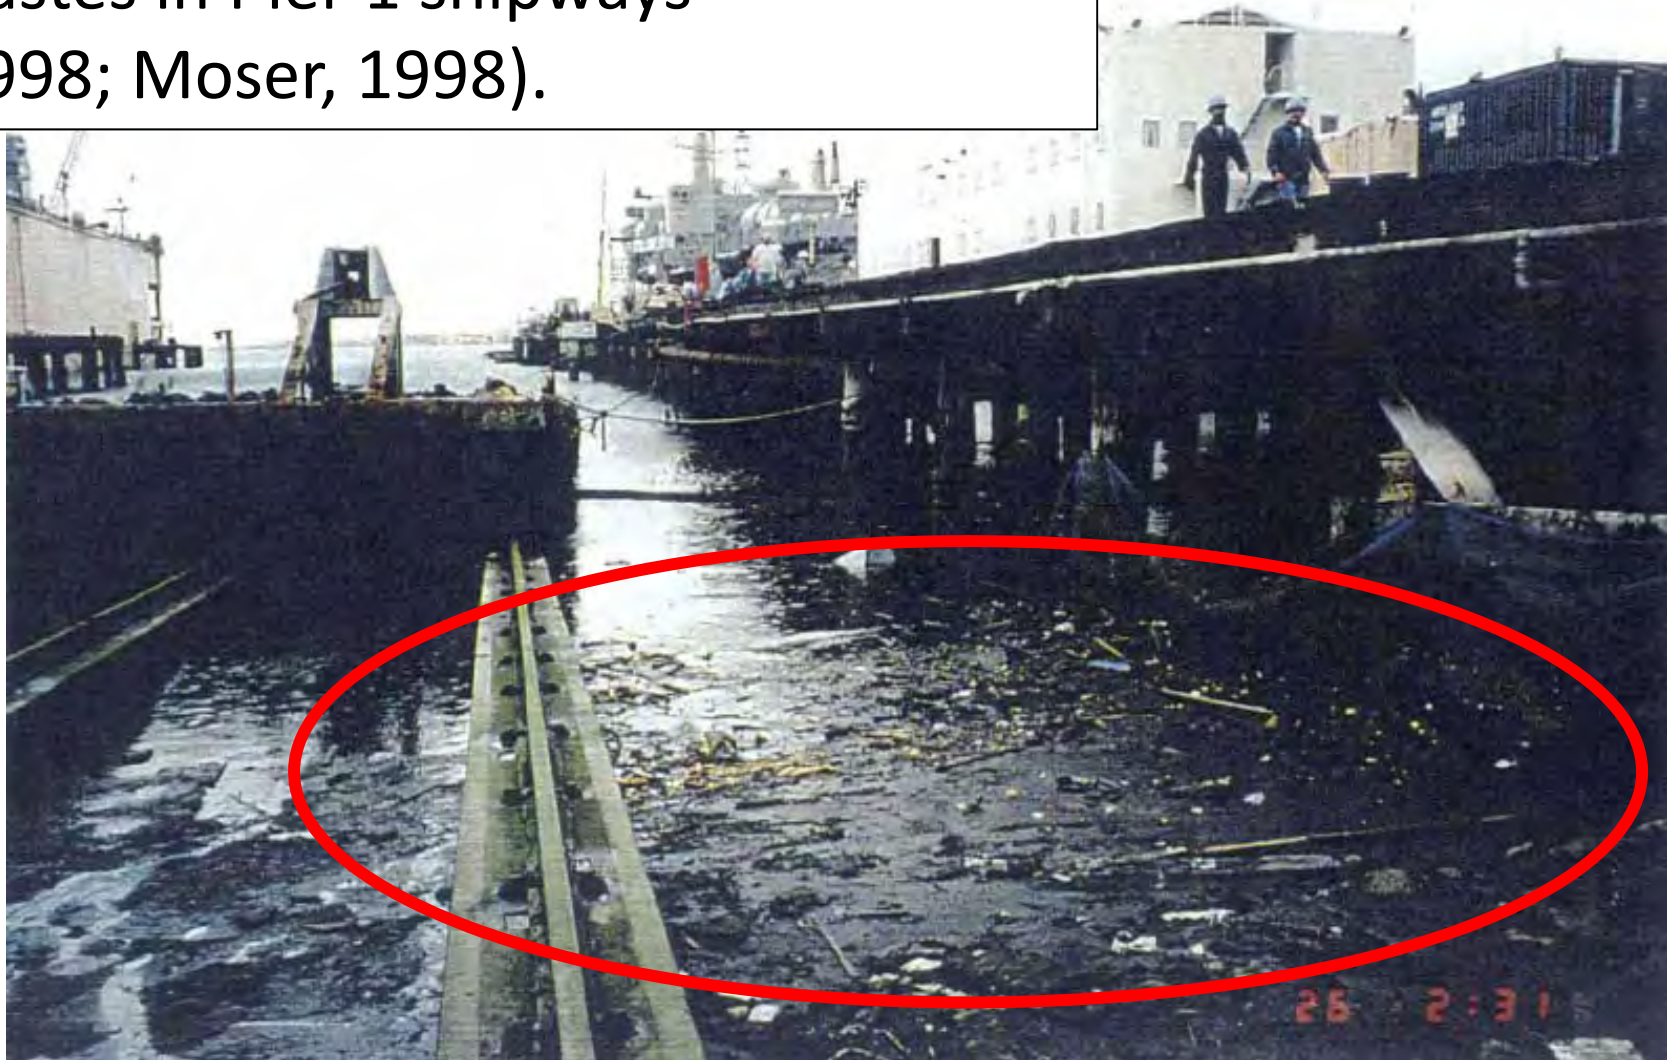
Wastes in Pier 1 shipways  
(1998; Moser, 1998).

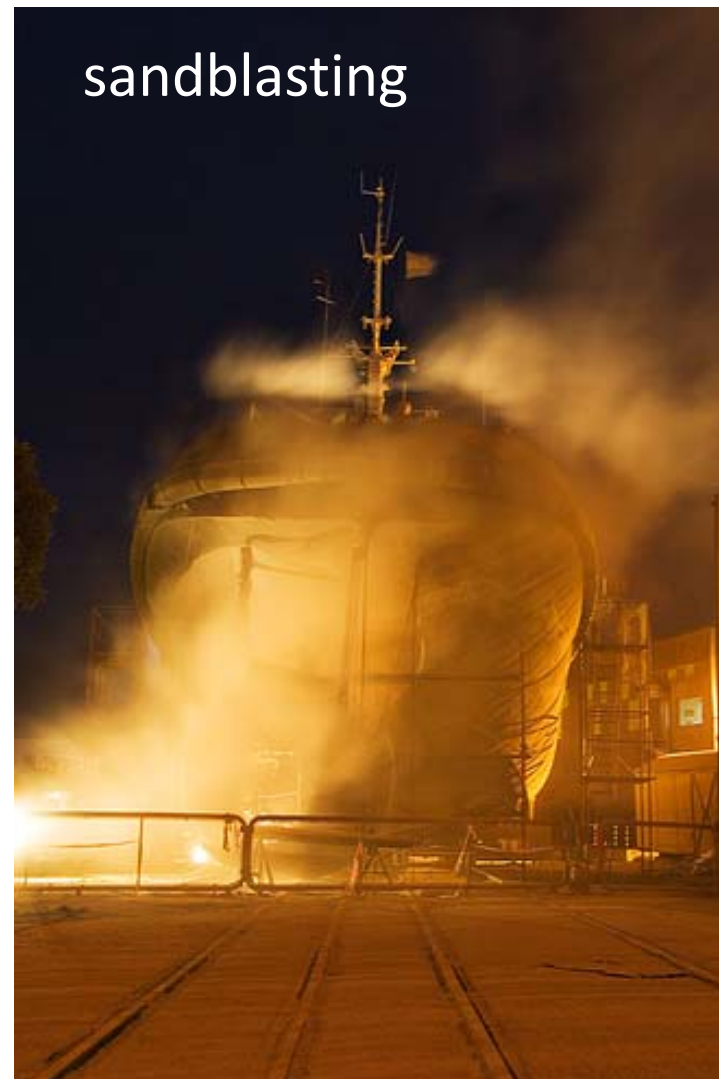
- Circa 1971, CRWQCB estimated that 5-10% of sandblasting material discharged to San Diego Shipyard Site, a mass of **~200-300 tons annually** (CRWQCB, 1972)
- During spray painting of ships in San Diego shipyards, 5-30% of paint is lost to the environment (USEPA, 1974)

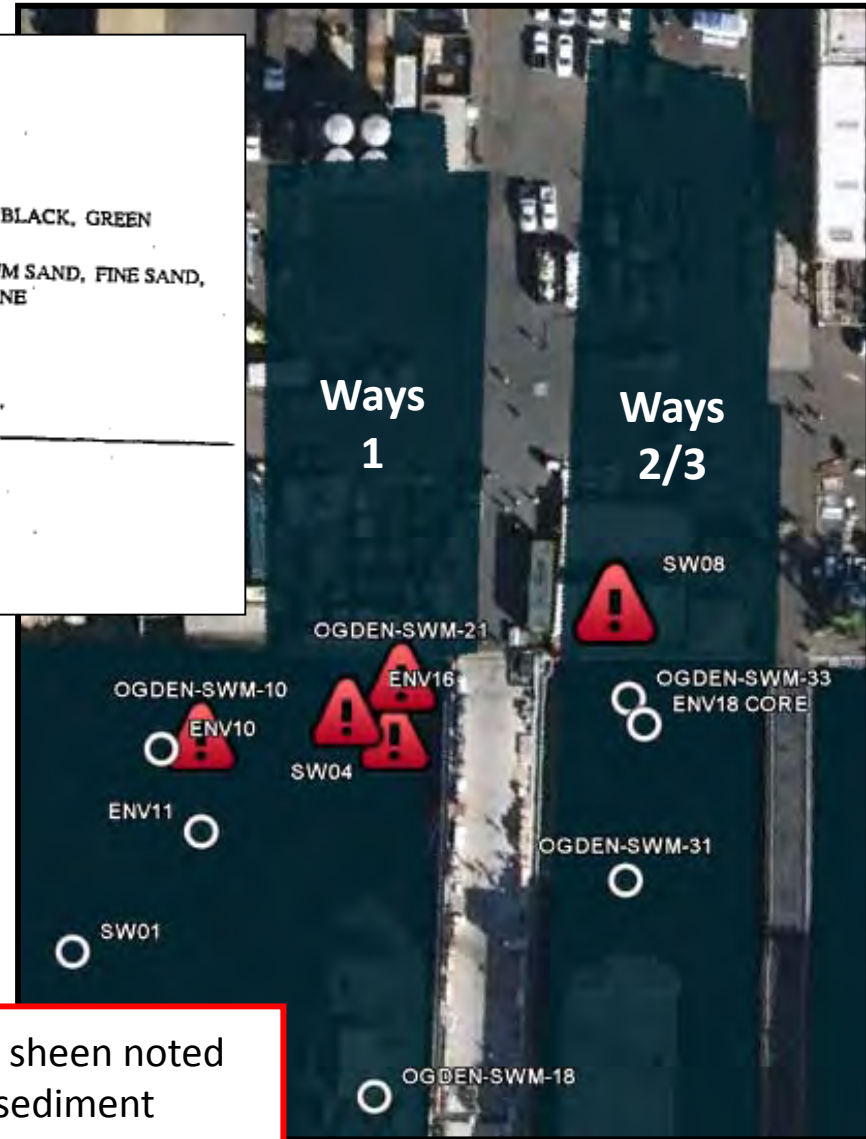
Does retrieval of core cause an OIL SHEEN?

YES / NO

+ Top 2 feet only

Oil sheen noted  
in sediment  
cores

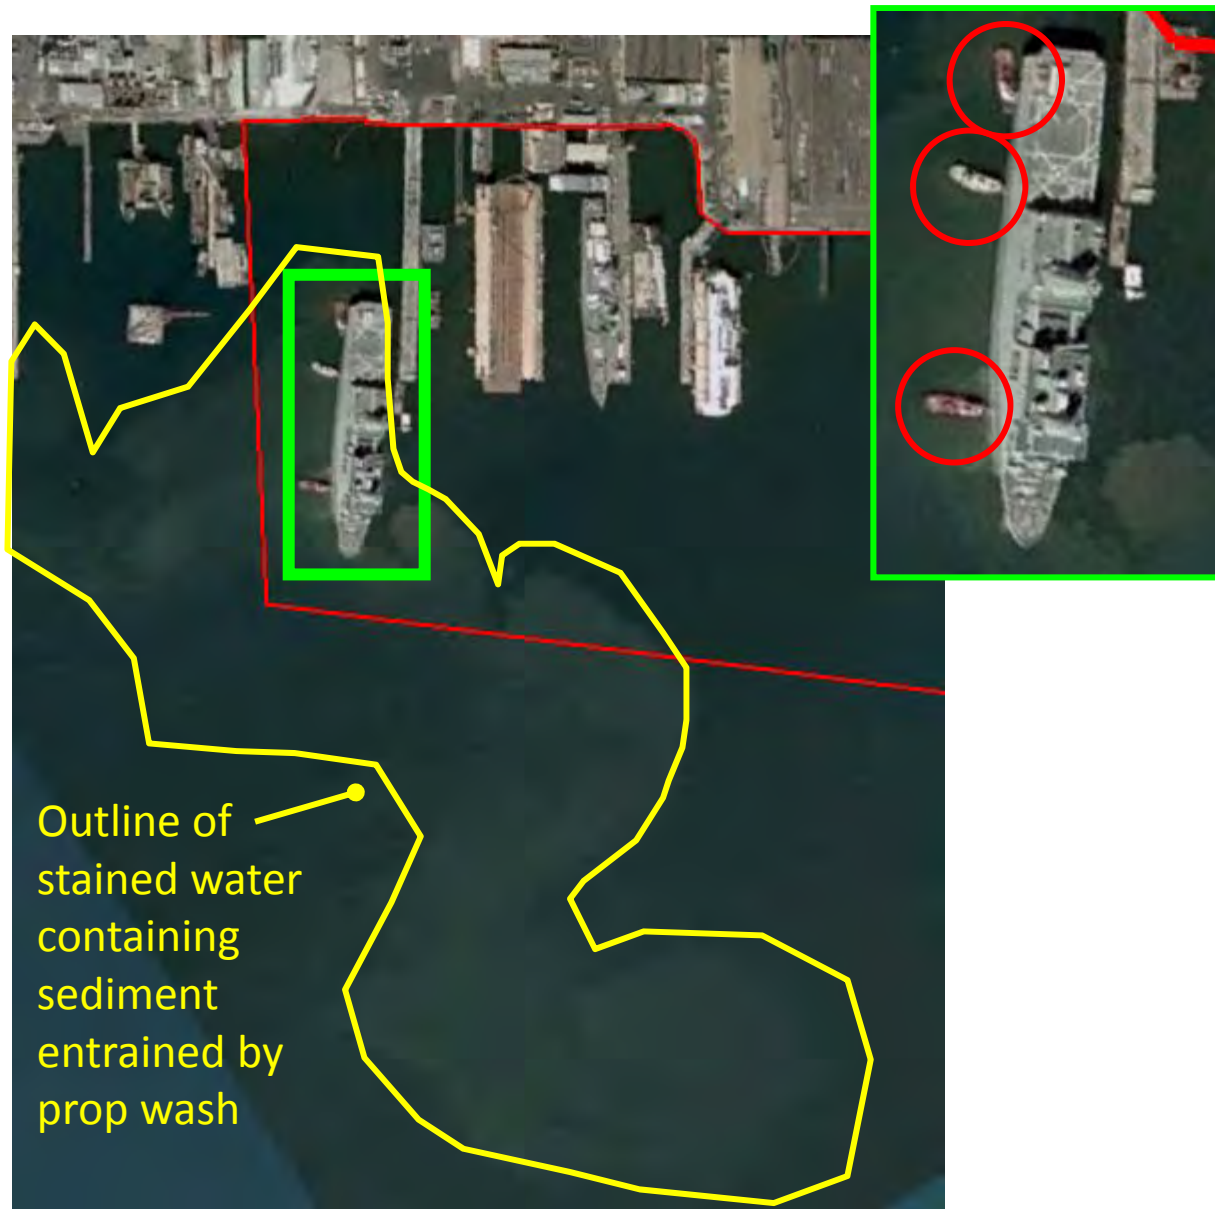
- Physical movement of sediment by shipyard activity:
  - Propeller wash (shown at left)
  - Dredging
  - In-water construction
