CSRMA and  
Chris Ewers, P.E.  
(Ewers Engineering)

# FORCE MAIN CONDITION: WHAT HAVE YOU GOT?

Serve your customers well. Plan ahead.

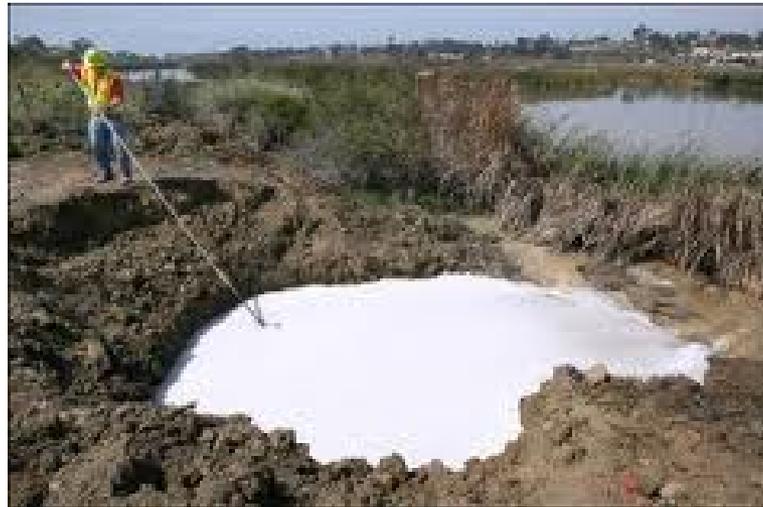
# Consequence of failure: Example 1

24" Force main rupture,  
3/31/07-4/3/07

7,300,000 gallons into lagoon

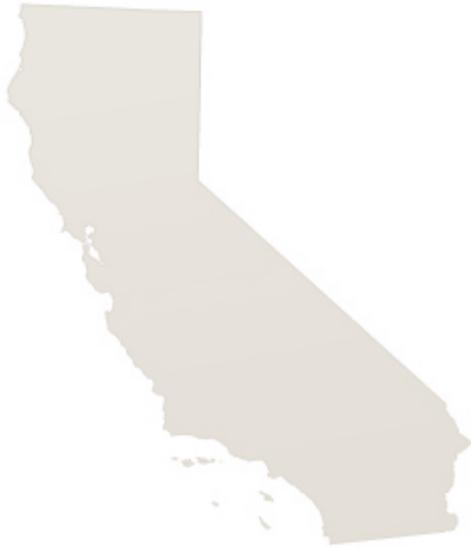
# Force Mains in California\*

- Age
  - ▣ Average: 32 years
- Length per agency
  - ▣ Average: 15 miles

*\*CSRMA survey of member agencies on force mains, 12/2012*

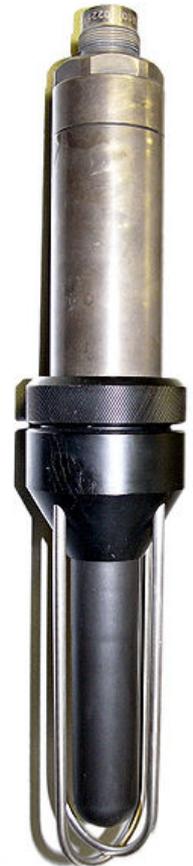
Technology: Acoustic sensing (hydrophone)

- Aided by high pressure, high flow ( $Re \geq 1,000$ )
- Sound of wastewater passing gas pockets permits their detection

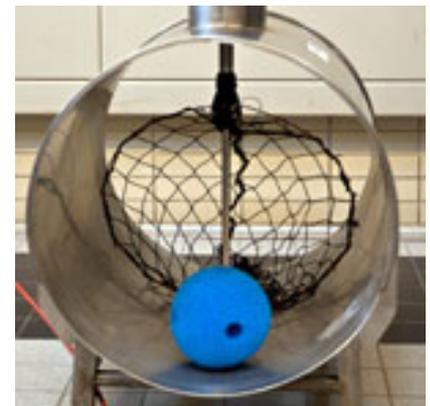
Technology: Acoustic sensing (hydrophone)

- Field hydrophones

- ▣ Attach hydrophone to live pipeline

- Sahara

- ▣ Tethered: Refined, repeatable location ( $\geq 0.25$  gpm leaks)

- Smartball

- ▣ Free-swimming: Accommodates long intervals at 3 mph min.

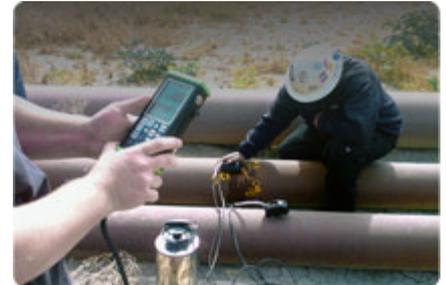
Tried,  
proven  
tool for  
profiling  
pipe wall

- Technology: **Ultrasonic Testing**
  - Coating removal, cleaning
  - Calibration with pipe wall required
  - Hand-held: B-Scan
  - Circumferential: Guided-Wave (50-500 ft.)

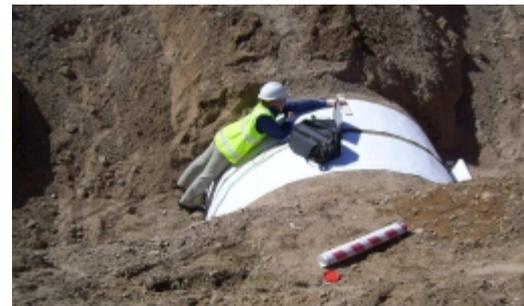
Hand-  
scan tool  
for  
detecting  
anomalies  
in ferrous  
pipes

- Technology: **Broadband Electromagnetic Testing**
  - Scans through 2” coating
  - Uses eddy current sensing
  - Data interpreted in Australia
  - Slow process finds relative changes in wall

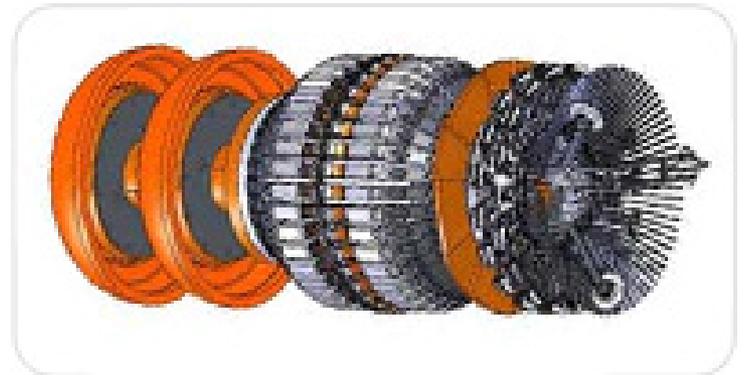
In-line  
tool with  
the finest  
resolution  
available  
for PCCP  
testing

- Technology: **Magnetic Flux Leakage**
  - In-line, sized to match pipe
  - Scans through mortar coating
  - Requires full-diameter access
  - Characterizes PCCP strand damage, small pits in ferrous walls
  - Cracks are often not detected

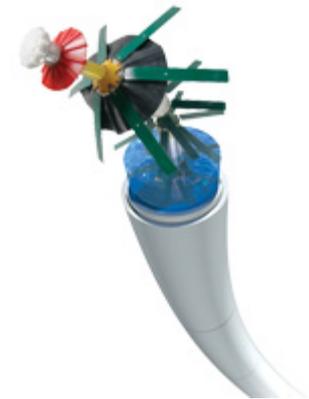
Live-pipe,  
free-  
swimming  
test of  
PCCP pipe  
walls

- Technology: **Remote Field Transformer Coupling (Pipe Diver)**
  - In-line, scans through mortar coating
  - Launch in live force main
  - Characterizes PCCP strand damage, ferrous pipe wall damage
  - Navigates bends, valves

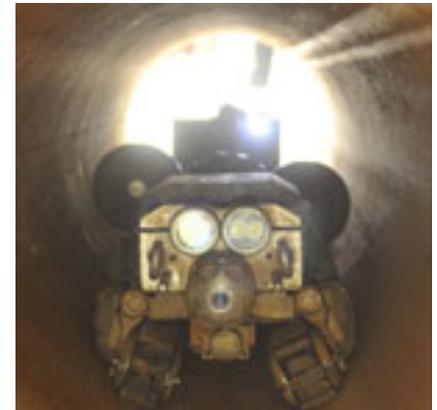
Flooded-  
pipe  
platform  
that can  
test PCCP  
pipe walls

- Technology: **SONAR, P-wave electro magnetics, CCTV, laser profiling, (robotic platform)**
  - In-line, tethered
  - Crawl 40 feet/min.,  $\leq 8,000$  feet
  - Float  $\leq 16,000$  feet
  - Characterizes PCCP strand damage, profiles, visual assessment
