AN ASSESSMENT OF ROAD REMOVAL AND  
EROSION CONTROL TREATMENT EFFECTIVENESS:  
A COMPARISON OF 1997 STORM EROSION RESPONSE BETWEEN TREATED  
AND UNTREATED ROADS IN REDWOOD CREEK BASIN,  
NORTHWESTERN, CALIFORNIA

A Thesis

In Environmental Systems: Geology

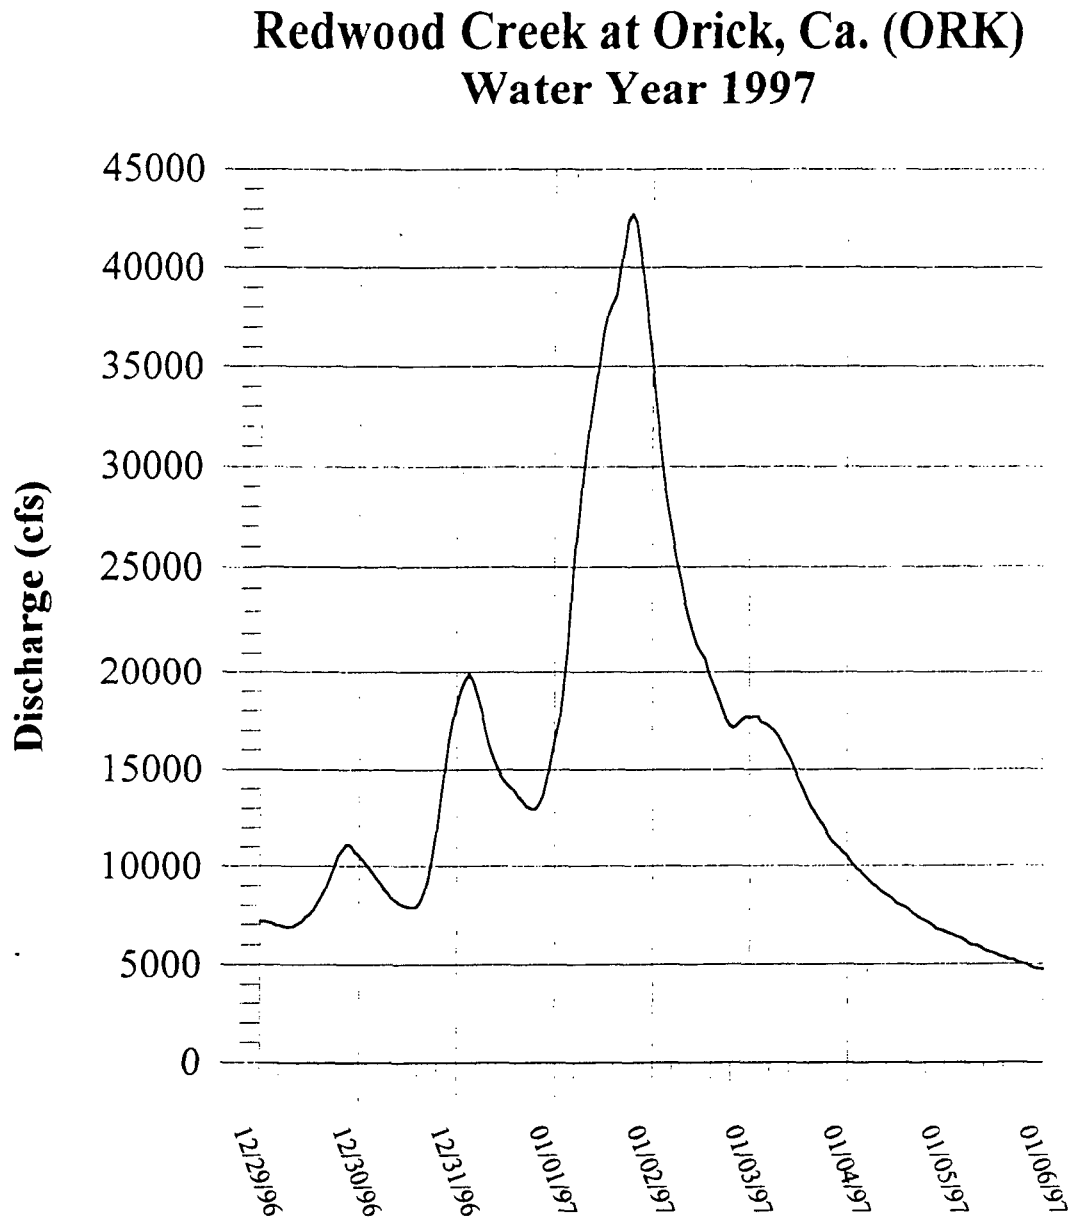
Figure 2. 1997 Storm flood hydrograph, created by Tom Marquette from data collected by Redwood National and State Parks.

Between December 31, 1996 and January 1, 1997, Bridge Creek experienced its largest storm since 1975. The Elk Camp rain gage, located directly across from the Forty-four Creek, a tributary to Redwood Creek, recorded precipitation amounts of 7.6 inches in 24 hours, and 2.54 inches in 6 hours (Redwood National and State Parks, in house records, 1997). Isopluvial maps for the region indicate that these events have recurrence intervals of  $Tr = 18$  years and  $Tr = 3$  years, respectively (Miller et al., 1973). Peak discharges measured on Redwood Creek at Orick had  $Tr = 12$  years (Redwood National and State Parks, in house records, 1997). These differences in recurrence intervals suggest that this storm was a long duration event, rather than a high intensity event. Long storm duration is also demonstrated by the elongated flood peak on the flood hydrograph for Orick, which is near the mouth of Redwood Creek (see Figure 2). Additionally, previous storms in the region resulted in wet antecedent conditions prior to this 1996-1997 storm event.

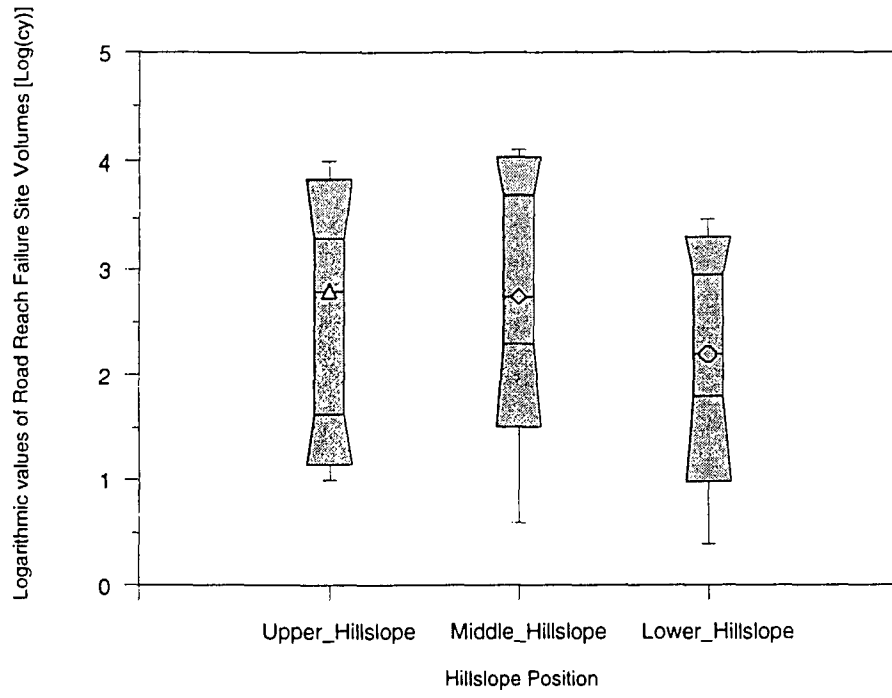
Figure 10. Post-treatment and 1997 storm road failure site volumes.

The middle and upper hillslope road failure volume populations are from the same data population based on their distributions and means (Kolmogorov-Smirnov test, K-S value = .188, probability = .941) (two-tailed, unpaired t-test, p-value = .512). This relationship is moderately apparent in the box whisker diagram in Figure 8. The subtle sample difference between these and the lower hillslope road failure volumes, as displayed in Figure 10, is not statistically significantly different.

According to respective means and medians (see Table 4), failure site volumes on lower hillslopes were slightly smaller than failures on upper and middle hillslopes (see Figure 10). However, lower hillslopes experience a greater frequency and overall volume of erosion per mile, than middle or upper hillslopes (see Table 4 and Figures 11 and 12). The smaller failure volumes may be attributed to the limited distance for a debris flow to run its course. For example, if a failure originates 50 feet above Bridge Creek, the break in hillslope at the creek will serve as a buttress. The greater number of failures may be attributed to the compounded influence of ground and surface water in the lower slope region.

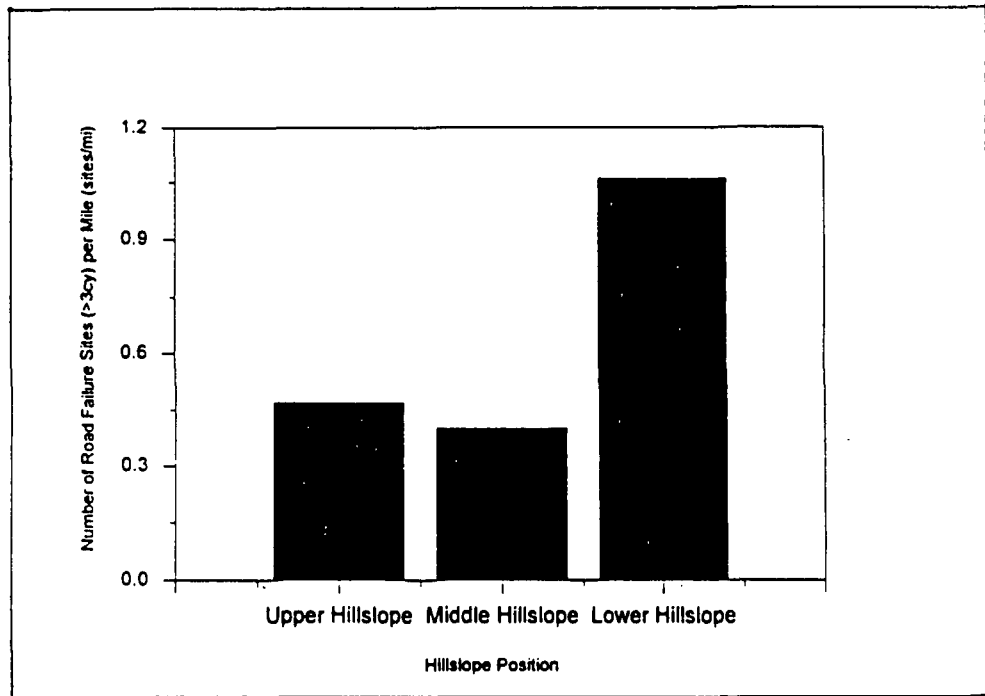
Figure 11. Number of road reach failure sites per mile.

It is visually (see Figures 11 and 12) and statistically apparent that the lower hillslope road failure data population is substantially different from middle and upper hillslope data

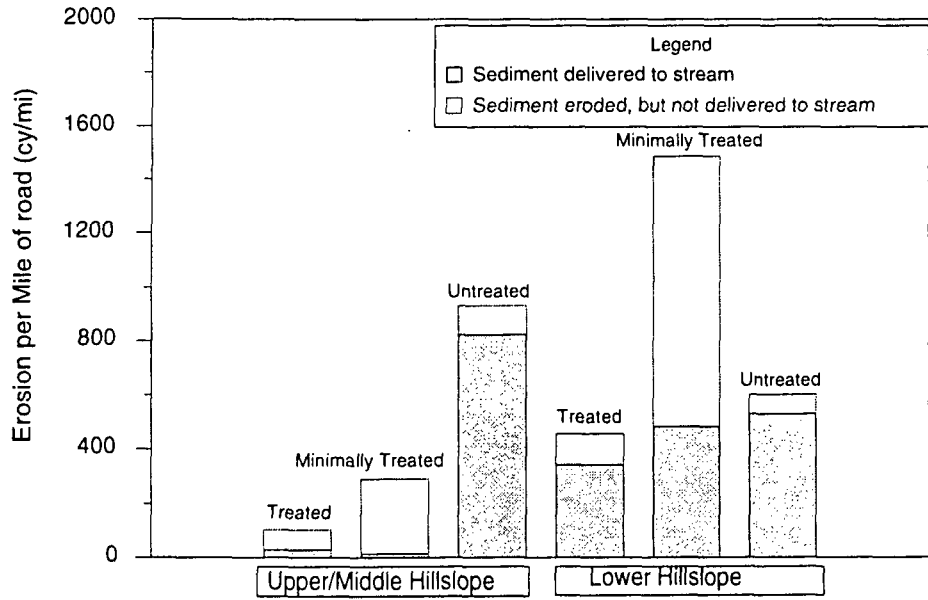
Figure 13. Total volume of road reach erosion per mile.

On the inventoried upper and middle hillslope roads, the untreated roads contributed 27 times more sediment per mile to streams than treated roads, and 59 times more sediment per mile to streams than minimally treated roads (see Table 5 and Figure 13) (for data, see Appendix VI). The lower hillslope untreated roads contributed 1.5 times more sediment per mile of road to streams than treated roads, and 1.1 times more sediment per mile of road to streams than minimally treated roads.
