**GEOTECHNICAL ASSESSMENT OF  
ALTERNATIVE RESERVOIR SITES  
AND PIPELINE ROUTES  
VOLUME 1 - REPORT**

**SANTA ROSA SUBREGIONAL  
LONG-TERM WASTEWATER PROJECT**

**City of Santa Rosa  
and  
U.S. Army Corps of Engineers**

**January 1996**

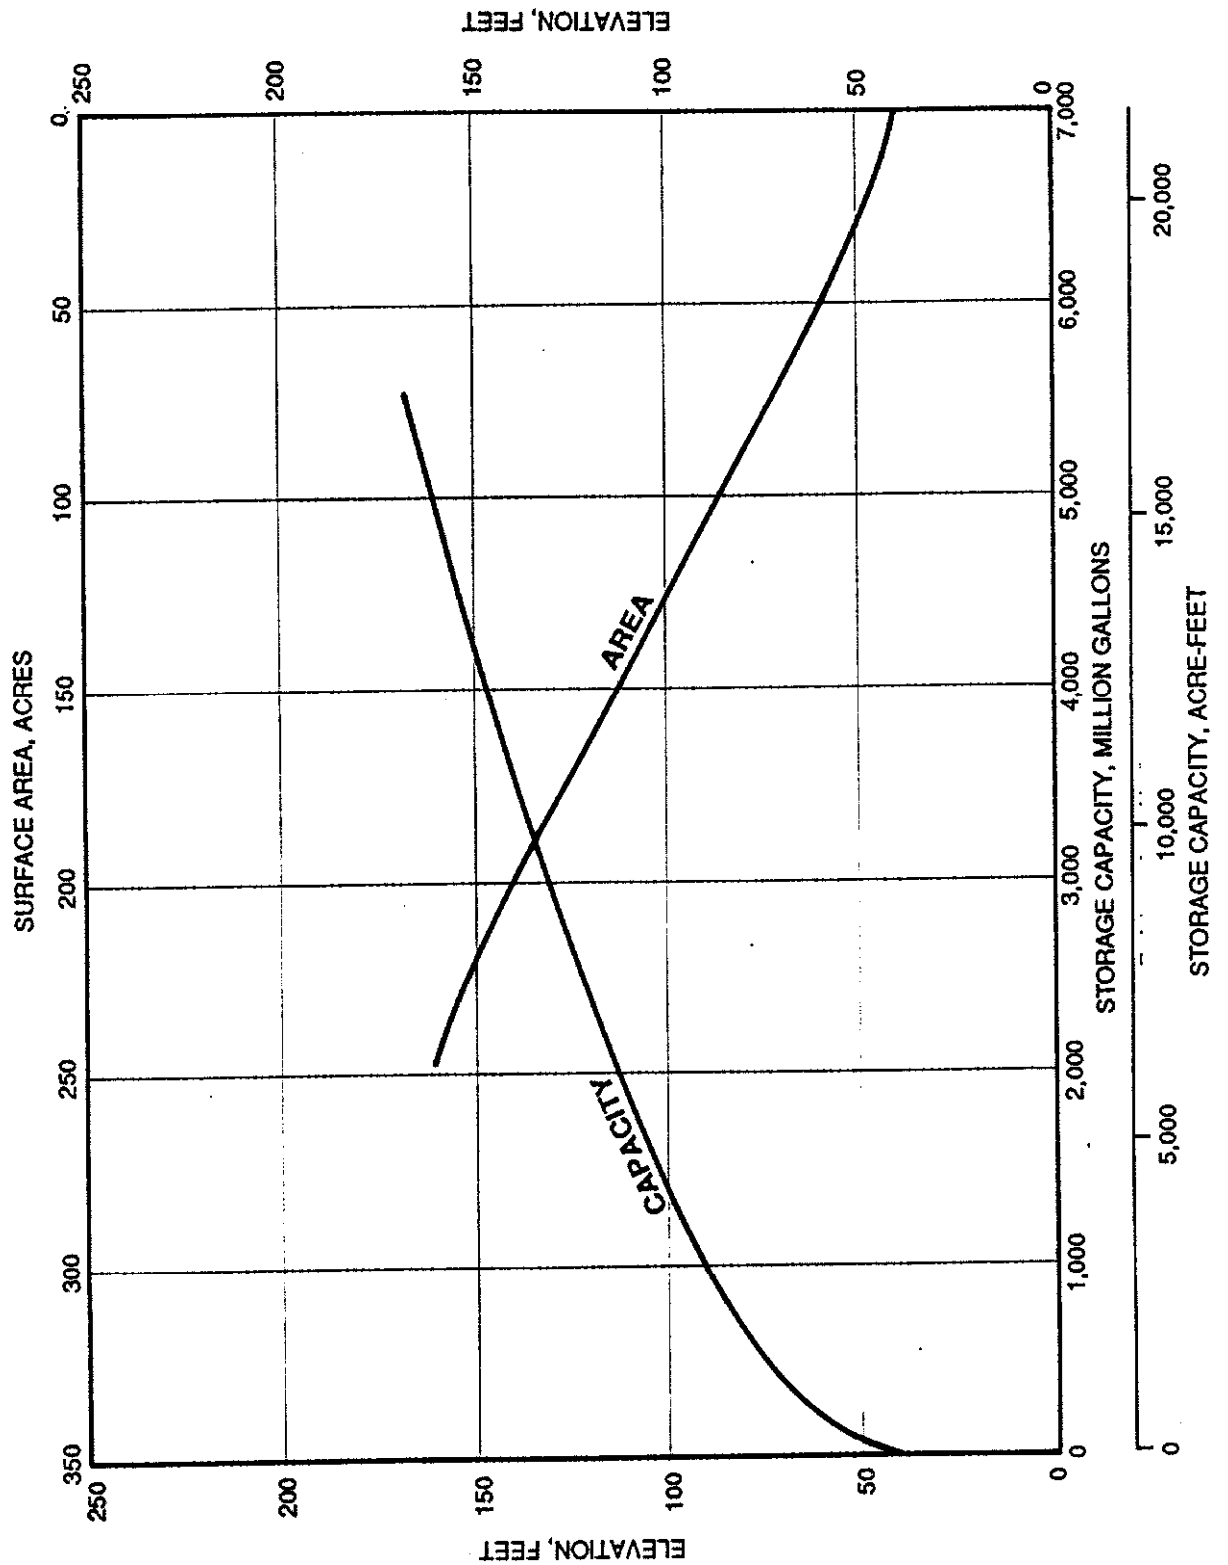
PROJECT NO. 88230
DATE OCTOBER 1995
FIGURE NO. 6-1

RESERVOIR AREA - CAPACITY CURVE  
VALLEY FORD EAST RESERVOIR SITE  
SANTA ROSA SUBREGIONAL LONG TERM  
WASTEWATER PROJECT

To size the embankment dam required at the various alternative storage sites, necessary for design and cost estimating, area-capacity curves were developed for each reservoir site. These relationships are provided on Figures 6-1 through 6-10 for the Valley Ford East, Carroll Road North, Bloomfield, Huntley, Two Rock, Adobe Road, Tolay Creek, Lakeville Hillside, and Sears Point sites, respectively. As indicated in Section 2, Table 2-1, two different reservoir configurations are evaluated for the Tolay Creek alternative storage site, one without a backdam (configuration "A" by others and referenced herein as "without backdam") and one with a backdam (configuration "C" by others and referenced herein as "with backdam"). The area-capacity curves for the Tolay Creek site without and with a backdam are provided on Figures 6-8 and 6-9, respectively. The curves are based on reservoir areas and estimated storage volumes above existing ground contours and upstream of the proposed dam axis. The area and capacity curves for this conceptual level of detail do not take into account the presence of the embankment fill upstream of the dam axis, which would tend to be compensated by increased area and capacity from borrow of construction materials from the reservoir area.

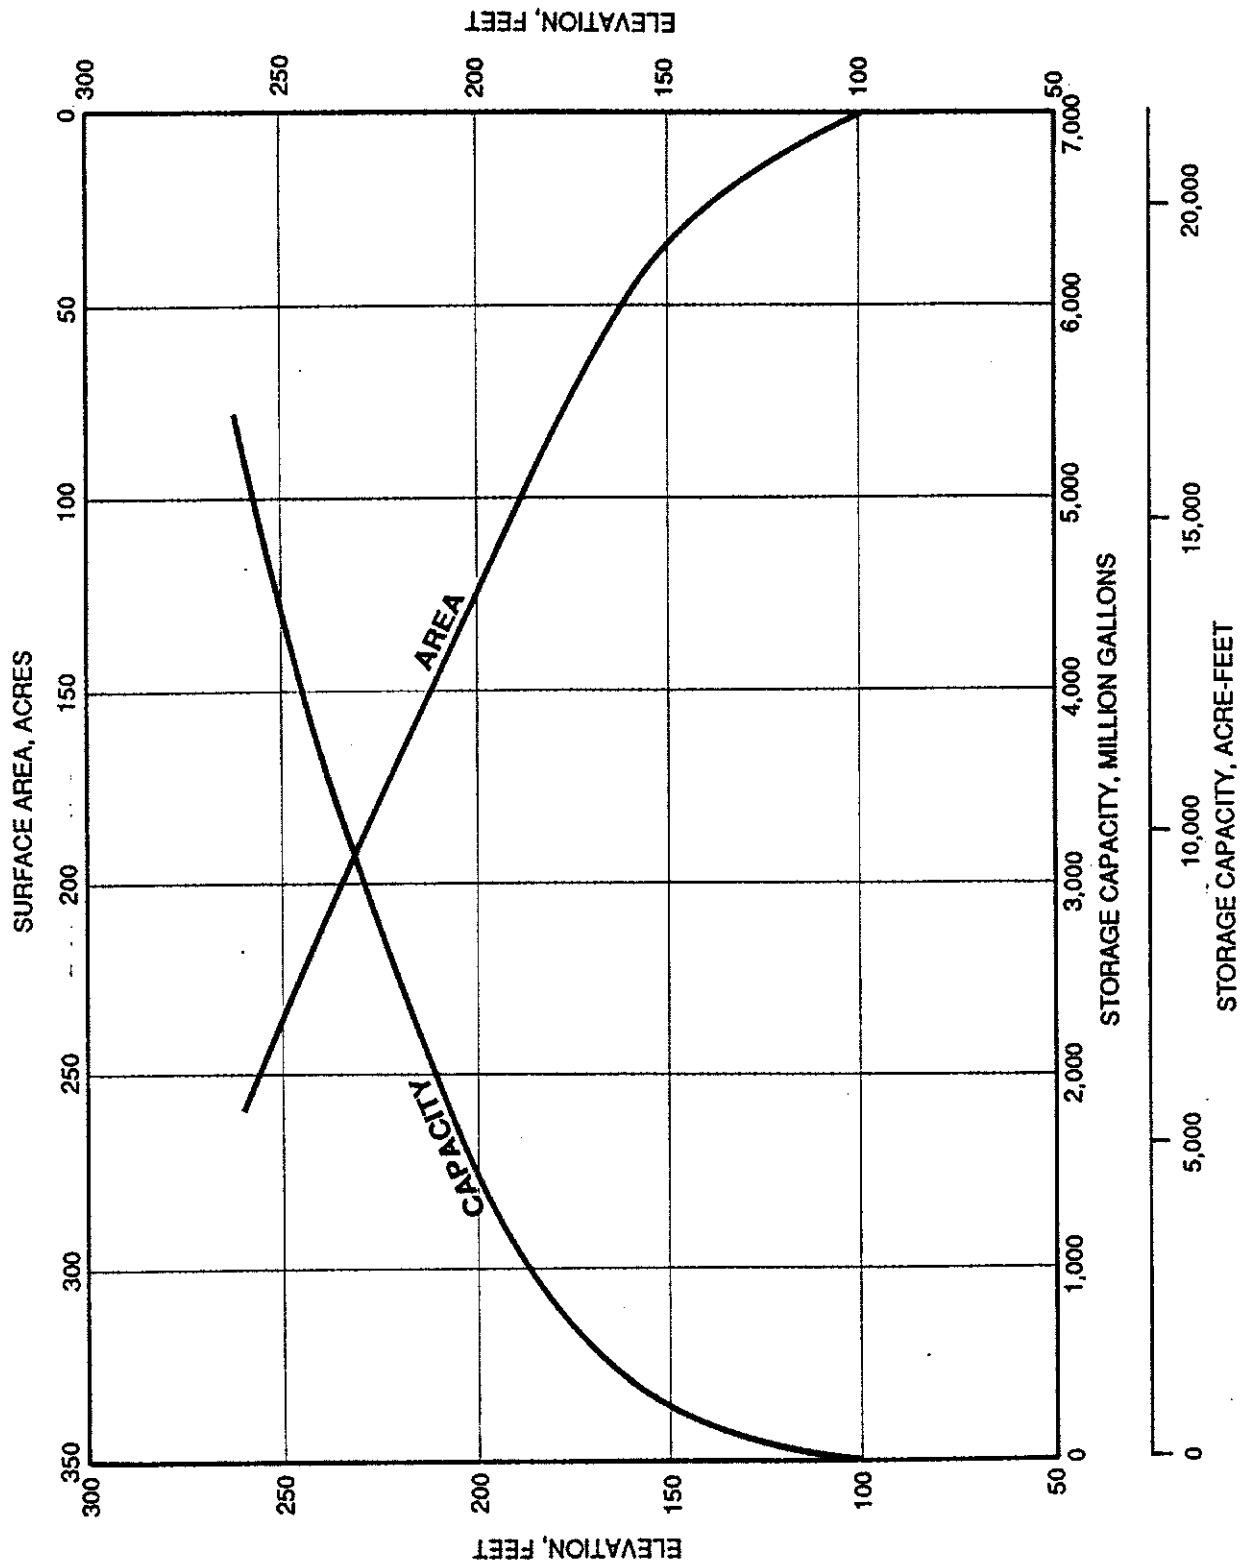
PROJECT NO.  
88230  
DATE  
OCTOBER 1995  
FIGURE NO.  
6-2

RESERVOIR AREA - CAPACITY CURVE  
CARROLL ROAD NORTH RESERVOIR SITE  
SANTA ROSA SUBREGIONAL LONG TERM  
WASTEWATER PROJECT

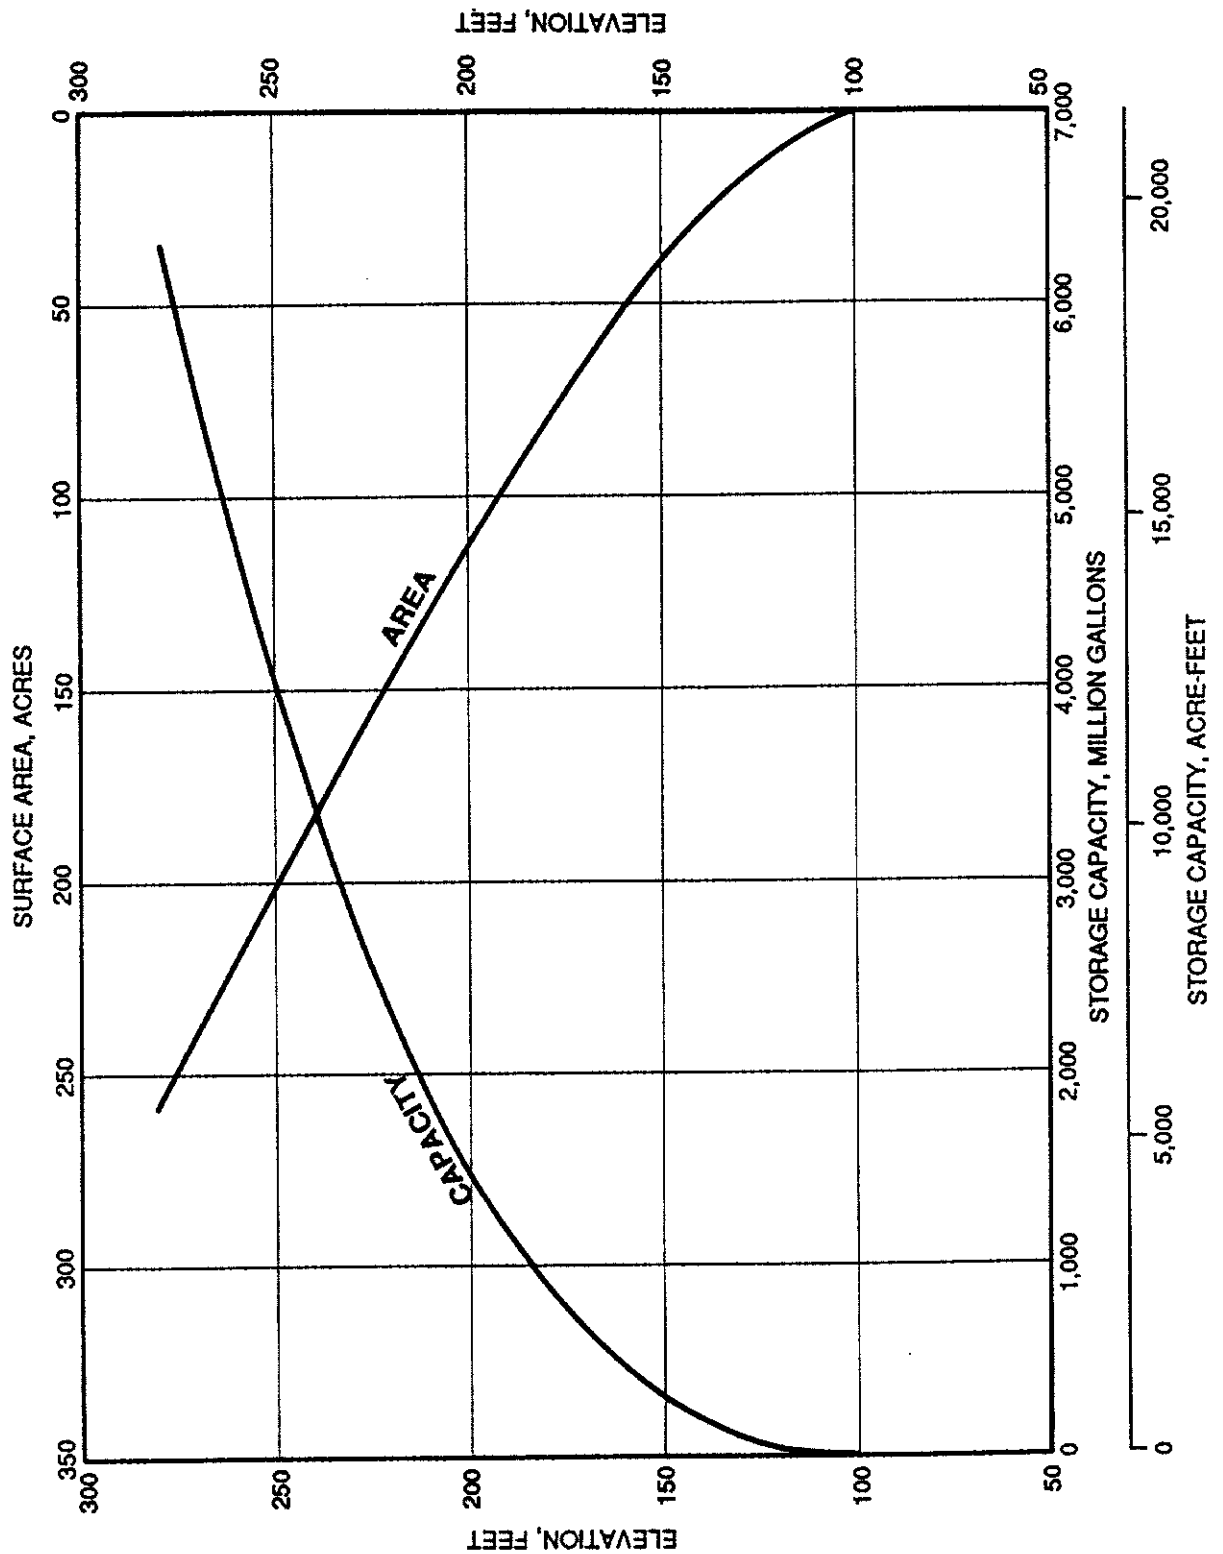
PROJECT NO.  
88230  
DATE  
OCTOBER 1995  
FIGURE NO.  
6-3

RESERVOIR AREA - CAPACITY CURVE  
BLOOMFIELD RESERVOIR SITE  
SANTA ROSA SUBREGIONAL LONG TERM  
WASTEWATER PROJECT

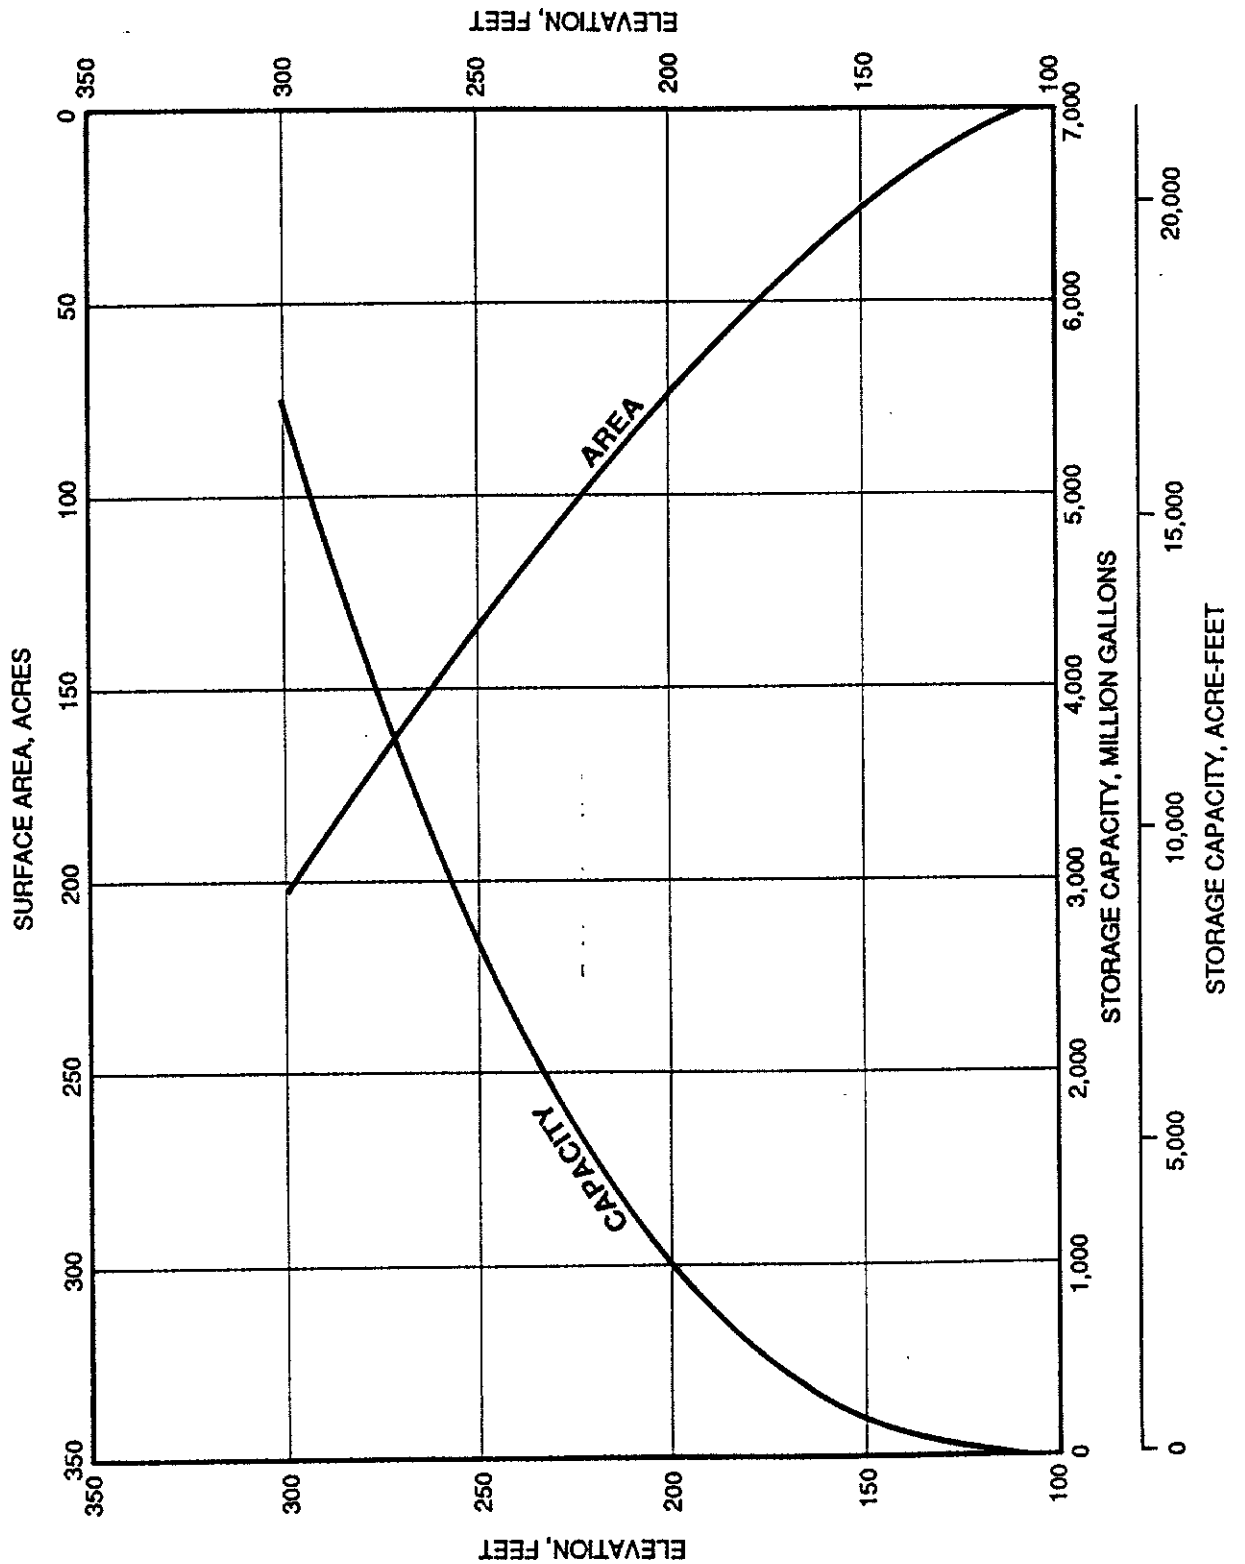
PROJECT NO.  
88230  
DATE  
OCTOBER 1995  
FIGURE NO.  
6-4

RESERVOIR AREA - CAPACITY CURVE  
HUNTLEY RESERVOIR SITE  
SANTA ROSA SUBREGIONAL LONG TERM  
WASTEWATER PROJECT

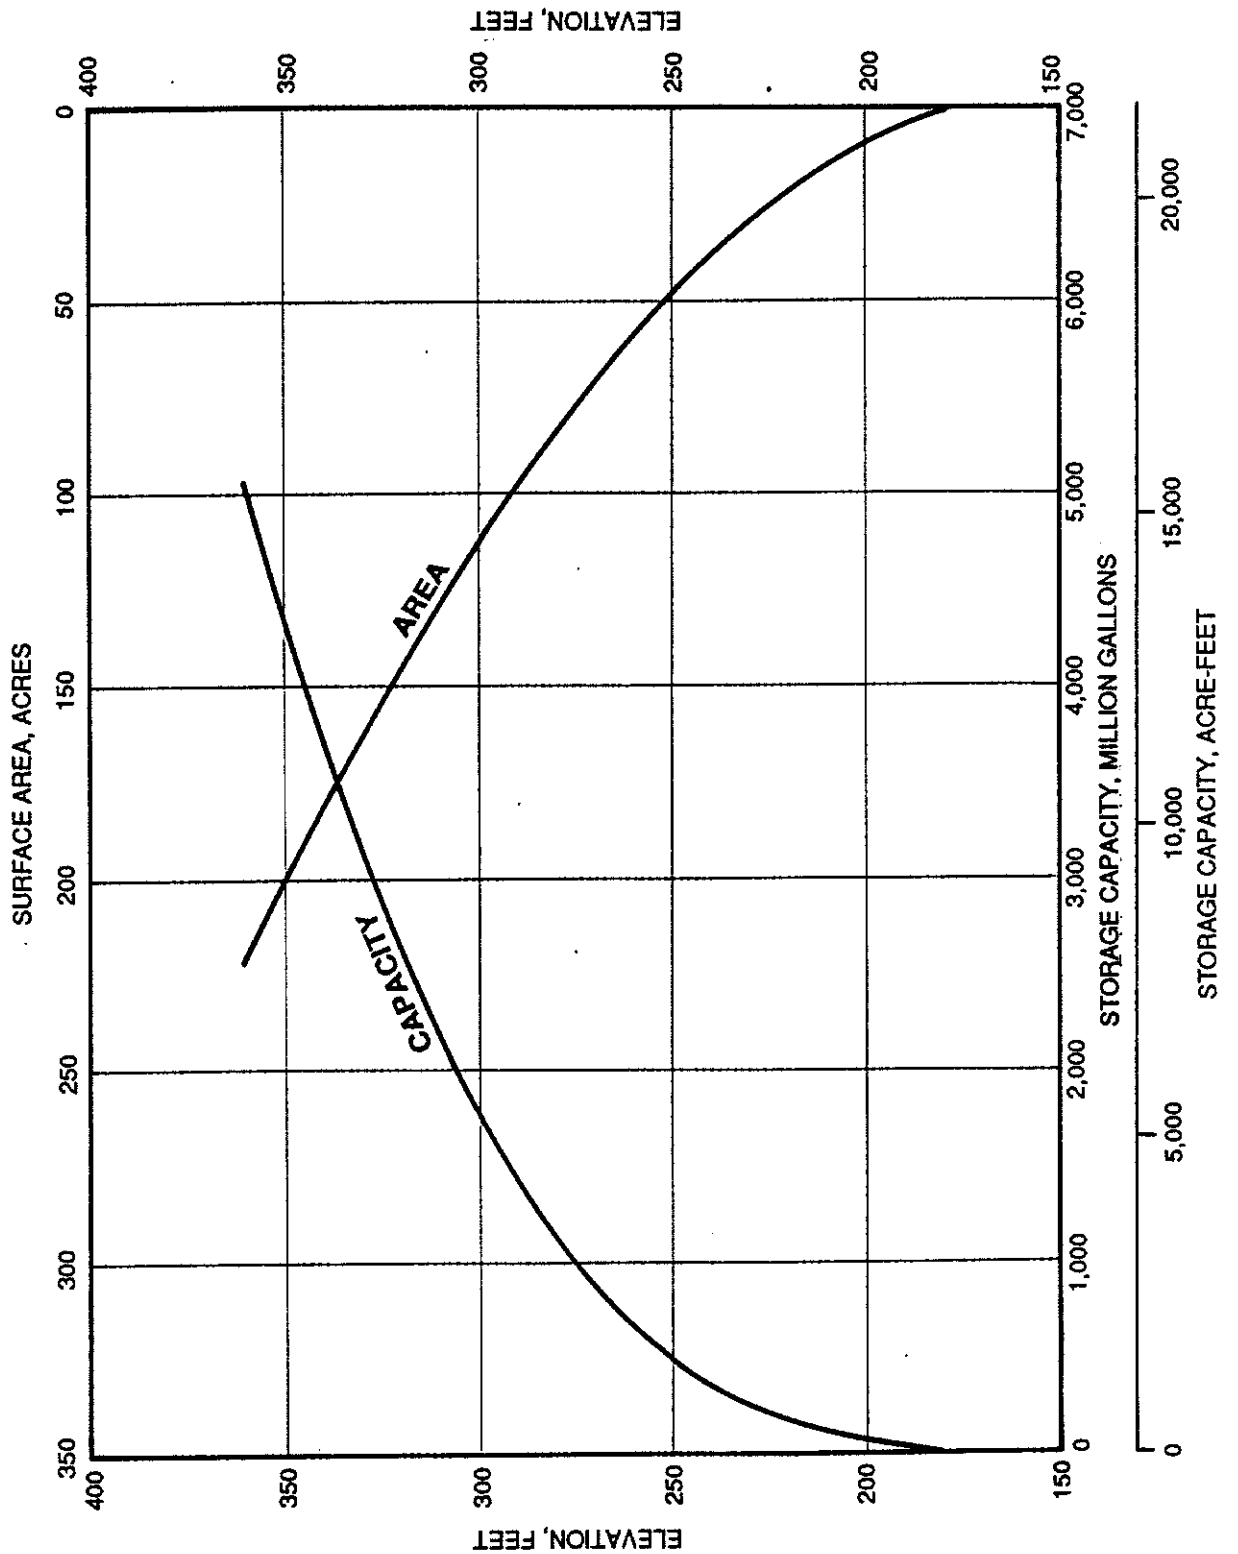
PROJECT NO.  
88230  
DATE  
OCTOBER 1995  
FIGURE NO.  
6-6

RESERVOIR AREA - CAPACITY CURVE  
ADOBE ROAD RESERVOIR SITE  
SANTA ROSA SUBREGIONAL LONG TERM  
WASTEWATER PROJECT

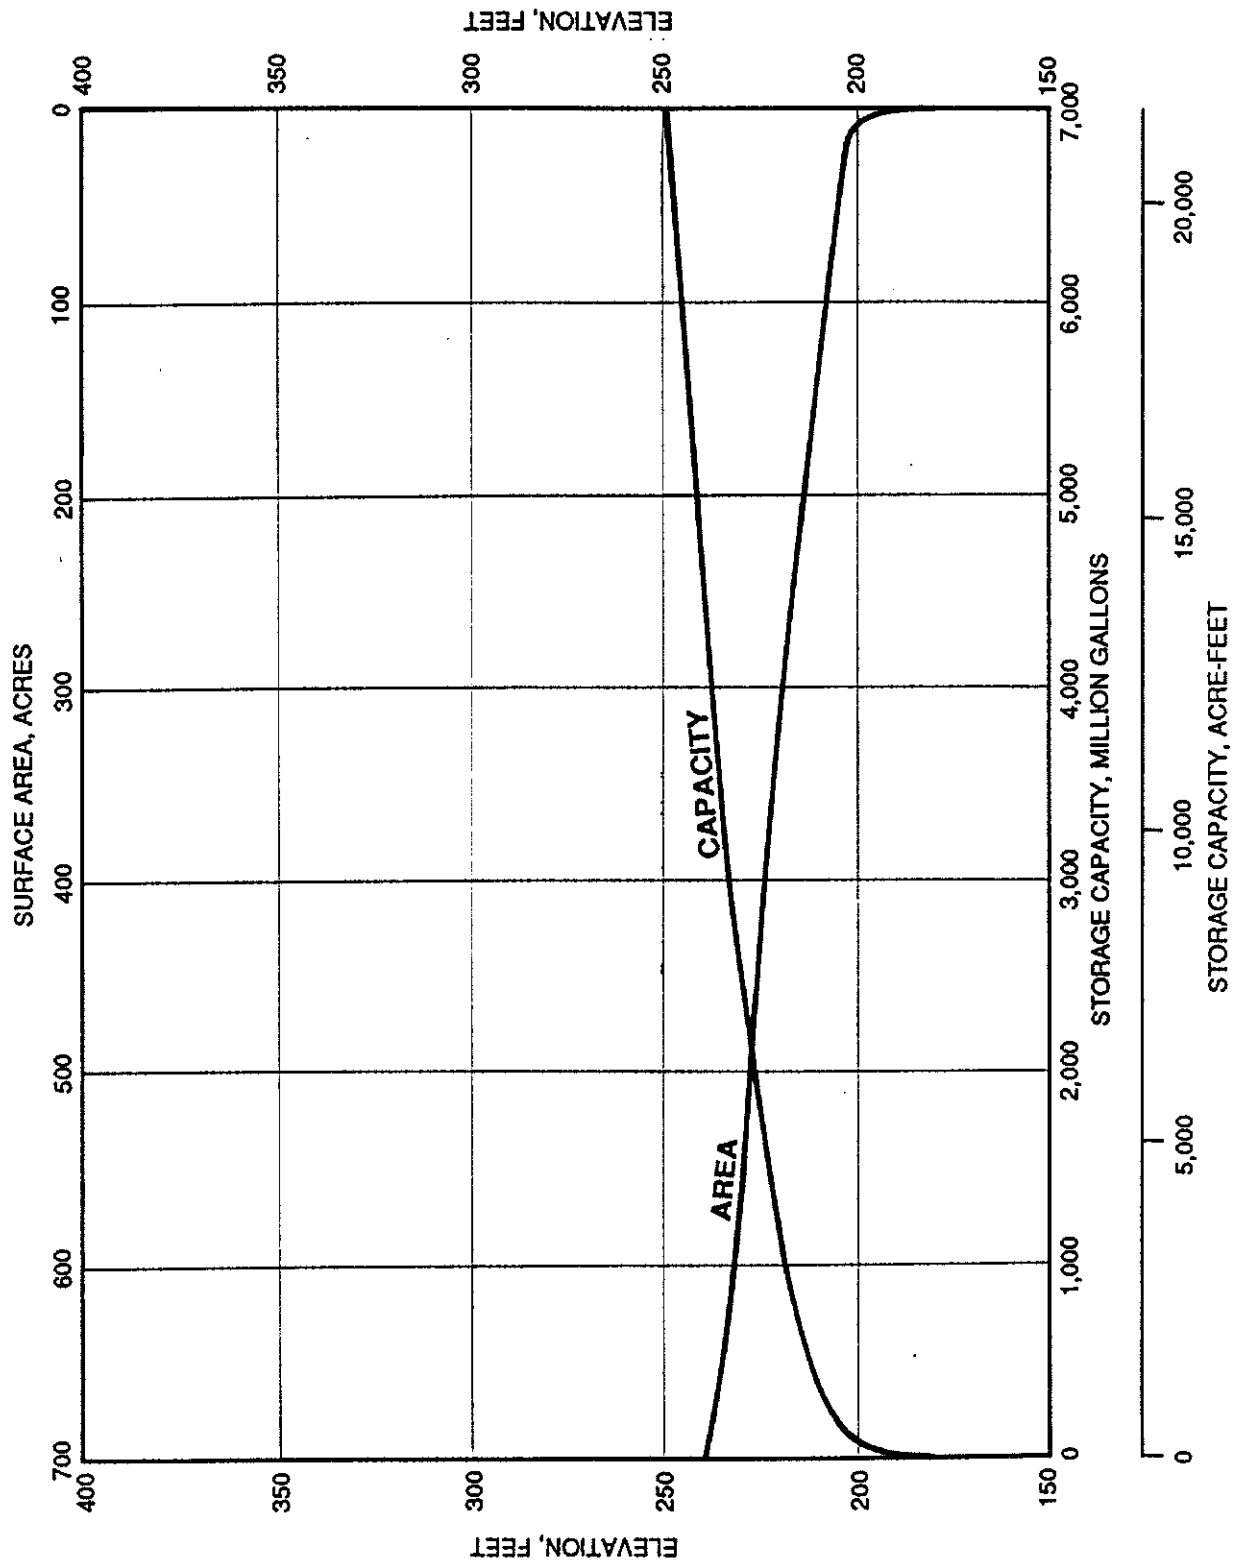
PROJECT NO.  
 88230  
 DATE  
 OCTOBER 1995  
 FIGURE NO.  
 6-8

**RESERVOIR AREA - CAPACITY CURVE**  
**TOLAY CREEK RESERVOIR SITE**  
 (without BACKDAM)  
**SANTA ROSA SUBREGIONAL LONG TERM**  
**WASTEWATER PROJECT**

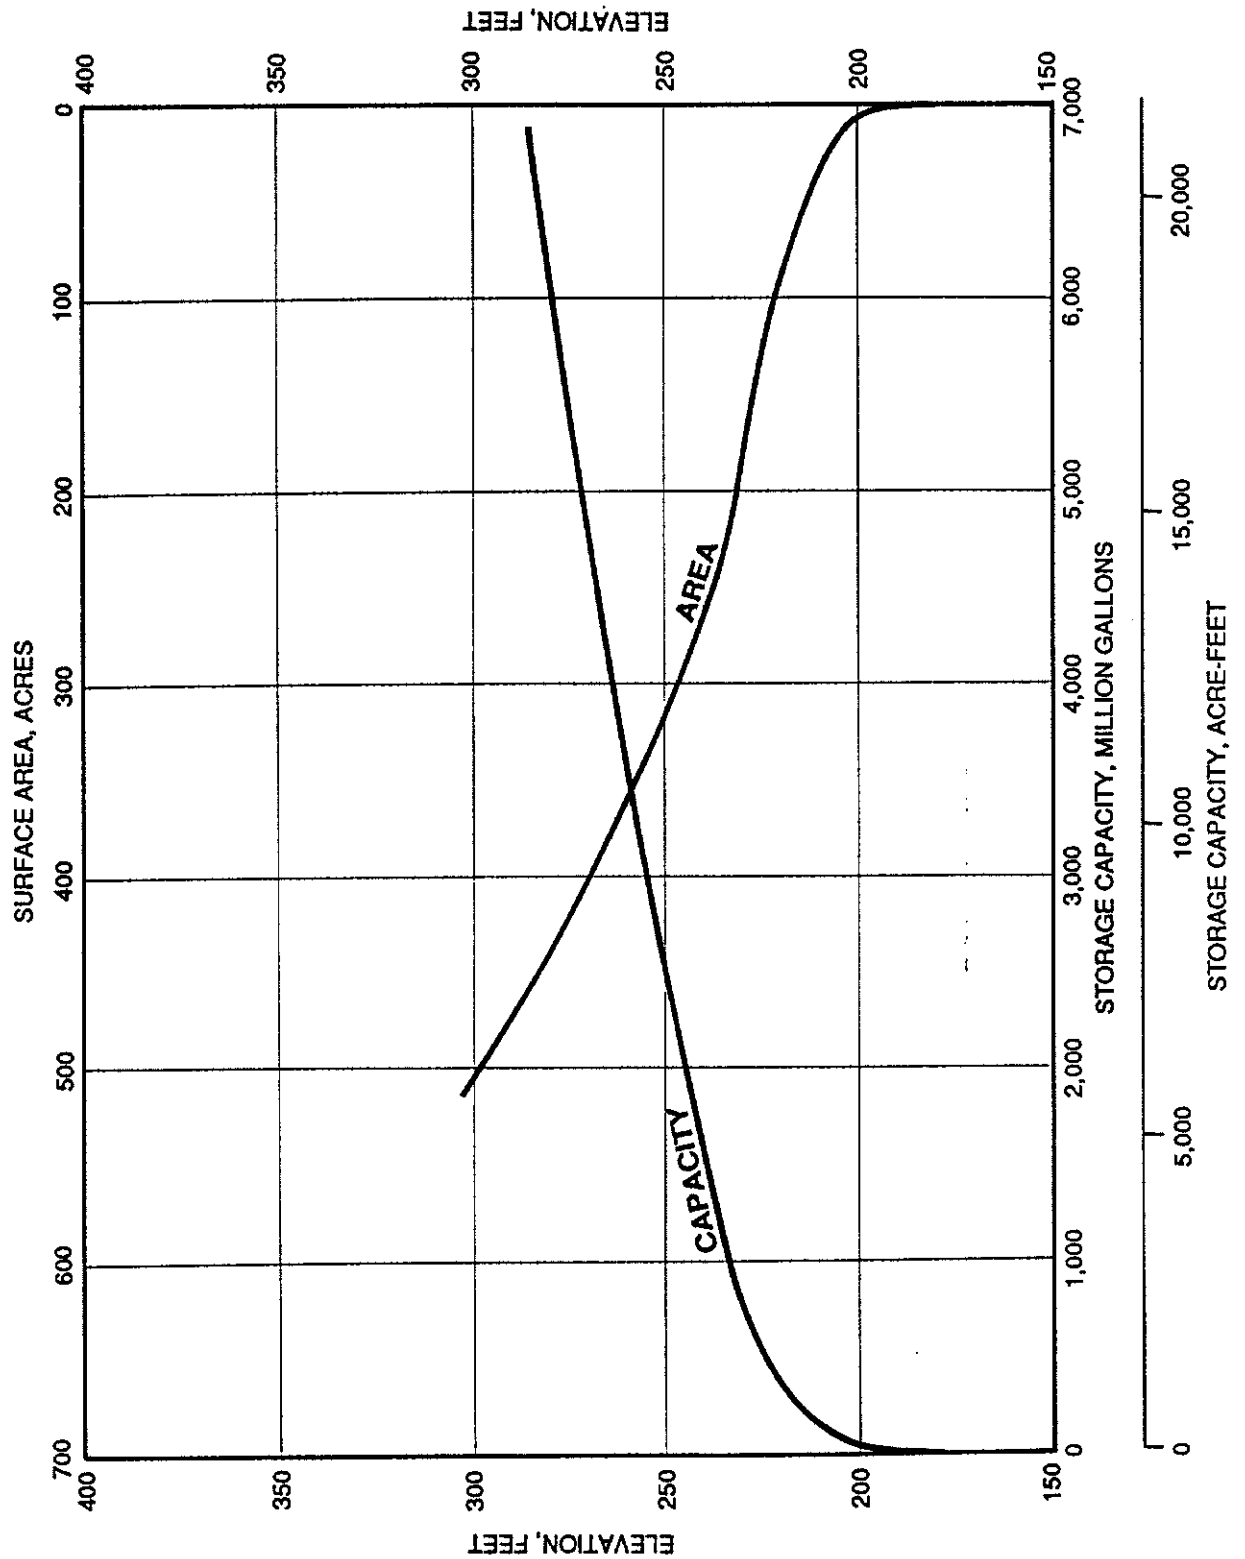
PROJECT NO.  
88230  
DATE  
OCTOBER 1995  
FIGURE NO.  
6-9

RESERVOIR AREA - CAPACITY CURVE  
TOLAY CREEK RESERVOIR SITE  
(with BACKDAM)  
SANTA ROSA SUBREGIONAL LONG TERM  
WASTEWATER PROJECT

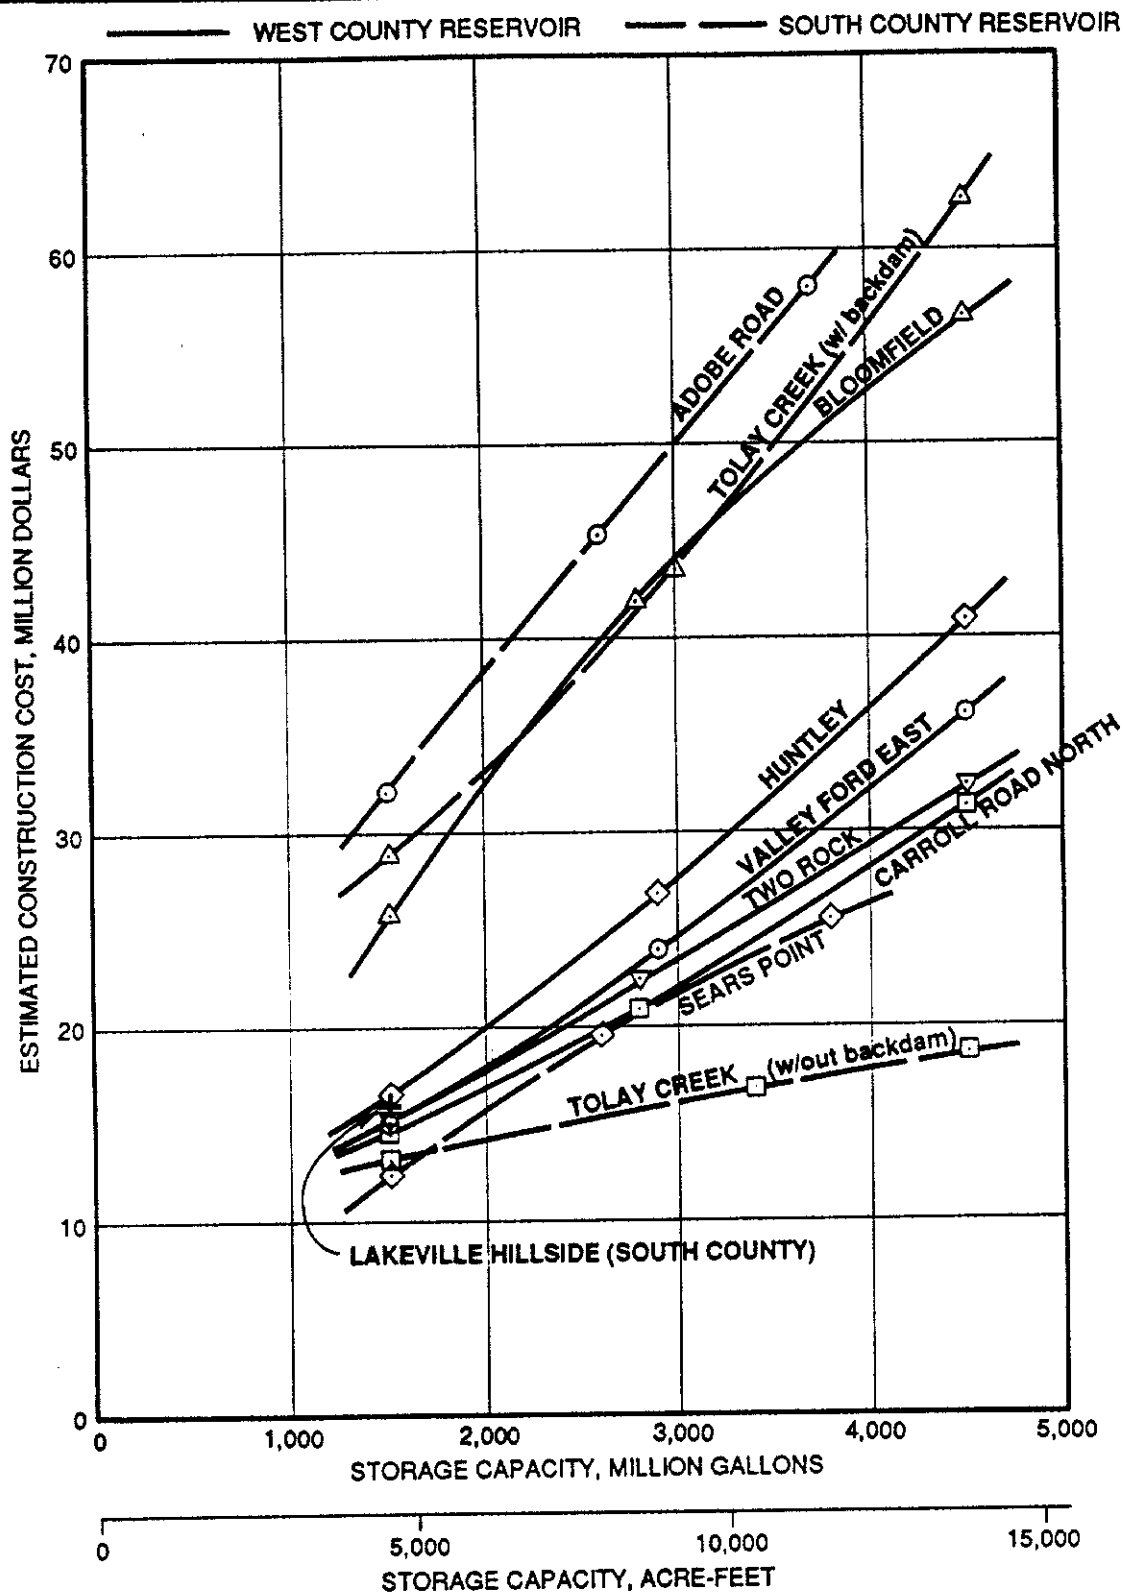
PROJECT NO.  
88230  
DATE  
OCTOBER 1995  
FIGURE NO.  
8-2

NOTE: ESTIMATED COSTS ARE 1995 DOLLARS, LIMITED TO EMBANKMENT EARTHWORK CONSTRUCTION COSTS. DOES NOT INCLUDE SPILLWAY, INLET/OUTLET WORKS, AND OTHER ANCILLARY FACILITIES OR ENGINEERING, ADMINISTRATION, LAND ACQUISITION AND CONTINGENCY COSTS, TO BE ADDED BY OTHERS.

STORAGE - CONSTRUCTION COST CURVES  
ALTERNATIVE RESERVOIR SITES  
SANTA ROSA SUBREGIONAL LONG TERM  
WASTEWATER PROJECT
