3.1 Geology, Soils and Mineral Resources

This section of the Draft Final Environmental Impact Report (EIR) discusses the current geologic and soil conditions at the proposed Eagle Mountain Pumped Storage Project (Project) site and identifies the potential geologic and soil-related impacts based on the construction and operational activities associated with the Project. Mitigation measures (MMs) are provided in order to reduce significant impacts to less than significant, where applicable. Information for this section was obtained primarily from existing reports, public and agency contacts, and Project area reconnaissance.

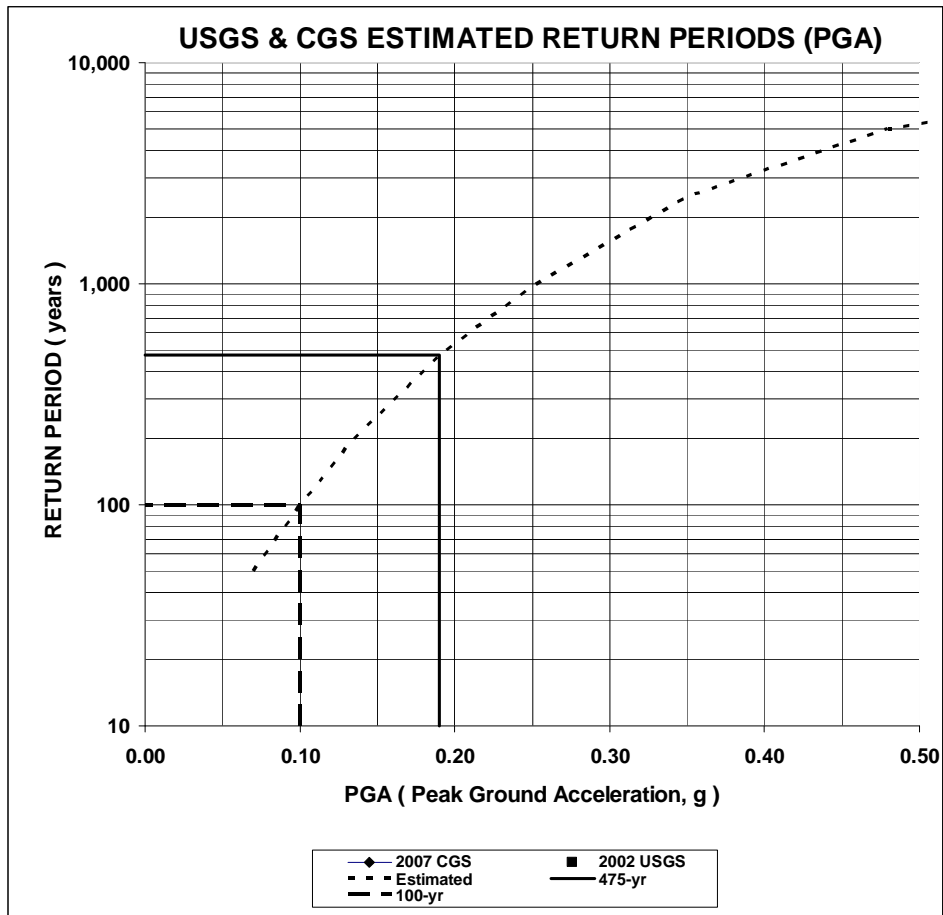
2002: USGS database
2007: CGS - soft rock database
(both databases accessed 2008)

T = Return Period
PGA = Peak Ground Acceleration
g = acceleration due to gravity

Note: Increase predictions by 30% for alluvium or soft soil site
