EXECUTIVE OFFICER'S REPORT

December 2013

3. Meyers Landfill BMP Repairs and Upgrades, El Dorado County - John Steude

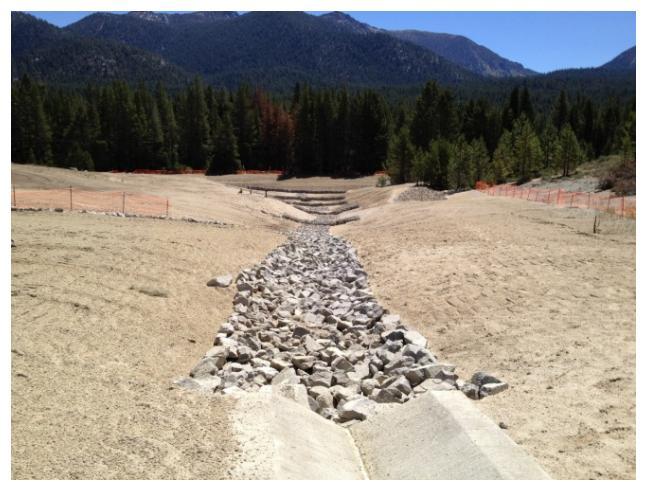
Previous condition of channel in mid-2012

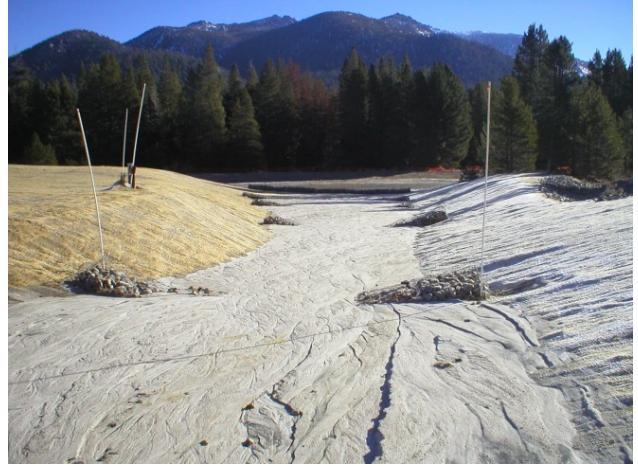
During a severe precipitation event in December 2012, stormwater undermined a portion of the southeast drainage channel at the landfill and the channel was filled with sediment. El Dorado County removed 450 cubic yards of sediment from the channel and increased the channel capacity in January 2013. Details of this storm event and initial repairs were discussed in the March 2013 Executive Officer's Report.

Condition after December 2012 storm event

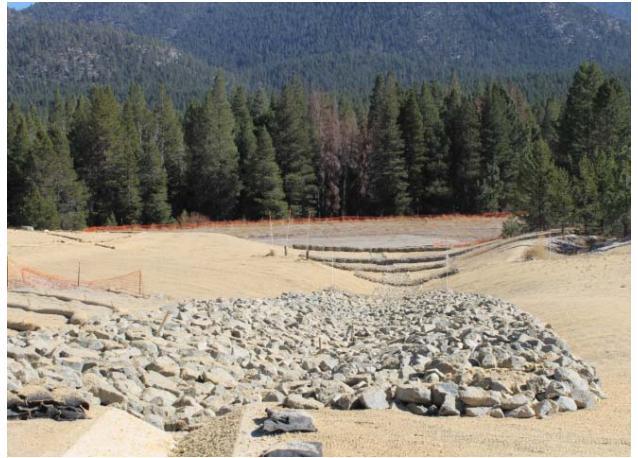
El Dorado County conducted major repairs and upgrades to the drainage channels and other erosion controls during the 2013 construction season. Channel rock lining was replaced and increased in size and depth in critical areas to prevent future potential undermining of the channel. Check dams along the bank of the concrete channel were installed to direct stormwater into the channel and prevent undermining along the sides of the channel.

Condition in October 2013 after repairs

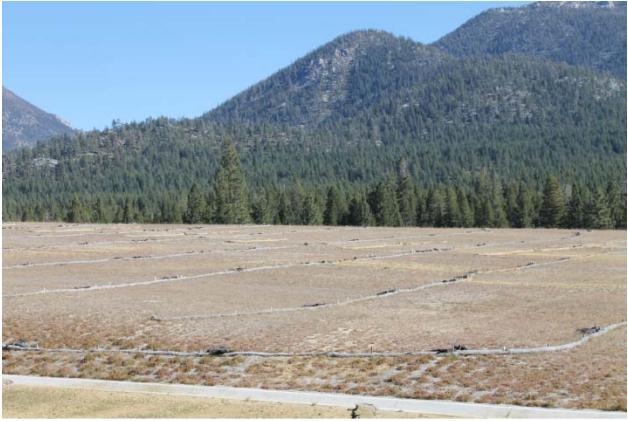
Revegetation, straw waddles, & tackifier

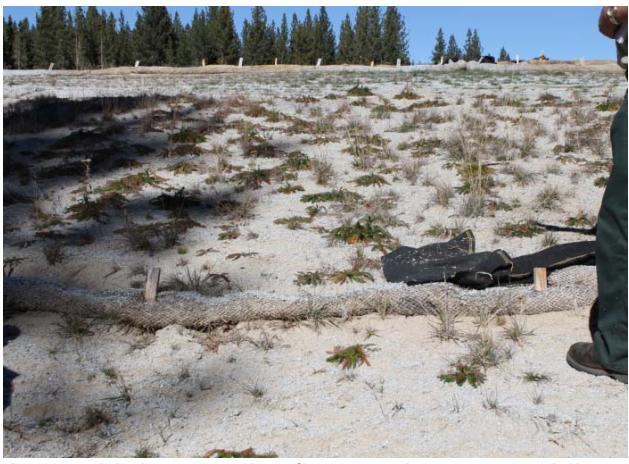
- Revegetation was achieved over 35% of the landfill cover area, although small areas of thin vegetation were still present during an October 2013 inspection. These small bare soil areas and a few slopes above rock lined channel were in need of the application of tackifier or an equivalent erosion prevention measure.
- An extensive network of straw waddles was installed to prevent concentrated flows and associated rills and gullies. The straw waddles were functional for the most part, although minor repairs were needed in a few areas before the onset of winter weather.
- A short reach of rock-lined channel required sediments to be removed to prevent them from being flushed downstream over the winter.

Area with bare soil & flattened straw waddle

El Dorado County representatives have informed Water Board staff on November 12, 2013 the required repairs and maintenance noted during the October 2013 inspection have been completed.

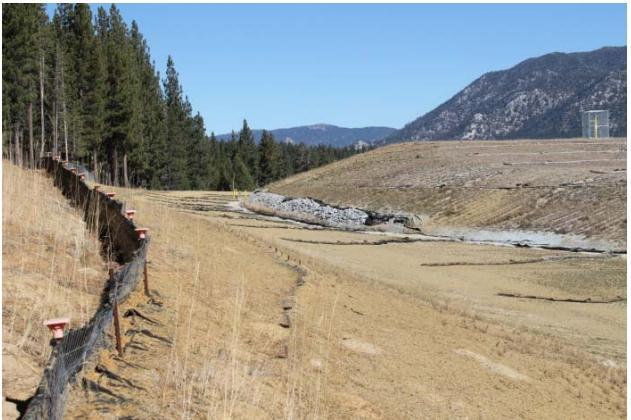
Rock-armored base of slope above channel, tackifier, straw waddles and revegetation
