**LAUREL MARCUS
EXECUTIVE DIRECTOR
CALIFORNIA LAND
STEWARDSHIP
INSTITUTE**

**The Fish Friendly Farming
Environmental Certification
Program started in the Russian
River watershed in 1999 currently
has over 25,000 acres enrolled in
the Mendocino County portion of
the Russian River and 23,000 acres
in Sonoma County.**

RUSSIAN RIVER WATERSHED

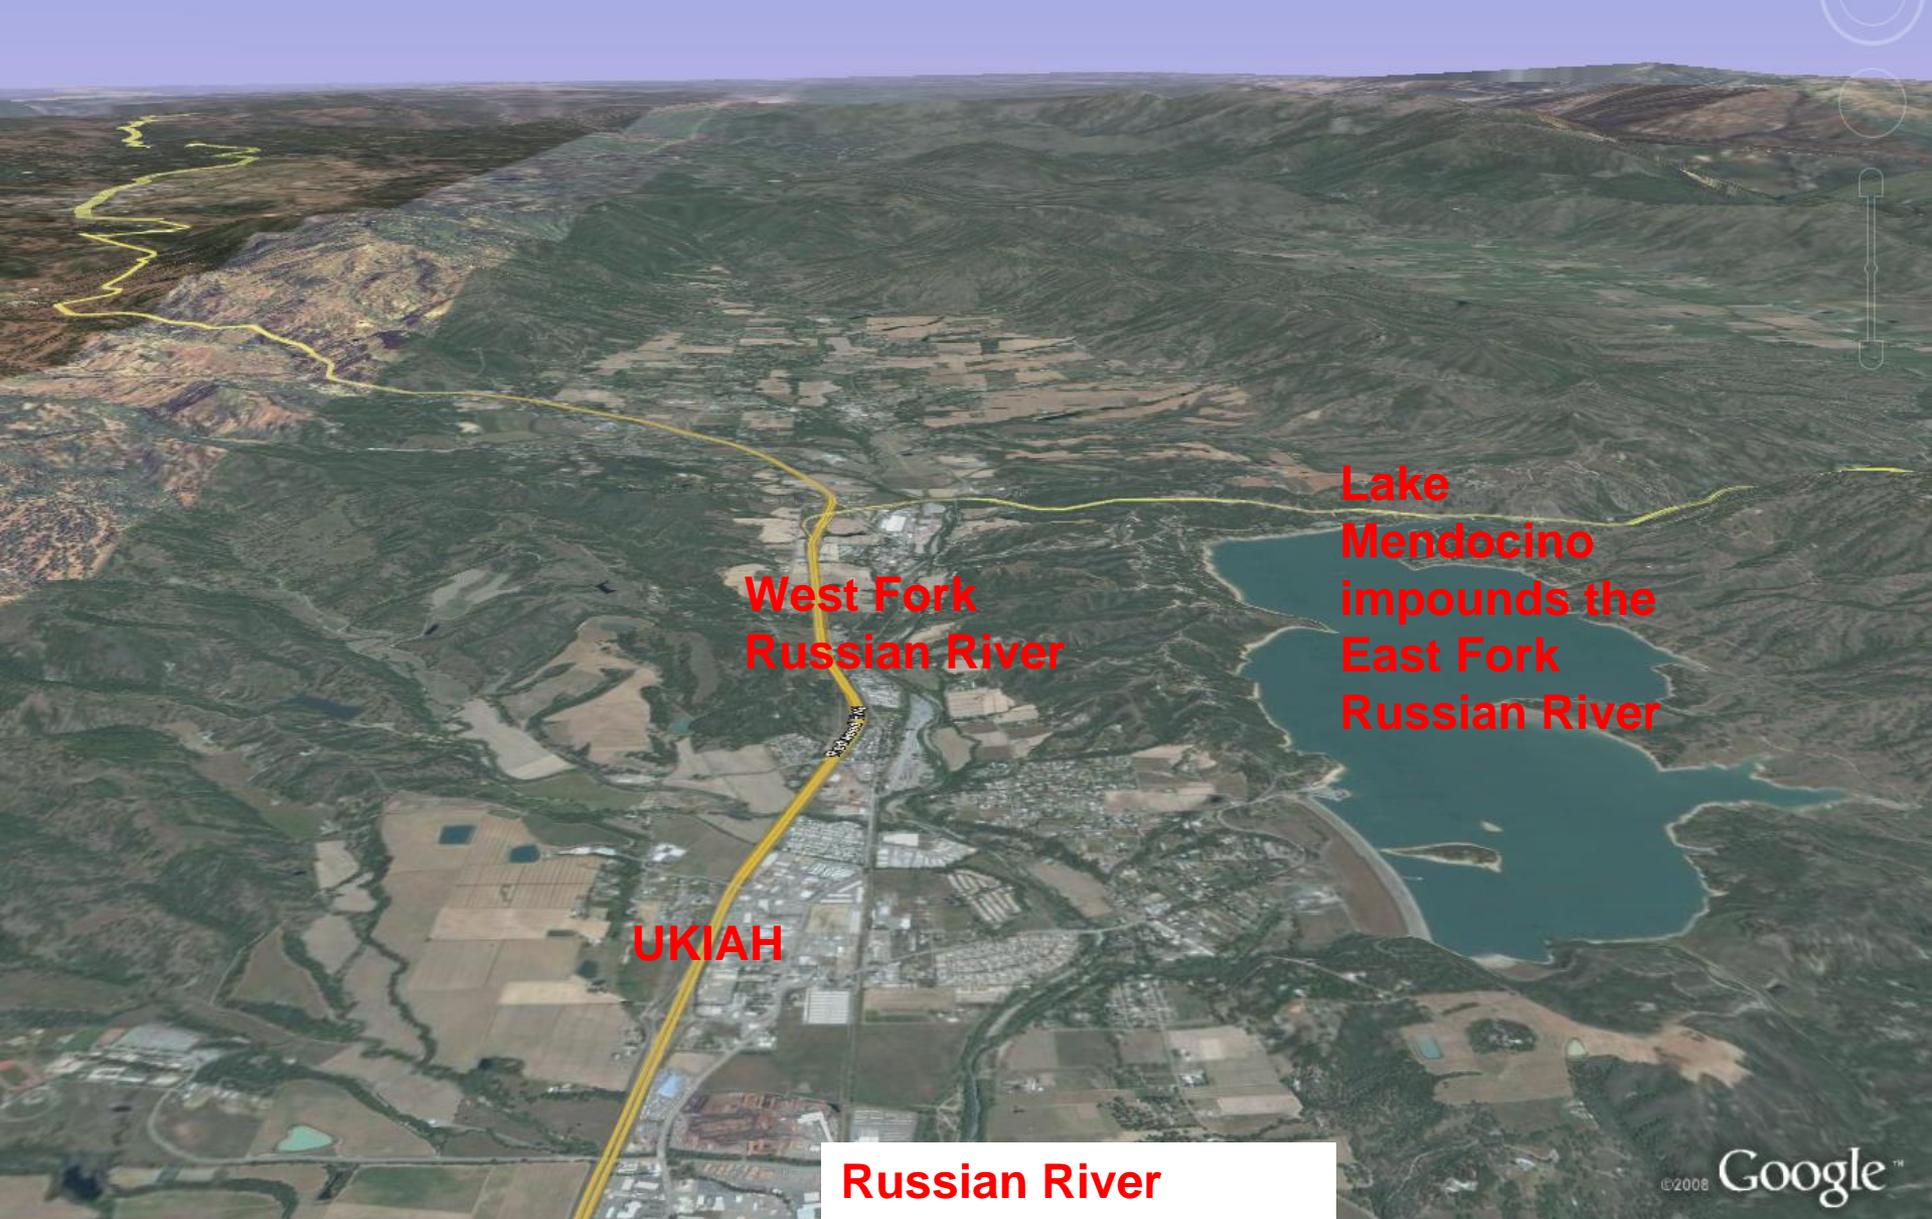
Lake Mendocino impounds the East Fork Russian River

West Fork Russian River

UKIAH

Russian River

The Upper Russian River drains an alluvial basin flanked by mountains. Lake Mendocino was built 50 years ago and has significantly altered the Russian River channel and its hydrology. These changes cannot be ignored when looking at stream flow and fish habitats.

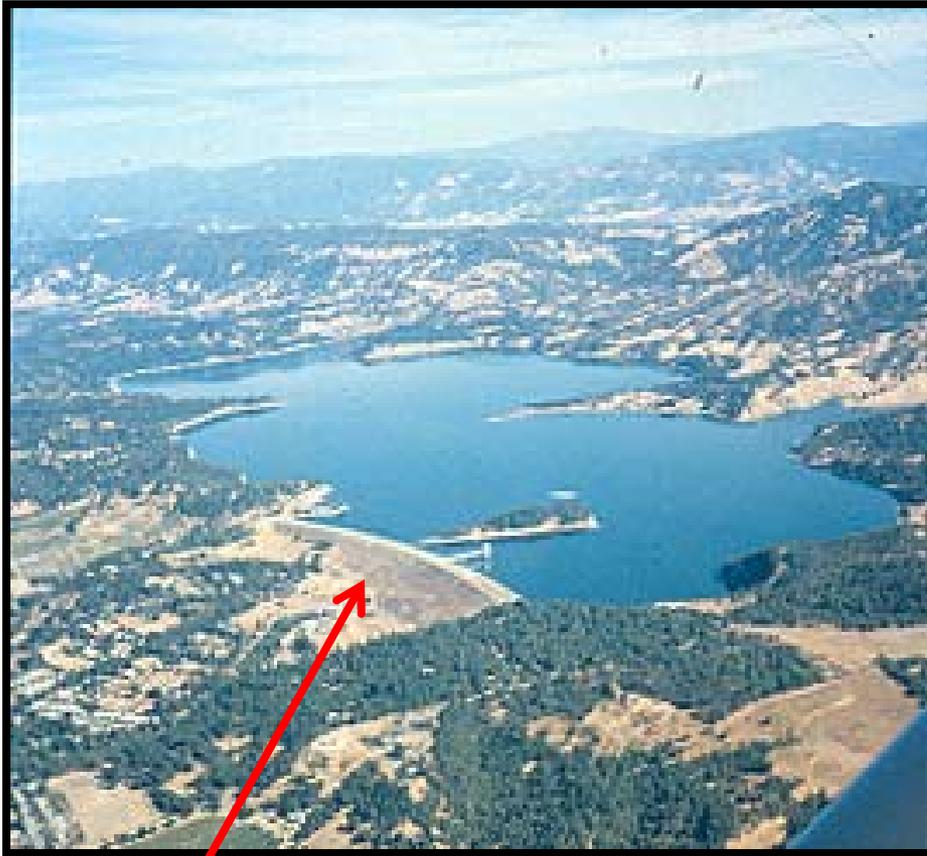
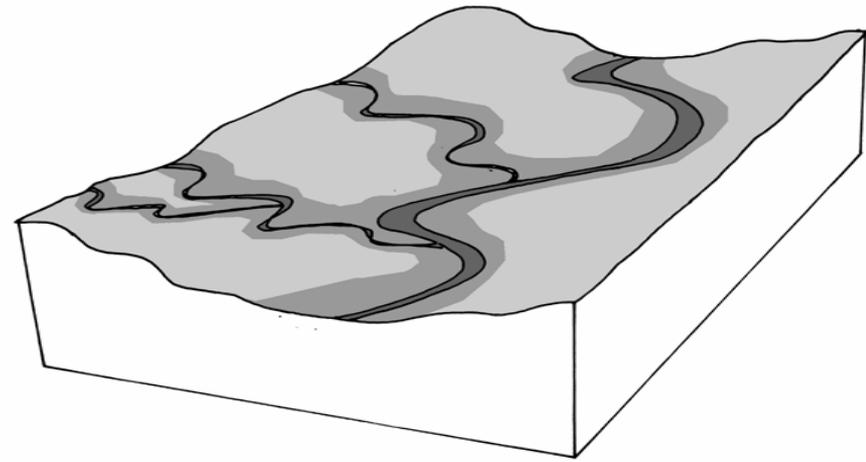
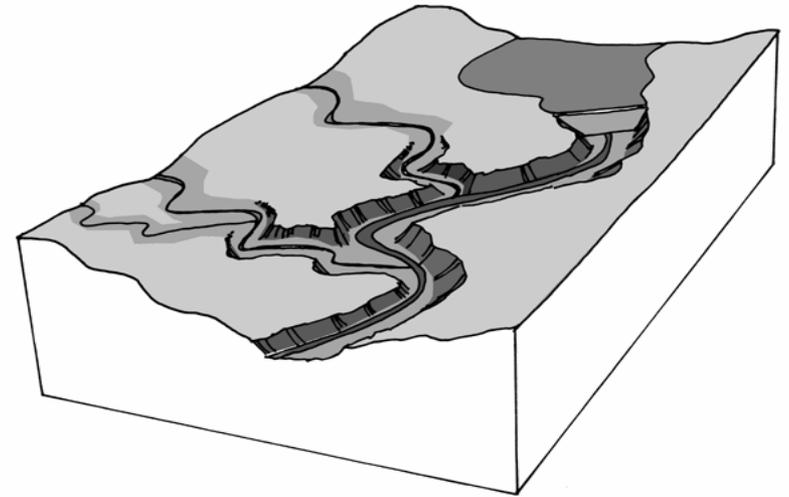
Coyote Dam has cut off sediment movement into the river causing the Russian River channel to incise or entrench nearly 20 feet into its alluvial floodplain. This change alters the timing of connected stream flow for fish to move between tributaries and the main river channel.

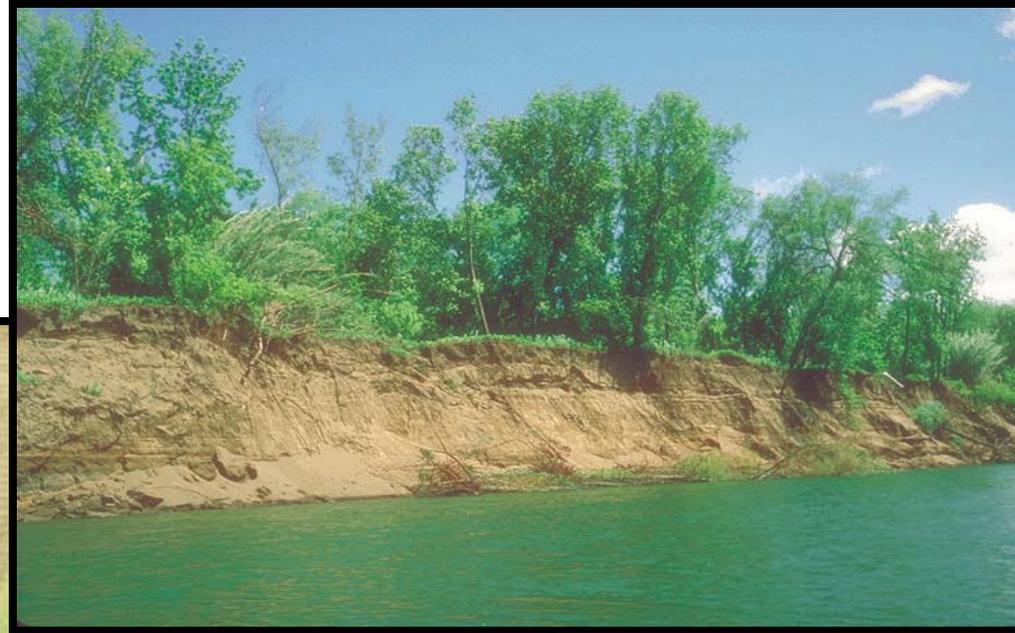
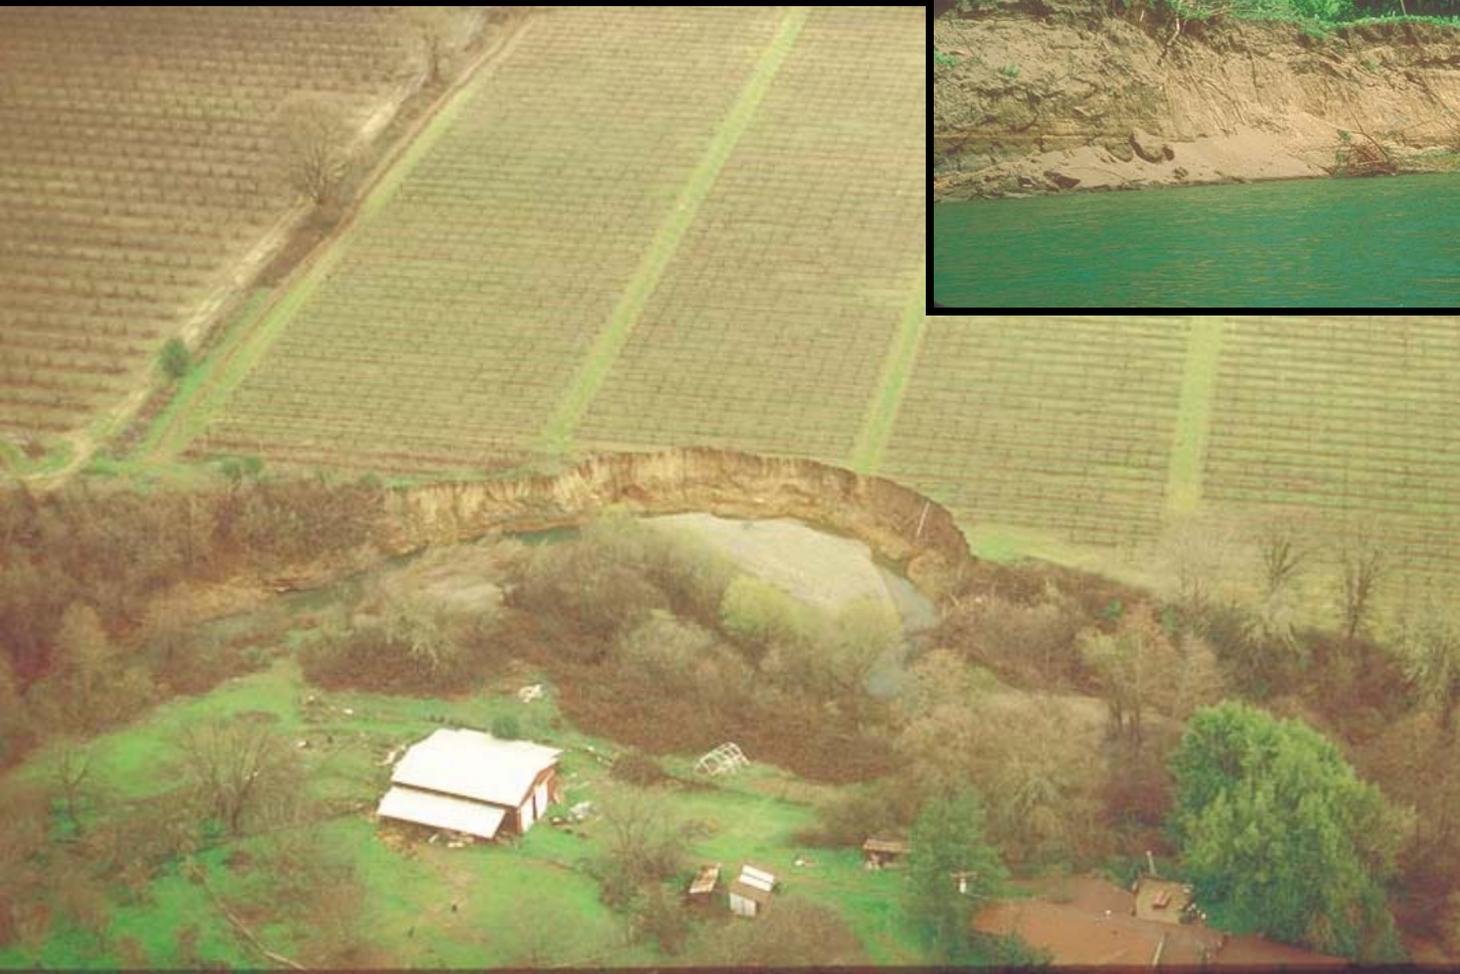
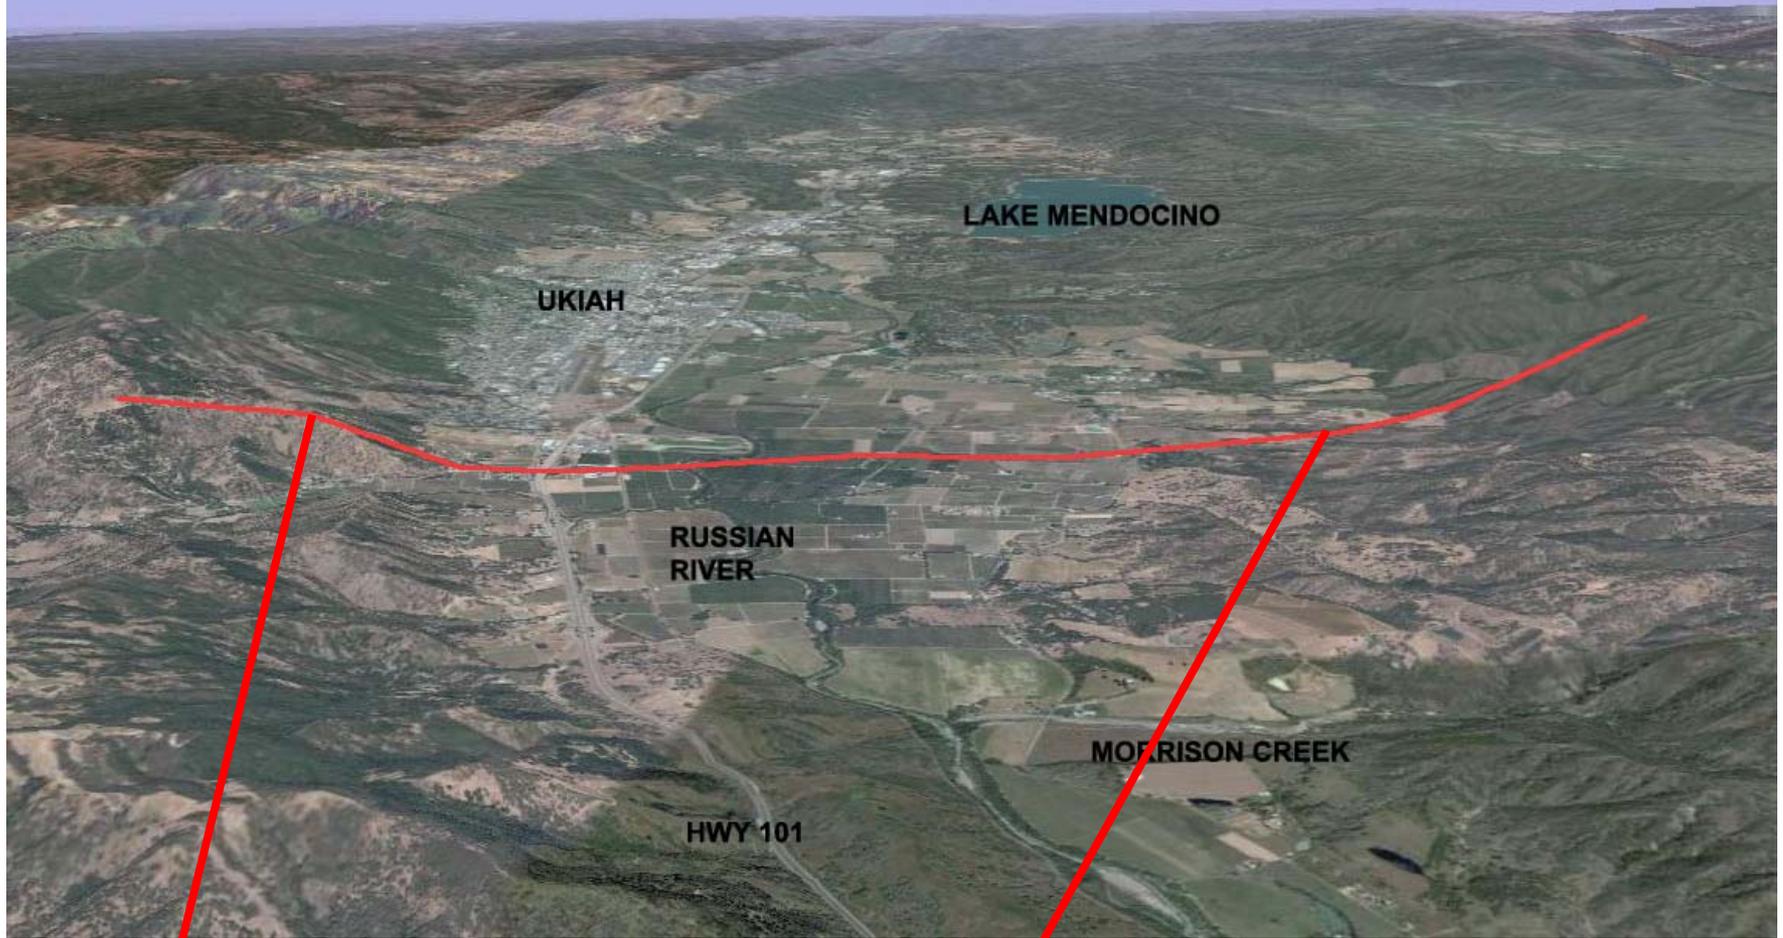
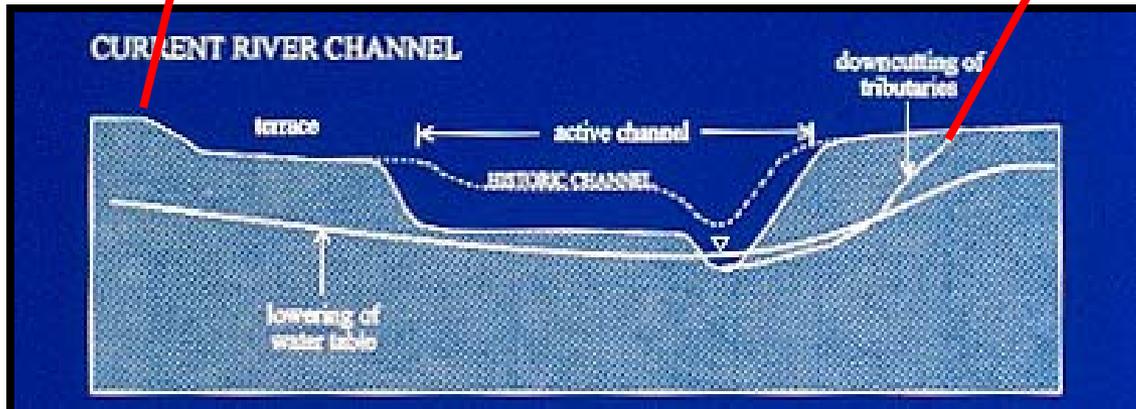
Channel entrenchment on the Upper Russian River is easily visible along the entire alluvial valley from the Dam to Hopland. The channel has dropped 20 ft with significant bank failures and loss of habitat and numerous bridges have been undercut and had to be replaced.

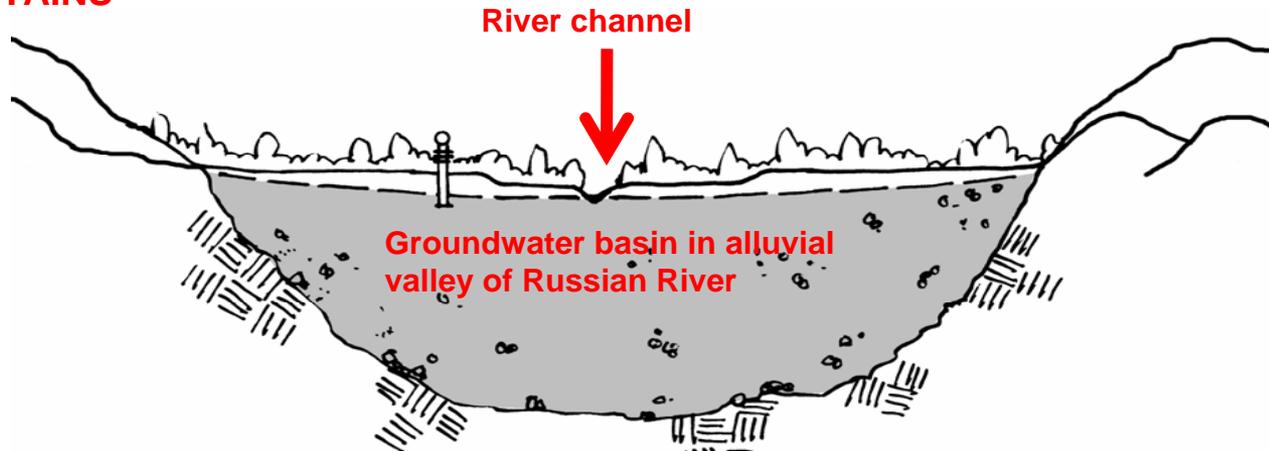
Channel entrenchment affects groundwater levels and therefore the timing and magnitude of stream flow

RIVER CHANNEL AND GROUNDWATER BASIN PRIOR TO ENTRENCHMENT

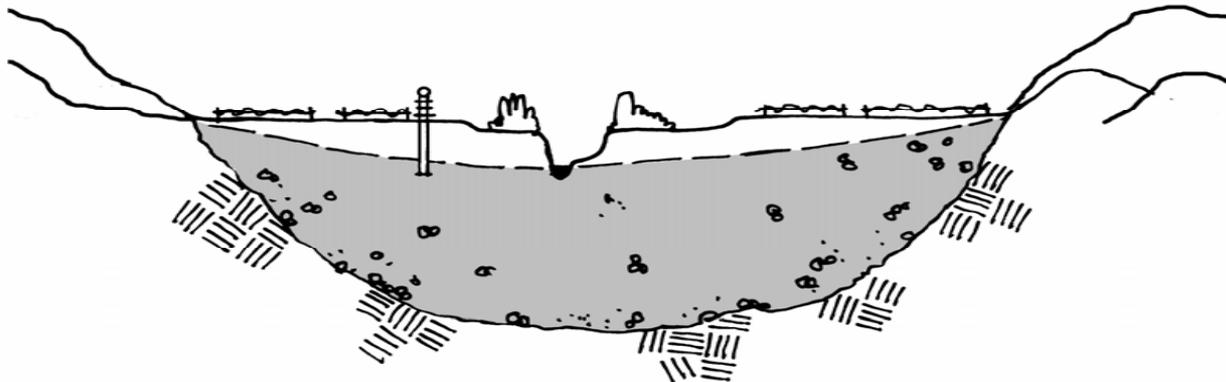
RIVER CHANNEL AND GROUNDWATER BASIN AFTER ENTRENCHMENT – SIGNIFICANT SYSTEM-WIDE CHANGE

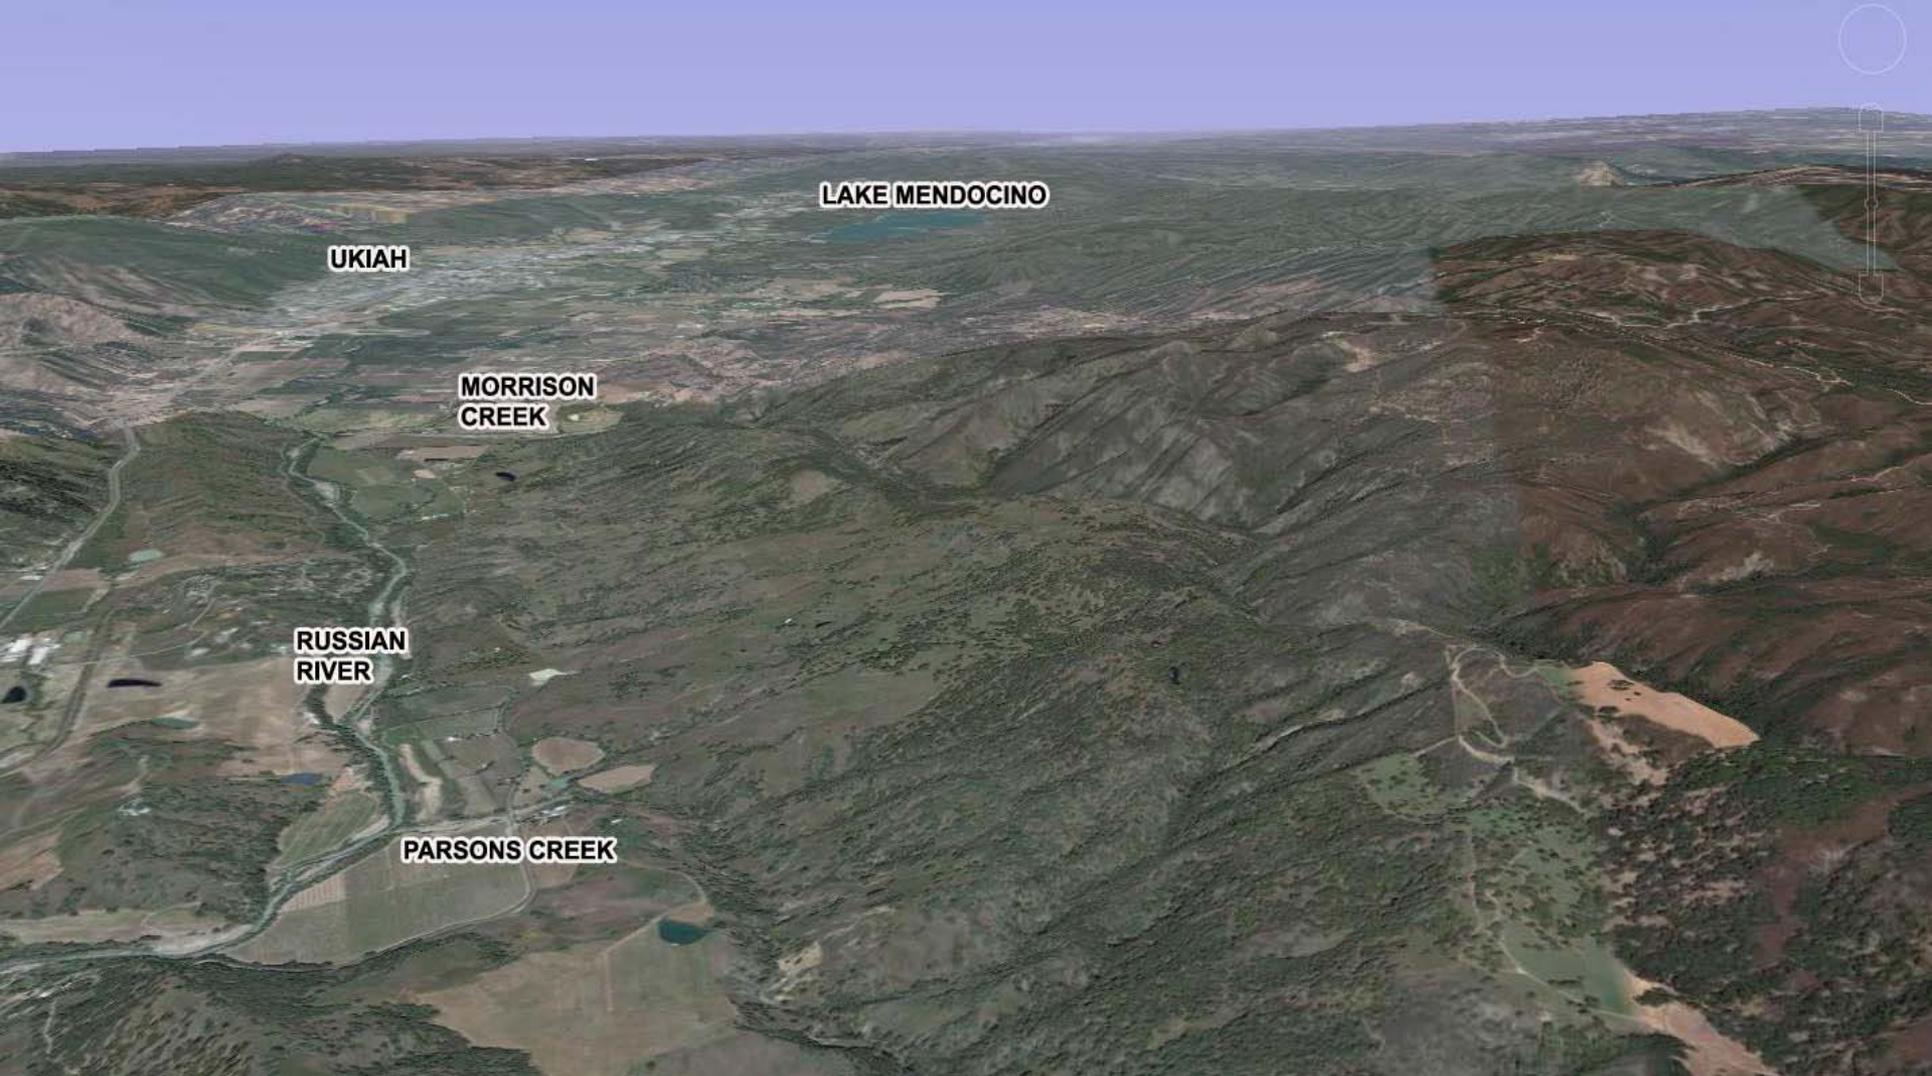
Morrison and Parsons Creeks both drain the steep mountains on the east side of the Ukiah Valley then spill out on to the alluvial valley to meet the Russian River. The monitoring was done in the alluvial valley reach of each creek. Morrison Creek has no reservoirs to affect flows and Parsons Creek has two small ponds.

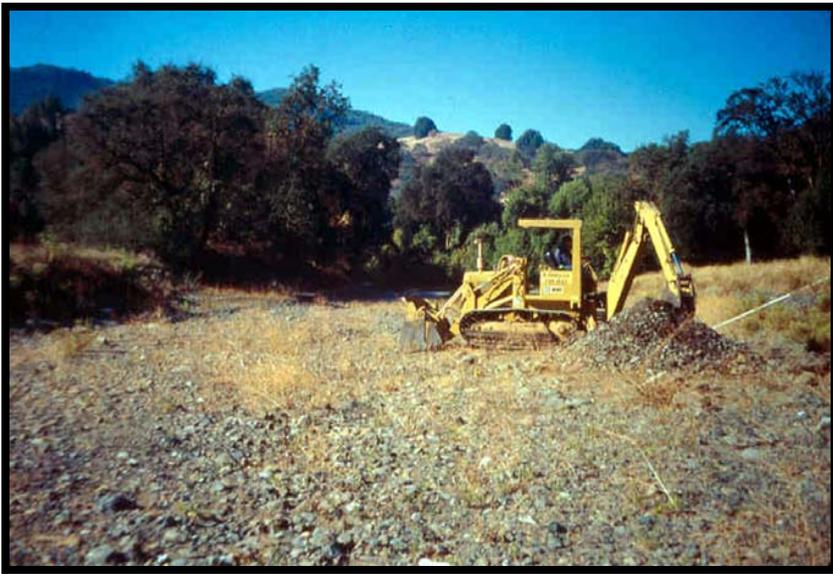
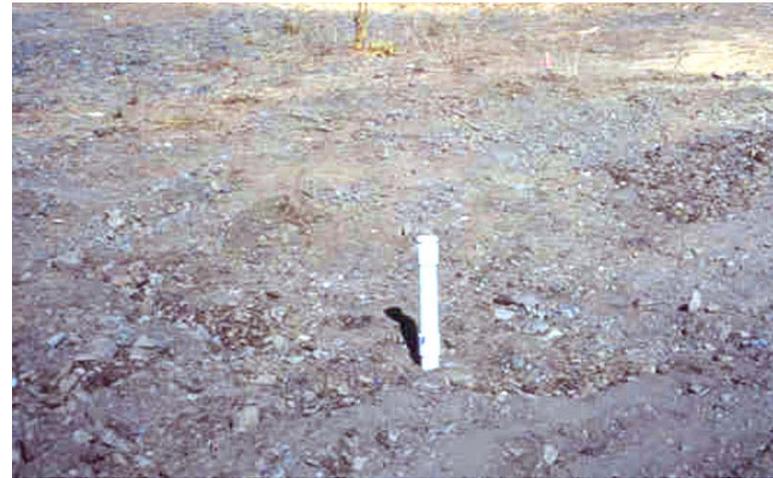
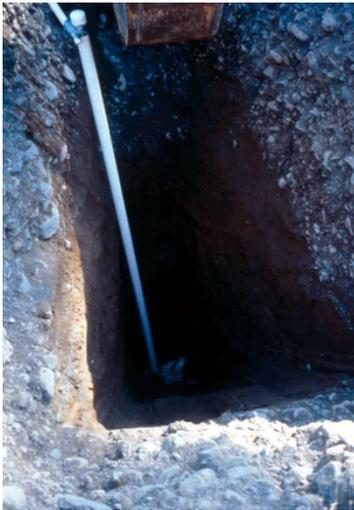
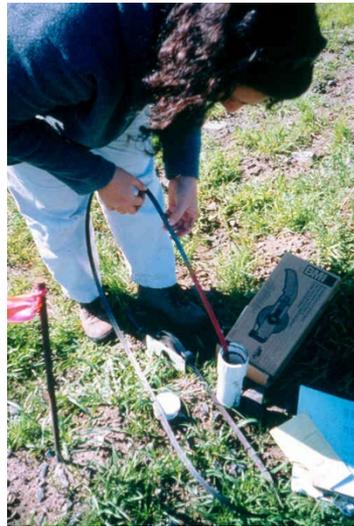
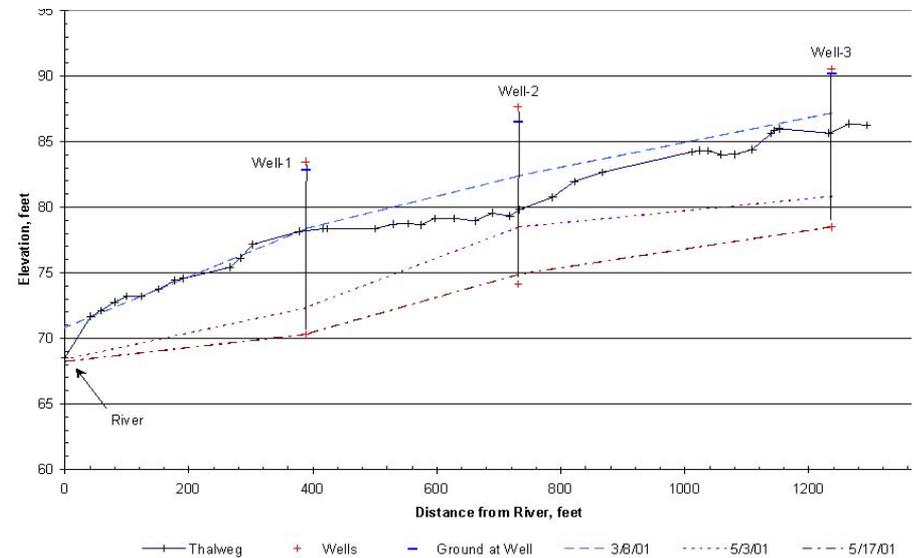
Three monitoring wells/creek were installed at scattered locations along Morrison and Parsons Creeks. Wells were 13 ft deep. No other agricultural wells were operating when readings were made.

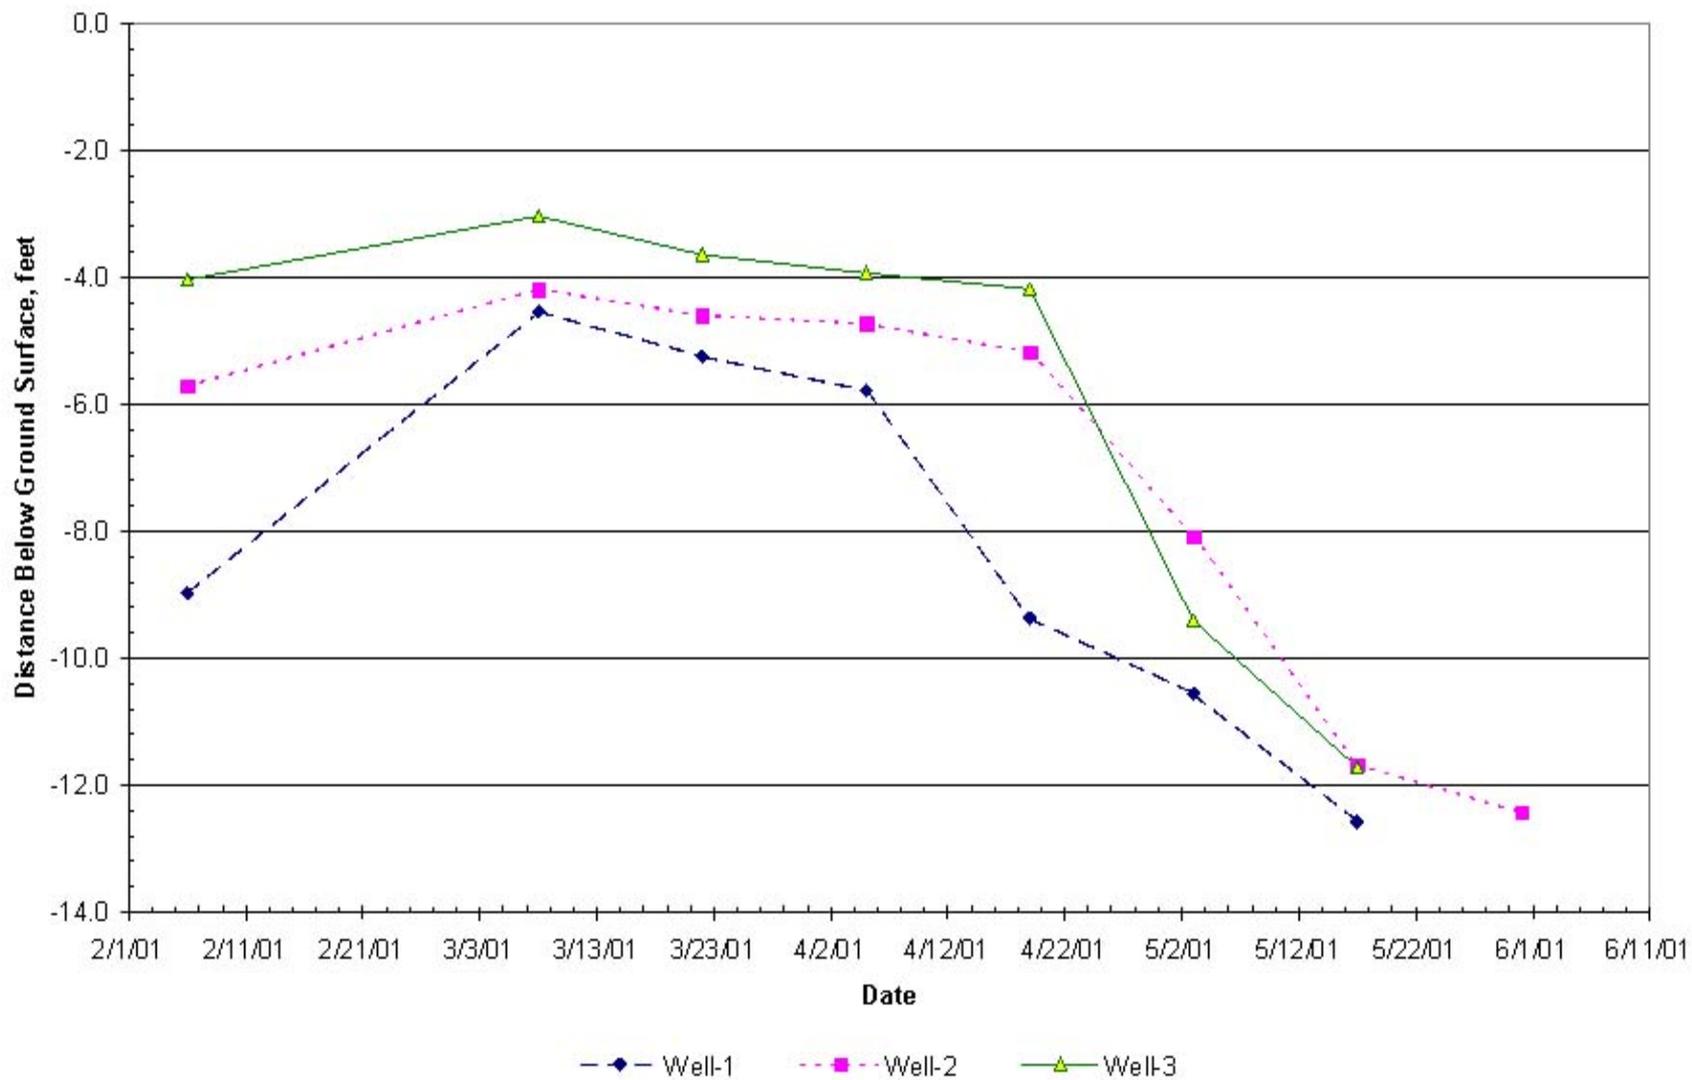
Morrison Creek Ground Water Levels Depth of Water Below Ground Surface in the Monitoring Wells

Groundwater dropped up to 9 feet in less than 3 months.

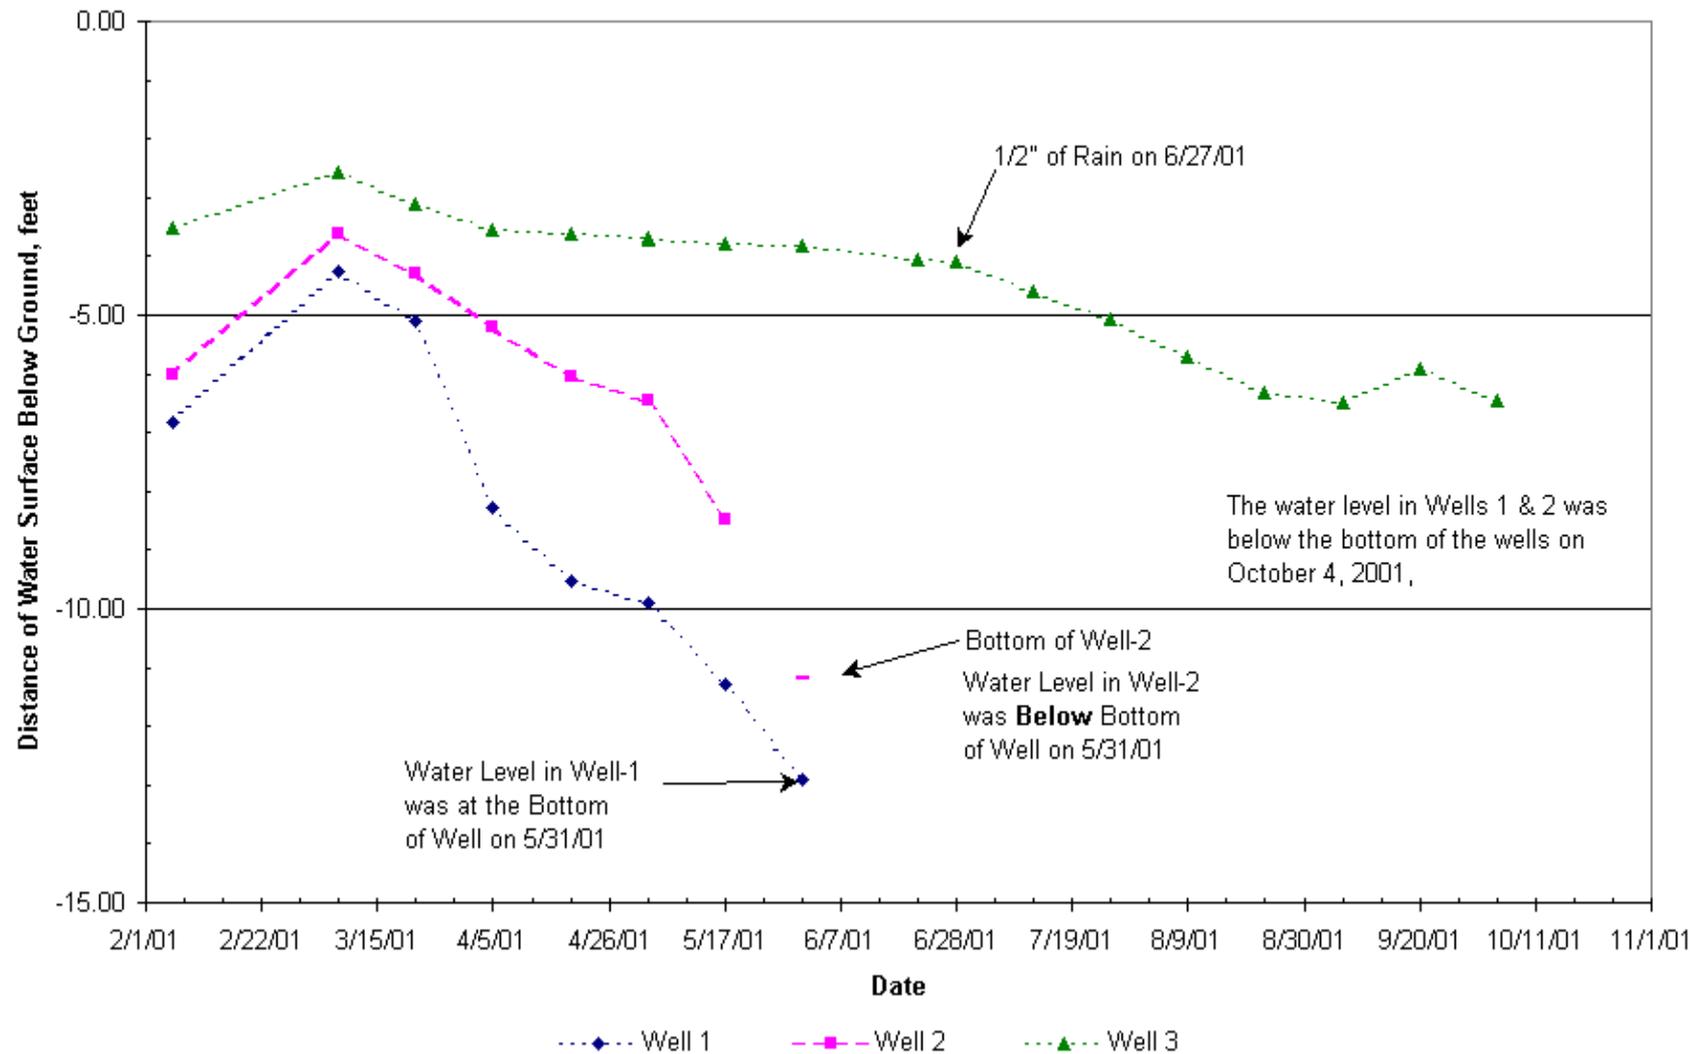
Parsons Creek Depth of Water Below Ground Surface in the Monitoring Wells

Same pattern in Parsons Creek as Morrison except for the well above the road bridge which is not as affected by river levels

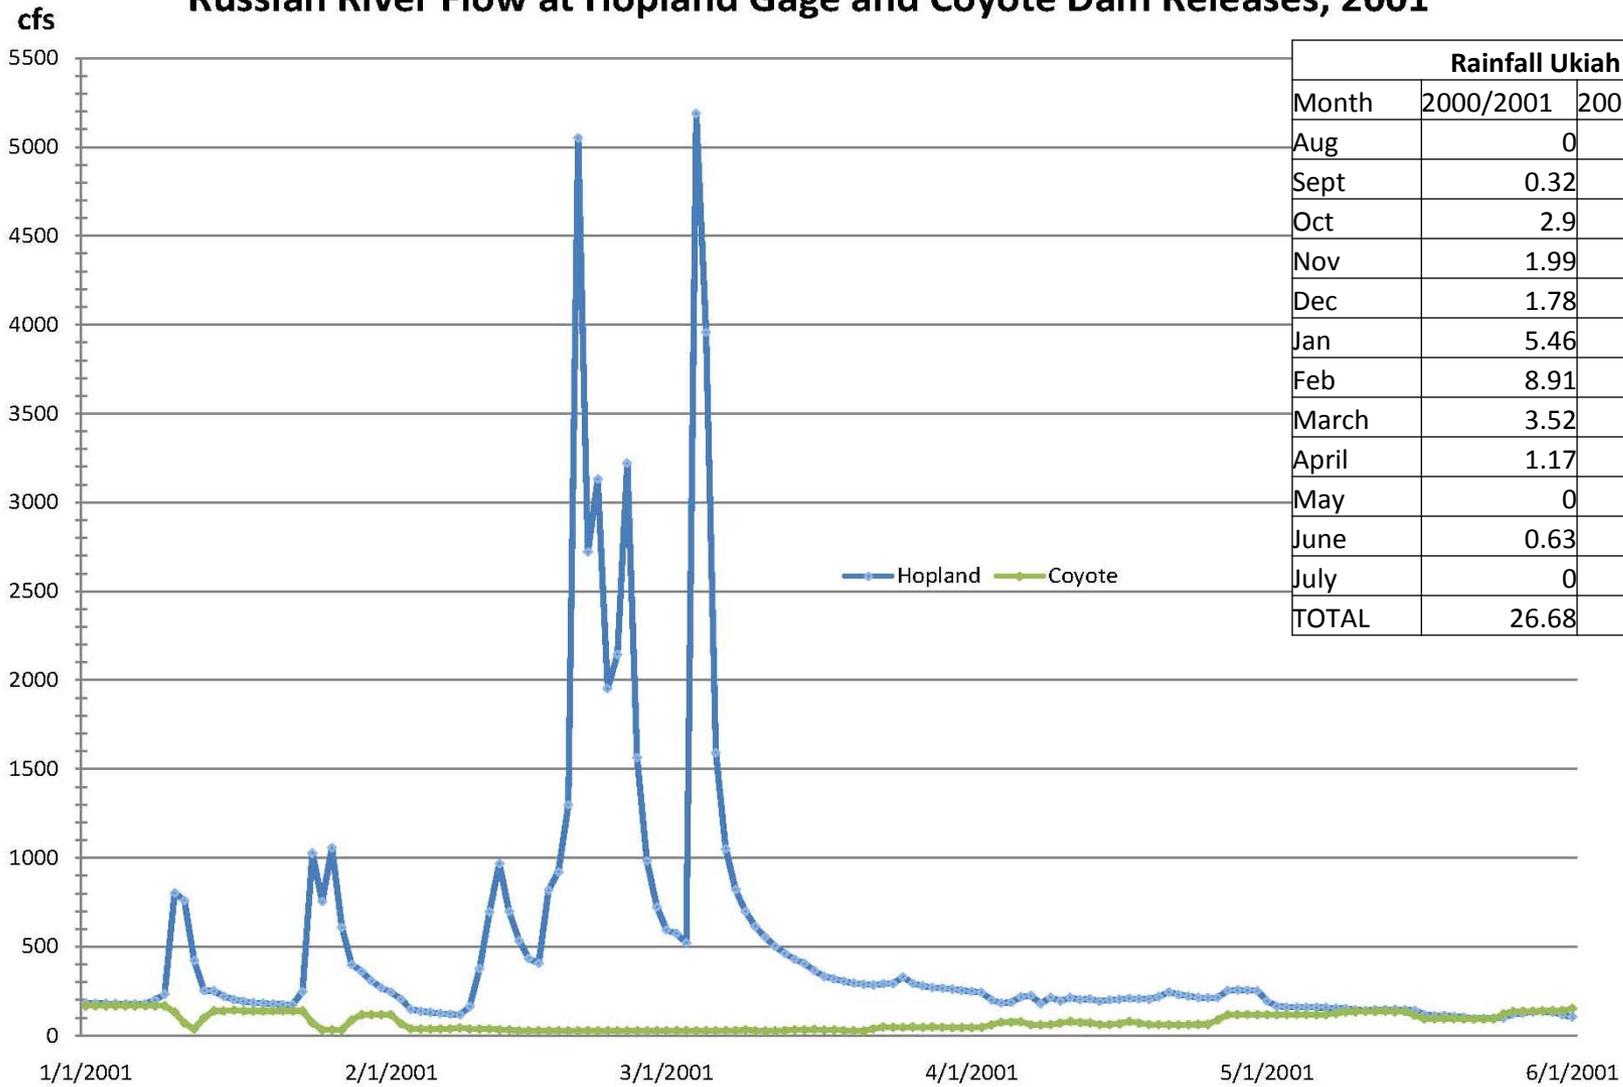
Russian River Flow at Hopland Gage and Coyote Dam Releases, 2001

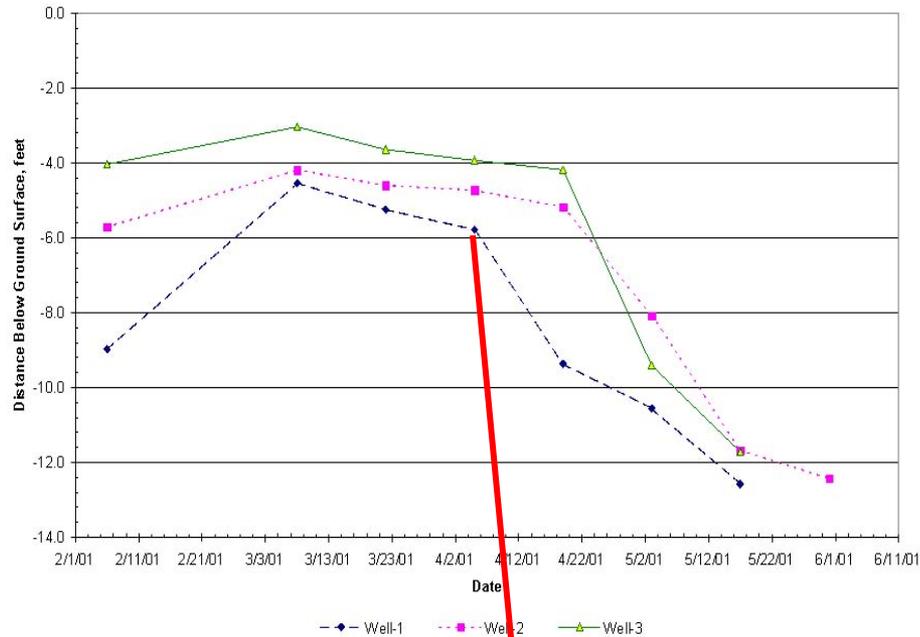
Morrison Creek Ground Water Levels
Depth of Water Below Ground Surface in the Monitoring Wells

Drop in ground water levels coincides with the drop in flow levels in the main river channel and is the greatest in the well located closest to the Russian River indicating that the river's water surface elevation is controlling the dewatering of the tributaries.

Flow in both Morrison and Parsons Creeks went subterranean as soon as the water level in the river dropped. No juvenile steelhead could have migrated out of these creeks which have year round flow in their canyons.

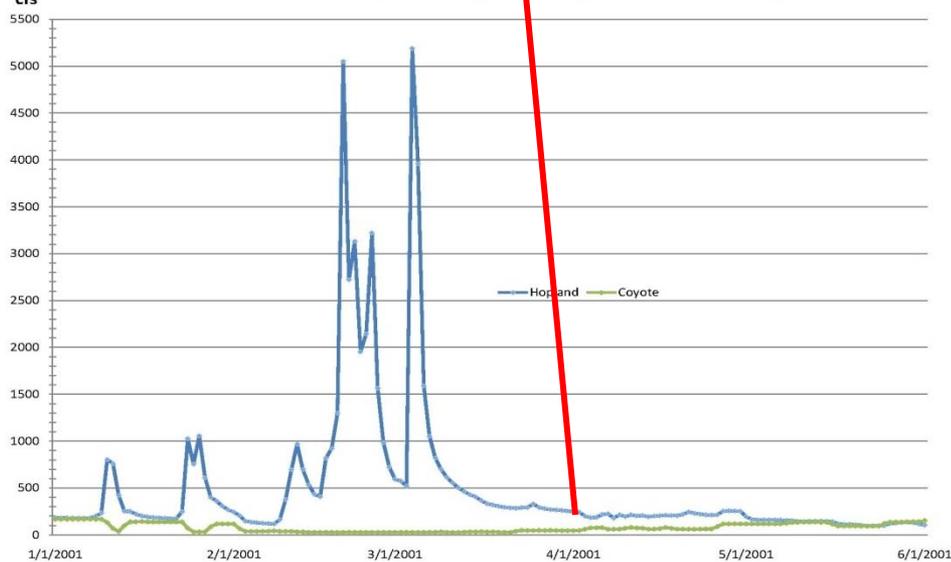
Russian River Flow at Hopland Gage and Coyote Dam Releases, 2001

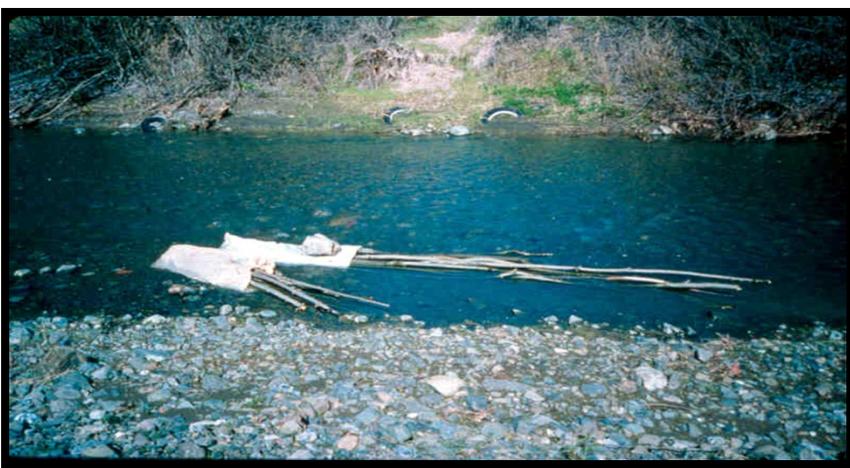
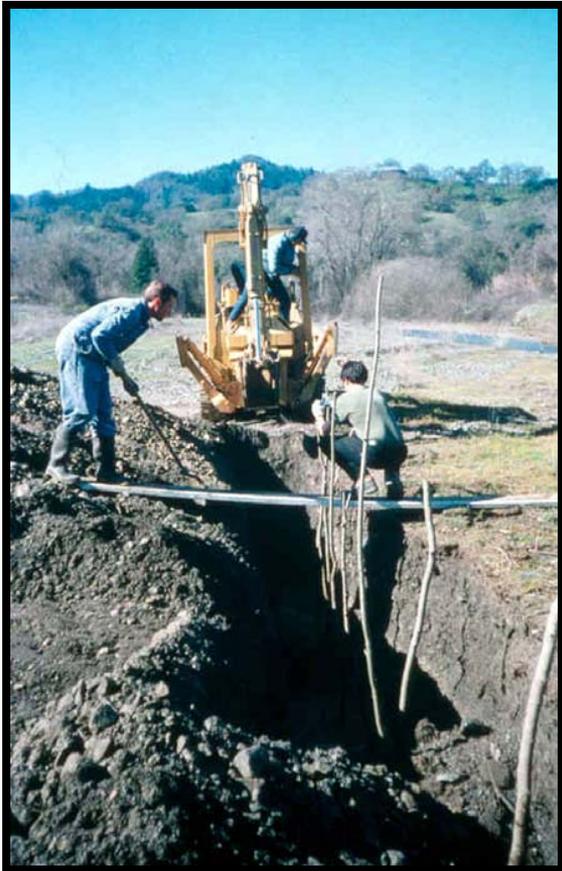
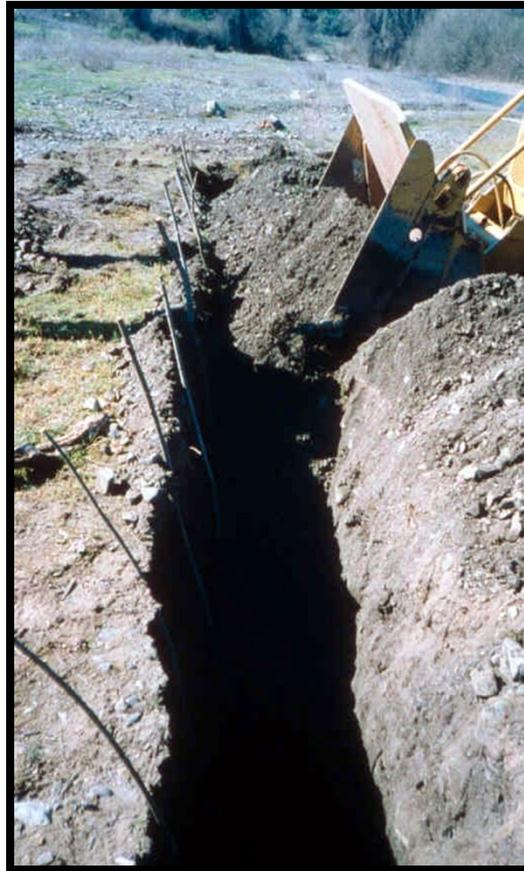
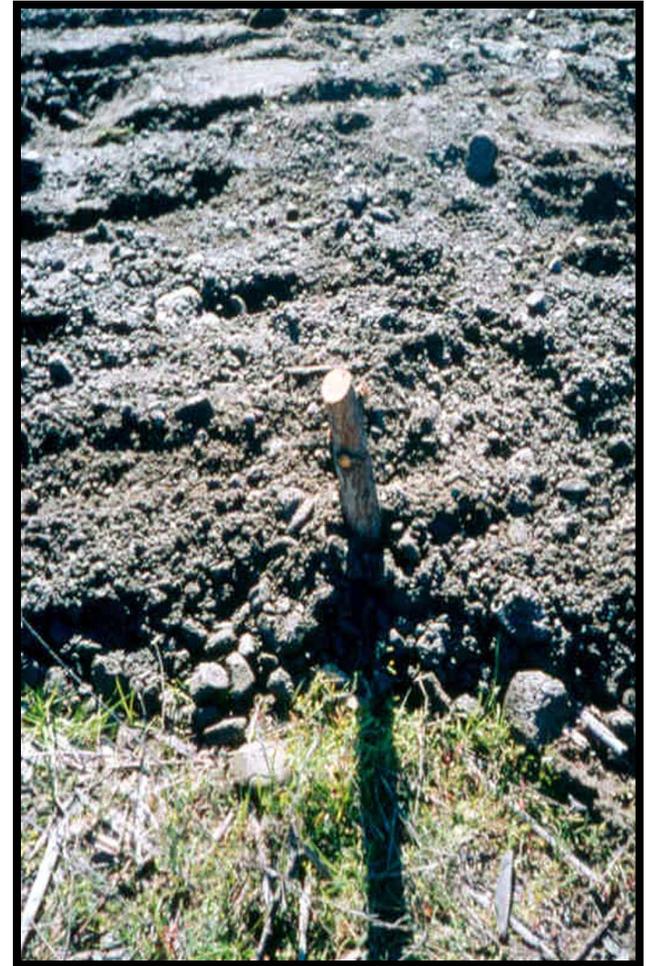
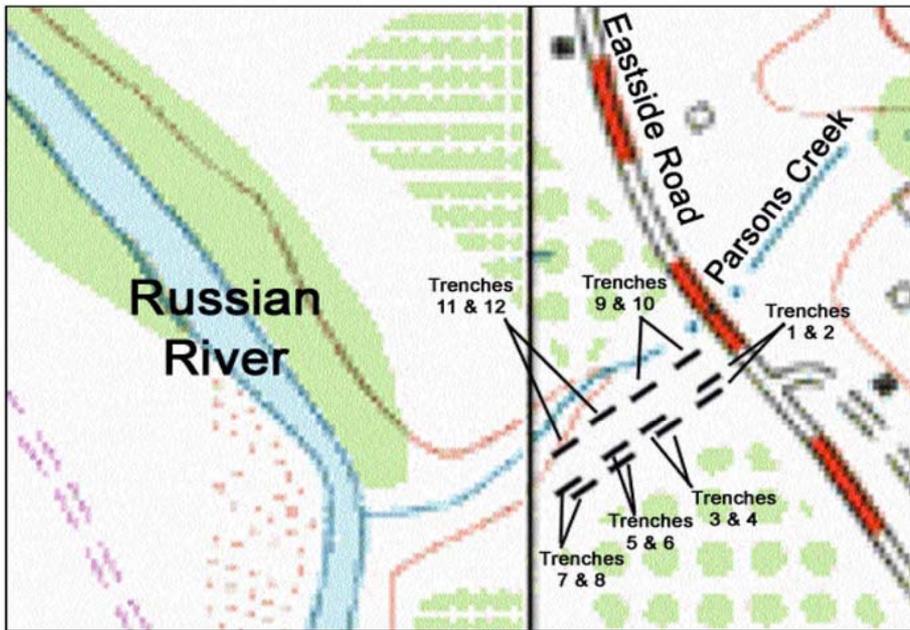
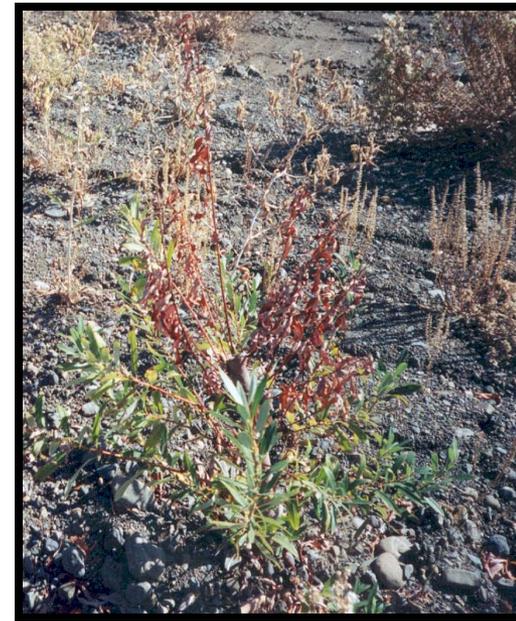
Dormant willow poles were placed in trenches 4 and 8 feet deep to determine if this technique would establish riparian vegetation on these creeks

All the willows in all the trenches leafed out indicating there was sufficient groundwater in the Feb-March period
