**LAUREL MARCUS
EXECUTIVE DIRECTOR
CALIFORNIA LAND
STEWARDSHIP
INSTITUTE**

**The Fish Friendly Farming
Environmental Certification
Program started in the Russian
River watershed in 1999 currently
has over 25,000 acres enrolled in
the Mendocino County portion of
the Russian River and 23,000 acres
in Sonoma County.**

RUSSIAN RIVER WATERSHED

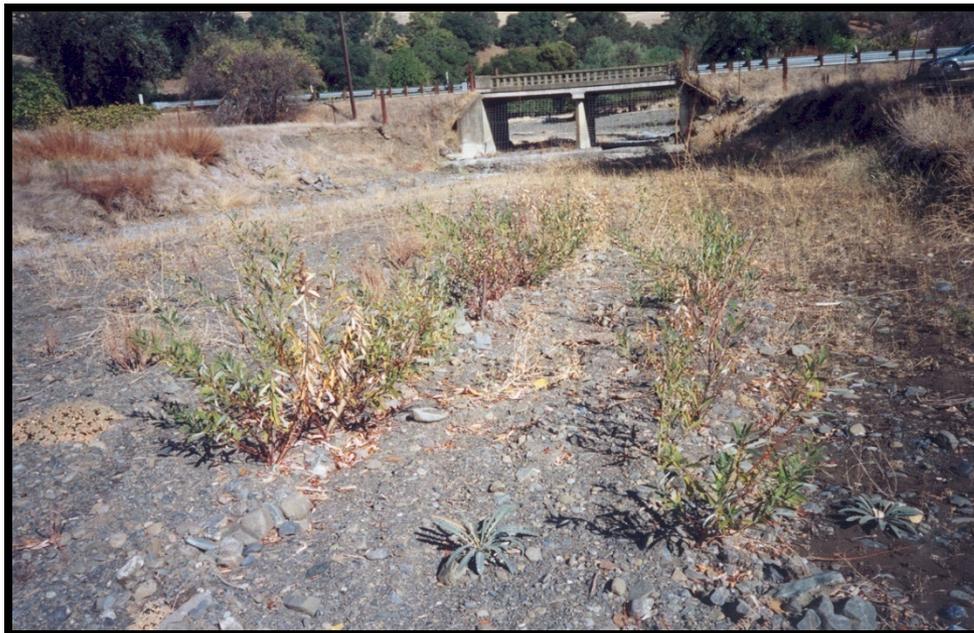
Willows survived in the most upstream trenches whether 8- or 4-foot in depth but all the willows died in the trenches closest to the river. The management of water levels in the main Russian River by releases from Coyote Dam has a significant effect on the function of the aquatic and riparian ecosystem in the Upper Russian River.

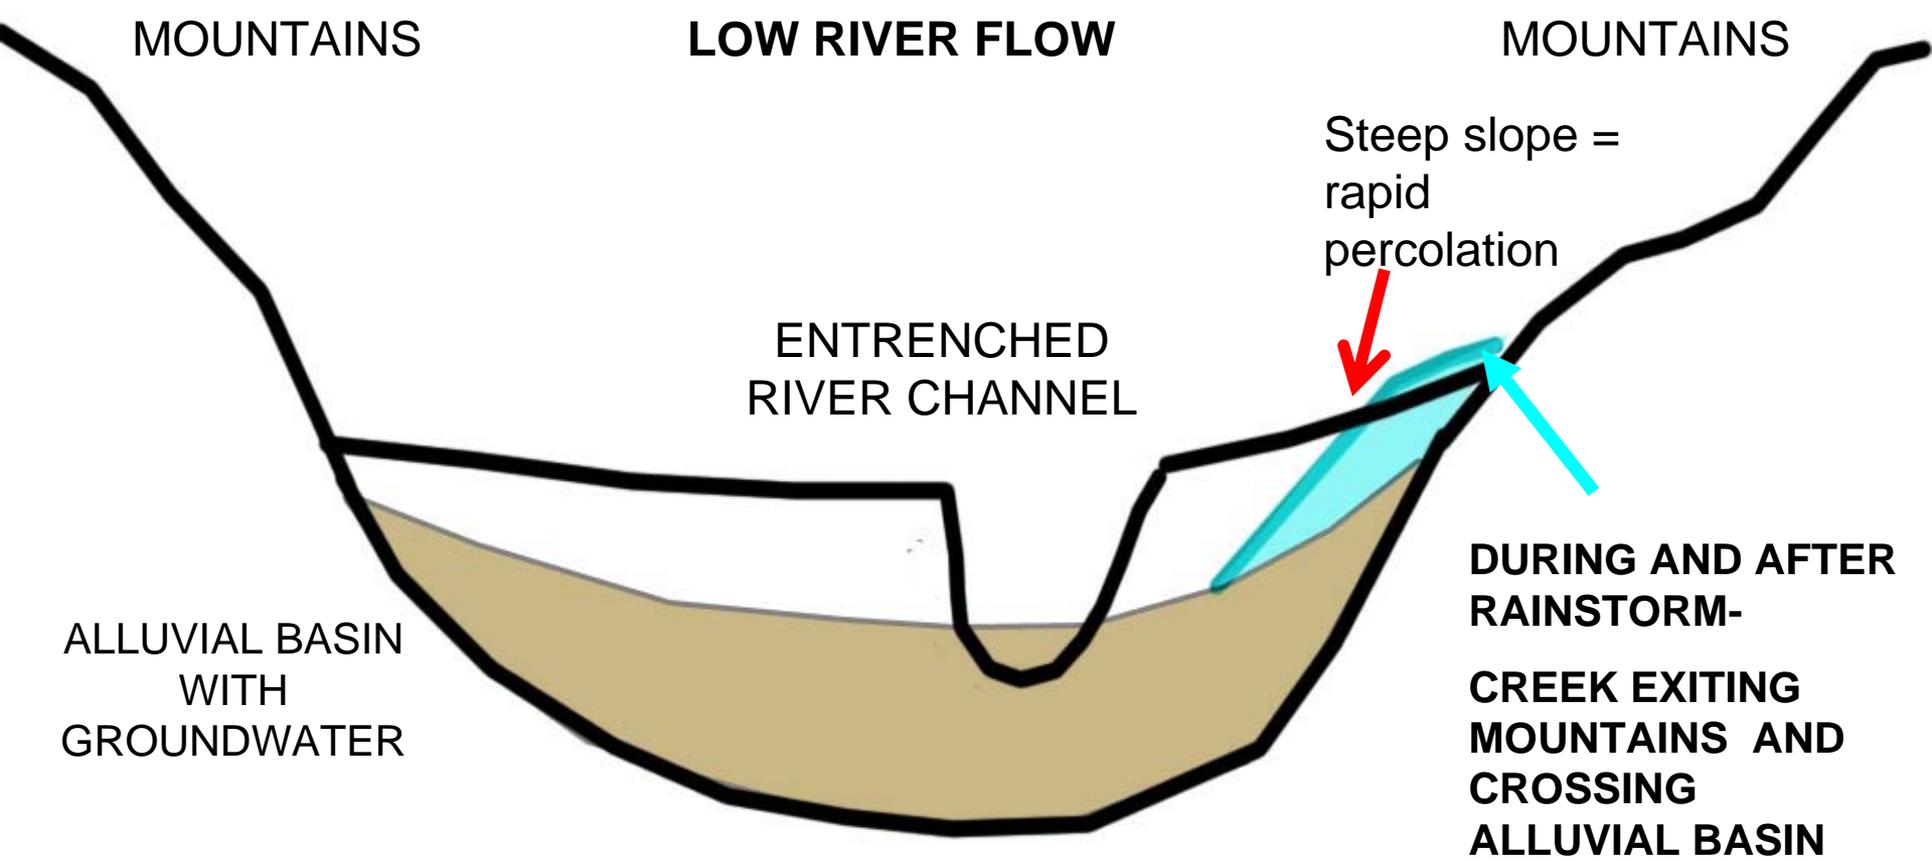
At low flow in the river channel water exiting the creek canyon onto the alluvial valley will percolate into the alluvium until the alluvium is filled with water and the river rises. The slope of the ground water basin between the creek outlet and the river level determines how quickly the water percolates

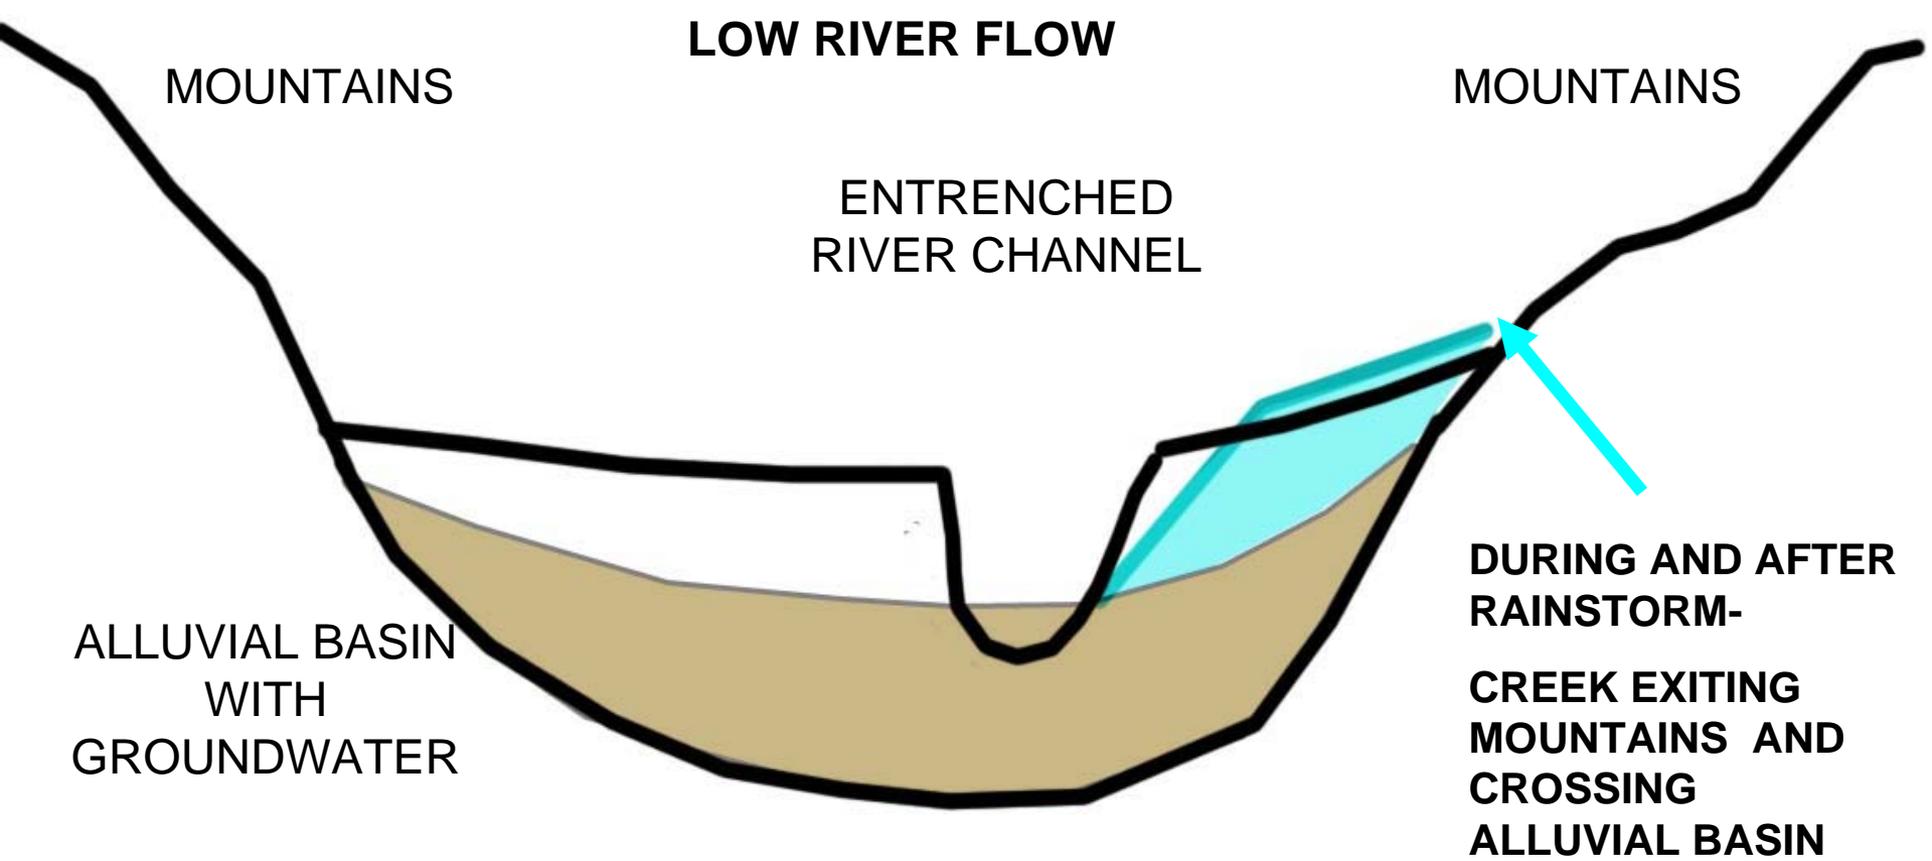
During large or intense rainfall events when the river is still low creek flow may be great enough to make it nearly to the river channel before percolating into the alluvium

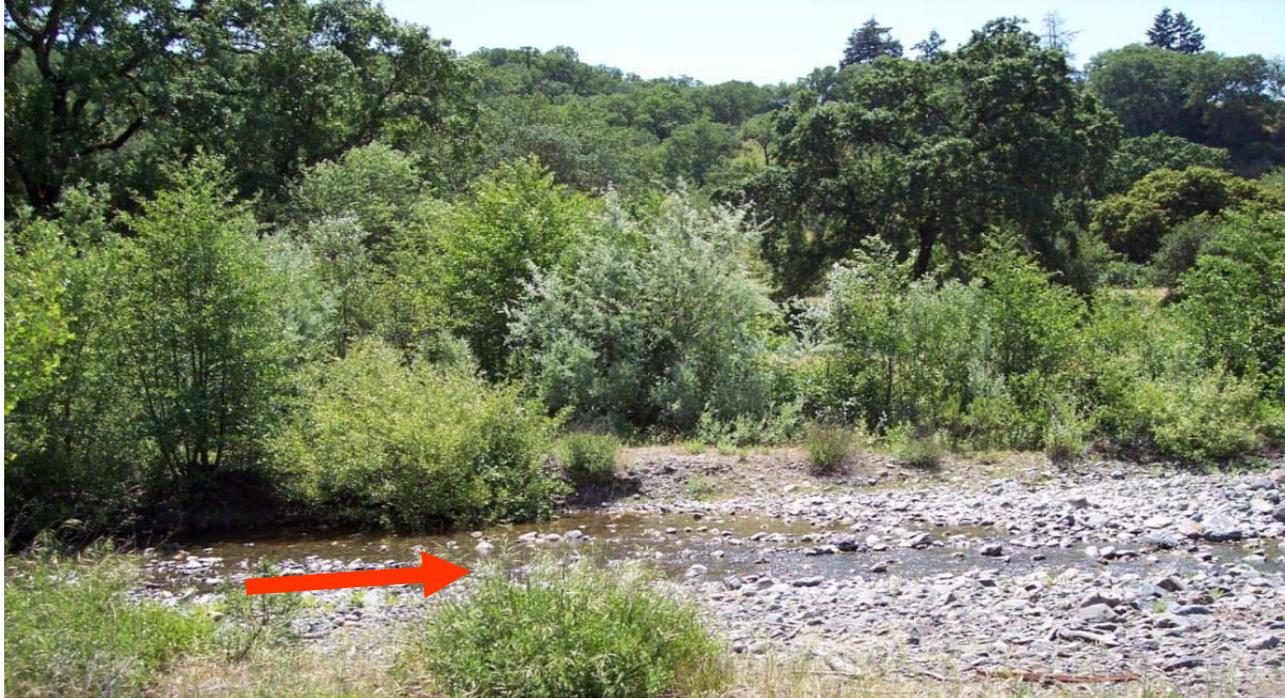
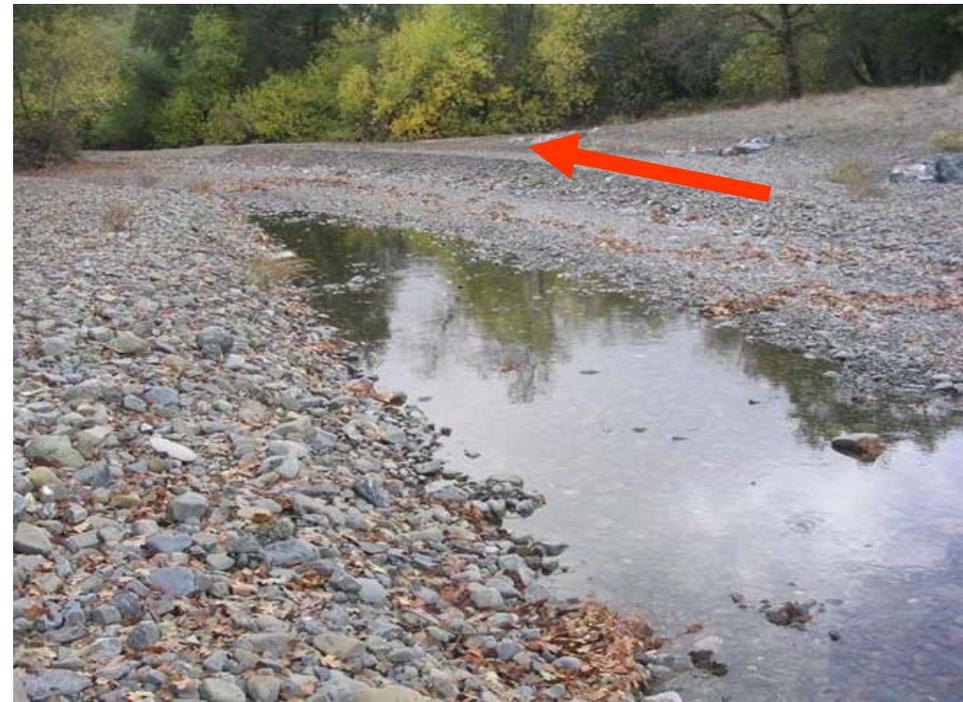
Morrison Creek in 2008/9 percolating into the alluvium near its creek outlet (above) and near the river. The Russian River is about 1000 ft. downstream from where the water is percolating into the ground in Morrison Creek. Red arrow indicates direction of flow.

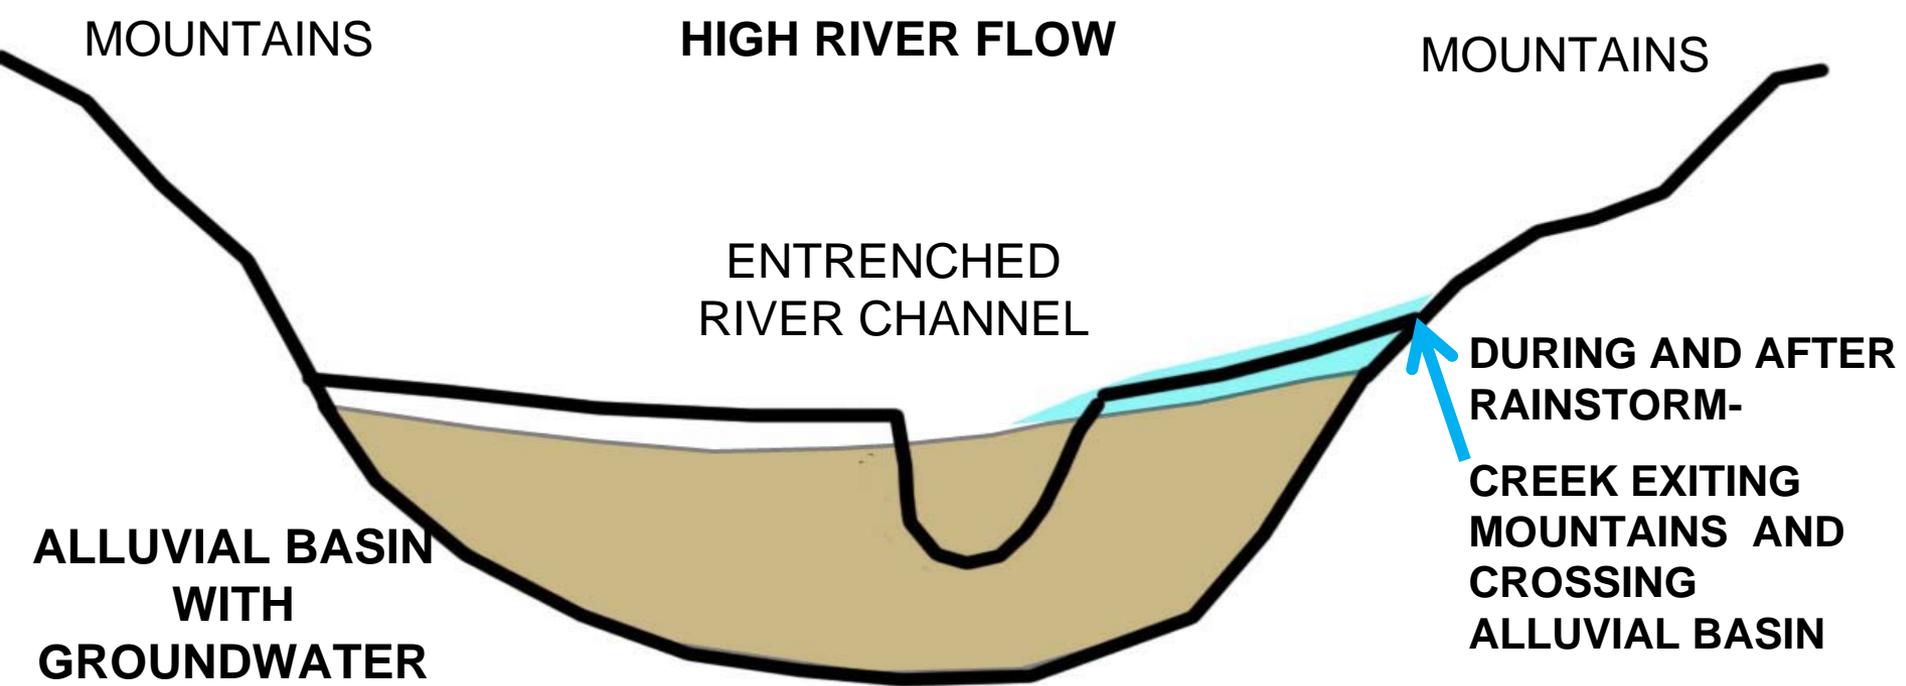
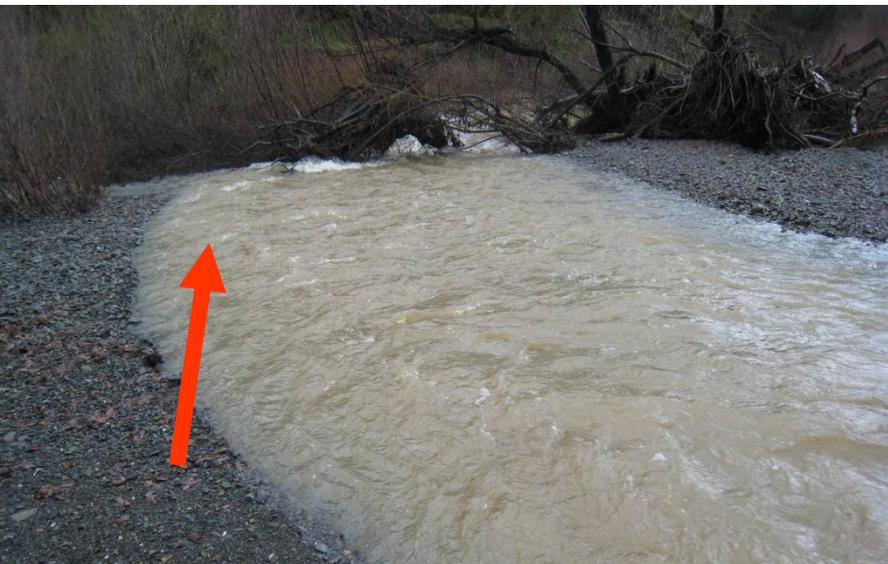
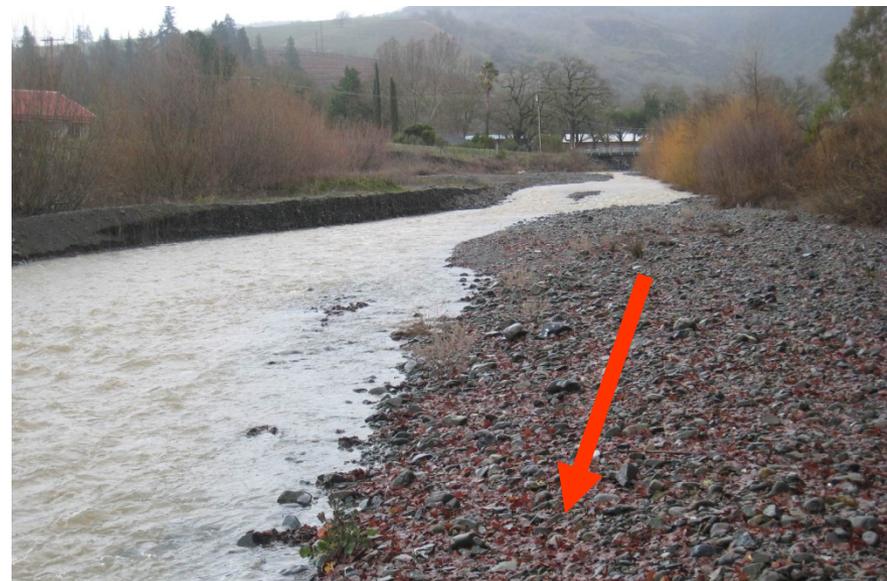
MORRISON CREEK AT HIGH FLOW IN FEBRUARY 2009. ONLY ONE PERIOD OF CONNECTED FLOW OCCURRED IN 2009.

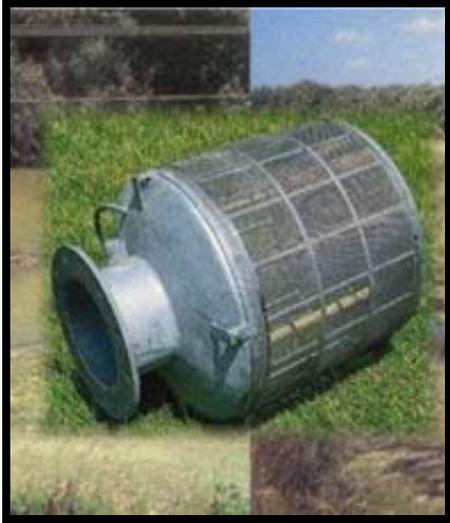
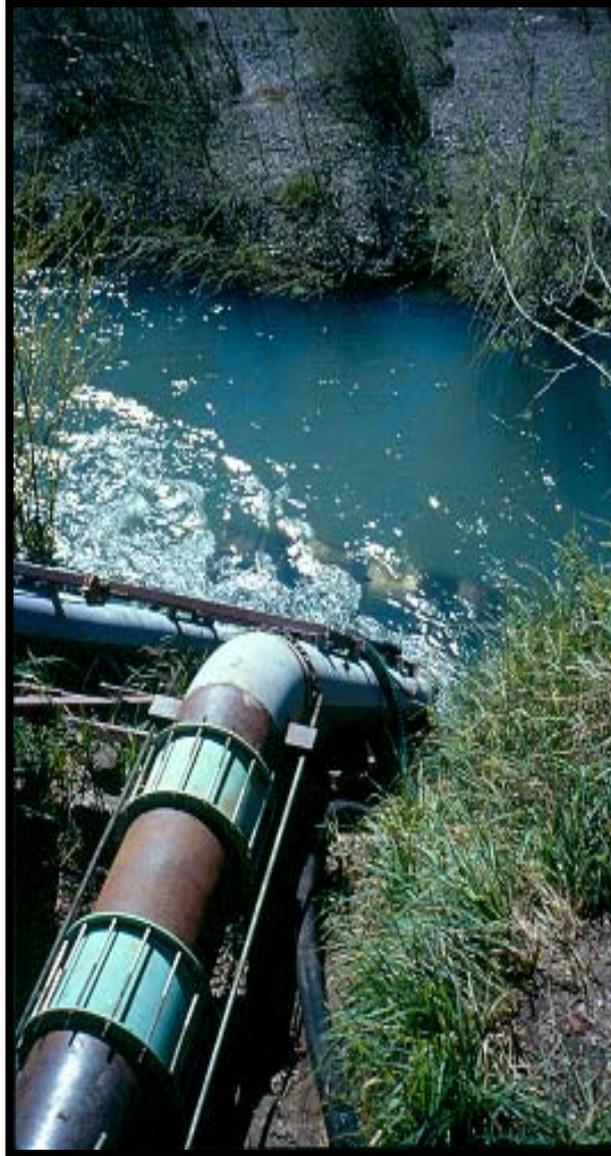
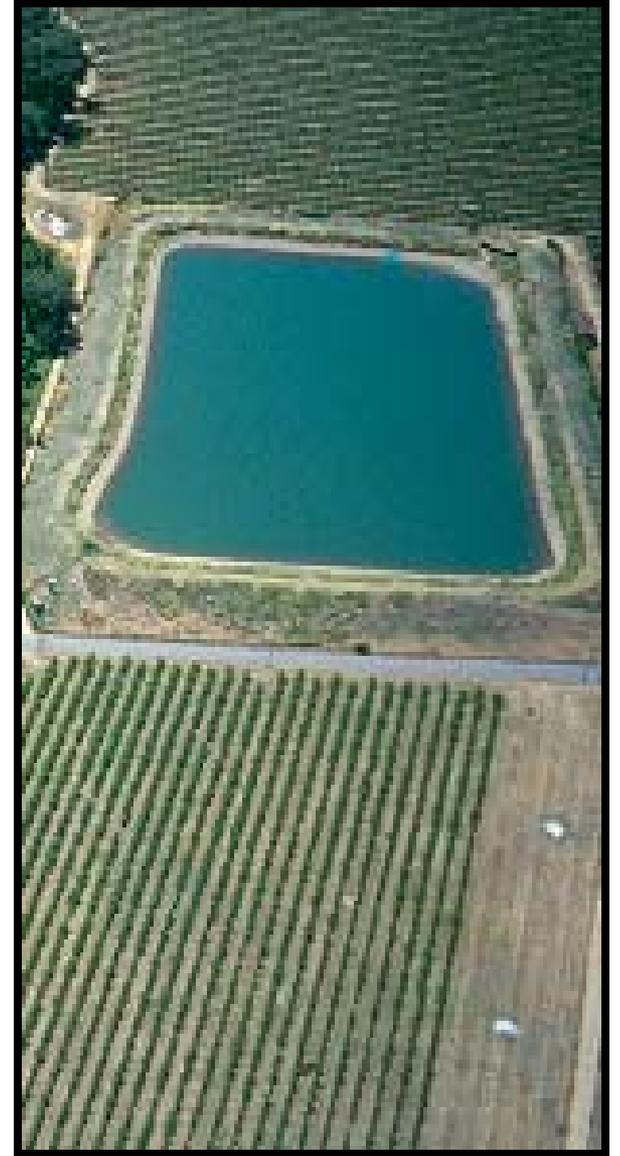
**Off stream
reservoir with
river diversion
fitted with fish
screen**
