Central Coast Regional Water Quality Control Board

CENTRAL COAST WATER BOARD NOTICE OF VIOLATION BASED ON RESULTS OF LIMITED COMPLIANCE AUDIT, CITY OF MONTEREY STORM WATER MANAGEMENT PROGRAM, WDID NO. 3 27MS03012, MONTEREY COUNTY

Attachment A - Photos taken by Central Coast Water Board staff on March 8, 2013

ATTACHMENT A – PHOTOS TAKEN DURING MARCH 8, 2013 AUDIT

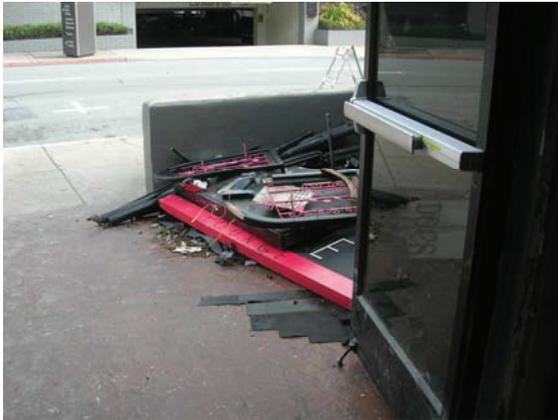
Photo 1. 400 Tyler Street

During the audit, Central Coast Water Board staff observed exposed construction materials, waste, and debris located where stormwater could carry pollutants into the storm drain. Precipitation in Monterey occurred both the day before and the day of the audit. See Photos # 1 and # 2 taken at 400 Tyler Street in Appendix A. Central Coast Water Board staff also observed an ineffective BMP for storm drain inlet protection. The fabric under the storm drain grate contained a large hole and a ring was visible around the inlet that indicated a pool of polluted water may have collected around the storm drain inlet. See Photo #3 taken at 2100 Del Monte Avenue in Appendix A. The Monterey Inspector did not identify the inadequate BMPs and did not demonstrate the willingness to require the contractor to correct the observed deficiencies. This violation is an ongoing issue and is similar to a deficiency observed during the September 2009 audit (see comment # 1 in the April 2010 NOV).

Action: Monterey’s must improve its construction oversight to include enforcement of effective minimum BMP control measures, so that construction sites within the city comply with the Monterey Regional SWMP minimum construction site BMPs.

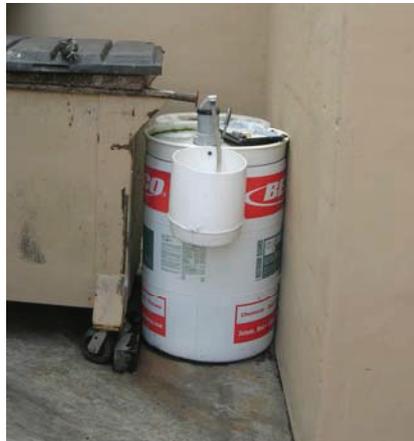
Photo 4. Monterey Sports Center and Pool

Central Coast Water Board staff observed a large drum of restroom cleaner stored such that it was a potential source of pollutants to be transported to the Monterey storm drain system. See Photo # 4 taken at Monterey Sports Center Pool in Appendix A.

Action: Monterey must implement effective procedures for proper material storage at municipal facilities.

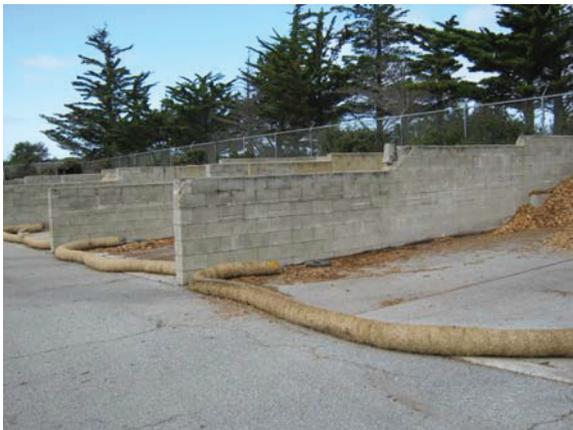
Photo 5. Ryan Ranch Corporation Yard

Central Coast Water Board staff observed wattles or sandbags used to prevent migration of stockpiled materials. Typically wattles and sandbags placed on hard surfaces are not effective in preventing the migration of stockpiled materials. Monterey should monitor the effectiveness of these BMPs during storm events and implement more effective BMPs if necessary. See Photo # 5 taken at Ryan Ranch Corporation Yard in Appendix A.

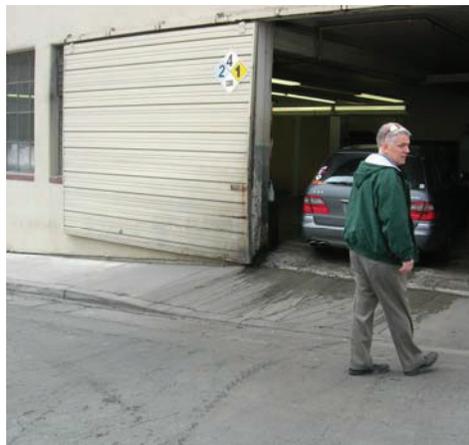
Photo 6. 498 Freemont Street

During the audit visits to private construction sites, Julia Dyer (Central Coast Water Board), Joe Headley (Monterey Inspector), and Tom Reeves (Monterey City Engineer) observed an auto repair facility (Stahl Motors located at 498 Fremont Street) that was cleaning a vehicle in a location such that the wash water drained to the street. See Photo # 6 taken at 498 Fremont Street in Appendix A. The Monterey inspector appeared reluctant to identify the activity as an illicit discharge, to correct the issue, and to follow up on the issue. Monterey inspection staff is either inadequately trained or unwilling to recognize and correct illicit discharges and threats to water quality.

Action: Monterey must implement actions to ensure applicable staff (including inspectors) are trained to identify, correct and follow up on potential illicit discharges as part of their typical work activities.

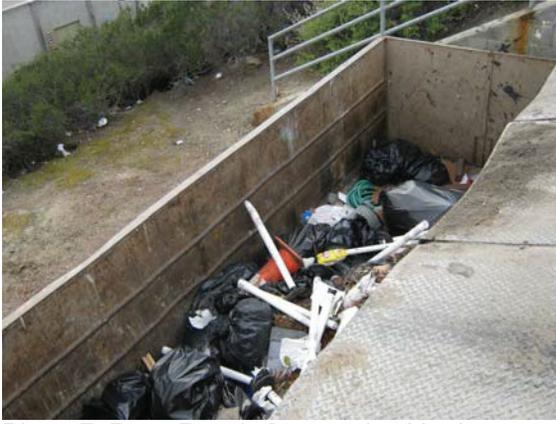
Photo 7. Ryan Ranch Corporation Yard

- Ryan Ranch Corporation Yard - Visible trash at the Ryan Ranch Corporation Yard in the area around a large uncovered trash bin indicated trash was migrating out of the container. See Photo # 7 taken at Ryan Ranch Corporation Yard in Appendix A.
- Monterey Wharf II - Open bins at the Monterey Wharf II were being used for trash collection and storage. The bins were uncovered and some of the bins were not water-tight (contained holes or gaps), creating the potential for wind or stormwater to transport

Action: Monterey must evaluate trash management practices in Monterey and implement actions to prevent trash from becoming a source of stormwater pollution. Monterey must develop and implement trash management improvements at the Ryan Ranch Corporation Yard and at Wharf II. Monterey should require all trash receptacles in Monterey to be covered, with receptacles located near bodies of water to be the highest priority.

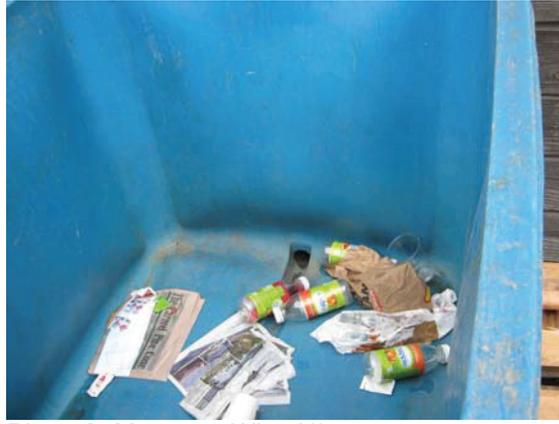
Photo 8. Monterey Wharf II

pollutants to the ocean below. All trash at the wharf should be kept in closed, water-tight containers. In addition, cigarette butts were observed on the wharf. Monterey should provide convenient disposal for cigarette butts to encourage their proper disposal. See Photos # 8 and # 9 taken at Monterey Wharf II in Appendix A

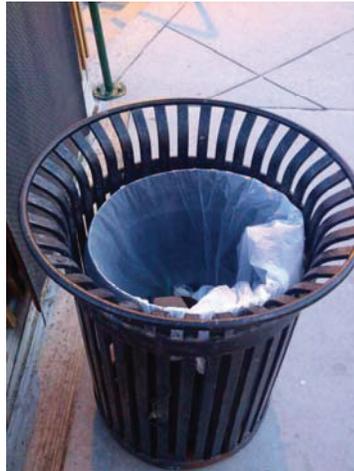
Photo 10. Steinbeck Plaza Area

- Steinbeck Plaza - An uncovered trash can in the Steinbeck Plaza area is located adjacent to a nearby beach. See Photo # 10 in taken at the Steinbeck Plaza in Appendix A. This is an ongoing issue. The same trash can was observed to be uncovered during the September 2009 audit (see comment # 112 in the May 2010 NOV).
