Information needed to characterize Ag Dominated Water Bodies

A. Water Body Categorization Information

San Luis Canal Company (SLCC) was established in 1913 as a private mutual water company that began service to lands within its boundaries. The Company continues to hold Pre-1914 Appropriative Water Rights. More information regarding SLCC can be found at: <http://www.slcc.net/>.

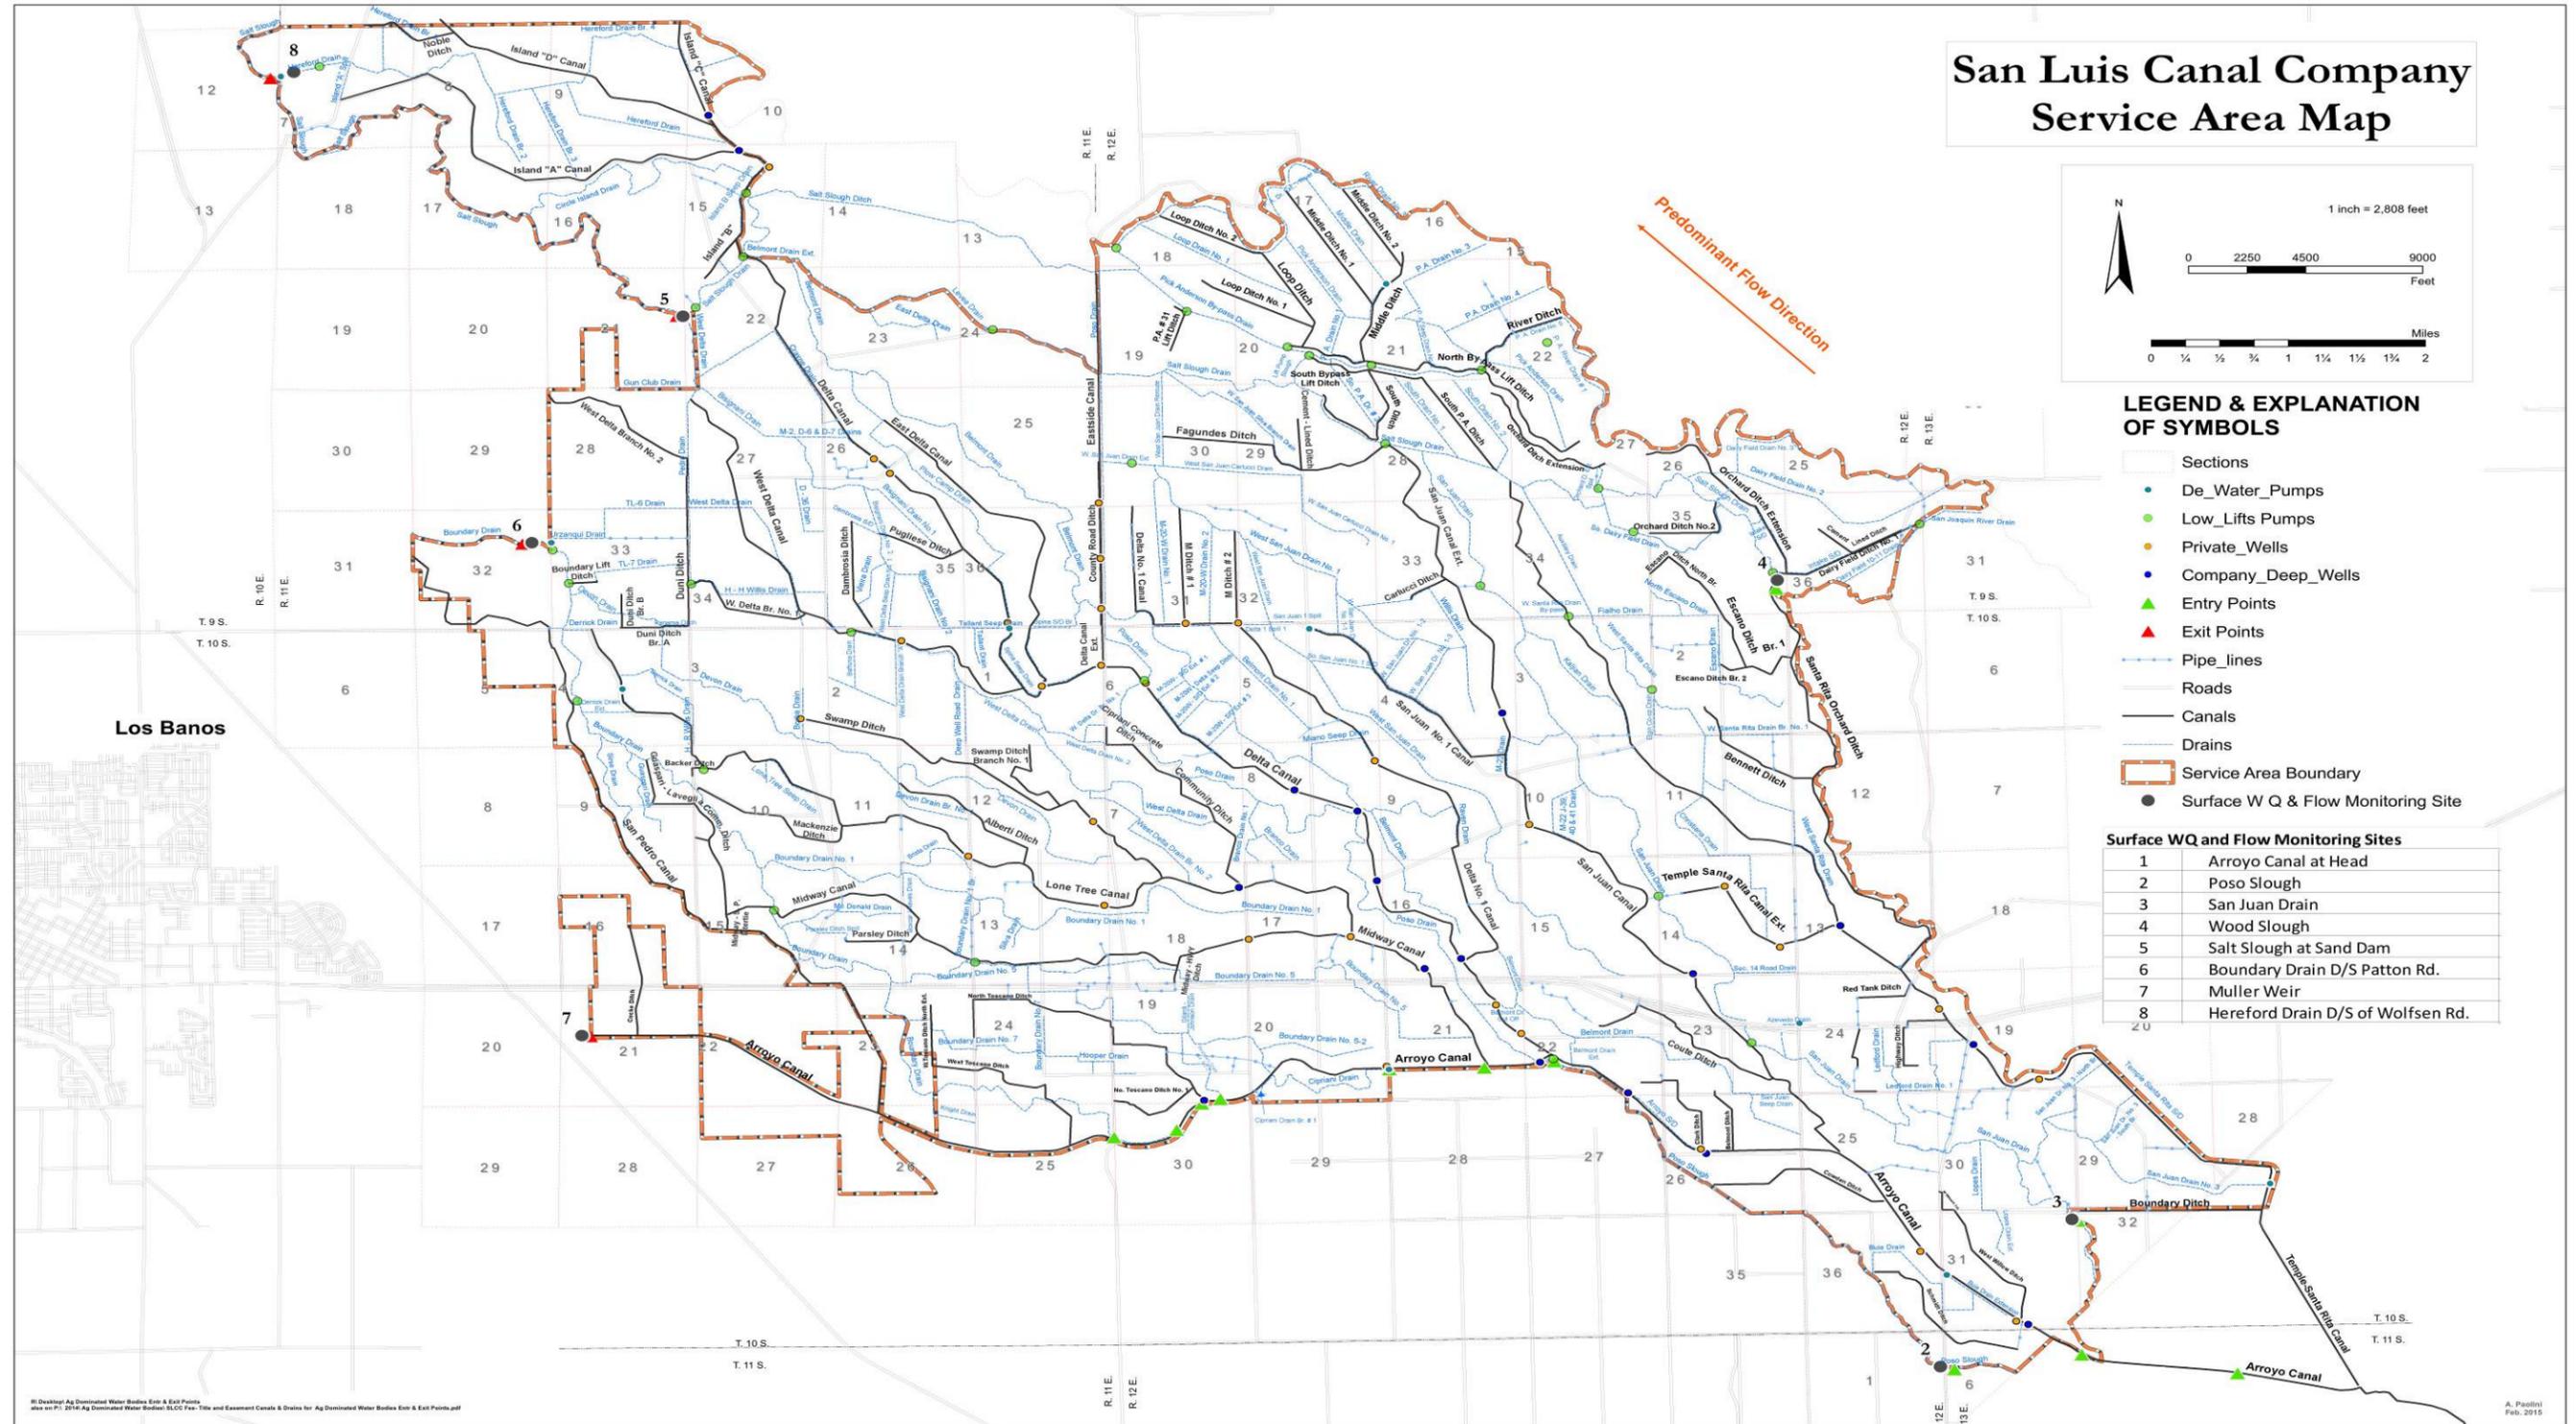
Figure 1 San Luis Canal Company Service Area

The boundary of San Luis Canal Company is provided in Figure 1.

Locations of intake points, groundwater supply points, and operation spills are displayed in Figure 1.

Water predominately flows southeast to northwest within the district and is indicated in Figure 1.

All monitoring locations with identifying labels are displayed in Figure 1 corresponding to map labels in Table 3 and 4.

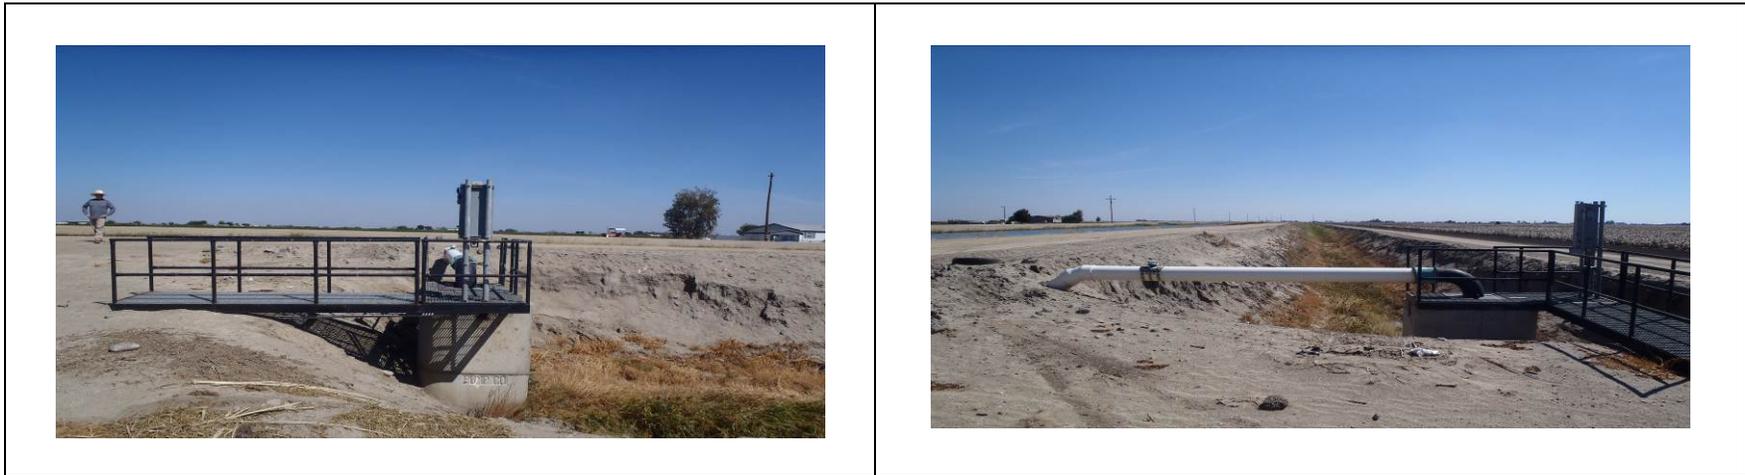
Arroyo Canal –Bertao Lift

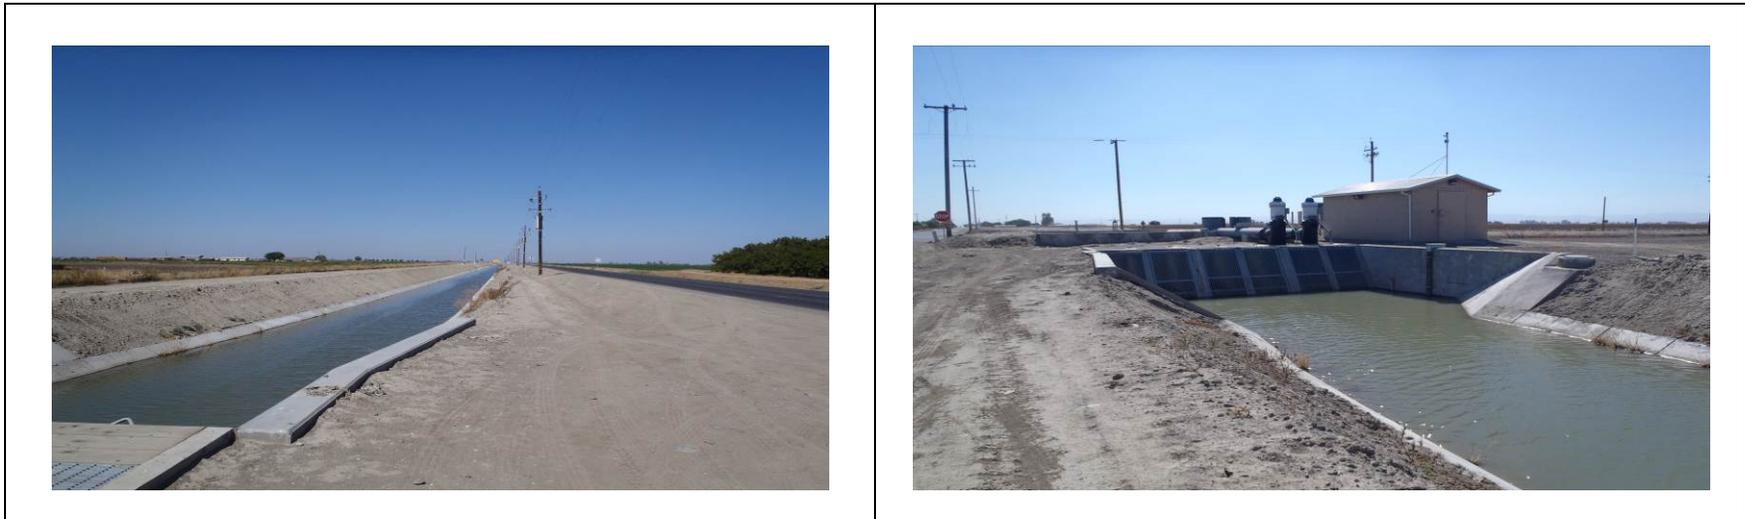
Eastside Canal—Concrete Lined and Pumping Plant

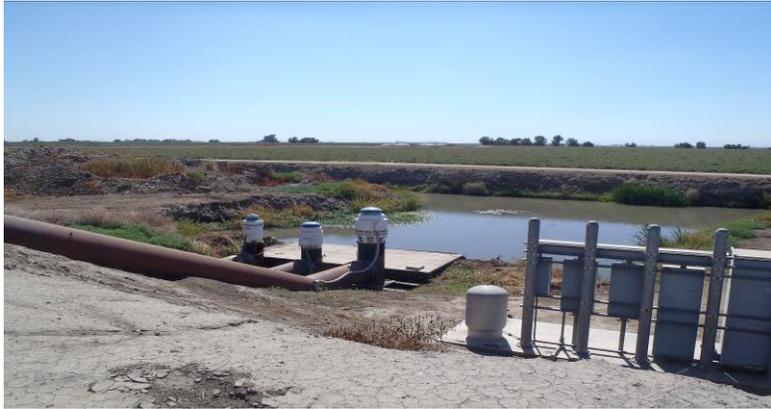
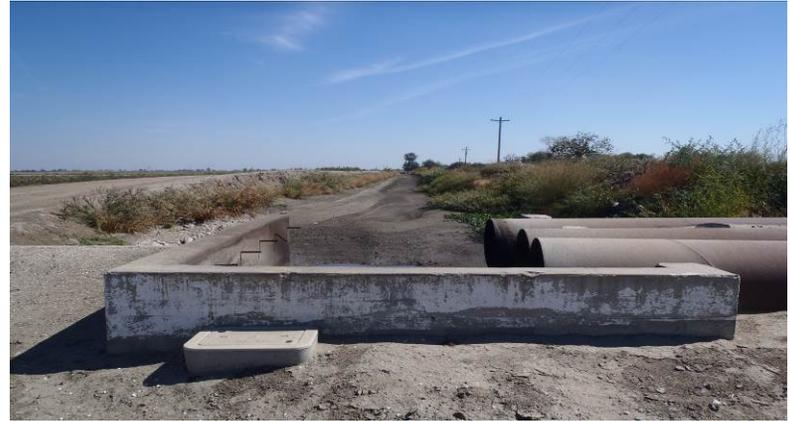
Pick Anderson 3-5 –Pumping Plant and Pipes

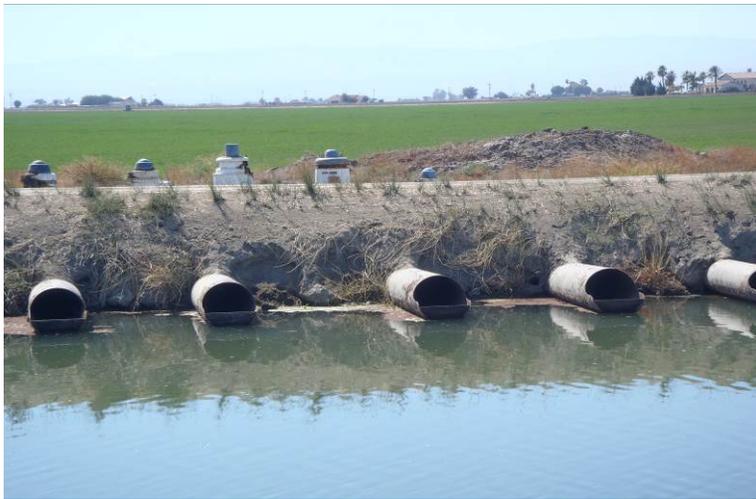
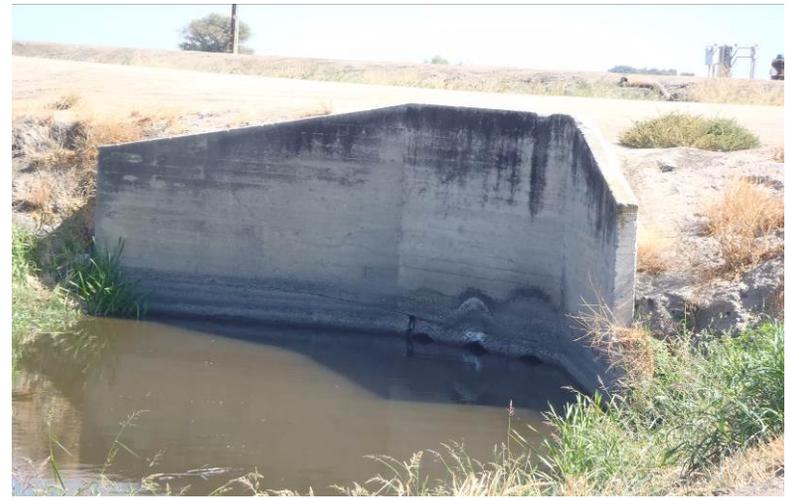
Poso Slough –Pumping Plant and Concrete Structure-Backup Weir

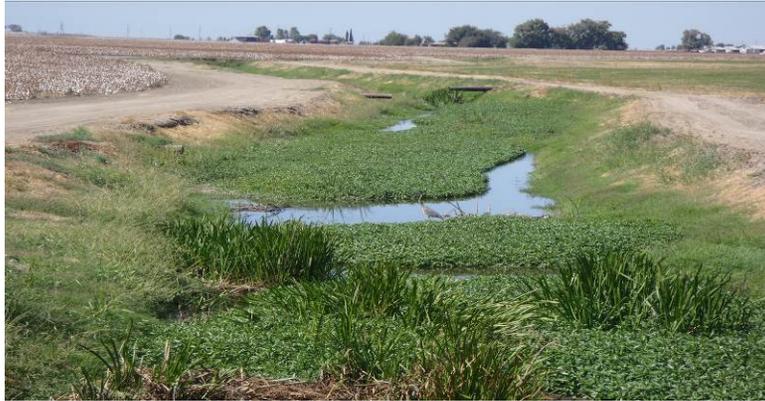
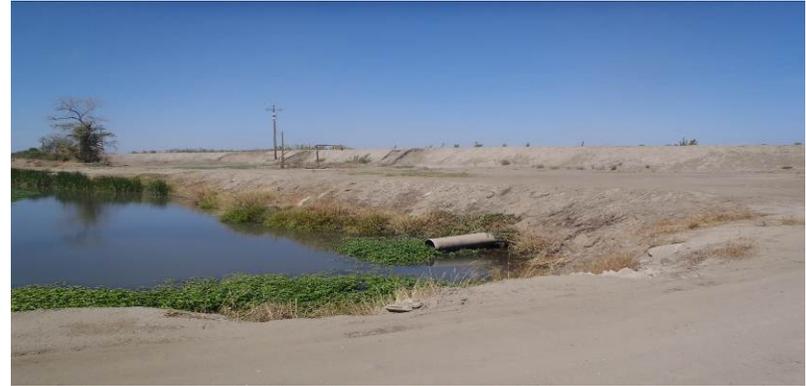
Poso Slough and Salt Slough—Pipes

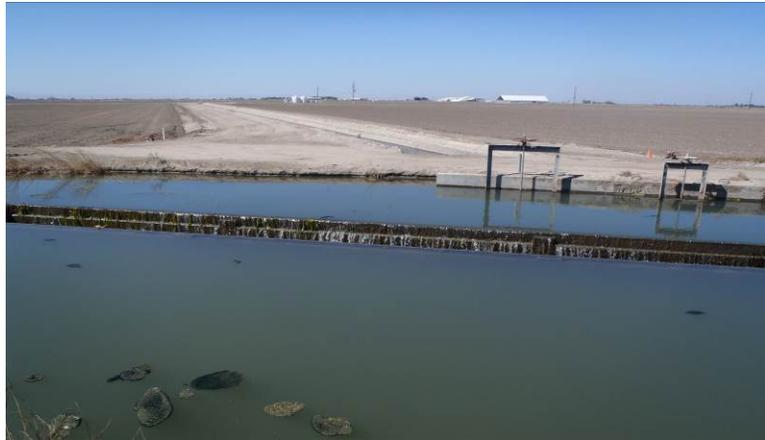
Santa Rita Canal –Long Crested Weir
