**CALIFORNIA REGIONAL WATER QUALITY CONTROL BOARD
LAHONTAN REGION**

SUBJECT: PROGRESS REPORT – CONSIDERATION OF POTENTIAL CHANGES TO A SETTLEMENT AGREEMENT IN THE MATTER OF AN ADMINISTRATIVE CIVIL LIABILITY AGAINST LOS ANGELES DEPARTMENT OF WATER AND POWER (LADWP) FOR ALLEGED VIOLATIONS AT LEE VINING CREEK DIVERSION STRUCTURE, MONO COUNTY

Potential projects – Todd Ellsworth, Watershed Program Manager, Soil Scientist, Inyo National Forest

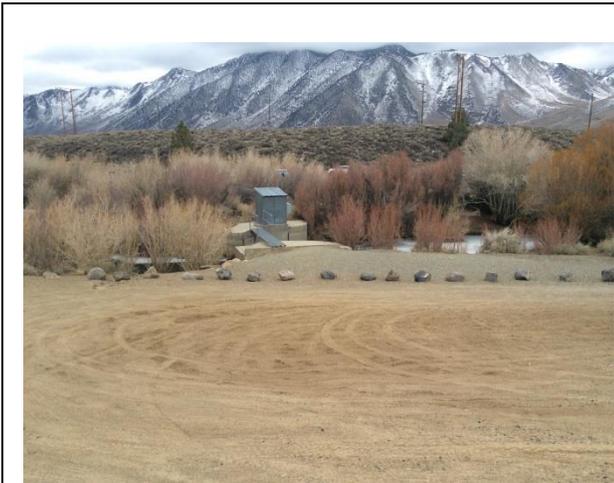
Caption:
Area proposed for narrowing and subsoiling. Access to the gauging station will remain.

1. Narrow and define parking area

- Subsoil compacted areas to allow for infiltration and reduce runoff into Mammoth Creek. Place boulders to narrow the footprint of the parking area allowing for adequate parking. Once completed, mulch bare soil area with local materials (duff, slash, branches, brush and rock) to protect soil from erosion and retain soil moisture to aid in vegetative recovery.
- Place restoration signs to inform public about the project and prevent trespass.

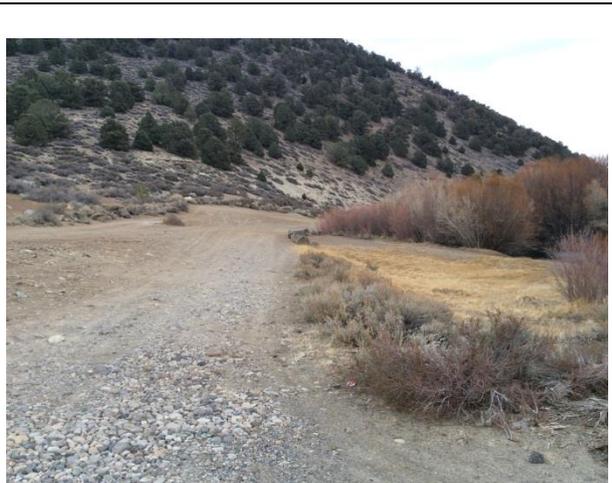
Caption:
Project area looking east. Mammoth Creek is in the right hand part of the picture.

The road (04S102B) is located east of old Highway 395 adjacent to Mammoth Creek. This area is highly popular for local residences to park and recreate around Mammoth Creek. It has expanded to the point of impacting Mammoth Creek and associated riparian vegetation. 04S102B was designated as a route in the 2009 Travel Management Environmental Impact Statement (EIS), subsequently the need for restoration action in the expanded areas of the route was identified in the Upper Owens/Bishop Creek Unauthorized Route Restoration Categorical Exclusion (CE) in 2014.

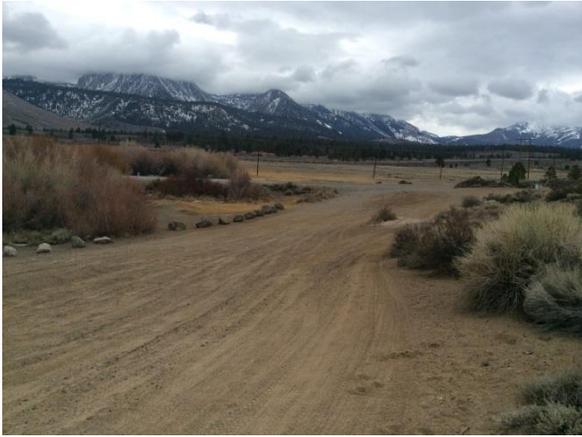
Caption:
Project area looking west.

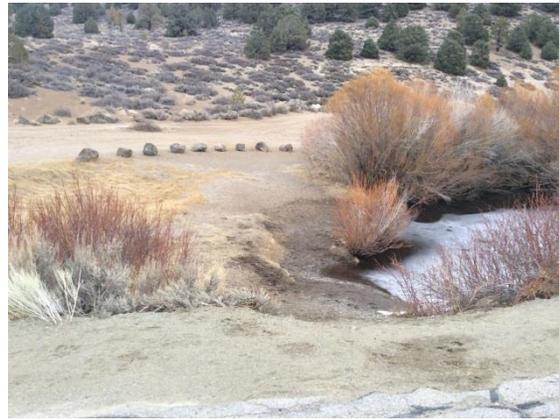
Caption:
Project area looking from old Hwy. 395 to the North East. Willow plantings in bare areas along Mammoth Creek

- Place large boulders defining the parking areas to prevent vehicle traffic from entering the channel.
- Transplant willow cuttings from nearby plants within wetted soil perimeter of the creek. Re-vegetation of the bank with willow or other local riparian species will aid with stabilization and restoration.

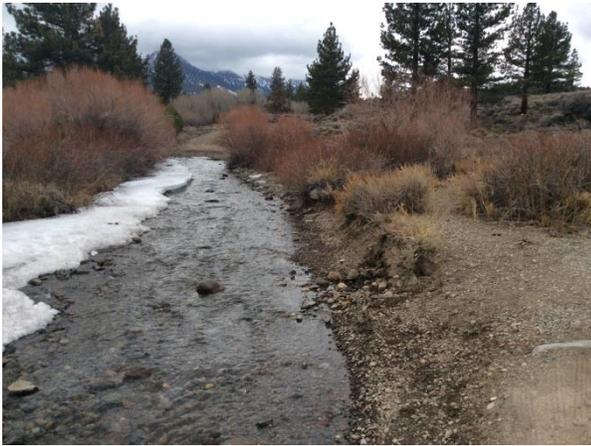
Caption:
Mammoth Creek Road intercepted by Mammoth Creek. Looking west

Mammoth Creek Road (Road #03S09) is located along Mammoth Creek between Highway 395 to the north east and Old Mammoth Road in the Town of Mammoth Lakes to the southwest. A section of the road near the Murphy Gulch / Mammoth Creek confluence has been damaged due to Mammoth Creek being diverted onto the road, channeling the majority of stream flow onto the road for approximately 150 feet. The affected road section is now the main stream channel and carries the bulk of the flow in Mammoth Creek. Travel by motorized vehicles on this section is hazardous when peak flows occur, and during base flows the channel is impacted when vehicles travel up or down the channel. Over time, stream flows have eroded the steep bank on the north end where the road leaves the channel and the stream makes an abrupt turn to the east. A gate was placed by the Forest Service on the northern entry to keep motorists from attempting to drive on the flooded road section.

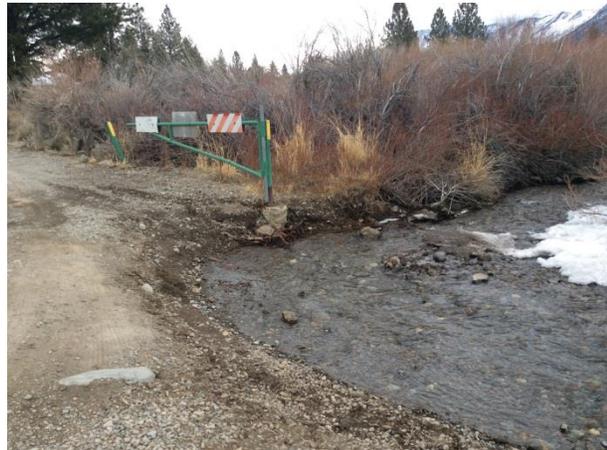
Caption:
Project area looking southeast. We propose to riprap the bend, remove the gate and plant willow and other appropriate riparian species.

- j) Place restoration signs to inform public about the project and prevent trespass.
4. Remove Forest Service gate.
5. Stabilize eroded stream banks:
 - Install boulder rip rap and geo-textile cloth on eroded stream banks on the north end of the channel. Large rip-rap (up to 3 foot diameter) would be placed to reduce the sharp angle at the channel turn from its current 90 degree angle to a more gradual 20-30 degrees to reduce soil erosion and direct flow downstream instead of straight into the streambank. An estimated amount of 20-30 cubic yards of large boulder fill would be placed by a large backhoe, on top of geotextile cloth.

- Place large boulders on the road to prevent vehicle traffic from entering the channel.
 - Transplant willow cuttings from nearby plants within wetted soil perimeter of the creek. Re-vegetation of the bank around the riprap with willow or other local riparian species will aid with stabilization and restoration.

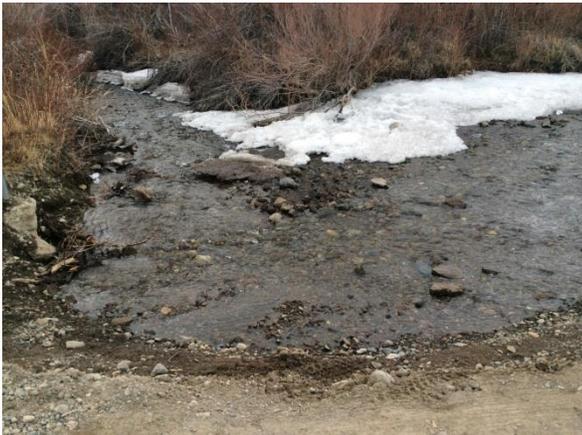
Caption:
Close-up of the bend where riprap and willow planting are proposed.

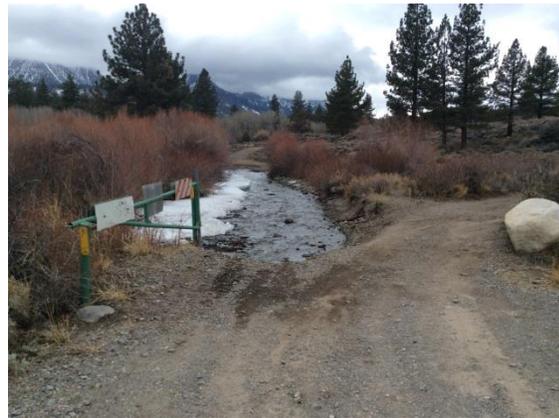
Caption:
Overview of project area looking west. Note: reroute is in the right section of the photo.

3. Create a re-route of Mammoth Creek road:
 - a) Utilize the footprint of the existing unauthorized route as much as possible to minimize impacts to existing soil and riparian vegetation.

- b) The route will be moved upslope (10 – 20 feet) out of riparian vegetation where possible and practical into adjacent uplands in dry and drained soils.

- h) The length of the re-route is approximately 350 feet. After re-route construction, place a line of large boulders along the downstream edge of the route to prevent trespass into the bare soil area along the southern entry to the creek (old road route).
