Santa Barbara Channelkeeper 714 Bond Avenue Santa Barbara, California 93103 (805) 563-3377 www.sbck.org

Ventura Stream Team 2001 - 2005

A review of the findings of Santa Barbara Channelkeeper's Ventura Stream Team January 2001 - January 2006

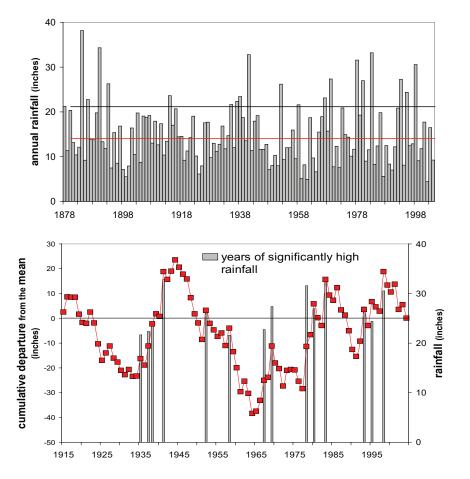
Figure 1. Annual (water-year) rainfall in downtown Los Angeles: 1878-2004 (upper panel). The lower line represents the annual average of 15 inches, the upper, 150% of average. Lower panel: The cumulative rainfall excess or deficiency — in other words, a running account of how much each year's rainfall varied from the 15-inch average. The plot reveals a pattern of alternately rising and falling trends generally lasting decades. The lower panel also shows years of significantly high rainfall, years when rainfall exceeded 150% of average, e.g., rainfall greater than 22 inches. Years of significantly high rainfall, many of which coincide with major El Niño episodes (but not all), heavily influence the rainfall record; a close grouping of unevenly spaced high rainfall years causes an increasing rainfall trend.

Figure 1 (lower panel), a plot of cumulative departure from the mean for Los Angeles rainfall (NWS-LA), attempts to show the influence of this pattern by plotting the cumulative rainfall excess or deficiency. In other words, the graph displays a running summary of how much each year's rainfall affected the long-term departure from the annual 15-inch average. The plot shows a pattern of alternately rising and falling trends, where rainfall was either generally above or generally below average, lasting decades. The 1880s and the 1930s had strong increasing trends, trends generally caused by an increased frequency of years of significantly high rainfall. The general pattern between 1944-1968 was below-average rainfall (a decreasing trend), but from 1968-1998 the trend reversed, except during the California drought of 1987-1992.

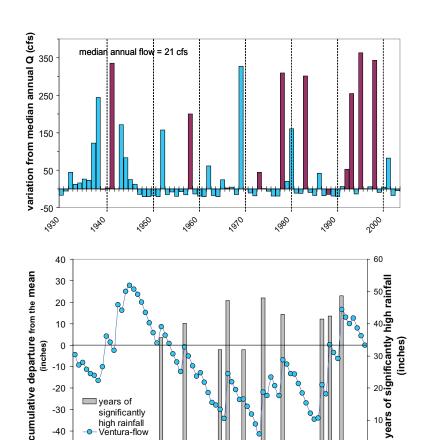
Figure 2. Upper panel: Median annual flow on the Ventura (at Foster Park) is 21 cubic feet per second (cfs), e.g., half the years on the chart had average flows less than this, the other half had greater. The distribution is skewed - "above the median" years tend to be very wet. Years shown as dark bars were major El Niño episodes. The 1940s, 1950s and 1990s were relatively "wet" decades. Lower panel: The cumulative flow excess or deficiency - a running total of how much each water-year's flow (measured in inches of runoff at Foster Park) moved the long-term trend from the 4.8 inch overall average. The plot shows a pattern of rising and falling trends, heavily influenced by wet years. Wet years, in this chart, represent Ojai rainfall above 31.5 inches. Note that in the late 1960s it took two wet years to reverse a 10-year declining trend.

Annual flows in the Ventura River mimic this rainfall record (flows measured at Foster Park, USGS-NWIS). Figure 2 (upper panel) shows how much each year's flow differed from the median flow of 21 cfs (half the years had average flows less than the median, half greater). The 1930s, early 1940s and 1990s were years of above average flow,

whereas other decades were below average. The lower panel of Figure 2 displays the cumulative flow excess or deficiency – the running total of how much each water-year's flow (measured in inches of runoff at Foster Park) moved the longterm trend away from the 4.8 inch overall average, and in which direction. The plot shows the same pattern of rising and falling trends, heavily influenced by very wet years, as Los Angeles rainfall. Years of significantly high rainfall, in Figure 2, represent Ojai rainfall greater than 31.5 inches. Note that in the late 1960s it took two years of significantly high rainfall to reverse a 10-year declining trend.

However, as shown in the upper panel of Figure 2, not all years with significantly high rainfall are severe El Niño years. At times, some really wet winters are caused by a much shorter weather cycle of 30-60 days called the "Madden-Julian Oscillation." Simplifying the process greatly, atmospheric high pressure off the Pacific Northwest moves west, allowing a low pressure system to develop offshore, which in turn sweeps heavy moisture from Indonesia into Southern California. This type of weather system is often called a "pineapple express," as the moisture plume passes over the Hawaiian Islands en route. This system delivered extraordinary amounts of rainfall in the winter of 2005, rainfall that continued through March and April (Figure 6, lower panel).

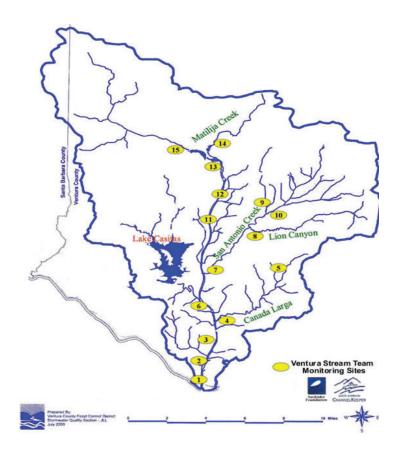
Figure 3: Map of the Ventura watershed with Ventura Stream Team sampling sites.

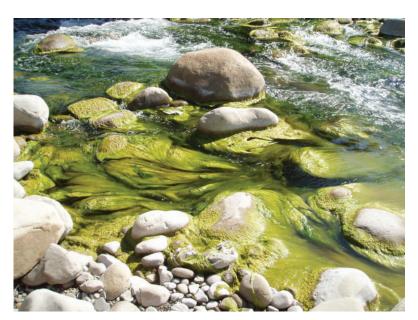
Following large storms that scour streambeds, filamentous algae often take over. This photo was taken at VR12 in May 2005, following the large January storms.

Major winter storms, such as occur during severe El Niño years, begin a transformational cycle by completely scouring the channel of vegetation and fine sediment (Figure 4); this occurs, on average, once every 7-10 years (Leydecker et al., 2003). Heavy flows scour streambeds of vegetation and fine sediment, clearing the way for a complete takeover by filamentous algae (principally Cladophora, Rhizoclonium, Enteromorpha and Spirogyra spp.). This is true even in

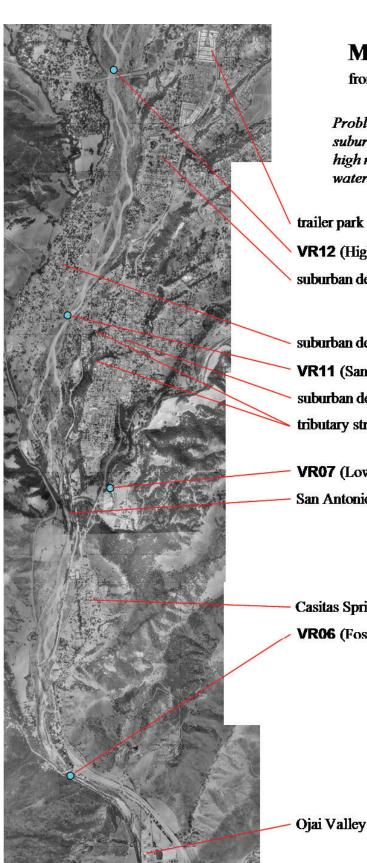
Middle Ventura River

from the Ojai wastewater treatment plant to Highway 150

VR06 (Foster Park) sampling point

Ojai Valley wastewater treatment plant

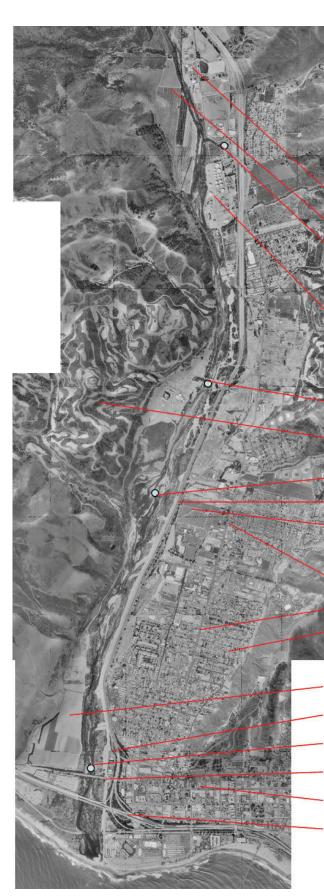
Lower Ventura River

from the ocean to the Ojai Valley wastewater treatment plant

downtown commercial area

Highway 101

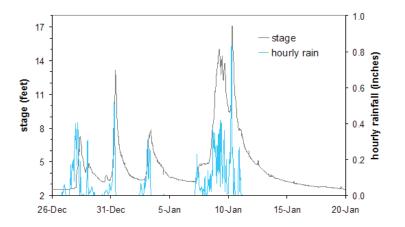
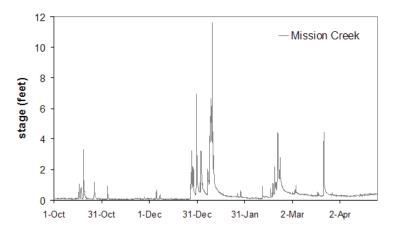
Figure 6. Upper panel: Stage (river height) on the Ventura River (at Foster Park, VR06) and hourly rainfall (Ojai) during the Christmas 2004 series of winter storms. Lower panel: Stage during the winter of 2005 at Mission Creek (Santa Barbara).

Figure 6 (upper panel) also shows a greater delay between rainfall and the river's response at the beginning of the storm period than at the end. It also shows a proportional increase in the amount of runoff per inch of rainfall during the latter half of the storm period (noticeably increased runoff from similar amounts of rainfall). The coastal mountains

tributary to the Ventura River contain a thin but highly porous layer of soil. This layer acts like a sponge during the first storms of the season, absorbing rainfall and limiting the amount of flow that comes from higher elevations. But when these soils become saturated, they deliver copious amounts of runoff to the valley below, and mountain rainfall becomes the primary cause of flooding on the coastal plain. Twenty-three inches of rain fell during the period shown on the graph, but only about six inches of this rain flowed down the river, most of it during the second storm pulse.

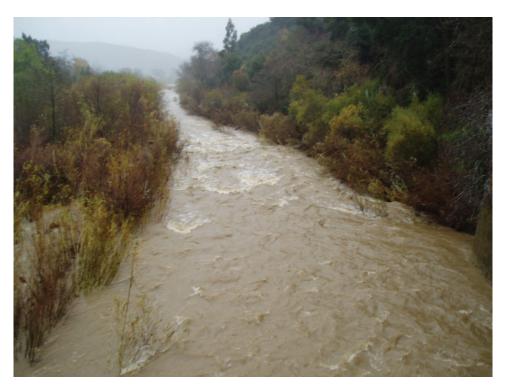
Foster Park (VR06) during the January 2005 storm.

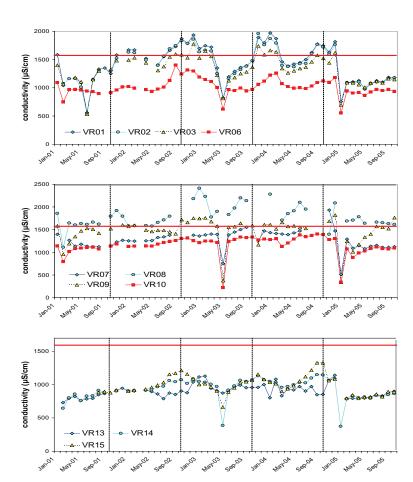
Figure 7. Conductivity, January 2001 to October 2005. Dashed vertical lines mark the start of each water-year. The overall trend indicates a gradual increase until the significant rainfall of the winter of 2005; very low values usually mark storm events (or, in some cases, meter error). The bold horizontal line indicates the typical 1,600 µS/cm drinking water limit.

In the Ventura River, Ventura Stream Team observed a long-term trend towards increasing conductivity until the winter of 2005 (Figure 7, summarized in Figure 8). The increasing trend (SBCK, 2004) was caused by increasingly depleted and generally older groundwater inflows, enhanced uptake by growing riparian vegetation, and a relative increase in evaporation as dry-season river flows continually diminished since the last year with significantly high rainfall (the high El Niño rainfall of 1997-98).

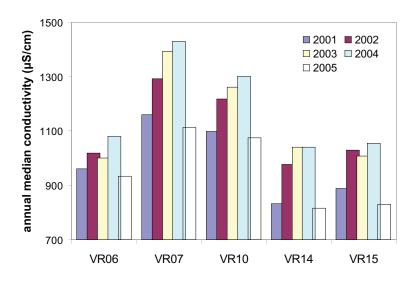
Figure 8. Changes in annual median conductivity for Ventura Stream Team sampling sites with relatively natural, year-round flows, 2001 to 2005. There has been a consistent increase in conductivity over the initial four years of sampling, with the occasional exception of the 2002 drought year (possibly due to a relative increase in evaporation of the extremely low flows of that year). The percent increase from 2001 to 2004 has been 12, 23, 19, 25 and 19 for VR06, VR07, VR 10, VR14 and VR15, respectively. However, in 2005, conductivity abruptly decreased by 20% throughout the Ventura River system.

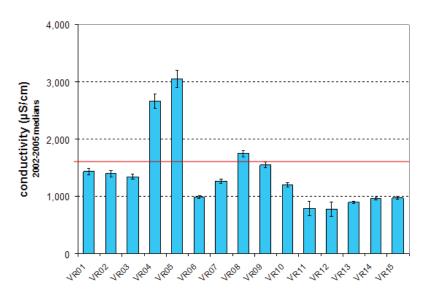
Figure 10. Median conductivity values, January 2001 to October 2005. The "error bars" indicate the standard error of the median. The solid line represents a generally accepted upper conductivity limit of 1,600 μ S/cm for drinking water. VR04, 05 and 08 are heavily impacted by cattle grazing and have very low flows prone to evaporative concentration.

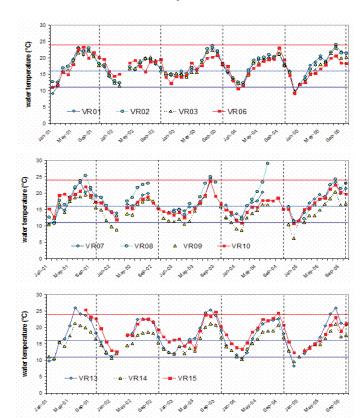
Figure 11. Stream temperature, January 2001 to October 2005. Dashed vertical lines mark the start of each water-year. The three horizontal lines mark important steelhead temperature milestones: above 24°C leads to death; below 16°C indicates good dry season conditions; and below 11°C is excellent for spawning and incubation.

Temperature is the simplest parameter measured, yet one of the most important. The expected annual pattern is straightforward: temperature rising from winter lows to summer highs, and then decreasing in early fall, paralleling seasonal changes in air temperature. On the Ventura River, that pattern is observed at all sites (Figure 11).

The temperature graphs include three horizontal lines, which mark important threshold temperatures for steelhead trout: above 24°C leads to death; below 16°C indicates good dry-season conditions, and below 11°C in winter provides ideal conditions for spawning and incubation (Brungs and Jones, 1977; Armor, 1991; McEwan and Jackson, 1996; Sau-

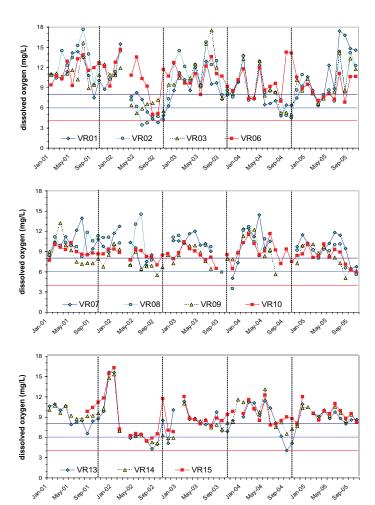
Figure 12. Dissolved oxygen, January 2001 to October 2005. Dashed vertical lines mark the start of each water-year. The three horizontal lines mark important DO milestones for steelhead: above 8 mg/L represents near ideal conditions; at 6 mg/L hypoxia begins and fish start to feel stress; and below 4 mg/L lies severe damage and death.

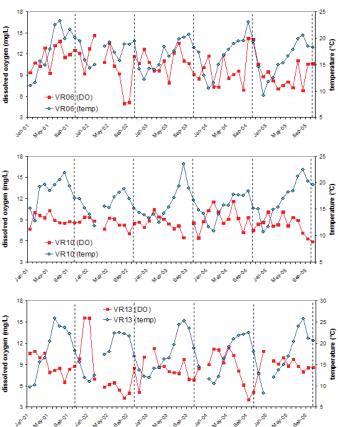
Figure 13. Dissolved oxygen and temperature for three sampling locations, January 2001 to October 2005. Dashed vertical lines mark the start of each water-year. Under ideal conditions, as temperature rises DO should fall, and vice versa. The absence of this pattern in the upper panel indicates problems with algae.

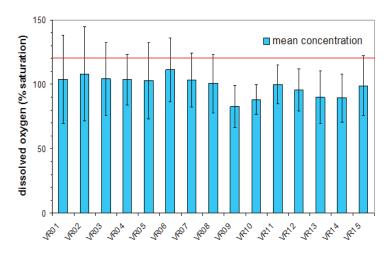
Figure 15. Mean dissolved oxygen (in percent saturation) values, January 2001 to October 2005. Concentrations above 120% saturation (horizontal line) usually indicate problems with algal growth; over-saturation during daylight is followed by depleted concentrations at night. The error bars indicate \pm the standard deviation of sampled concentrations at each site (e.g., 67% of the monthly samples will have values between the error bars). Locations from VR01 to VR08, and VR15, have periodic problems with algae.

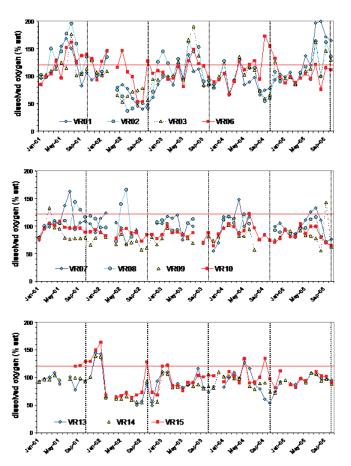
Figure 14. Dissolved oxygen measured in percent saturation, January 2001 to October 2005. Dashed vertical lines mark the start of each water-year. Concentrations above 120% saturation (horizontal line) usually indicate problems with algal growth; over-saturation during daylight followed by depleted concentrations at night.

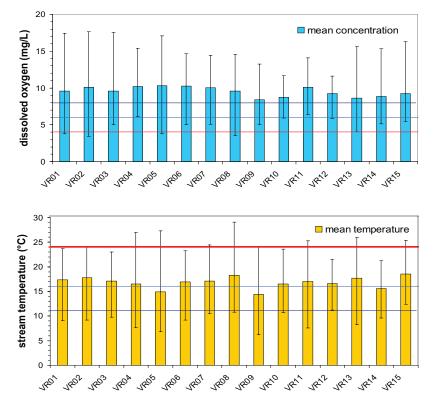
Figure 16. Upper panel: Average dissolved oxygen, January 2001 to October 2005. The three horizontal lines mark the important DO milestones for trout and steelhead explained in Figure 12. Lower panel: Average stream temperature, January 2001 to October 2005. Above 24°C leads to death; below 16°C indicates good dry season conditions; and below 11°C is excellent for spawning and incubation. The "error bars" represent the maximum and minimum measured values. Extreme values become critical at locations with measurements below (for DO) or above (for temperature) the bold line. As stressed, night-time oxygen depletion at sites with significant algal growth remains largely unknown, a complete evaluation of DO conditions on the river depends on collecting this data.

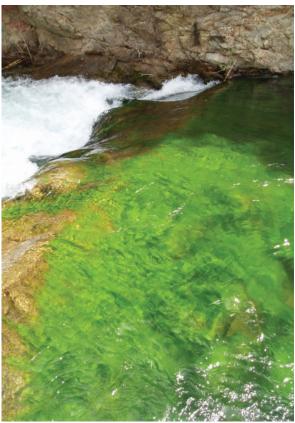
Following the large winter storms of 2005, even relatively pristine sites such as VR13 contained excessive amounts of algae.

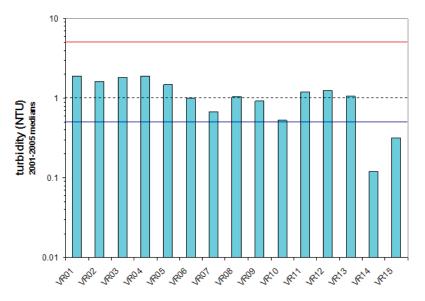
Figure 18. Median turbidity values, January 2001 to October 2005. The three horizontal lines mark typical Public Health drinking water quality benchmarks: a maximum turbidity of 5 NTU; no higher than 1 NTU for 8 hours; and no more than 5% of monthly samples with greater than 0.5 NTU.

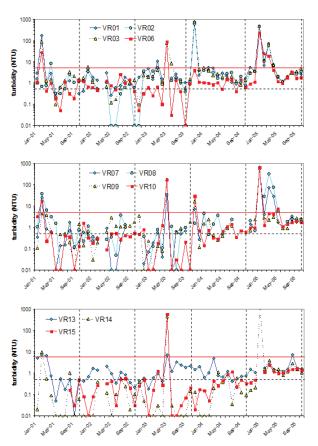
Figure 17. Turbidity, January 2001 to October 2005. Dashed vertical lines mark the start of each water-year. The two horizontal lines mark Public Health drinking water quality benchmarks: a maximum turbidity of 5 NTU, and no more than 5% of monthly samples with greater than 0.5 NTU.

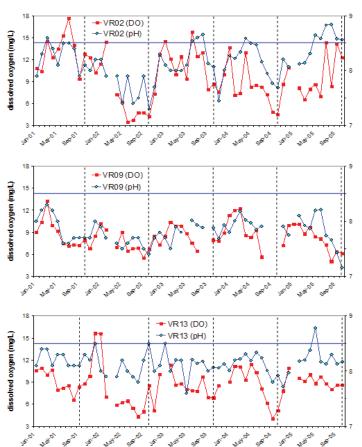
Figure 20. Dissolved oxygen and pH for three sampling locations, January 2001 to October 2005. Dashed vertical lines mark the start of each water-year and the horizontal line represents the 8.5 upper pH limit. Ordinarily, pH should bear little resemblance to DO concentrations. However, significant algal growth causes similar patterns in both parameters as carbon dioxide removed from water by photosynthesis (decreasing acidity) is replaced by oxygen.

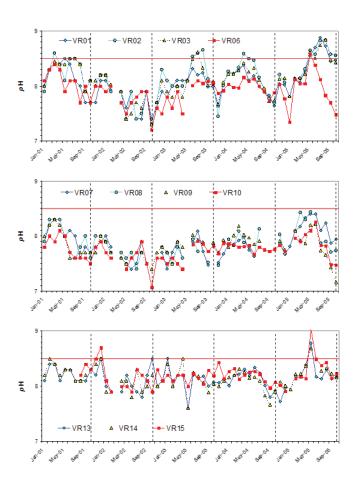
Figure 19. pH concentrations, January 2001 to October 2005. Dashed vertical lines mark the start of each water-year. The horizontal line marks the Regional Water Quality Control Board's upper pH limit of 8.5.

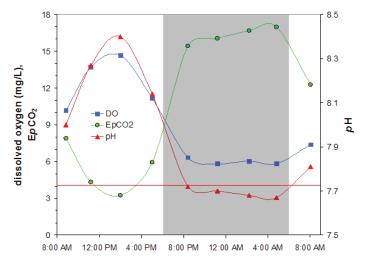
Figure 21. The chart shows results from a 24-hour sampling at Foster Park on September 10-11, 2003. These measurements provide a look at daily (diel or diurnal) changes during an episode of abundant algal growth. The grey area on the chart indicates night-time measurements. Dissolved oxygen changed from a high of 15 mg/L in the early afternoon to a low near 5 mg/L at night. The change in acidity (pH) follows the change in DO, from a high of 8.4 to a low of 7.6. EpCO2 is the ratio of measured CO2 to what would normally be dissolved in water of the same temperature at equilibrium. CO2 varied in opposition to DO and pH, from three times the equilibrium concentration during the day to 17 times greater at night. These changes are caused by algal photosynthesis - the removal of carbon dioxide from water during sunlight in the creation of biomass. During photosynthesis algae generate oxygen, increasing dissolved oxygen concentrations as they decrease CO2. At night, algae respire, reversing the process by removing oxygen and increasing CO2.

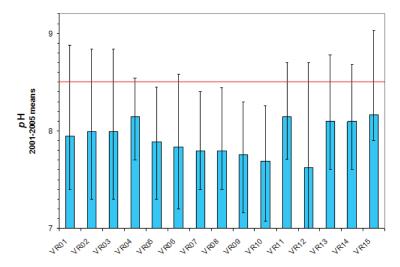
Figure 24. Average pH values, January 2001 to October 2005. The "error bars" indicate the highest and lowest values measured at each sampling location. The horizontal line represents the Los Angeles Regional Water Quality Control Board's upper pH limit of 8.5 (from the Basin Plan). Average pH is equivalent to the mean hydrogen ion concentration.

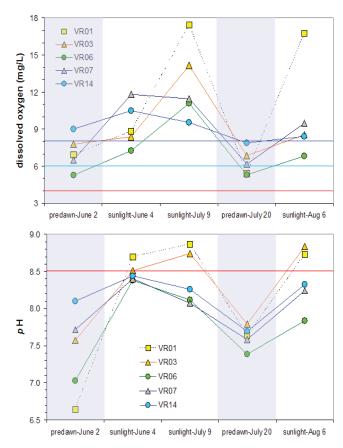
Figure 23. Dissolved oxygen (upper panel) and pH (lower panel) at selected Ventura Stream Team sites: June 2 to August 6, 2005. Predawn measurements are shown against a shaded background and the horizontal lines mark important DO (for steelhead) and pH milestones (see Figures 12 and 19).

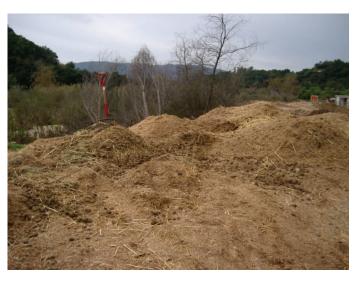
A major source of nutrient contamination is manure from horse and cattle facilities. At the horse facility shown in the photo, large piles of horse manure line the banks of San Antonio Creek.

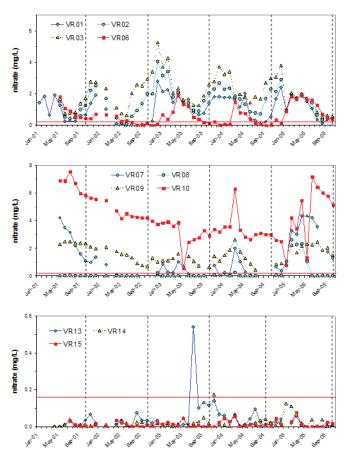
Figure 25. Nitrate concentrations, January 2001 to October 2005.

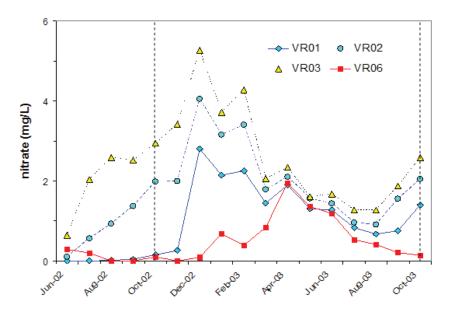
Figure 26. Nitrate concentrations on the lower Ventura River from June 2002 to October 2003. The vertical lines mark the beginning of the water-year. The lower river provides an interesting view of what happens with nitrate over the course of a year. VR06 (Foster Park) represents the normally expected variation in nitrate: a slow rise during the winter to peak values at the end of the rainy season (caused by increasing amounts of high nitrate soil- and ground-waters entering the river as the rainy season progresses), followed by a slow decrease (as plants and algae remove nutrients) throughout the growing season.

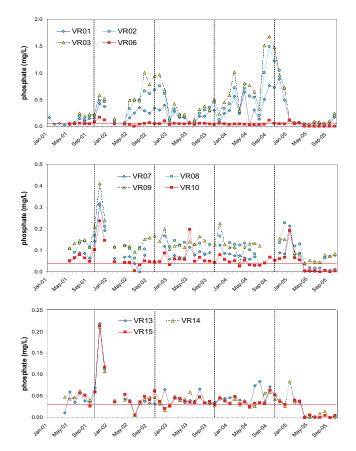
Figure 27 (above). Phosphate concentrations, January 2001 to October 2005. Dashed vertical lines mark the start of each water-year. The horizontal line marks the EPA proposed target for maximum phosphorus in this region: 0.030 mg/L (Ecoregion III, sub-region 6). The graphs show phosphate, which typically makes up around 90% of the total phosphorus in the stream. Note that the graphs use different vertical scales.

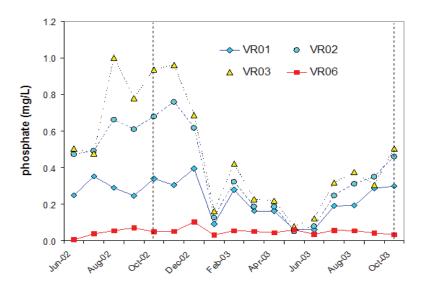
Figure 28 (left). Phosphate concentrations on the lower Ventura River from June 2002 to October 2003. The vertical lines mark the beginning of the water-year. Unlike nitrate (Figure 26), there is very little variation in phosphate concentrations at VR06 (Foster Park). Sometimes there is an increase in phosphate around the time of storms, particularly for the first storm of the year (Figure 27, middle and lower panels), but generally, concentrations are relatively stable. However, the situation is quite different for sampling locations below the Ojai wastewater treatment plant (VR03 to VR01). Here, concentrations have a dramatic pattern: a continuous rise from the beginning of summer until late fall. This pattern is the same one exhibited by nitrate at these sites and it has the same cause - outflows from the treatment plant. Treated effluent is not only high in nitrate but also high in phosphorus, and as effluent increasingly dominates flow in the lower river during the dry season, phosphate concentrations correspondingly rise. When winter runoff finally begins to influence flow, concentrations decrease. Because of sewage effluent, these three sites have the highest phosphate concentrations on the river (Figure 27, upper panel). Again, as with nitrate, concentrations decrease downstream from VR03 to VR02 to VR01, as plants, algae and bacteria, and chemical transformations remove phosphate.

A discussion on patterns of phosphate variation on the lower river, paralleling the nitrate discussion, is provided in Figure 28. At the remaining locations, there is a noticeable association of increased phosphate with the beginning of the rainy season (Figure 27). The first storms mobilize much of the phosphate accumulated on impervious surfaces and in riparian areas during the dry season and transport it to streams (Hager, 2001; MBCWMN, 2002). These storms also move a great deal of sediment and accumulated debris in what were initially dry or near stagnant streams, which also increases phosphate concentrations. The effects of these storms usually remain evident for days afterwards, which is why these increases are evident in the data.²¹

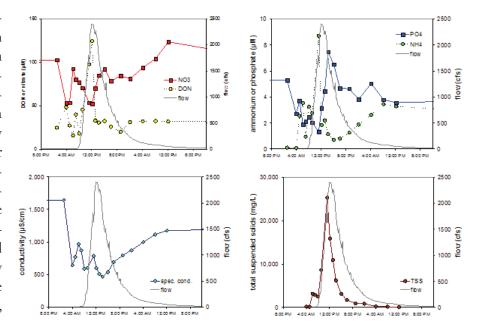
Figure 30. Variation in dissolved nutrients, conductivity and suspended sediment at Main Street (VR01) on March 15, 2003 (the largest storm of that year). The hydrograph measured at Foster Park (VR06) is shown; it only approximates conditions at VR01. The most intense rainfall occurred prior to 4 AM, and the first third of the variations exemplify the response of the lower, more urbanized, Ventura River watershed: initial pulses of urban runoff are characterized by a peak in ammonium, a rise in DON and depressed concentrations of nitrate, phosphate and conductivity. Maximum flow occurred hours after the rain had stopped; considerable time is needed for runoff from Ojai and more distant parts of the watershed to reach Foster Park.

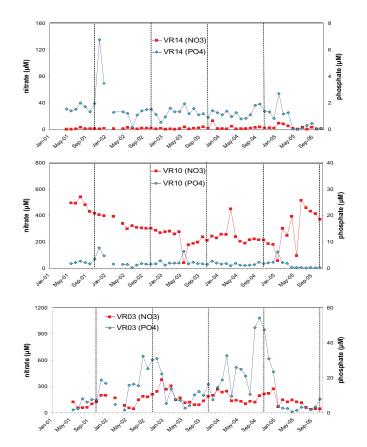
Figure 31. Nitrate and phosphate for three sampling locations, January 2001 to October 2005. Dashed vertical lines mark the start of each water-year. Concentrations are given in micro-moles/L (µM) and the nitrate scale is 20 times the magnitude of the phosphate scale: 20:1 roughly represents the nutrient uptake ratio (N to P) of terrestrial aquatic organisms.

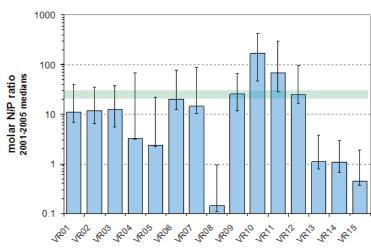
Figure 32. Median nitrate to phosphate ratios for the Ventura Stream Team sampling sites, January 2001 to October 2005. Life requires both nitrogen and phosphorus, but in different amounts. Plankton, on which the oceanic food chain is based, use nitrogen and phosphorus in a ratio of 16 molecules of N to 1 of phosphorus; this is known as the "Redfield Ratio." In creeks and rivers, the ratio is closer to 30:1 and is indicated by the shaded horizontal bar in the figure (the nitrate to phosphate ratio is being used as an approximation of the nitrogen to phosphorus ratio; on average, nitrate is approximately 85% of the total nitrogen and phosphate 90% of the total phosphate). The Matilija tributaries and Lion Canyon are severely "nitrogen limited," meaning that while phosphorus is plentiful, nitrogen is often exhausted. VR10, below Ojai, is "phosphorus limited"; more than sufficient nitrogen is present but phosphorus is typically in short supply. All other locations move across the boundary depending on time of year, typically being phosphorus limited during winter and spring and nitrogen limited in summer and fall. The error bars indicate the quartile points, e.g., 50% of the monthly N/P ratios for that location lie within the band represented by the error bar.

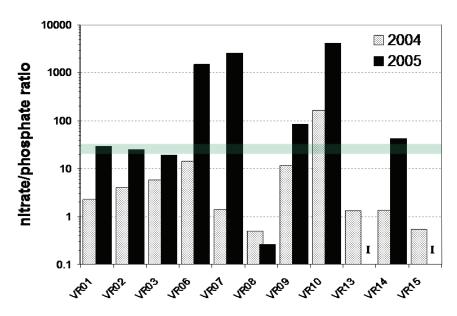
Figure 33. Average dry season (June through September) nitrate to phosphate ratios for 2004 and 2005. The shaded horizontal bar marks the approximate 20:1 to 30:1 zone where both nutrients are in balance. The letter "I" indicates sites where phosphate concentrations fell below detection limits (< 0.3 μM) and the N:P ratio was indeterminate. The increased nitrate concentrations and heavy algal growth following a wet winter produced a substantial increase in N:P ratio at all locations except VR08 (Lion Canyon).

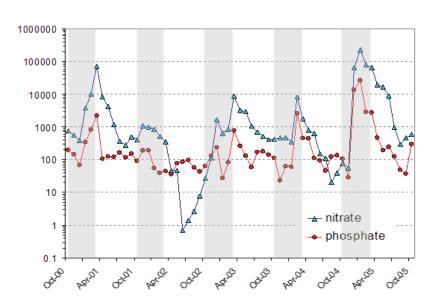
Figure 34. Monthly export of nitrate and phosphate to the Ventura Lagoon, 2001-2005. The shaded areas represent winter rainy seasons. Units are kilograms of nitrogen or phosphorus per month. Export was calculated as the product of monthly concentrations (bi-monthly in 2003 and 2004) and estimated flow at VR01 (USGS gauging data at Foster Park plus average Ojai wastewater treatment plant discharge). Nitrate varies substantially: the kilogram scale is a log scale, each major division representing a factor of 10; the difference between the highest and lowest monthly fluxes is little less than six major divisions, e.g., six decimal places – a difference of almost a million. There is also a big difference from year to year. During drought or relatively dry years (2002 and 2004), nitrate almost disappears from the river at this location. Note that phosphate export is quite different: the flux, particularly during the dry season, is relatively consistent at roughly 100 kg/month. The Ventura lagoon generally gets sufficient phosphate, but depending on the year, nitrate usually becomes either mildly or strongly limiting as the growing season develops, and in drought years a lack of nitrogen is probably extremely limiting.

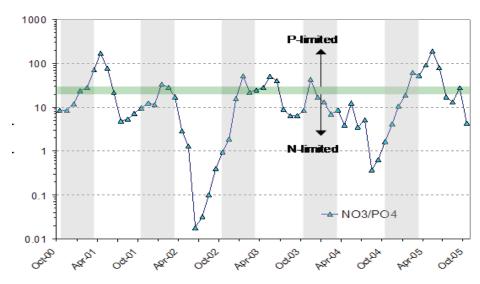
Figure 35. The relative proportions of nitrate and phosphate export to the Ventura Lagoon, 2001-2005. The graph simply shows the nitrate concentration divided by the phosphate concentration for each month's sampling data at VR01. The shaded vertical bars indicate rainy seasons. The thick horizontal shaded bar represents a molecular ratio of 20:1 to 30:1; the approximate zone where both nutrients are in balance. If the ratio is above the line, water going into the lagoon is phosphorus limited, and if below the line, nitrogen limited. Winters and early spring are mostly in balance or phosphorus limited, while the remainder of the dry season is nitrate limited. In some drier, low-rainfall years (2002 and 2004), freshwater supplies to the lagoon become severely nitrogen deficient.

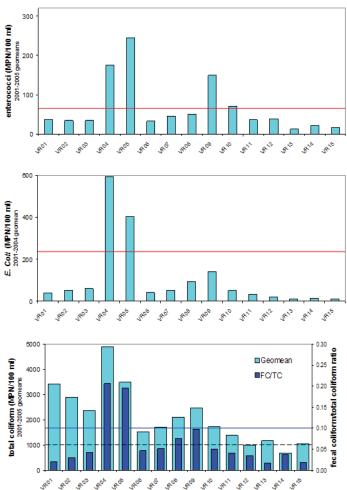
Figure 36. Average enterococci, E. Coli and total coliform concentrations, January 2001 to October 2005. Solid horizontal lines mark the EPA's recommended freshwater beach Public Health limits for maximum enterococcus (61 MPN/100 ml) and E. Coli (235 MPN/100 ml). The California limit for total coliform (10,000 MPN/100 ml) decreases to 1,000 (dashed line) if the fecal coliform/total coliform ratio exceeds 0.1 (solid horizontal line).

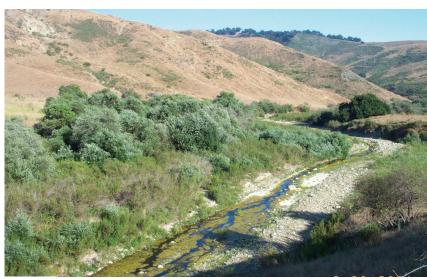
Canada Larga Creek did not meet any bacteria standards.

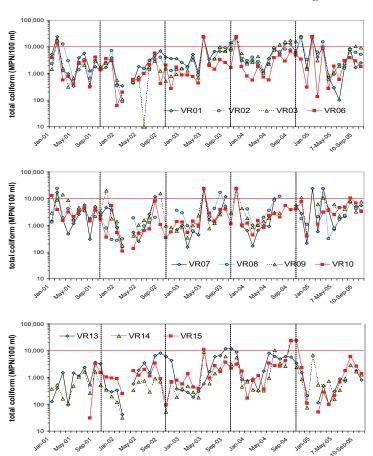
Figure 38. Total coliform concentrations, January 2001 to October 2005. Dashed vertical lines mark the start of each water-year. The horizontal line marks the Public Health single sample freshwater-beach limit of 10,000 MPN/100 ml. The dilution typically used during the test procedure cannot determine concentrations above 24,192 MPN/100 ml, so concentrations greater than 24,192 have been assigned this number.

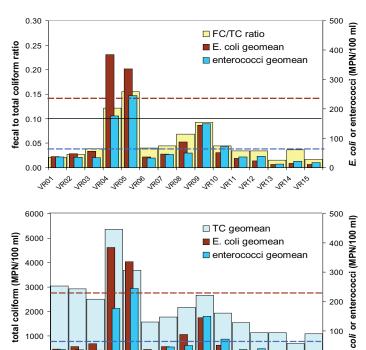
Figure 37. Upper panel: The average fecal to total coliform ratio, and E. coli and enterococci concentrations, January 2001 to October 2005 (as geomeans). Dashed horizontal lines mark the EPA's recommended freshwater beach Public Health limits for maximum enterococcus (61 MPN/100 ml) and E. Coli (235 MPN/100 ml). The California limit for total coliform (10,000 MPN/100 ml) decreases to 1,000 (indicating a pollution problem) if the fecal coliform/total coliform ratio exceeds 0.1 (solid line). Lower panel: Total coliform, E. coli and enterococci geomean concentrations, January 2001 to October 2005.

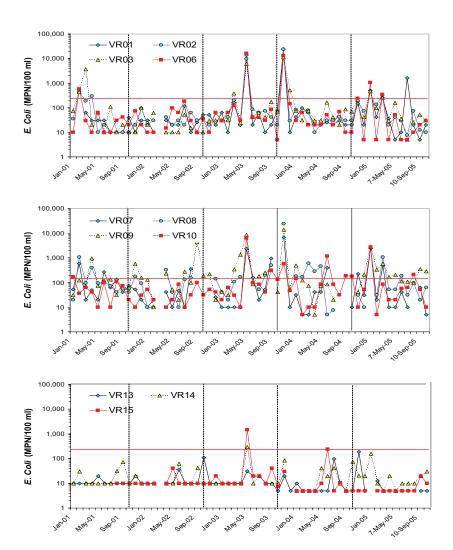
Figure 39. E. Coli concentrations, June 2002 to October 2005. Dashed vertical lines mark the start of each water-year. The horizontal line marks the Public Health single sample freshwater beach limit of 235 MPN/100 ml. The dilution typically used during the test procedure cannot determine concentrations above 24,192 MPN/100 ml, so concentrations greater than 24,192 have been assigned this number (during stormflow in November 2003).

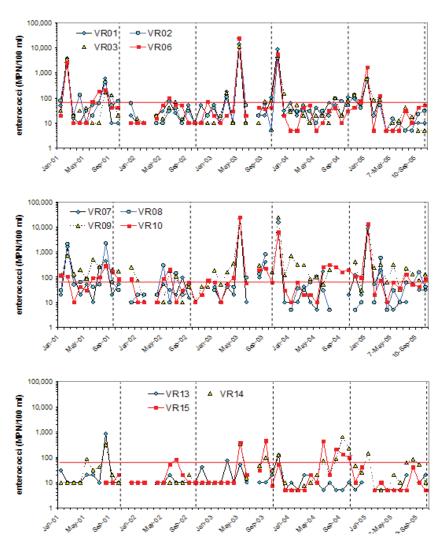
Figure 40. Enterococci concentrations, January 2002 to April 2005. Dashed vertical lines mark the start of each water-year. The horizontal line marks the Public Health single sample freshwater beach limit of 61 MPN/100 ml. The dilution typically used during the test procedure cannot determine concentrations above 24,192 MPN/100 ml, so concentrations greater than 24,192 have been assigned this number (during stormflow in May 2003).

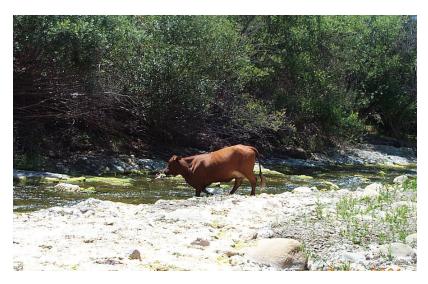
Cattle grazing is a major source of nutrient contamination in San Antonio Creek. This photo was taken just downstream of VR08.
