## EPA Region IX and California Water Resources Control Board

### NPDES Compliance Evaluation Inspection (CEI) Report

**McKinleyville Community Services District Wastewater Management Facility**  
**(NPDES No. CA0024490) Photo Log**  
Inspected by: Craig Blett (PG Environmental, LLC) and Cathy Goodwin (North Coast Water Board)

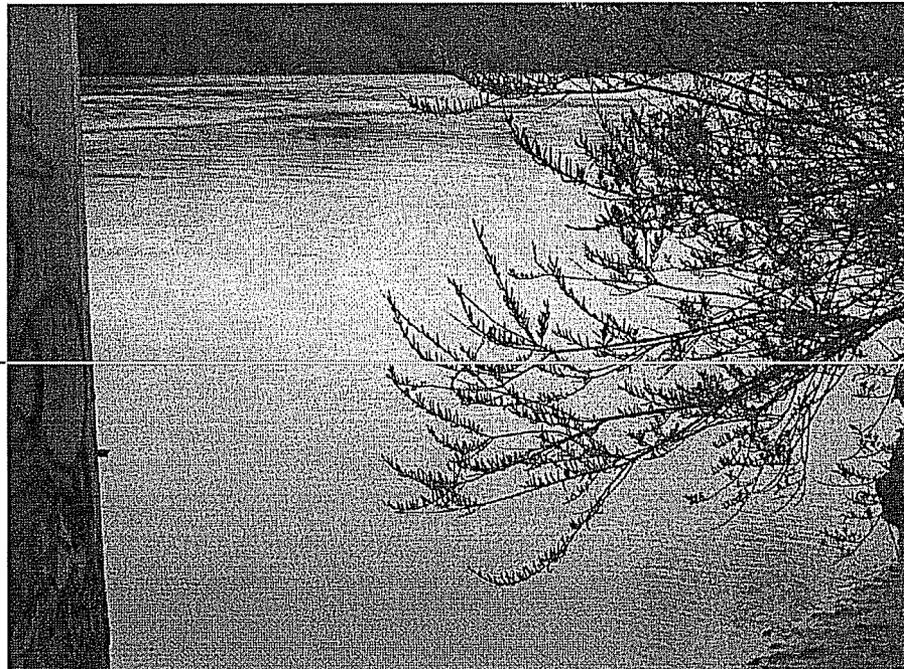
Photo 2: View of receiving water (Mad River) looking downstream. The Facility was not discharging at the time of the photograph.
