**Good and Workmanlike Practices  
Guidance Handbook  
for  
Beneficial Reuse Projects  
and  
Waste Pile Management Facilities**

*As Regulated by the  
Central Coast Regional Water Control Board*

*Prepared by Tracer ES&T*

**October 2006**

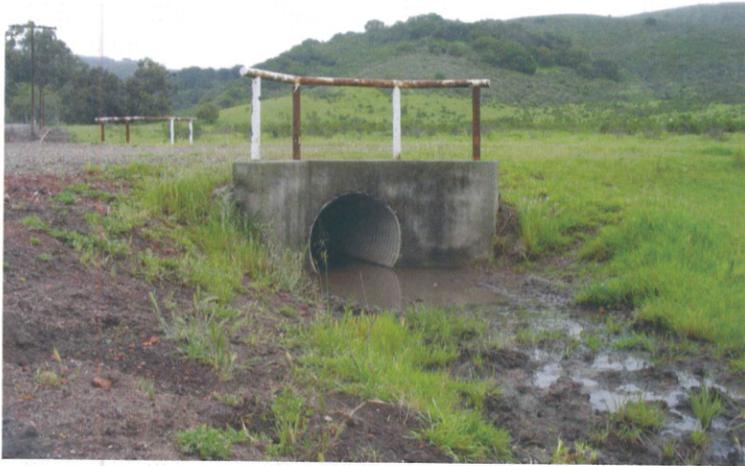
Beneficial Reuse Road

Good example of culvert used to insure that water doesn't undermine the road.

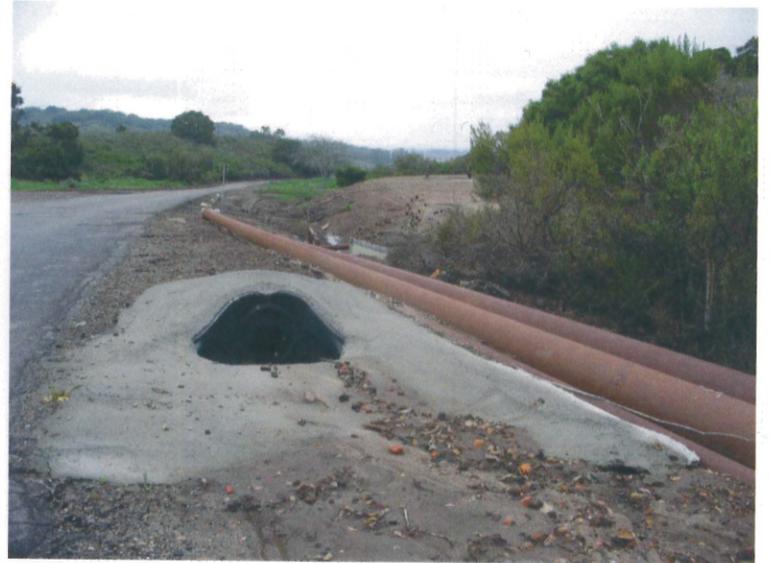
Beneficial Reuse Road

Culvert used to channel water away from road. A debris grating over the opening should be considered to prevent plugging of the culvert.

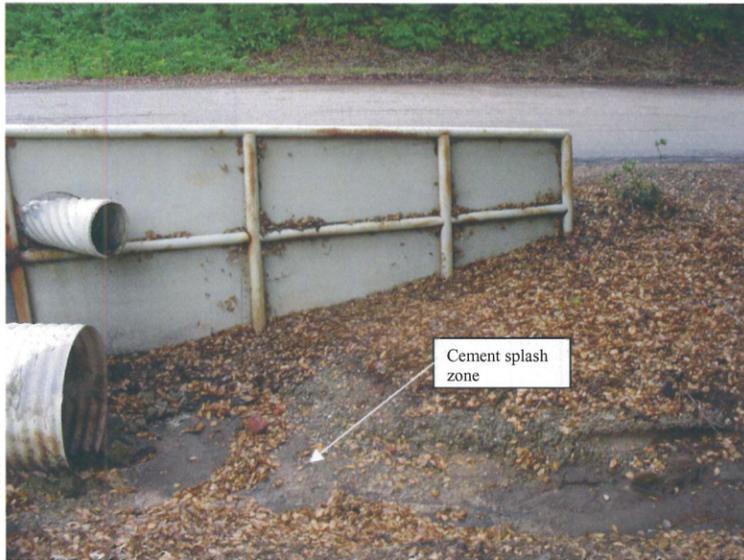
Beneficial Reuse Road

Culverts divert flow from road. Cement splash zone insures that undermining doesn't occur from water flow.

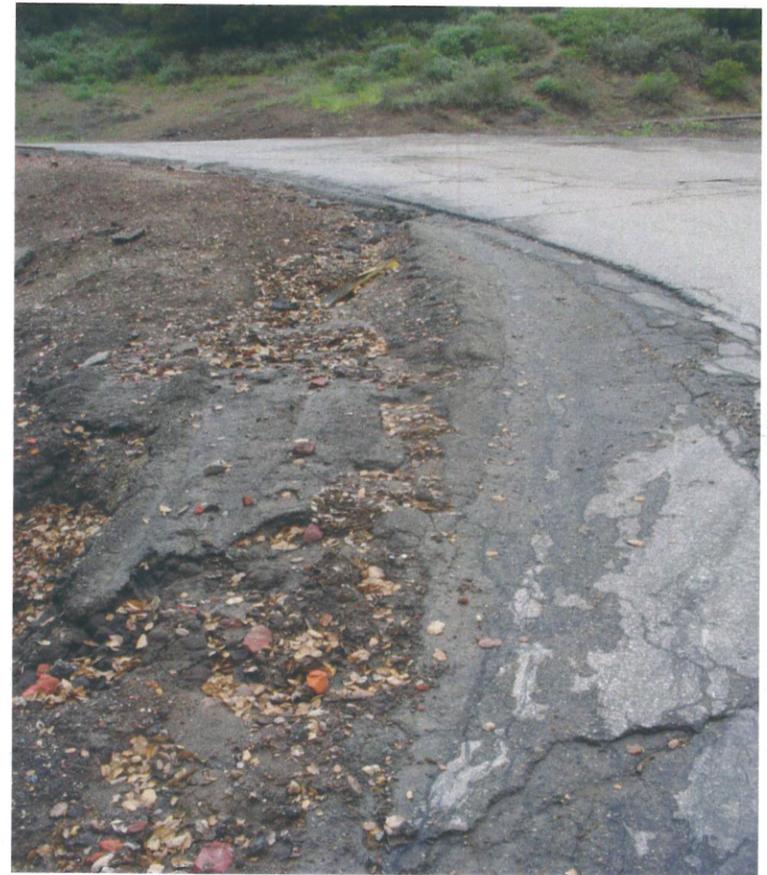
Beneficial Reuse Road

Uncontrolled water flow from road is causing erosion on sides of road that can impact road integrity.

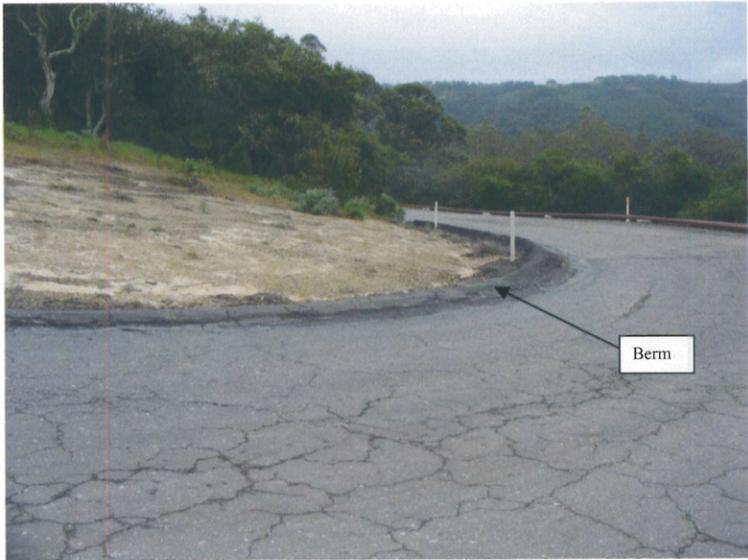
Beneficial Reuse Road

Berm at side of road prevents sheet flow from causing roadside erosion.

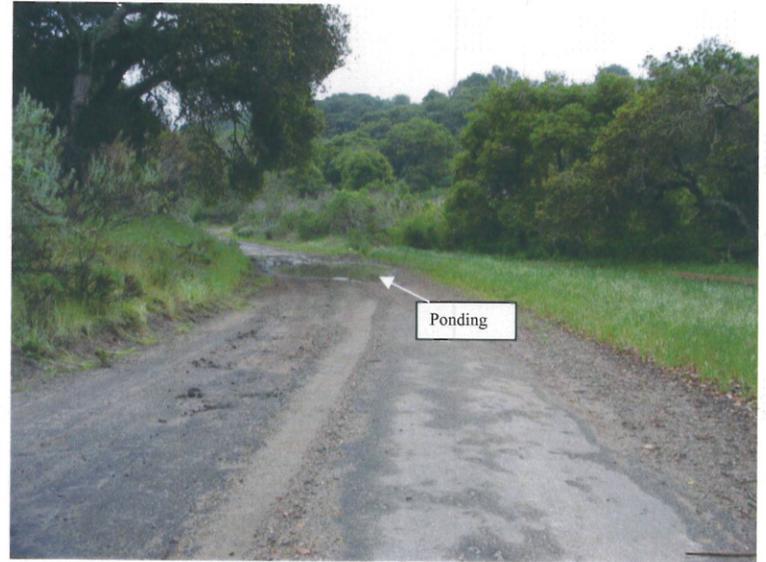
Beneficial Reuse Road

Water ponding on road can cause deterioration of road. Culvert or berms should be used to divert water from road.

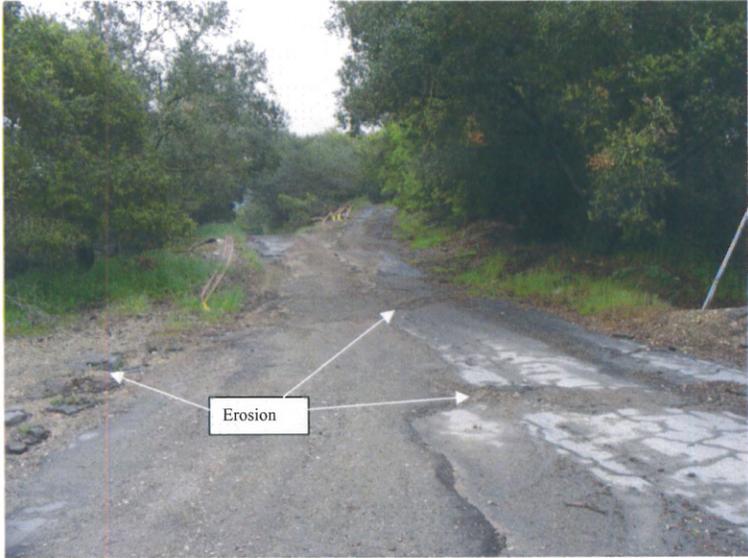
Beneficial Reuse Road

Inadequate water control causes erosion of road and adjacent areas.

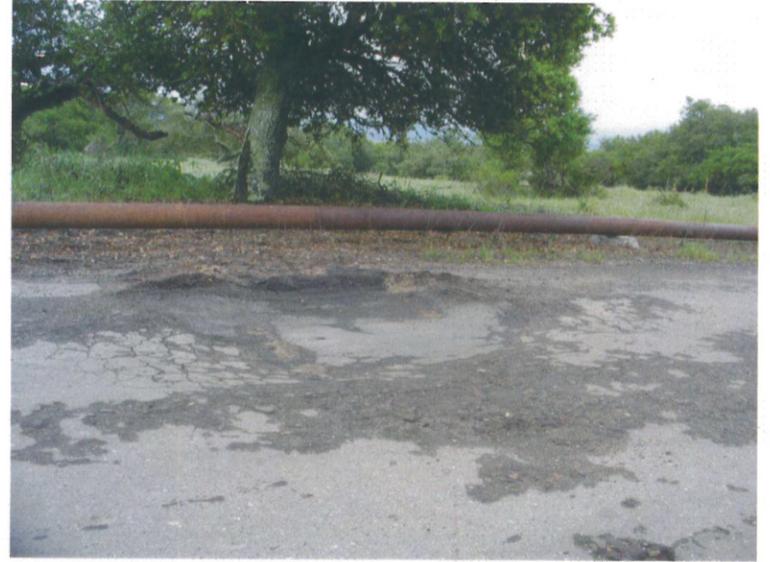
Beneficial Reuse Road

Inadequate sub-base and aggregate will allow road to buckle and deteriorate.

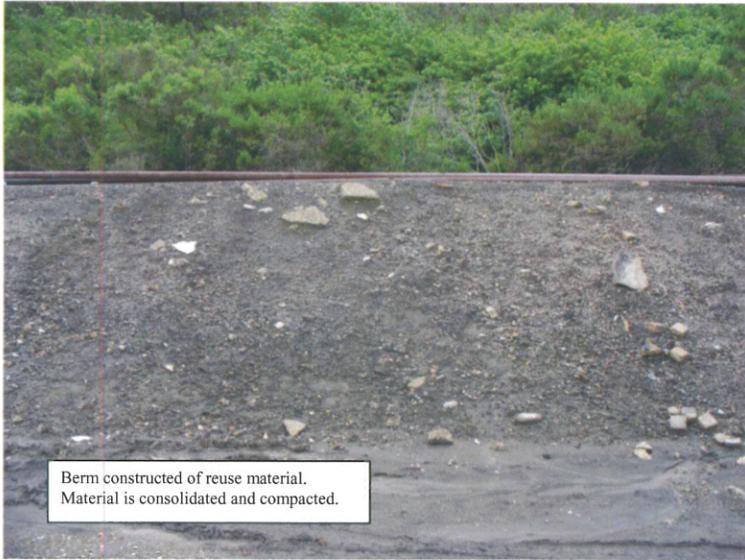
Waste Pile Management Facility

Beneficial reuse material can be used to construct berms around WPMF's. However, it must be capable of containing both the material to be used and rainwater that falls on the WPMF. Stormwater run on and run off is prohibited.

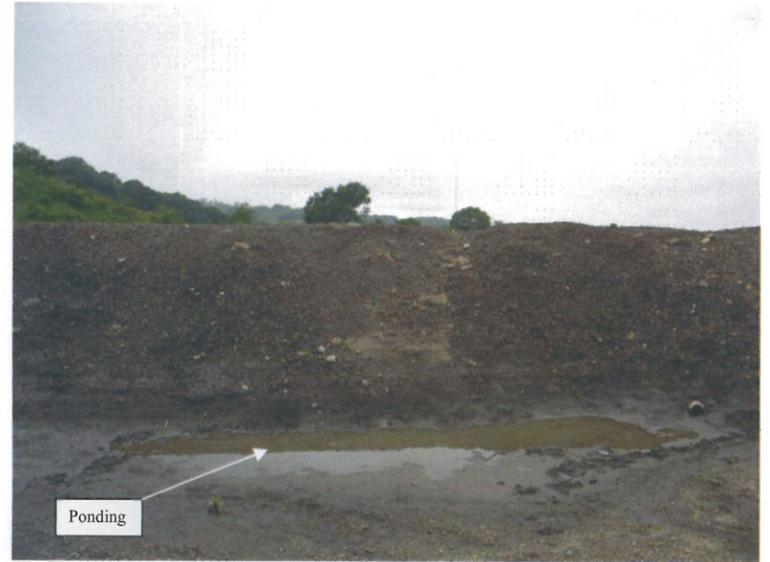
Waste Pile Management Facility

Some ponding of water is inevitable within a WPMF. However, persistence of water within the berms is prohibited.

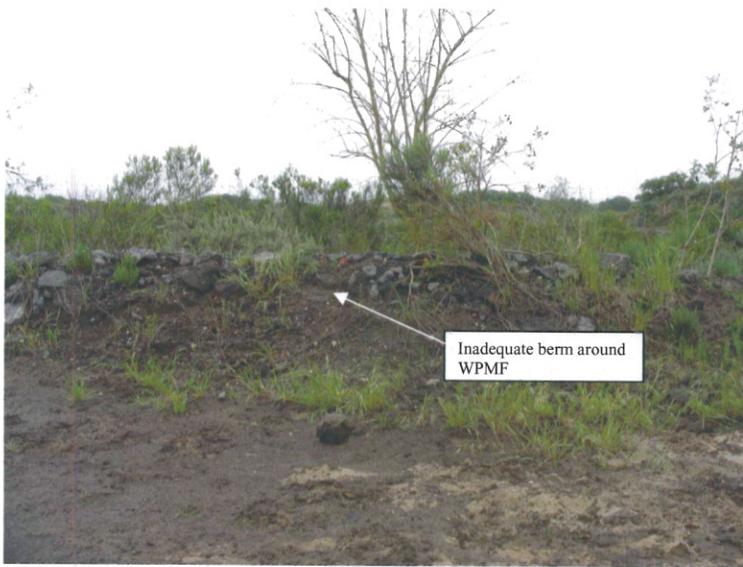
Waste Pile Management Facility

Beneficial reuse material can serve as the impermeable bottom layer or containment for a WPMF. In this photo however, the reuse material is unconsolidated and does not provide adequate protection.
