CALIFORNIA REGIONAL WATER QUALITY CONTROL BOARD

TECHNICAL ANALYSIS

Proposed Administrative Civil Liability
Contained in Complaint No. R9-2015-0166

San Diego Association of Governments
Rail Projects Within the LOSSAN and Mid-Coast Corridor

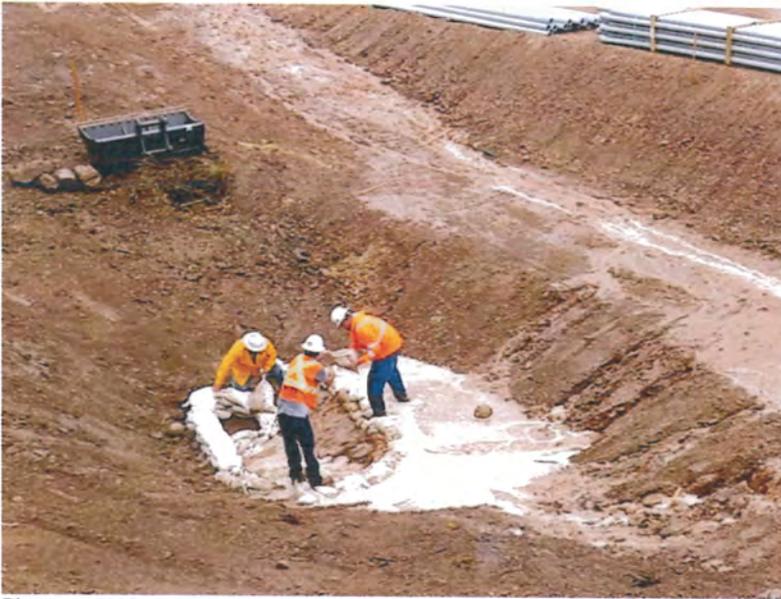
The San Diego Water Board inspectors observed the Project from the Rose Creek Hiking Trail, where Regents Road terminates at the edge of Rose Canyon. The San Diego Water Board inspectors observed evidence of numerous sediment discharges from the Project. The following photograph of an active discharge was taken by the Complainant on September 15, 2015 prior to the San Diego Water Board inspectors' arrival (Photograph 1):

Photograph 1: Discharge of sediment to a culvert discharging to Rose Creek.

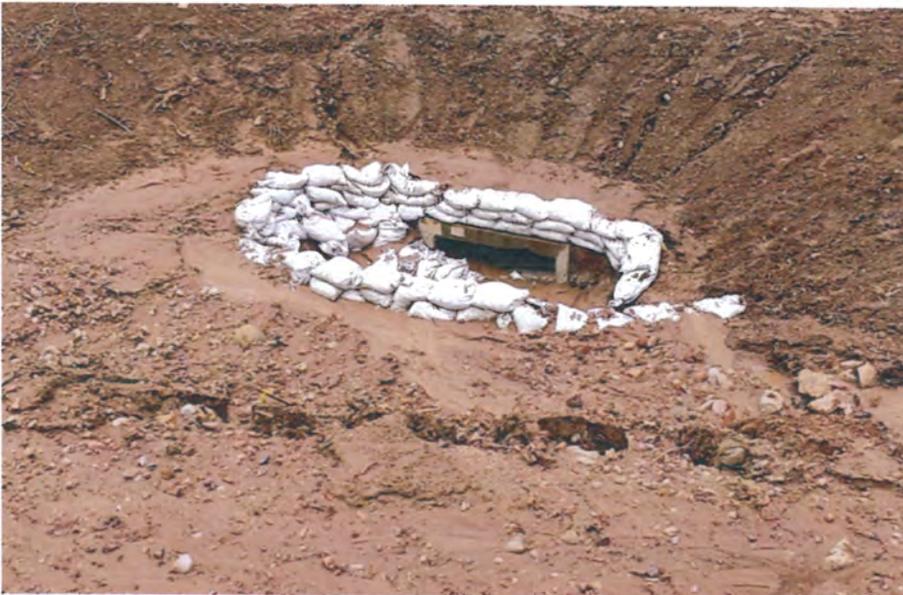
The same storm drain culvert observed by the San Diego Water Board inspectors showed residual sediment, overwhelmed sediment control BMPs (gravel bags), no visible erosion control BMPs and severe rilling of the surrounding slopes (Photograph 2):

Photograph 2: Storm drain culvert (also pictured in photograph 1) with evidence of sediment discharge and erosion of surrounding slopes.

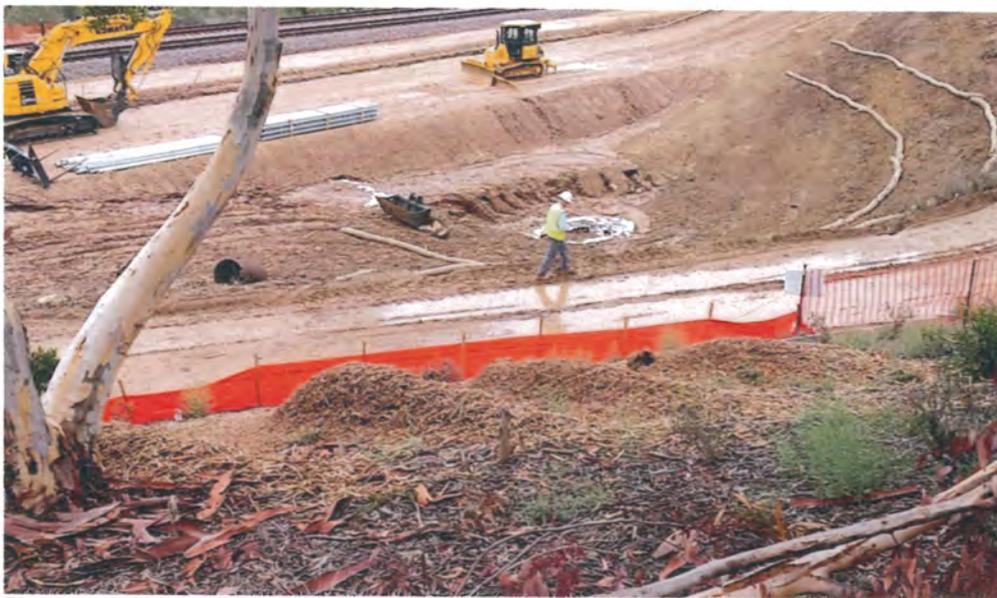
A constructed access road with no erosion control BMPs and an overwhelmed row of sediment control BMPs (gravel bags) provided a conduit for a large volume of storm water run-on to be directed to a storm water culvert as indicated in Photograph 1. The absence of erosion control BMPs in all directions upgradient of the culvert allowed storm water to convey sediment directly into Rose Creek. The lack of erosion control BMPs is depicted in the following photograph (Photograph 3):

Photograph 3: Constructed “bowl” around storm drain culvert with no apparent erosion control BMPs and ineffective sediment control BMPs.

The MCTC representatives also indicated that run-on from a broken storm drain culvert in the neighborhood located above the Project to the northeast was not identified prior to the storm event, causing a large amount of unanticipated run-on to flow into the constructed "bowl" depicted in photographs 1, 2, 3, and 4.

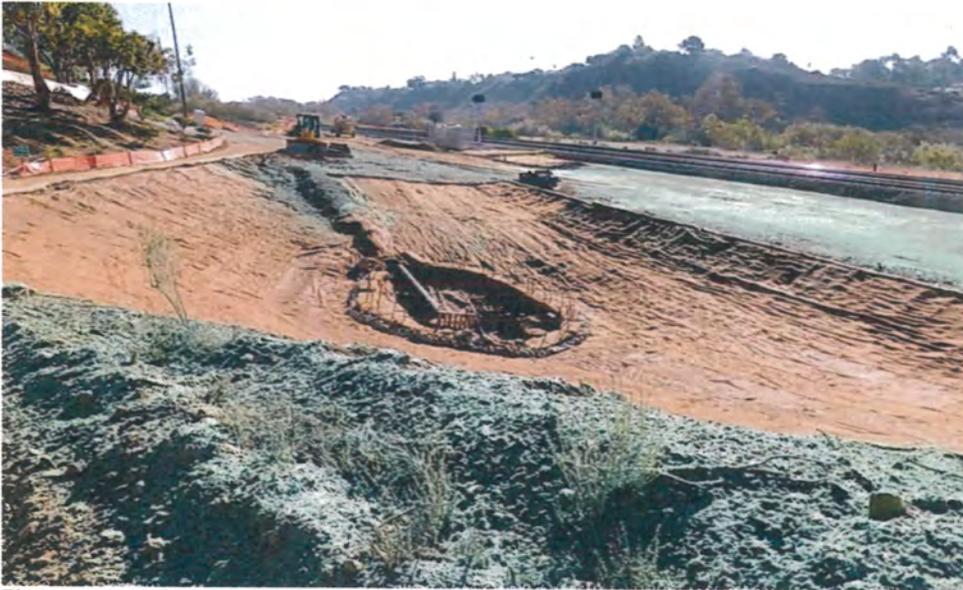
Photograph 4: Constructed "bowl" around storm drain culvert after implementation of erosion and sediment control BMPs.

In the following days, Discharger implemented more robust erosion and sediment control BMPs within the constructed “bowl” including redirecting the run-on away from exposed soils, stabilization of exposed soils with protective blankets and bonded fiber matrix, and extensive sediment controls around the inlet structure. The following photograph (Photograph 4) depicts the level of BMP implementation that should have been present prior to the September 15, 2015 storm event:

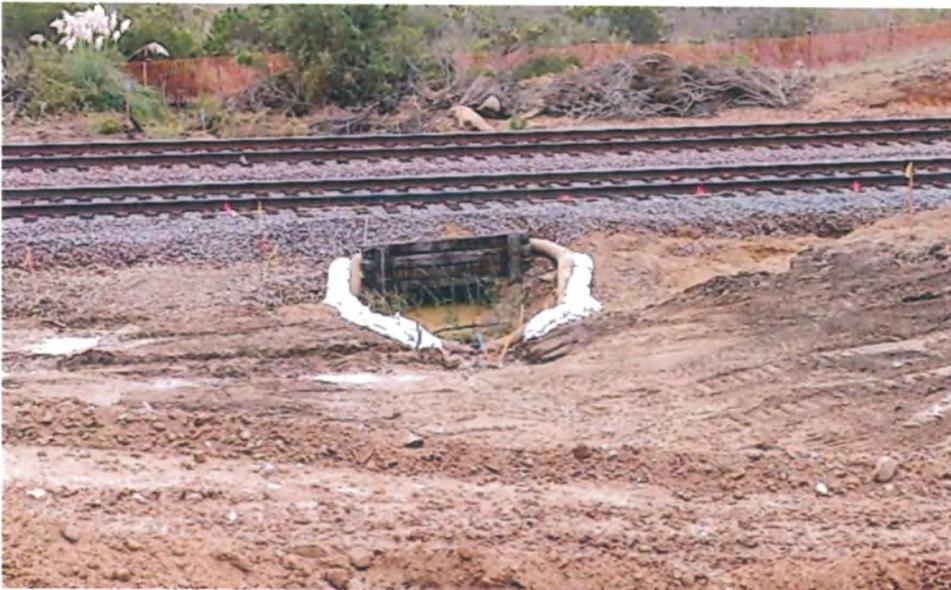
Additional discharge points with evidence of sediment discharges were also observed by the San Diego Water Board inspectors. As shown below (Photograph 5), there are no erosion control BMPs visible and there is standing sediment laden storm water at the entrance of the culvert's discharge point to Rose Creek:

Photograph 5: Second culvert with evidence of sediment discharge and no erosion control BMPs.

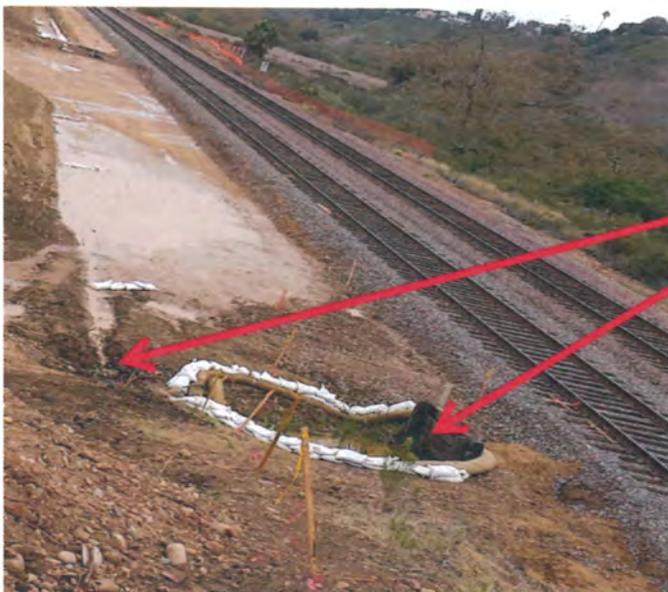
The San Diego Water Board inspectors observed a third culvert that showed evidence of an additional sediment discharge to Rose Creek. The photograph below (Photograph 7) shows the absence of erosion control BMPs, indications of storm water flows entering the storm drain culvert, and ponded sediment laden storm water adjacent to the inlet:

Evidence of sediment laden storm water discharge to storm drain. Ponded water in front of exit point.

Photograph 7: Third storm drain culvert with evidence of sediment laden storm water discharge.

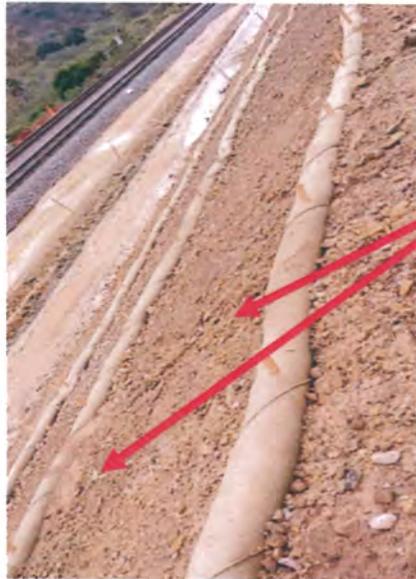
In addition to the evidence of discharges, the San Diego Water Board inspectors also observed the absence or lack of adequate erosion control BMPs on slopes that appeared to be inactive. The visible sediment control BMPs (straw wattles) appeared to be installed incorrectly as evidenced by erosion and rilling on the unprotected slope (Photographs 8 and 12):

Evidence of sediment control BMP failing and sediment leaving the exposed slope.

Photograph 8: Inactive slope with no evidence of erosion control BMPs. Rilling on slope indicates that sediment control BMP (straw wattle) was improperly installed by rills evident below wattles.

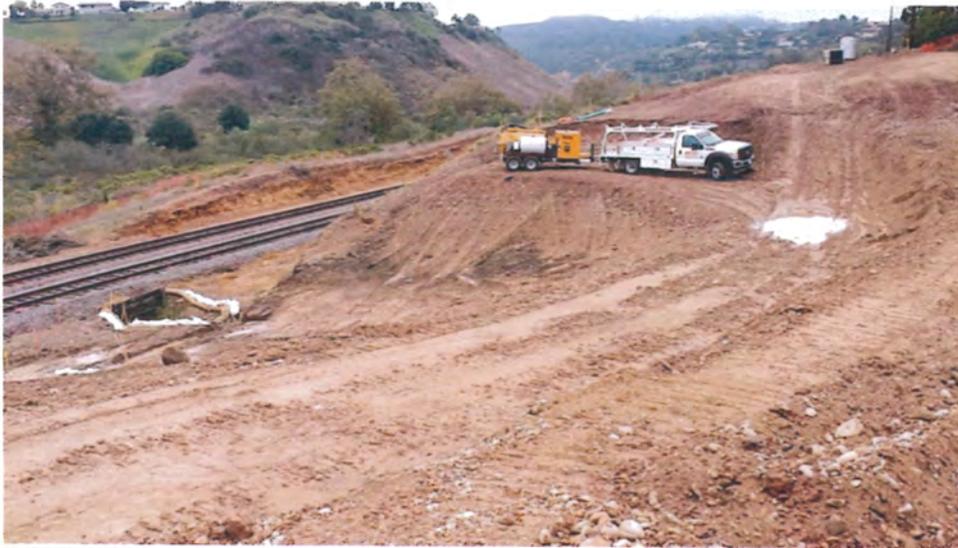
San Diego Water Board inspectors found areas that appeared to be active lacking erosion control BMPs (runoff control and soil stabilization) as illustrated in the following photograph (Photograph 9):

Photograph 9: Active area with no erosion and sediment control BMPs. The storm drain culvert is the same as depicted in Photograph 7.

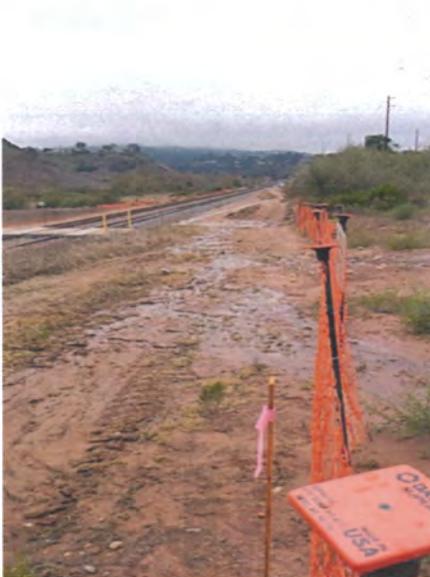
San Diego Water Board inspectors also observed run-on that continued to enter the Project and inadequate perimeter controls (Photographs 10 and 11):

Photograph 10: Run-on onto project. With inadequate perimeter controls.

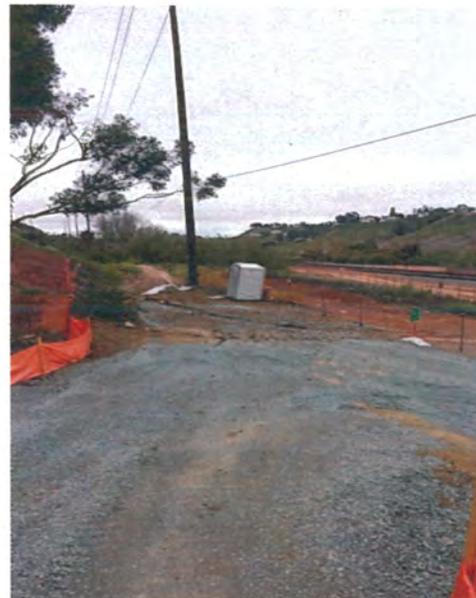
Photograph 11: Inadequate run-on and perimeter controls.

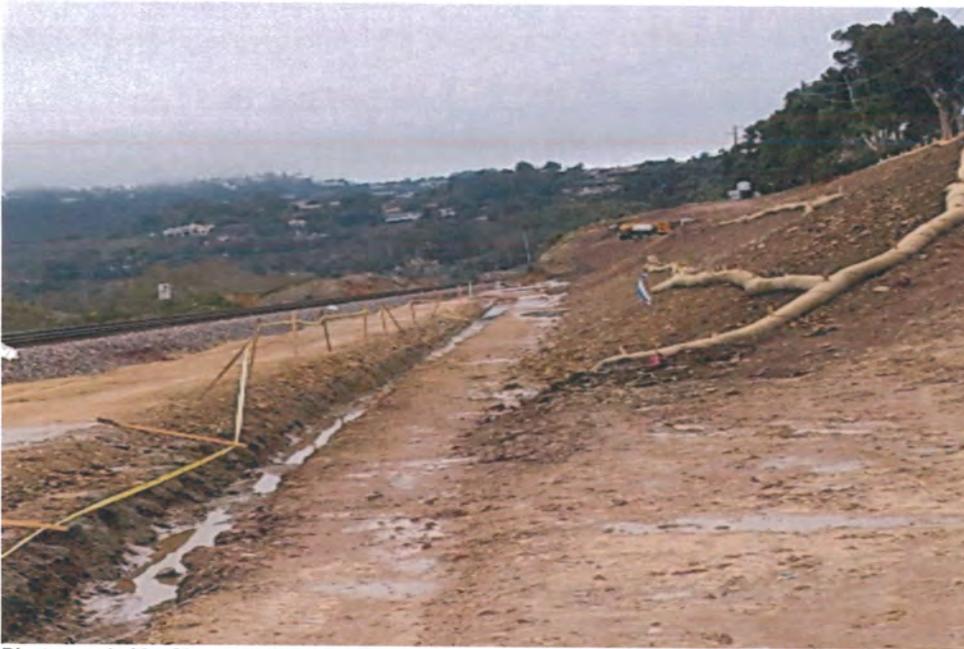
The San Diego Water Board inspectors also observed slopes with no linear controls along the toe and grade breaks. The lack of linear controls along grade brakes resulted in erosion rilling as shown in the Photographs 12 and 13 below:

Photograph 12: Slope with no linear controls at toe of slope and improperly installed straw wattles as evidenced by sagging.

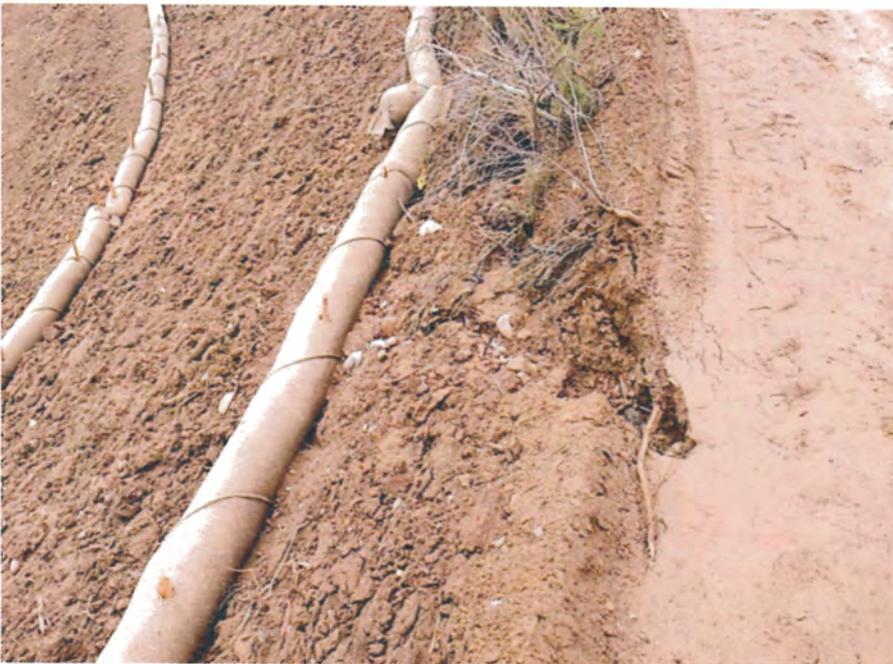
Photograph 13: Slope with no linear controls along grade break with erosion rills visible.

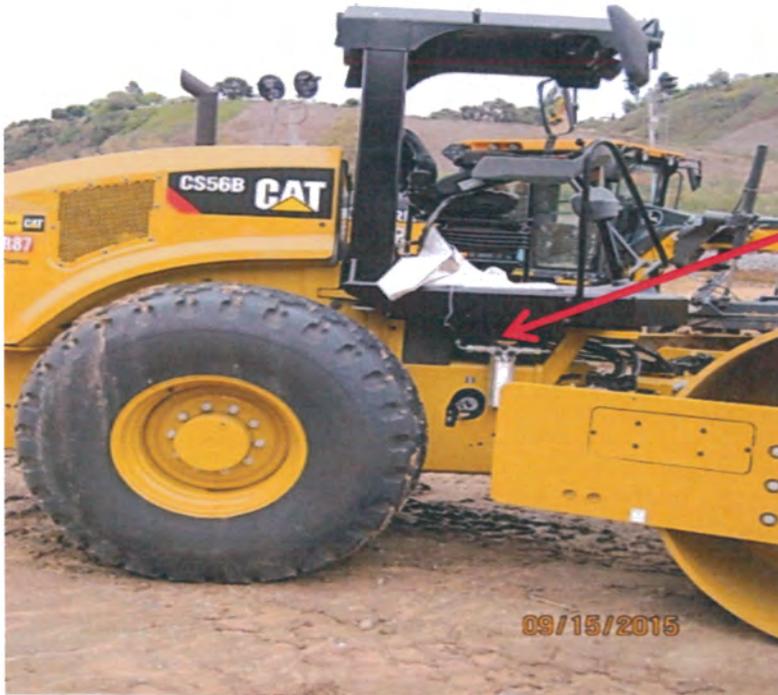
The San Diego Water Board inspectors also observed heavy equipment parked on bare dirt with no drip pads to contain leaking fluids from contacting storm water. Where drip

pads were deployed, most were no longer located under the appropriate area of the vehicle to capture drips, as they were not anchored properly (Photographs 14 and 15):

Drip pad is located in the cab of the vehicle not under it.

Photograph 14: Construction equipment with no drip control BMPs.

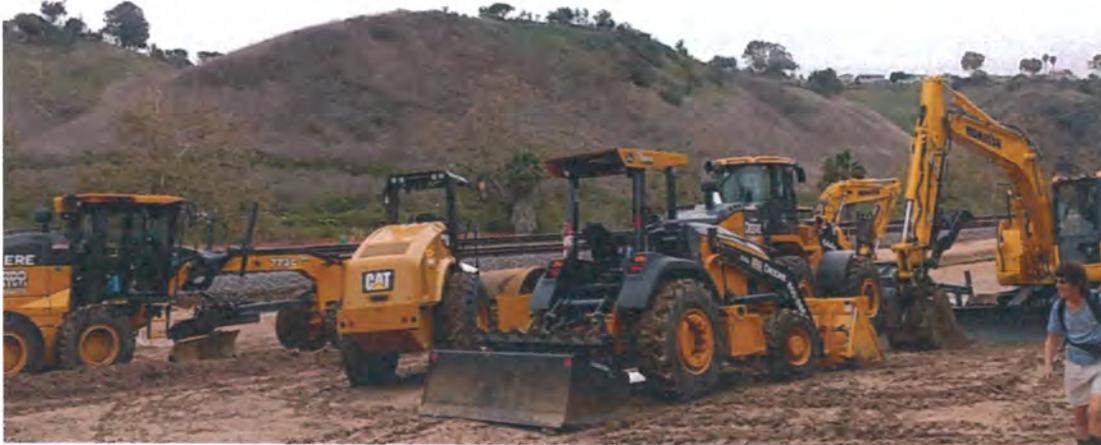
Photograph 15: Construction equipment with no drip control BMPS.
