**Berryessa Creek Element
Coyote and Berryessa Creeks
Flood Control Project
Santa Clara County, California**

Appendix B: Engineering and Design

**Geomorphologic and Sediment Transport
Assessment**

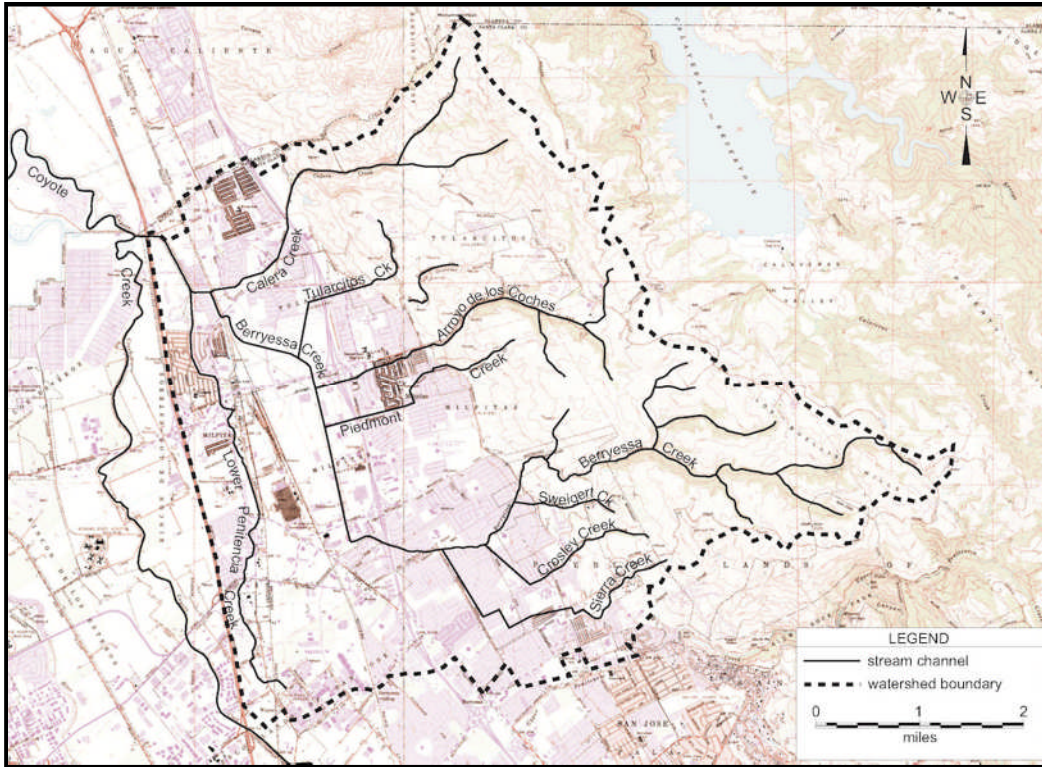
Figure 1-1 Watershed Map (Source: NHC 2003)

Figure 1-1 shows the delineations of watersheds draining to the project area, as presented in the NHC hydrology report (2003). Figure 1-2 shows the project footprint relative to the road crossings and other features within the project area.

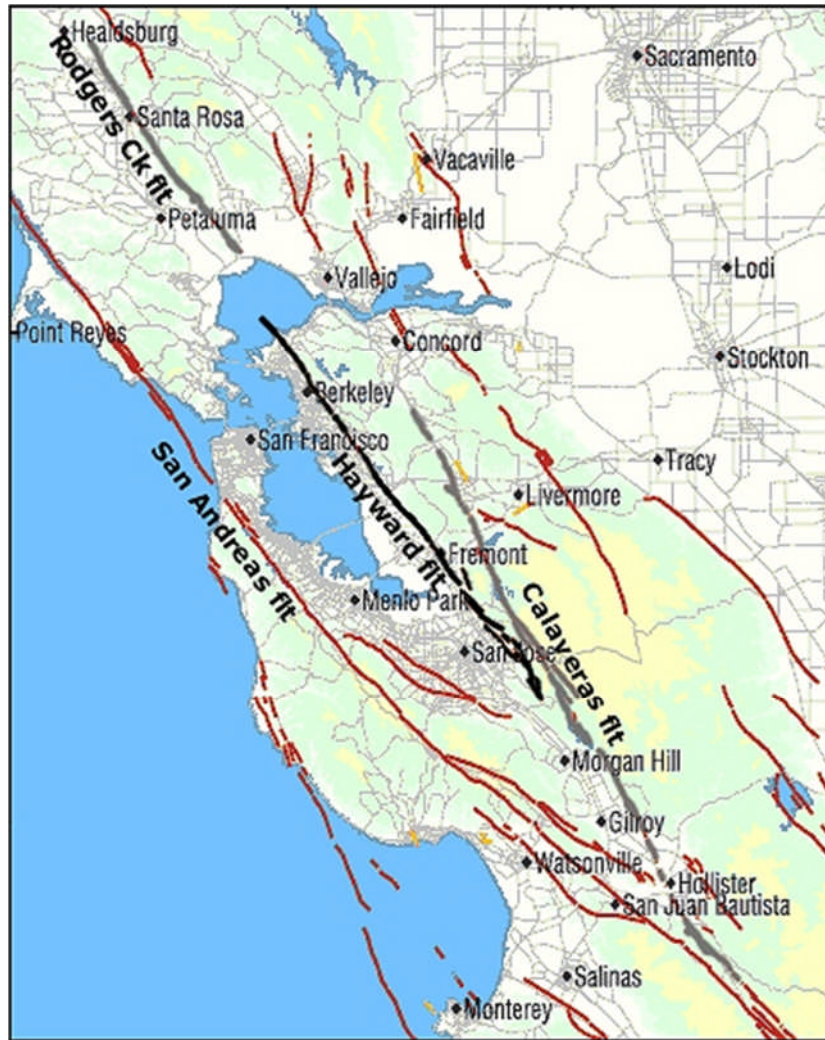
Figure 2-1 Bay Area Fault Zones (Source: USGS)

In the uplands, the geology consists mainly of Tertiary and Quaternary age sedimentary rocks composed primarily of sandstone, siltstone and shale. Minor tuff, claystone and partially to completely serpentized ultramafic rock outcrop in the basin in smaller amounts (NHC 2001). As shown in Figure 2-1, two major faults cross the lower and upper extents of the watershed. The Hayward Fault zone trends across the base of the Los Buellis Hills and the Calaveras Fault passes along the upper watershed boundary. These two major faults and numerous minor faults cross the Berryessa Creek watershed in northwest to southeast direction.

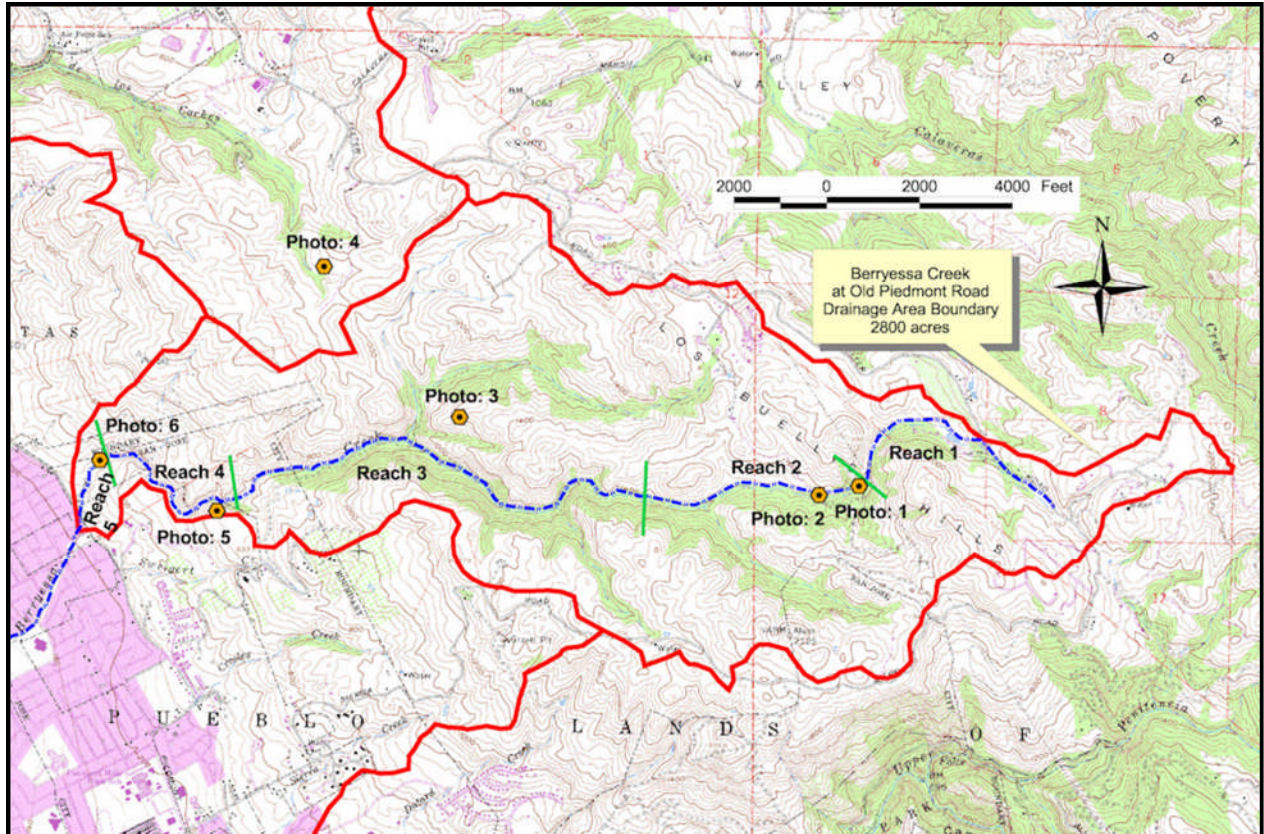
Figure 2-2 Upper Watershed Boundary, Reaches, and Photo Locations

The watershed upstream of Old Piedmont Ave. was broken into reaches with common characteristics based on field observations. Classification of these characteristics by reach allows for explanation of sediment transport-related trends and prediction of future erosion and deposition zones on a qualitative basis. The reach breakdown is shown in Figure 2.2 along with the locations of photographs presented below.

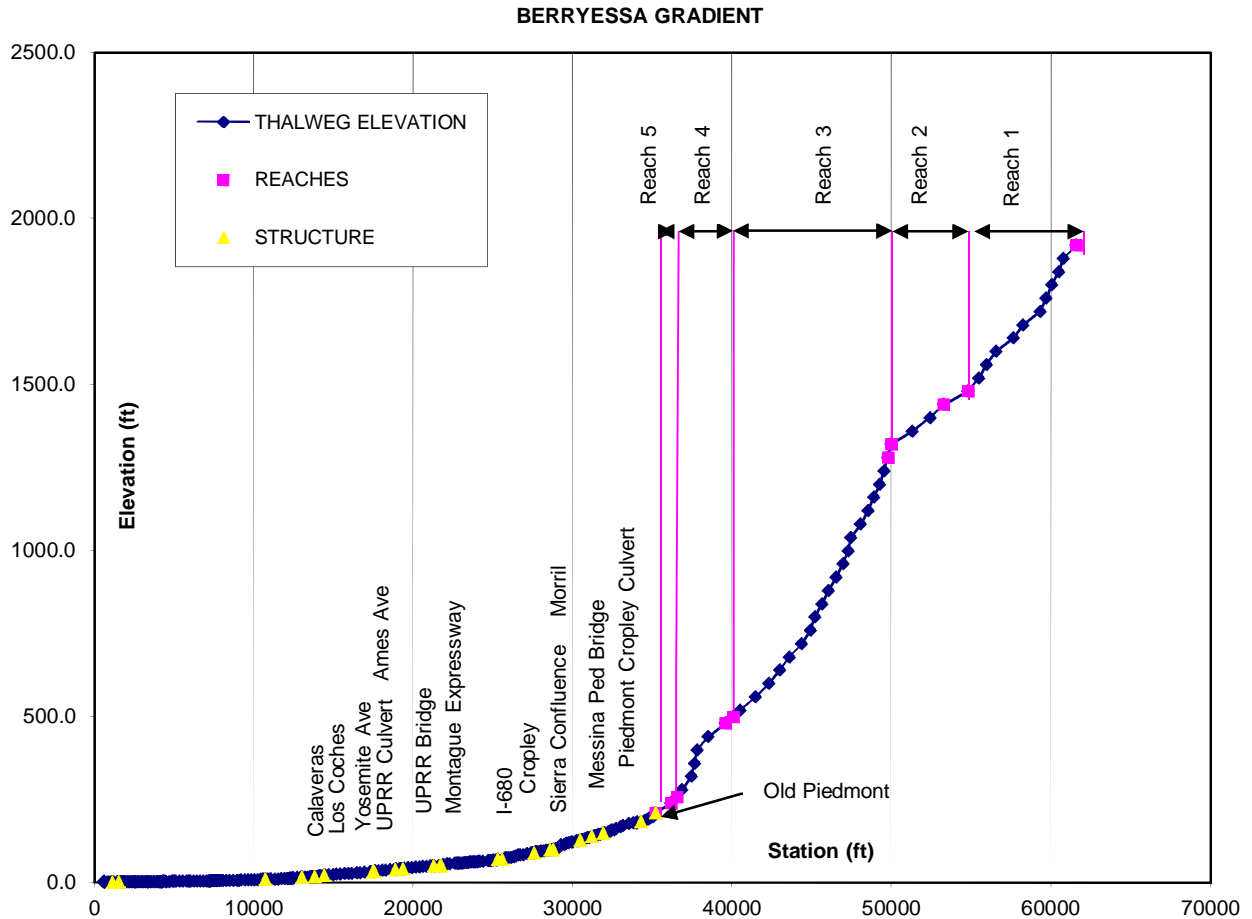
Figure 2-3 Berryessa Creek Profile from the Estuary to the Headwaters

There is a distinct difference between the profile of Berryessa Creek in the uplands and on the alluvial fan within the Santa Clara Valley. Figure 2-3 shows the profile for the entire length from the estuary downstream from the confluence with Coyote Creek, upstream to the headwaters. Within the valley reach, which includes the project area, the channel gradient averages less than 1 percent. In contrast, the upland reach averages over 6 percent.

The channel leaves the uplands at a gradient of about 3 percent and gradually reduces to a slope on the order of 1 percent at I-680. However, below I-680, the gradient abruptly decreases by a factor of 3 to 0.35 percent between I-680 and Montague Expressway. Below Montague, the slope increases to approximately 0.5 percent.

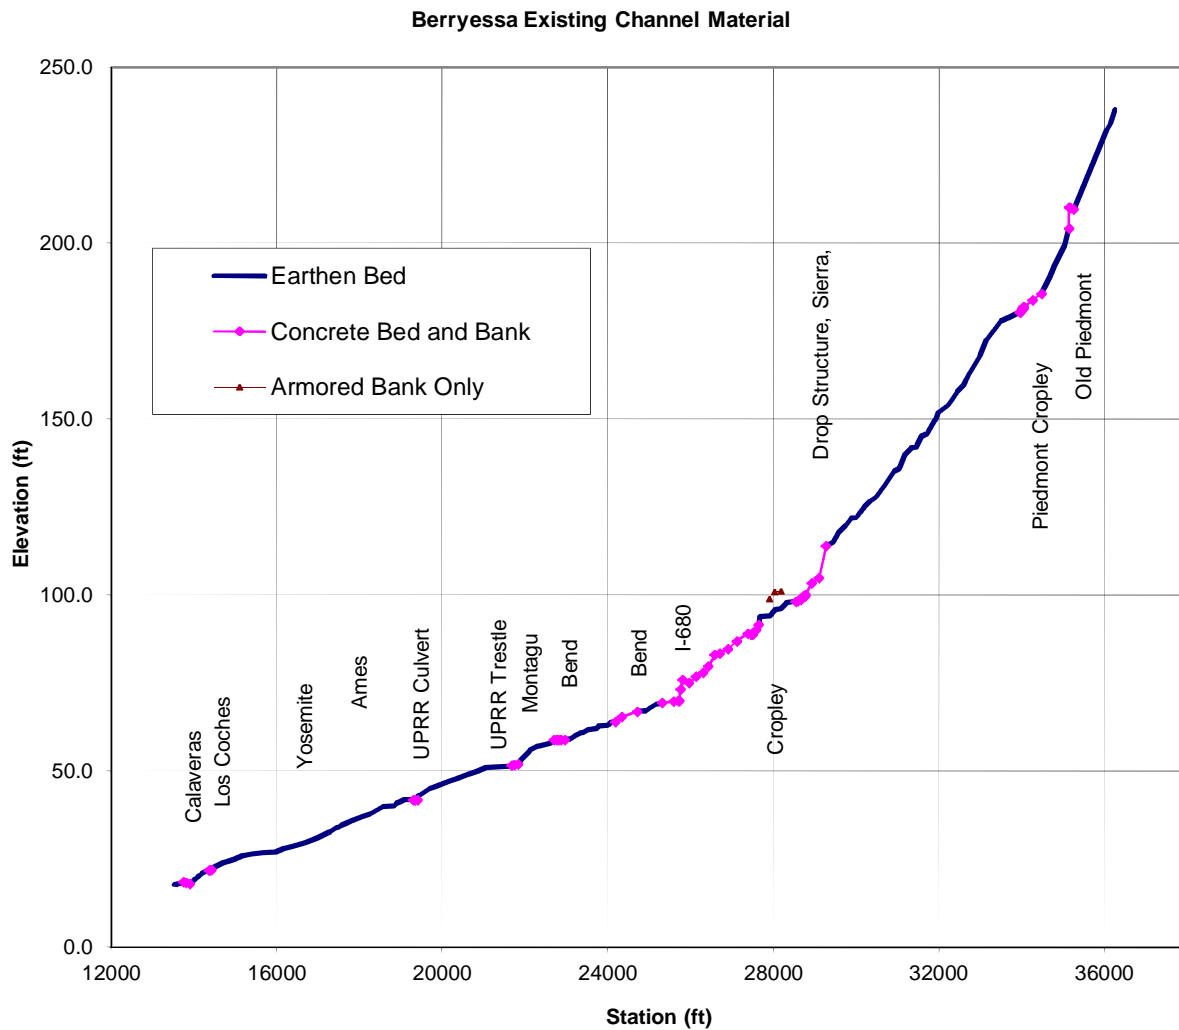
Figure 2-4 Location of Current Bed Controls along Berryessa Creek

There are numerous bed controls throughout the project area. These are formed by bridges or box culverts with concrete bottoms, drop structures, and segments of channels lined with concrete. Figure 2-4 identifies locations along the profile that act as grade controls.

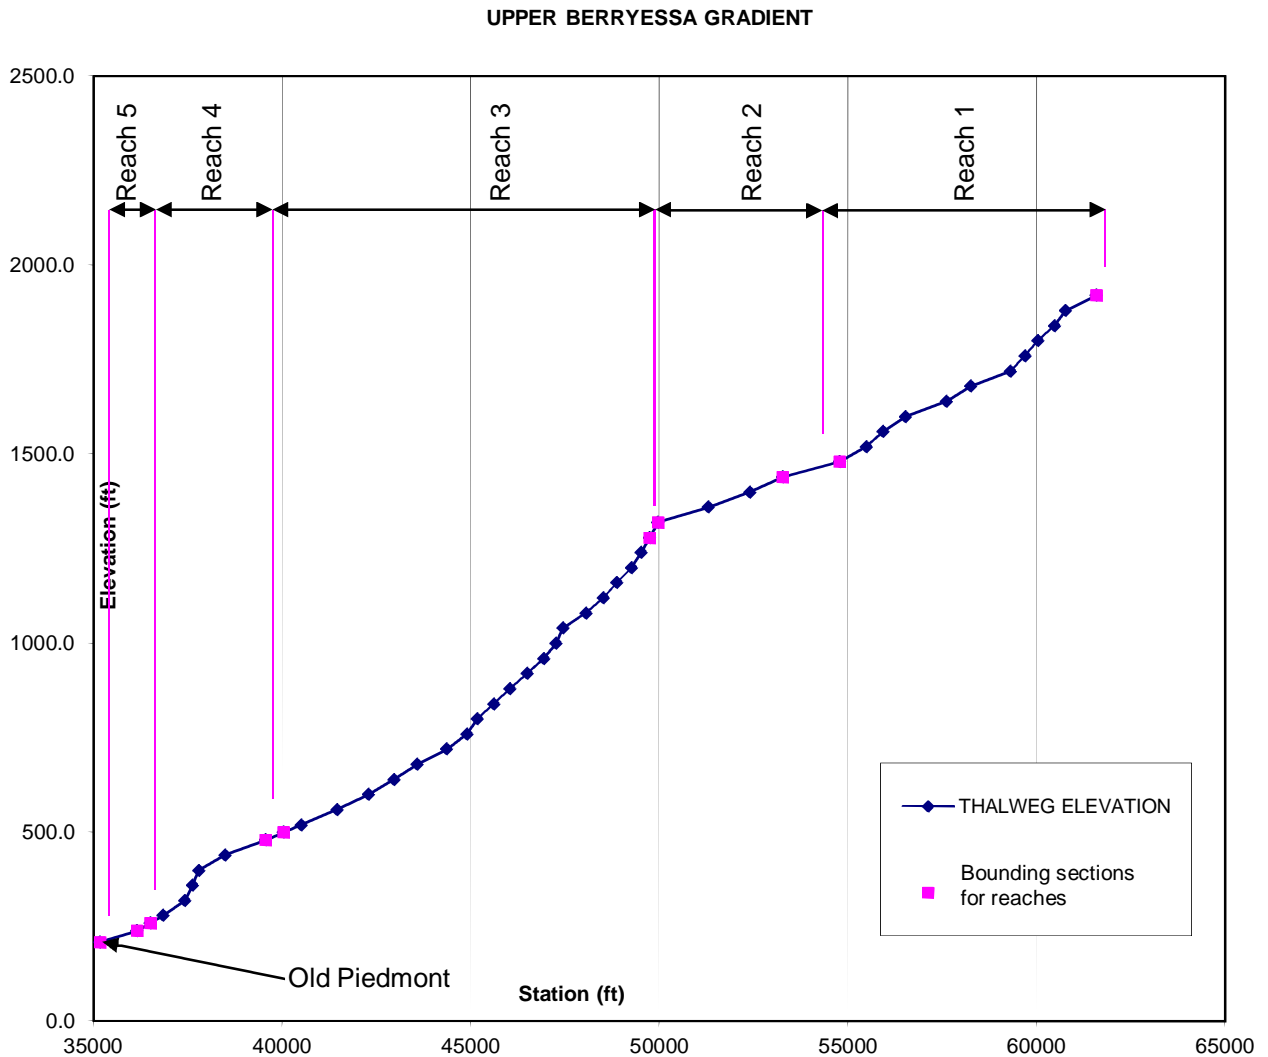
Figure 2-5 Berryessa Creek Profile from Old Piedmont Road to Headwaters

The stream through the upper watershed was divided into five segments. Figure 2-5 provides a profile of the upland portion of Berryessa Creek. For the upper 1.3 miles, the gradient averages 6.5 percent. For about a mile, the gradient flattens to 3 percent. The gradient increases for the next two miles, averaging 8 percent with a gradual decrease in the downstream direction. The gradient then picks up as the stream crosses the Hayward Fault zone and passes through the “canyon” reach (Reach 4). The average gradient through this segment is 8 percent with a portion of the stream near the center of the reach with a gradient of 15 percent. In the downstream 1,500 feet above Old Piedmont Road, Berryessa Creek transitions from the uplands to the alluvial fan with an average gradient of 4 percent.

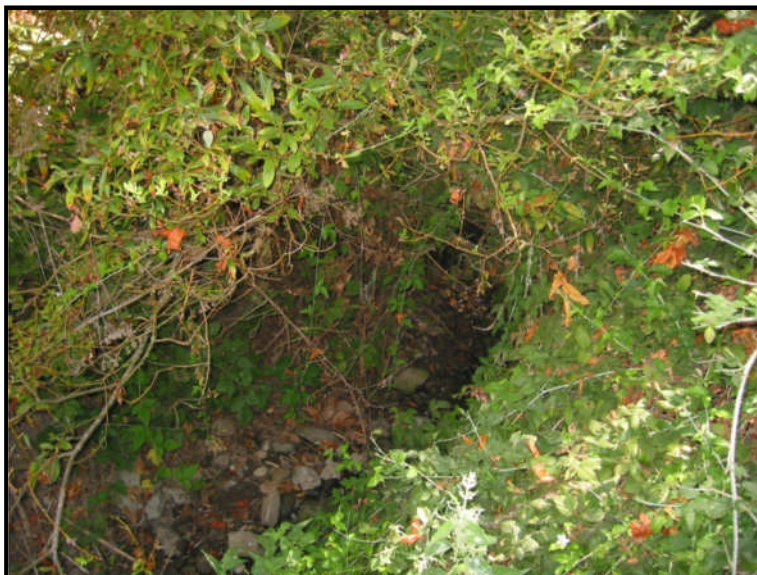
There were five distinct areas or zones observed in the stream and adjacent watershed. In the upper most 1.3 miles (Reach 1, upstream of the 1,480 foot contour), the creek is of moderately steep gradient averaging 6.5 percent and has a bed comprised of a wide range of material from gravels and cobbles to fines. The channel may be incised in some areas by several feet. There did not appear to be a high transport rate of the larger bed material (gravel and cobble) as there were few depositional bed features and there was a significant amount of finer material in the bed and heavy vegetation on the banks (Photo 2.1). On the hillsides, some minor gullying was observed where flow had been concentrated by roads or trails, but in the small gullies there were only a scattering of coarser materials so that it does not appear that this process is a significant source for coarser sediments in the upper portion of the watershed.

Photo 2.1 Typical Channel in Reach 1, Heavy Vegetation on Banks

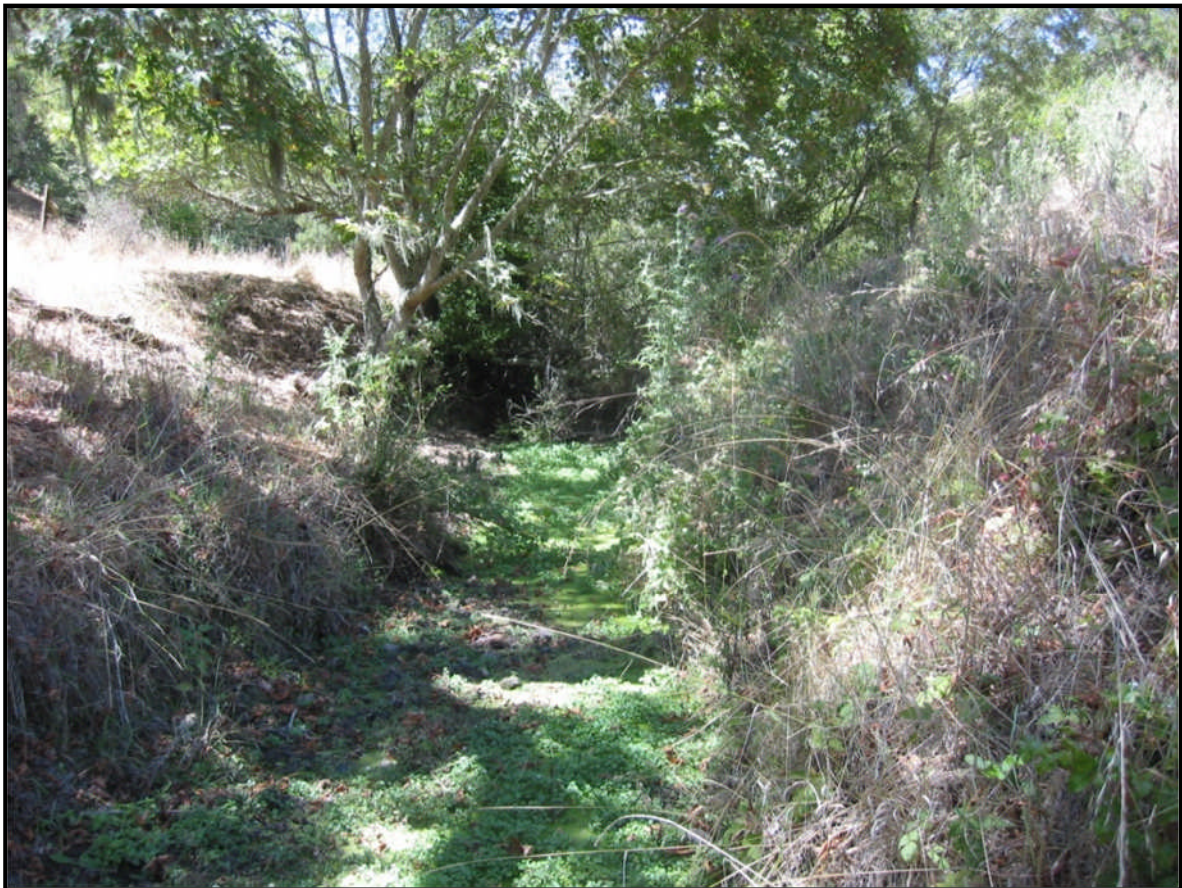
The second segment of the channel (Reach 2) is relatively low gradient, particularly considering its location high in the watershed. This flatter section extends for approximately one mile at an average gradient of 3 percent, from the 1,480 foot contour on downstream to the 1,320 foot contour. Though the gradient flattens, the channel still has an incised appearance in areas. A significant depositional area of coarse material was not observed in this reach. This implies that the sediment production, of coarser materials is not high in the upper reach, otherwise the material would deposit in the area of reduced slope. The bed was comprised of sands and silts in portions of this reach, with only a scattering of angular gravels and cobbles (Photo 2.2). These larger materials may have fallen into the channel from the adjacent banks. In some areas where the bank material was exposed, there was a fairly heterogeneous matrix of material ranging from fines to small cobbles.

Photo 2.2 Typical Channel in Reach 2, Low Gradient

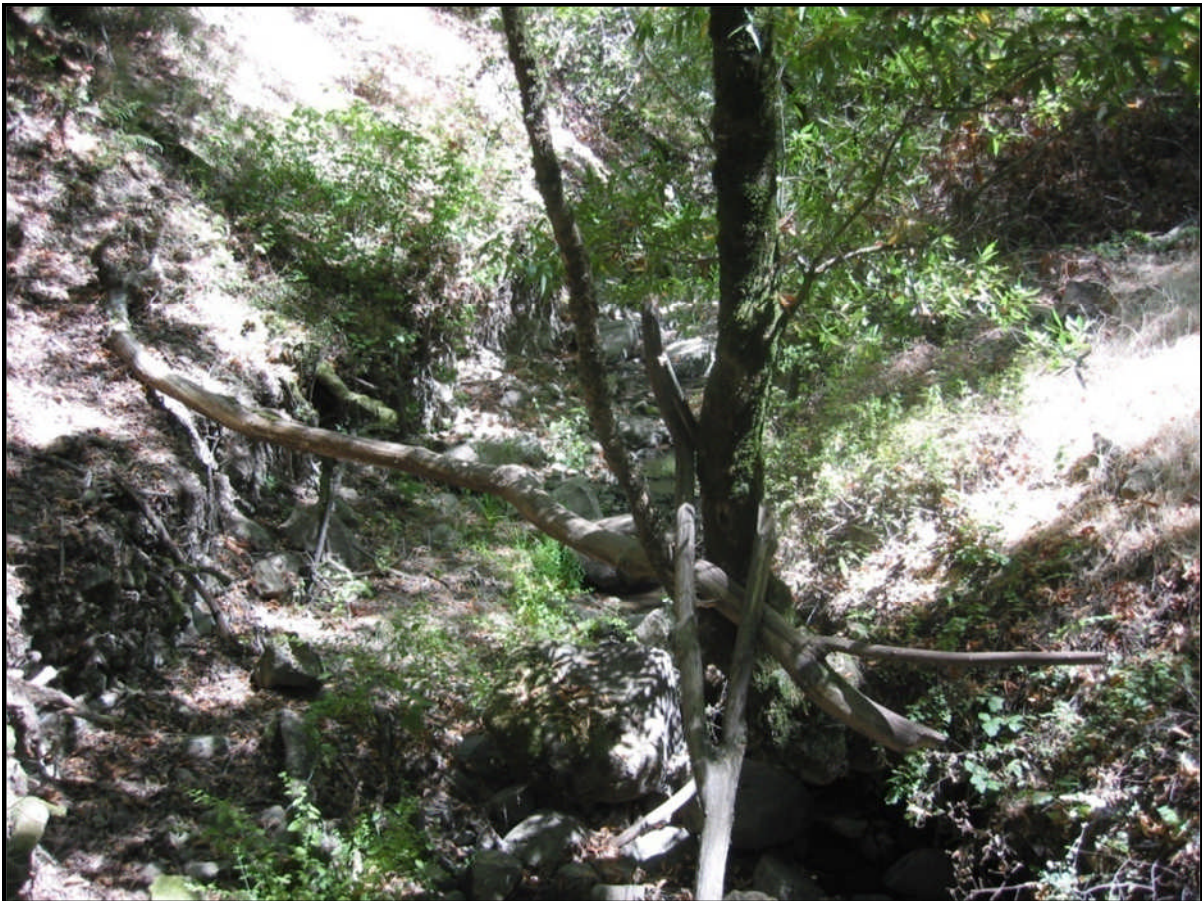
The third segment (Reach 3) of the upper channel starts as the stream gradient steepens and the channel becomes confined by steep hillsides. The bed material becomes dominated by gravels, cobbles and boulders with some bed rock outcroppings (Photo 2.3). The gradient was estimated at 8 percent for this reach which extends for approximately 2 miles to the 500 foot contour. Passage down the creek became difficult, so the inspection team walked along the hillside on the north side of the channel. At the several locations where the team returned to the creek bed, it was evident that the channel was capable of transporting materials up to boulders of over a foot in diameter. At several locations, bedrock was exposed in the channel and small falls were created. Though the watershed is very steep in this reach, the only landslides were observed near the downstream boundary of this reach. The south side of the valley wall is heavily forested while the north side is dominated by shrubs and grasses, except for a strip along the very bottom of the valley near the channel.

Photo 2.3 Typical Channel Section in Reach 3, Gradient of 8 Percent

Based on the coarse bed material and steep gradient in Reach 3, a significant amount of gravel and cobble can be transported through this reach. However, no large point sources were identified. The team did not walk this portion of the creek bed so it could not be observed if there were large areas of bank erosion or contributions of sediments from point sources along the creek. This statement is based mainly on the lack of gullies crossed in walking along the north side of the valley wall and no visual identification of larger landslides on either the north or south valley wall. Construction of a sediment retention facility in this reach would be difficult due to the limited access and the small amount of storage volume per foot of structure height because of the steep channel gradient and steep confining valley walls.

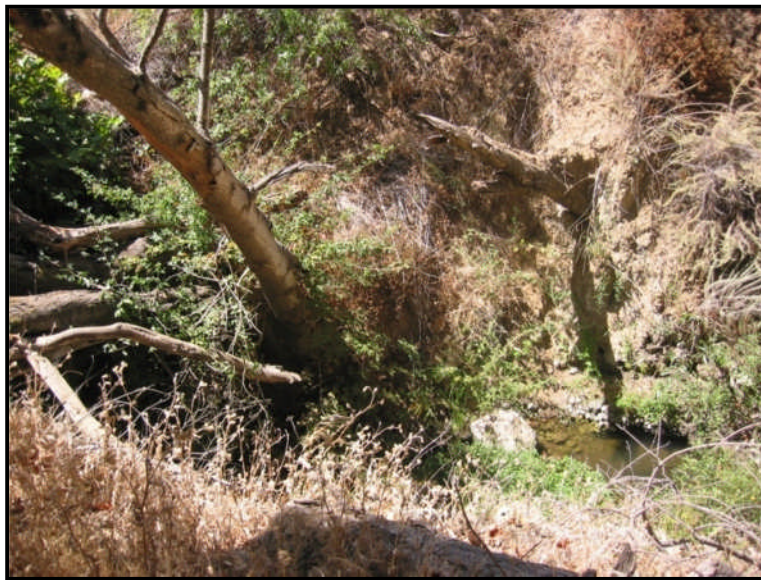
Reach 4 begins where the stream enters what was referred to in previous reports (USACE 1993 and NHC 2001) as the canyon reach. The reach extends for approximately 0.6 miles at an average gradient of 8 percent with a short steep section of over 15 percent in the center of the reach. The most striking feature in this reach are a number of larger landslides that start hundreds of feet up on the hillside and continue down to the creek (Photo 2.4). These features are the largest concentrated sediment sources observed. The creek bed in this area is dominated by coarse material ranging from gravels and cobbles up to boulders on the order of 4 feet in diameter and greater. There is evidence that at times, the channel has transported debris torrents or flows. The formation comprising the surficial geology in this portion of the watershed is more susceptible to erosion and mass wasting than further upstream (Photo 2.5). This condition is further influenced by the Hayward Fault zone. The reduction in vegetative cover as elevation and rainfall decreases may also be a factor.

Photo 2.4 Mass Wasting Directly into Creek near Upstream Limits of Reach 4

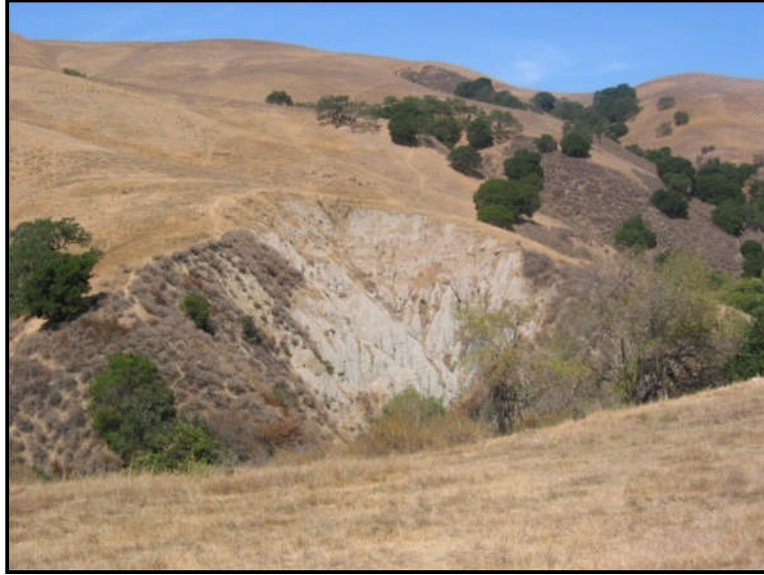
Photo 2.5 Landslide Scarp on North Valley Wall in Reach 4 (Canyon Reach)

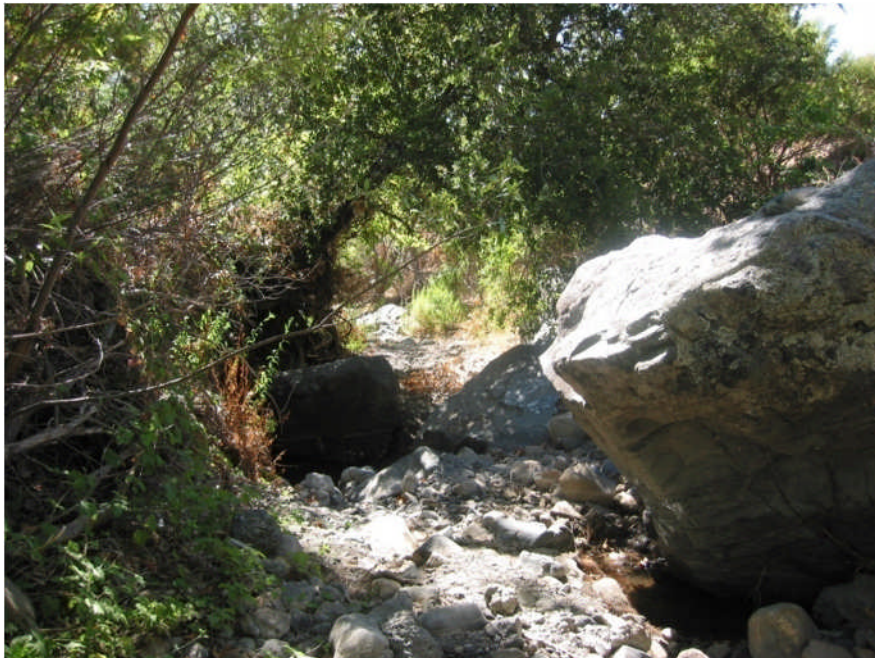
Reach 5 is a transition zone from the steeper upper watershed to the much flatter alluvial fan. The average gradient through this 0.3 mile reach is 4 percent. The channel bed in this reach is still comprised of material ranging from gravels to large boulders (Photo 2.6). Most or all of the larger boulders generated upstream appear to be deposited in this reach and do not cross Old Piedmont Road.

Photo 2.6 Typical Reach 5 Channel in Transition from Uplands to the Alluvial Fan

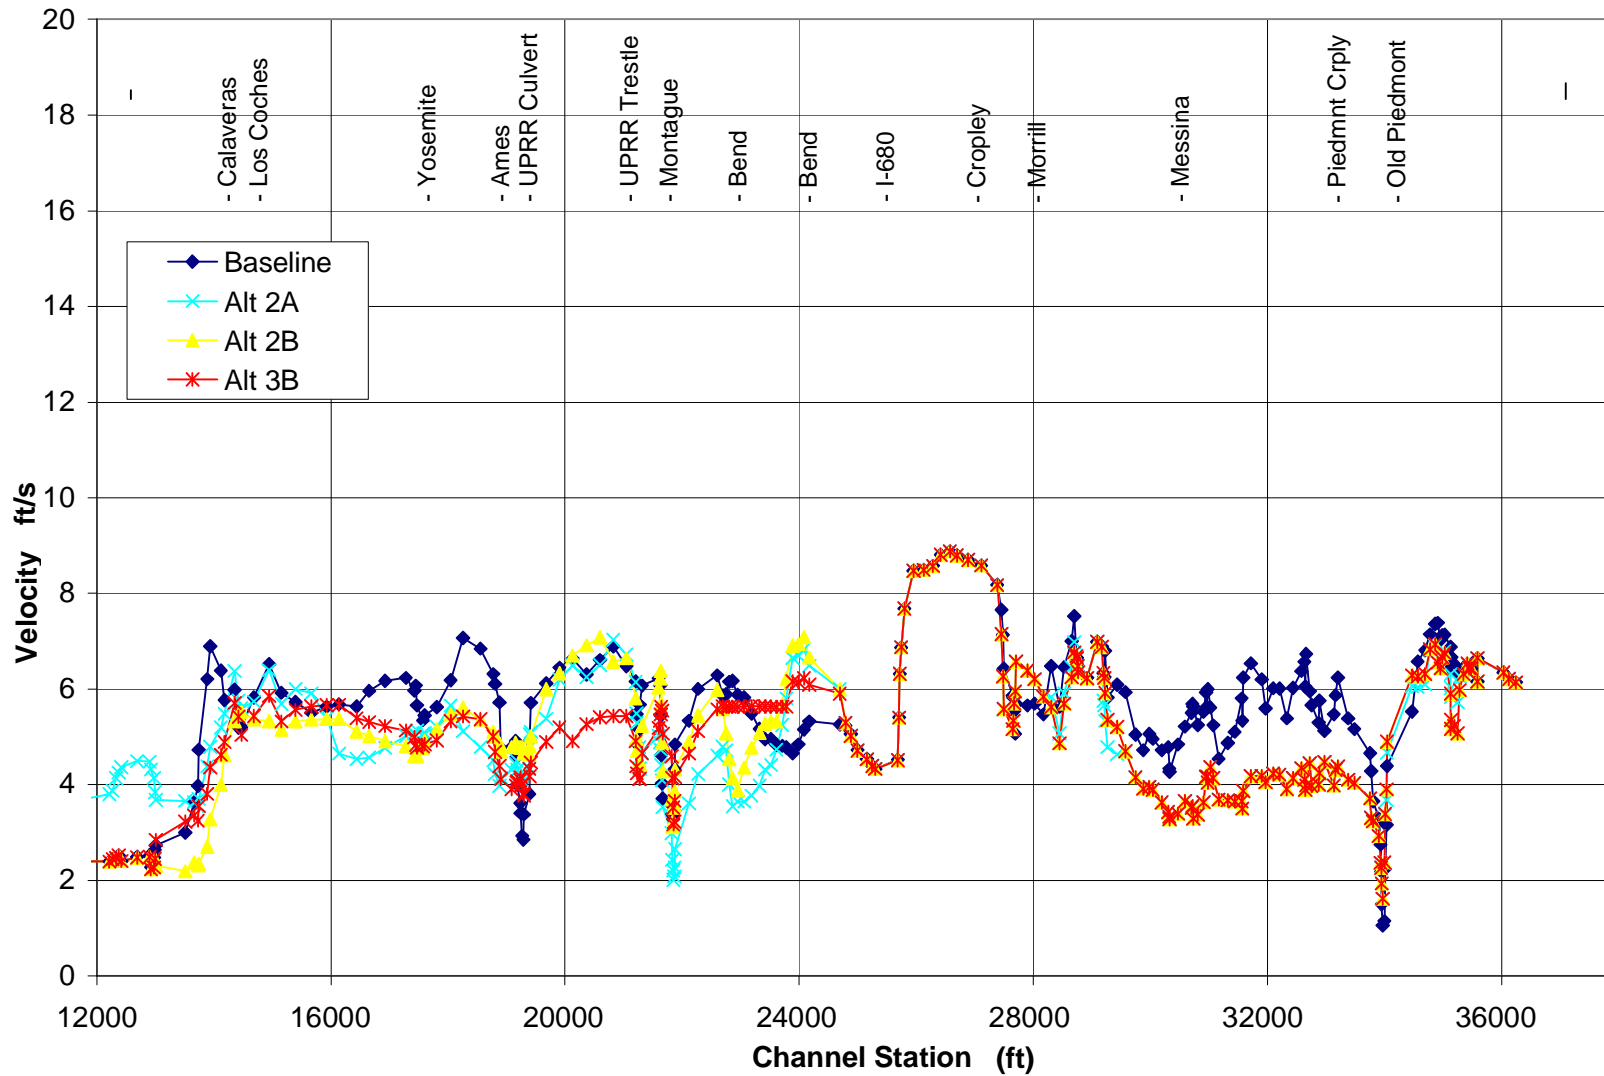
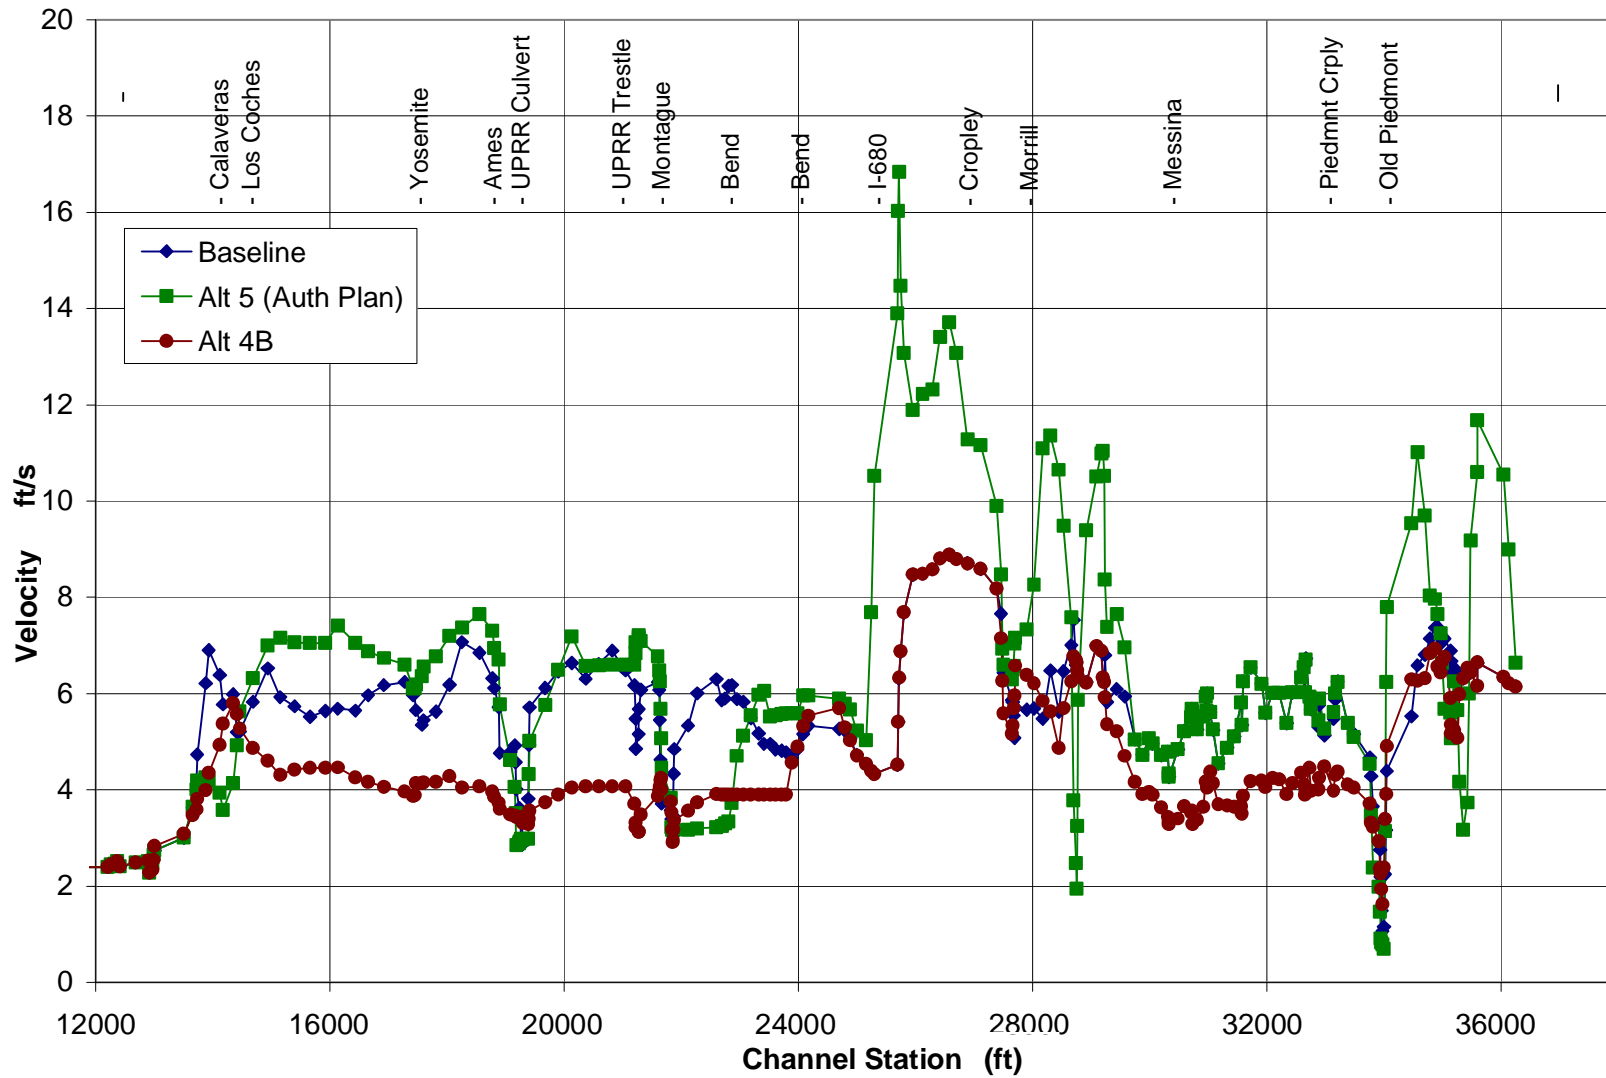
Figure 3-1 (Part 1 of 2) – Main Channel Velocity for Without- and With-Project Conditions, 50% Chance Exceedance Event

Figure 3-2 (Part 2 of 2) – Main Channel Velocity for Without- and With-Project Conditions, 50% Chance Exceedance Event

There is a general trend in reduction of the 50% chance exceedance event velocity for the with-project condition in the Calaveras Boulevard to Montague Expressway reach. Starting from the downstream end of the project, in the reach extending 500 feet upstream of Calaveras Boulevard, the velocities for all alternatives decrease by between 2 and 7 feet per second. The without-project velocity spikes at station 141+21 at 11 feet per second while the with-project velocities range from 3 to 7 feet per second. The largest decrease in this area is with Alternatives 2B and Alternative 5. For the rest of the distance up to Montague Expressway, the velocities for Alternatives 2A, 2B and 3B are similar to without-project condition, except where the velocity spikes (to almost 10 feet per second) downstream on the UPRR culvert; these higher values are eliminated for these with-project alternatives. A high velocity spike of nearly 9 feet per second is introduced in Alternative 2B immediately upstream of the UPRR culvert. The velocities for Alternative 4B are generally lower than the without-project condition in this reach, and the velocities for Alternative 5 are slightly higher than the without-project condition.

Upstream of I-680 to Morrill Avenue, the with-project conditions are extremely similar to the without for all alternatives except Alternative 5. Alternative 5 contains similar velocities to the without-project condition in some of this reach, but varies in particular in the vicinity of bridges due to differing conveyance capacity of the bridges and culverts in this alternative.

Upstream of Morrill Avenue to the upper extent of the Greenbelt area, the velocities of the without-project condition are generally higher than Alternative 2A, 2B, 3B and 4B, oscillating between roughly 3 and 8 feet per second. Many of the spikes are approximately 50 % higher than the values for these Alternatives (8 feet per second compared at 5 to 6 feet per second). Conversely, Alternative 5 has very similar velocities to the without-project condition in this reach, with the exception of two very high velocity spikes of 16 and 17 feet per second at stations 344+67 and 355+86 respectively.

The values in both sets of plots are for the main channel since this is the portion of the flow that is responsible for nearly all the bed material load transport and it is the bed material load transport that determines the aggradation and degradation characteristics within the project area. Additionally, it is the sand and larger material that has been removed from the channel and sediment basin by past maintenance activities. The larger variation in shear stresses and velocities in the alternatives are related to the in-line detention basins, with backwater conditions behind and weir flow over the crest.

The 50% chance exceedance event was used in the comparison because this event is considered to be approximately the channel forming flow, i.e. most representatives of typical conditions that determine the behavior of the channel over the long term.

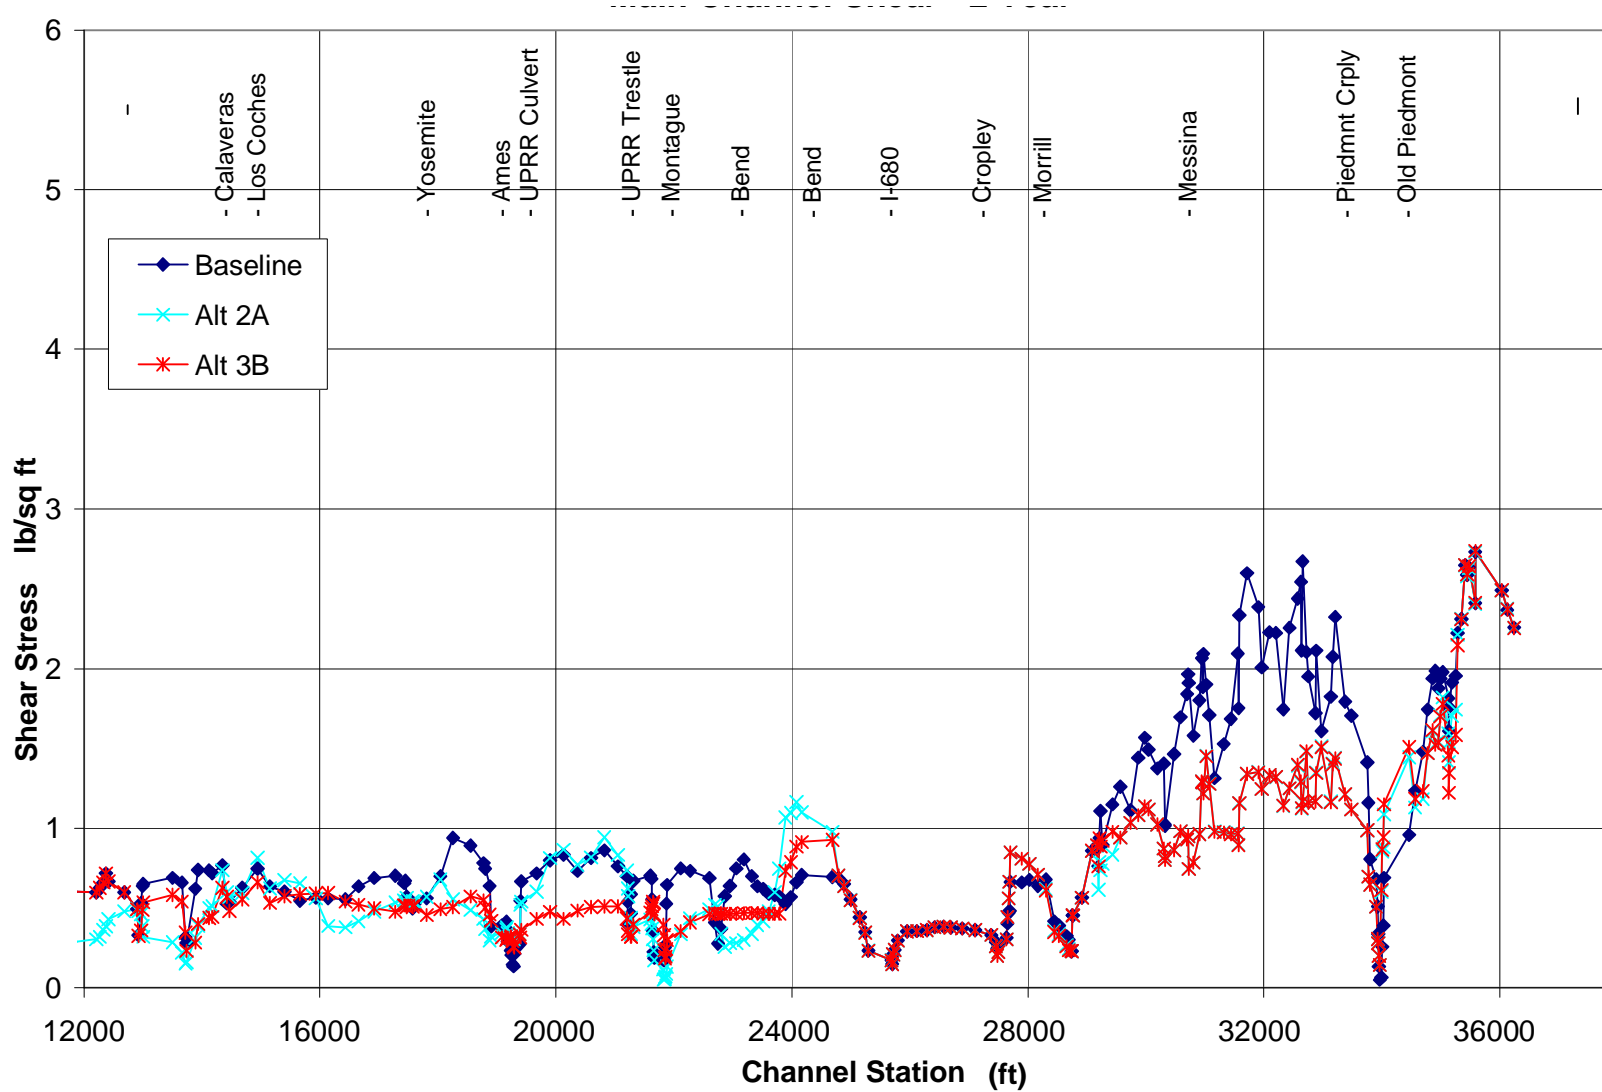
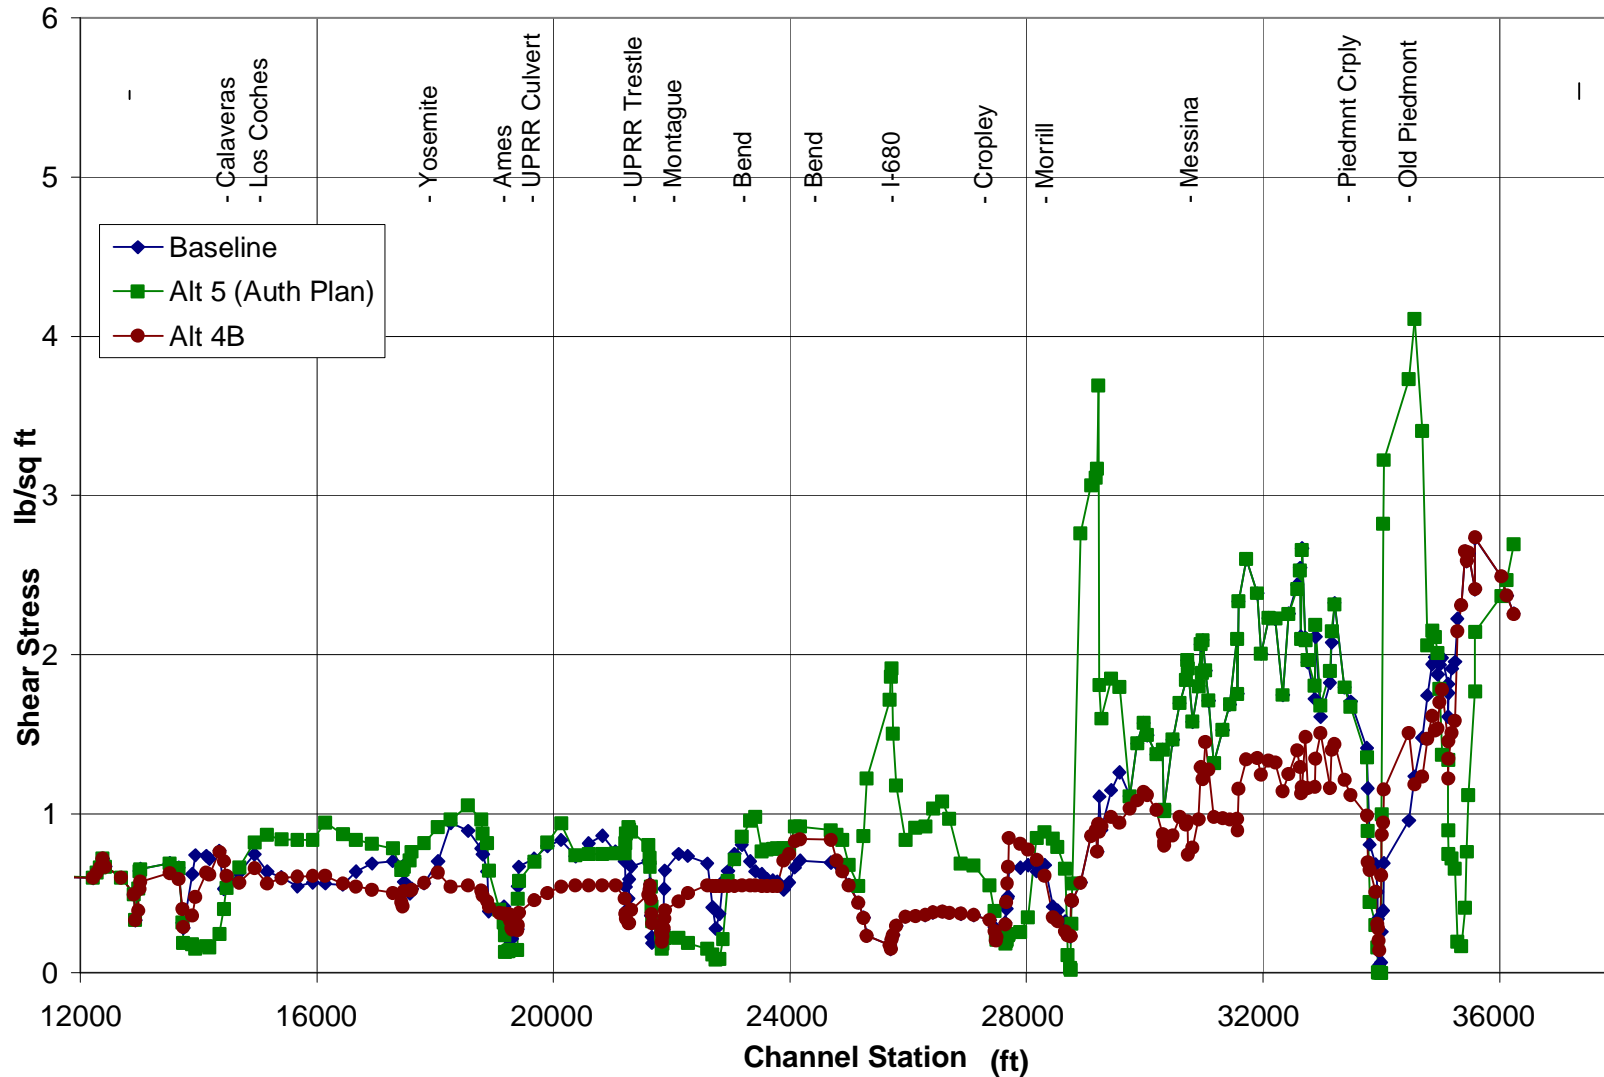
Figure 3-3 (Part 1 of 2) – Main Channel Shear Stress for Without- and With-Project Conditions, 50% Chance Exceedance Event

Figure 3-4 (Part 2 of 2) – Main Channel Shear Stress for Without- and With-Project Conditions, 50% Chance Exceedance Event

The comparison of shear stress for the 50% chance exceedance event show similar trends to the velocity comparison described previously. In the vicinity of Calaveras Boulevard, the shear stresses drop by 0.5 to 1 lbs/ft² for all with-project Alternatives. In the reach extending from Calaveras Boulevard up to I-680, shear stresses for all Alternatives are on average slightly lower than the without-project condition. Between I-680 and Morrill Avenue shear stresses of Alternatives 2A, 2B, 3B and 4B are identical to the with-project condition, typically 0.5 to 1 lbs/ft². From Morrill Avenue to the project upstream limit, shear stresses of the without-project condition oscillate considerably between 1 and 4 lbs/ft². Values for Alternatives 2A, 2B, 3B and 4B oscillate, generally between 1 and 2.5 lbs/ft². Alternative 5 differs significantly from the other with-project alternatives, due to the presence of in-line detention basins and the differing conveyance capacities of the bridges and culverts.
