**Berryessa Creek Element
Coyote and Berryessa Creeks
Flood Control Project
Santa Clara County, California**

Appendix B: Engineering and Design

**Geomorphologic and Sediment Transport
Assessment**

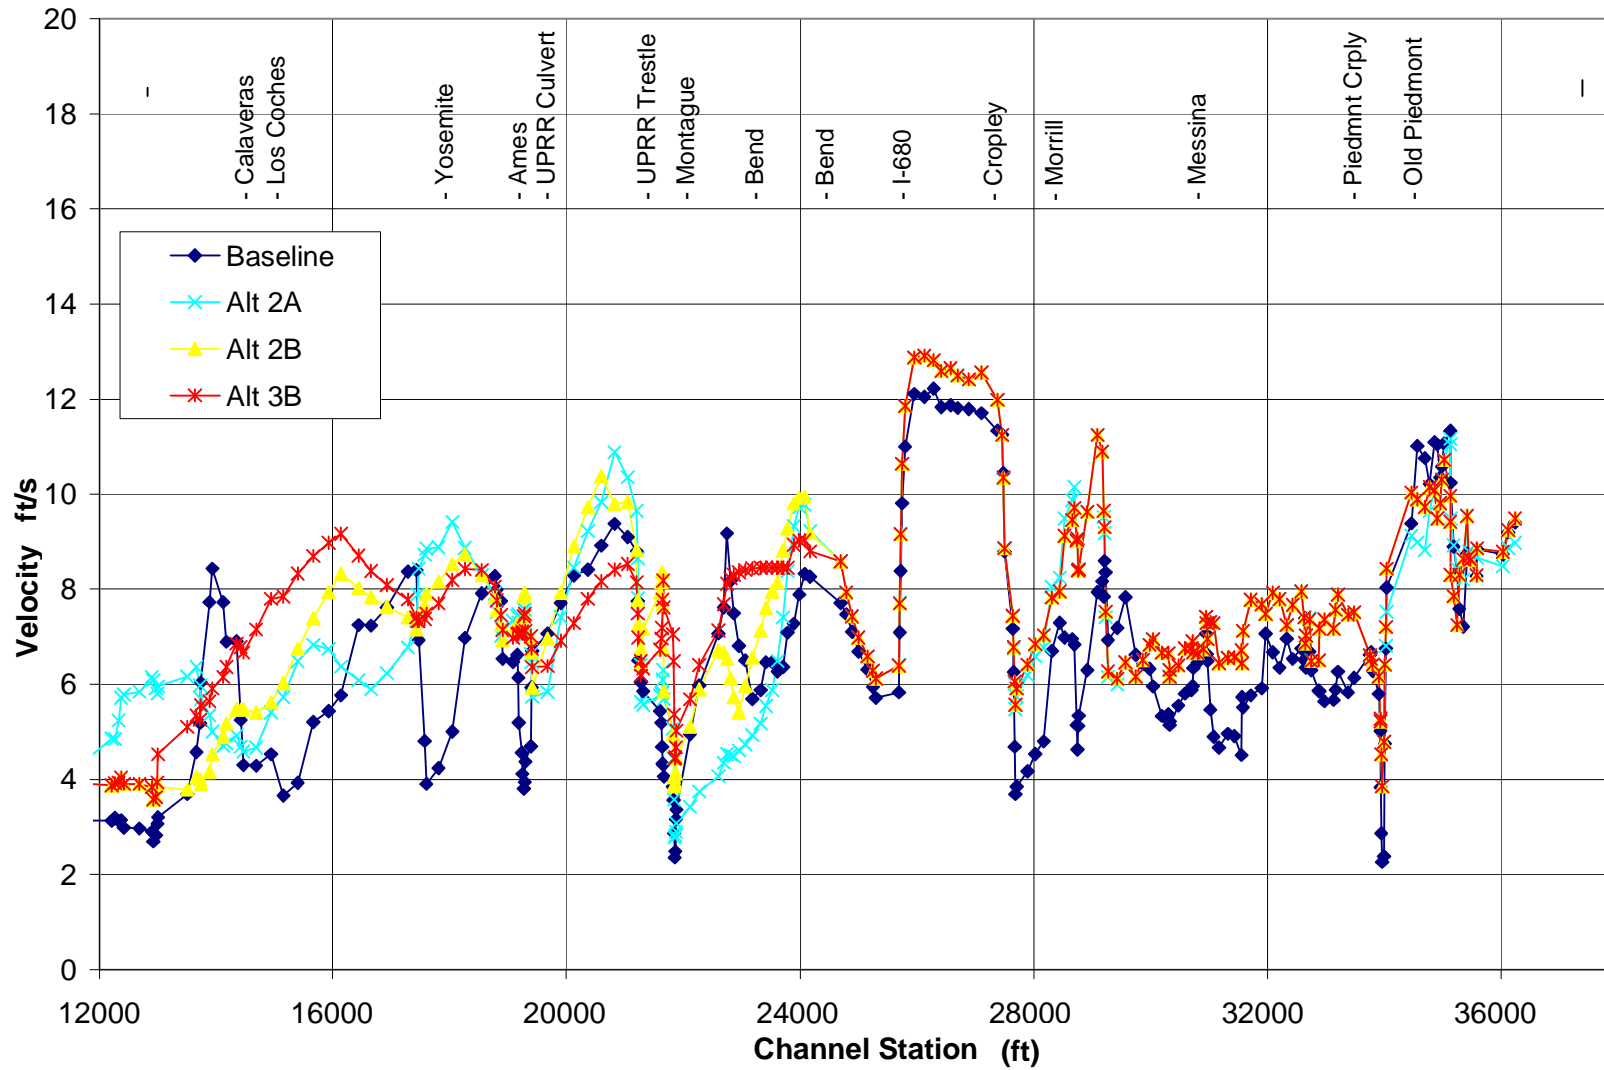
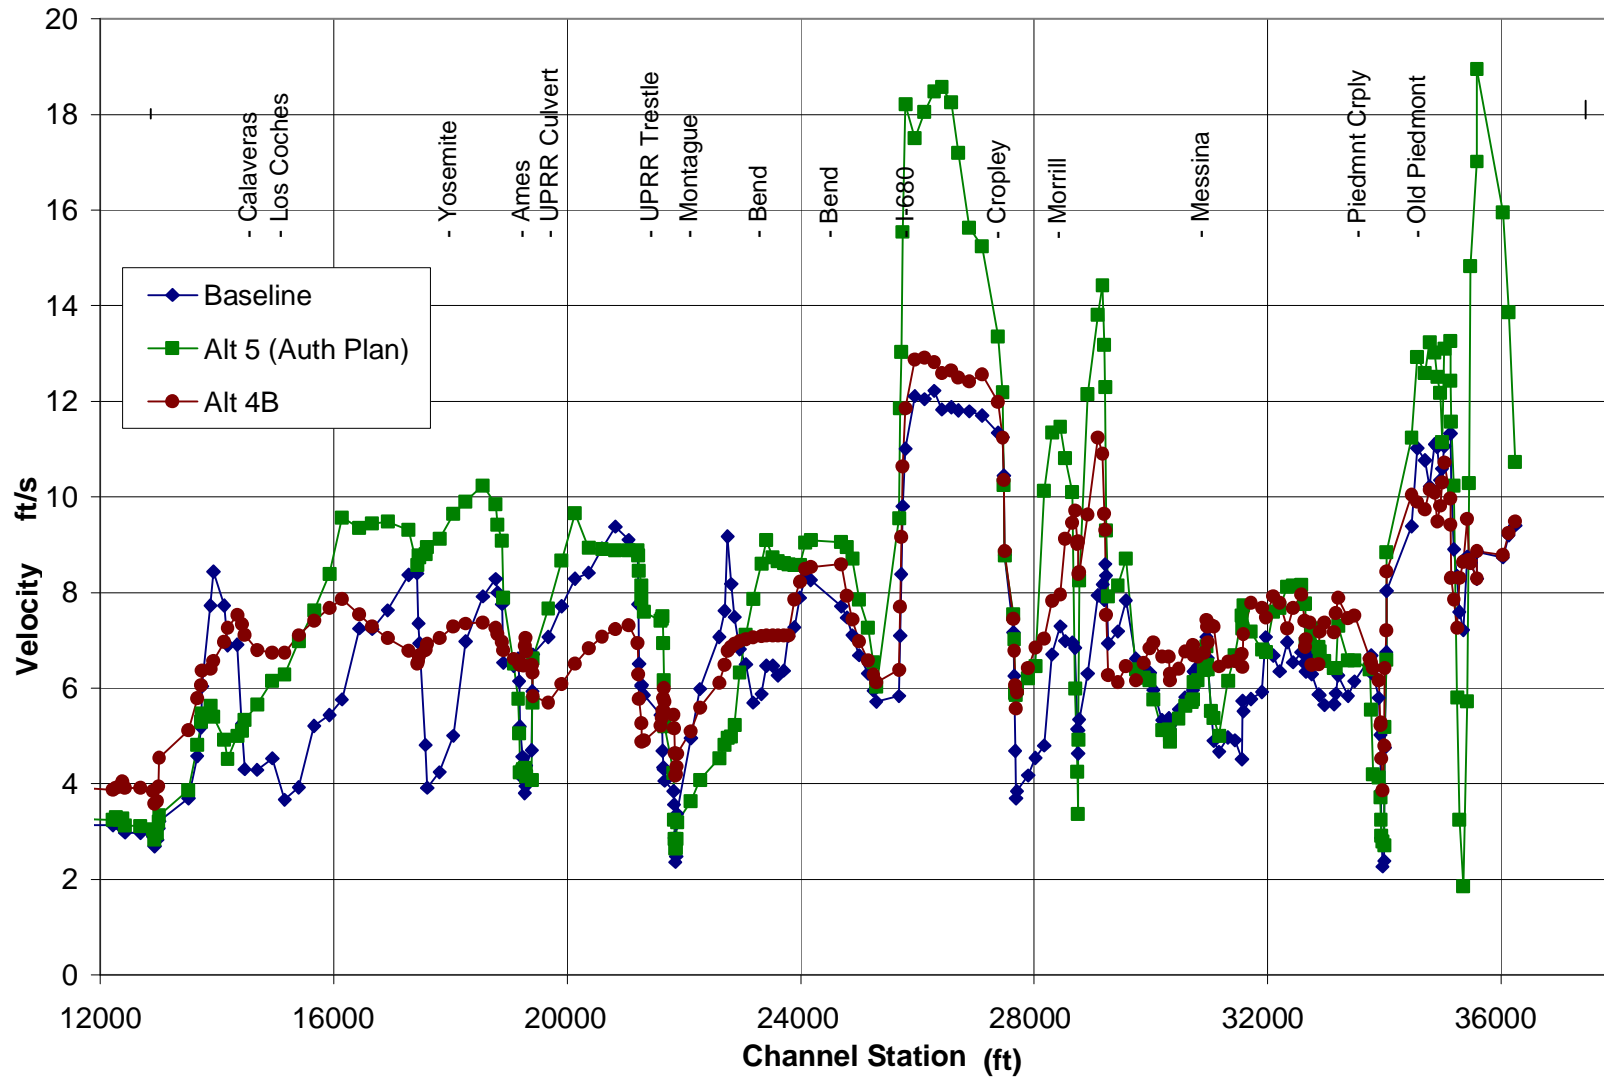
Figure 3-5 (Part 1 of 2) – Main Channel Velocity for Without- and With-Project Conditions, 1% Chance Exceedance Event

Figure 3-6 (Part 2 of 2) – Main Channel Velocity for Without- and With-Project Conditions, 1% Chance Exceedance Event

For the 1% chance exceedance event velocity, the velocity changes in the area of Calaveras Boulevard are more significant than for the 50% chance exceedance event. From 1,000 feet downstream to Calaveras Boulevard, they increase by about 1 foot per second for all with-project conditions, Alternative 2A showing a greater increase of up to 3 feet per second. At station 141+21, the without-project velocity spikes to 12 feet per second, whereas the velocities for the with-project alternatives are lower ranging from 5 and 8 feet per second. From upstream of Calaveras Boulevard to I-680, there is no clear trend between the with- and without-project conditions. Though the velocities are not the same, they all vary widely from about 4 feet per second to 12 feet per second, with similar averages through the reach but with significant differences at individual locations. Generally, velocities for the without-project condition spike and fall to a greater degree than for the with-project alternatives. Between the UPRR culvert and Trestle, Alternative 2A has two spikes over 12 feet per second, whereas Alternatives 2B, 3B, 4B and 5 are consistently between 8 to 10 feet per second. The baseline condition varies from 6 to 10 feet per second in this reach.

The 1% chance exceedance event was used in the comparison because it is a large event that is typically utilized to represent the most severe conditions that the project is likely to experience during its design life. Though the 50% chance exceedance event indicates the general behavior of the project over a long period, the response during the 1% chance exceedance event can cause damages that can require significant maintenance or destroy project features.

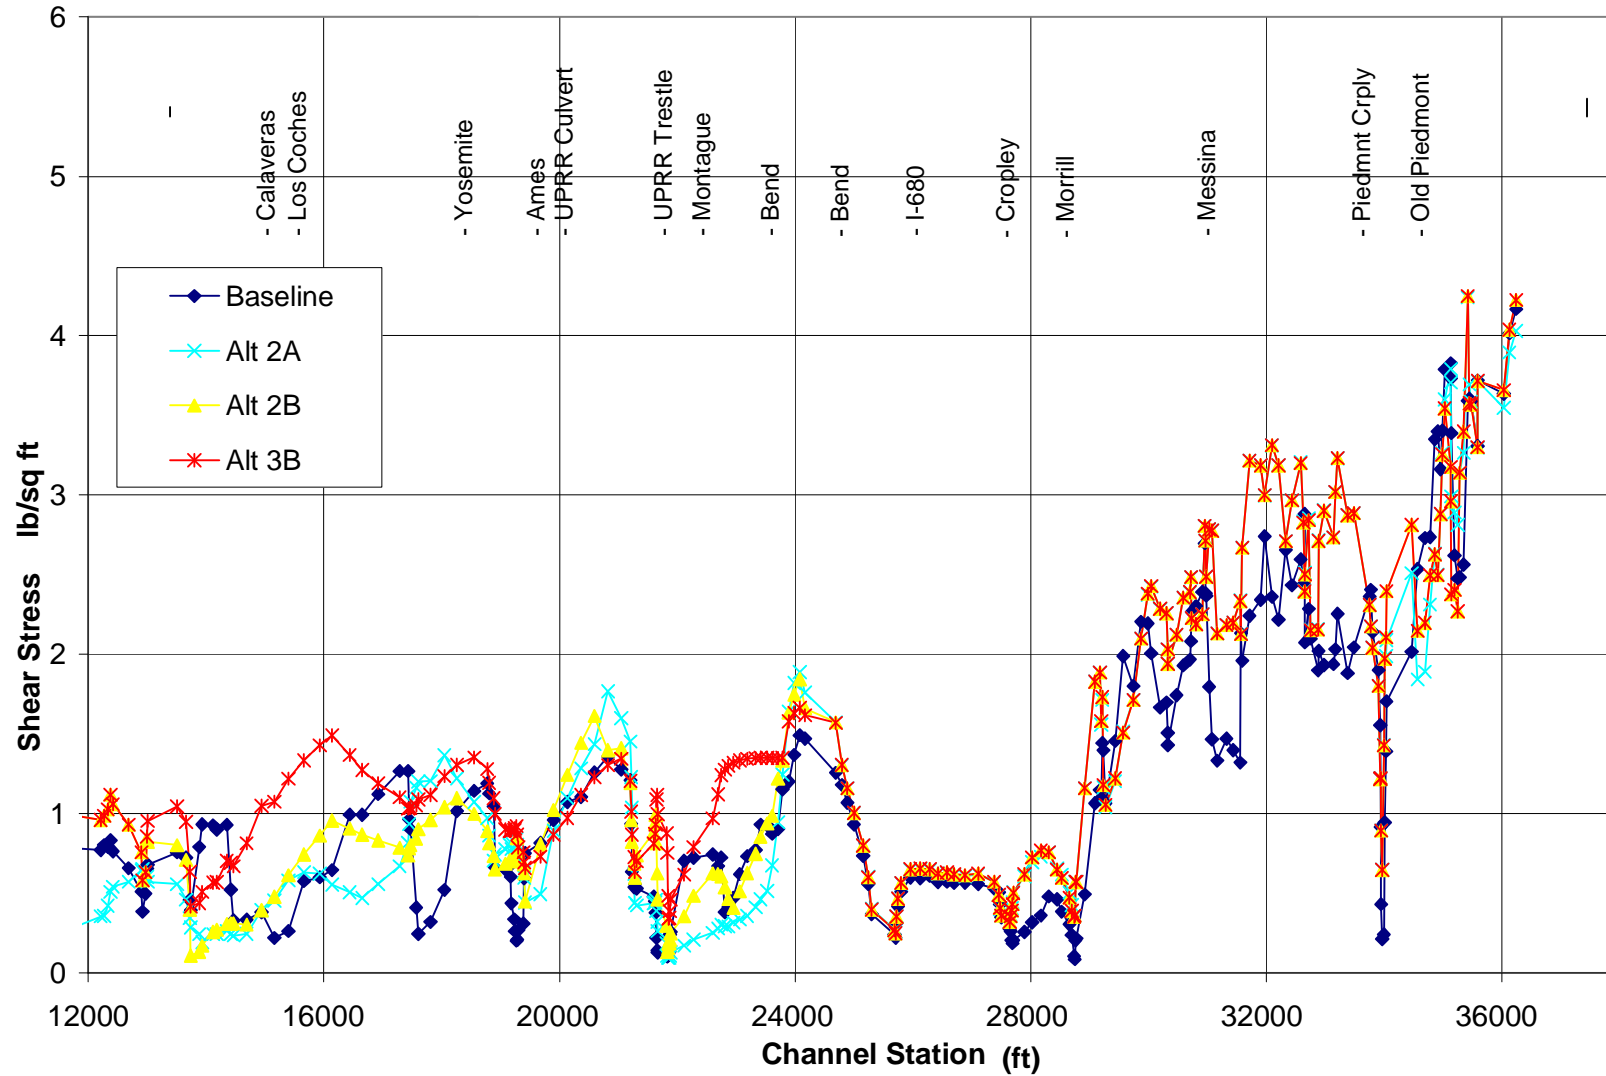
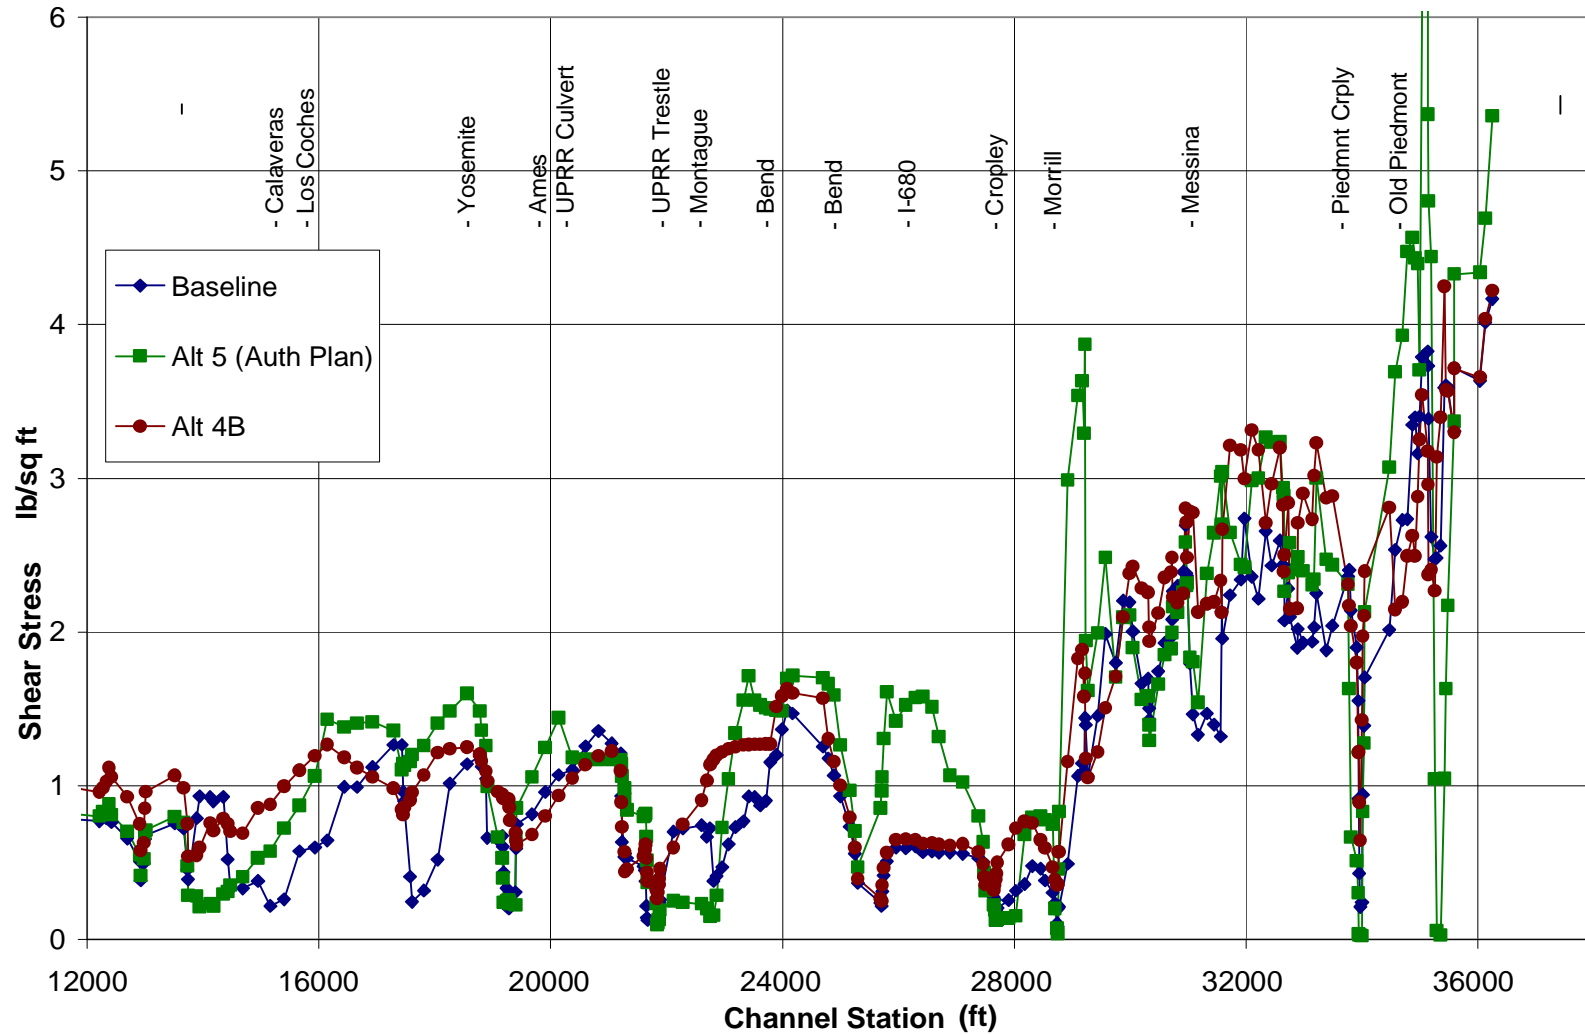
Figure 3-7 (Page 1 of 2) – Main Channel Shear Stress for Without- and With-Project Conditions, 1% Chance Exceedance Event

Figure 3-8 (Page 2 of 2) – Main Channel Shear Stress for Without- and With-Project Conditions, 1% Chance Exceedance Event

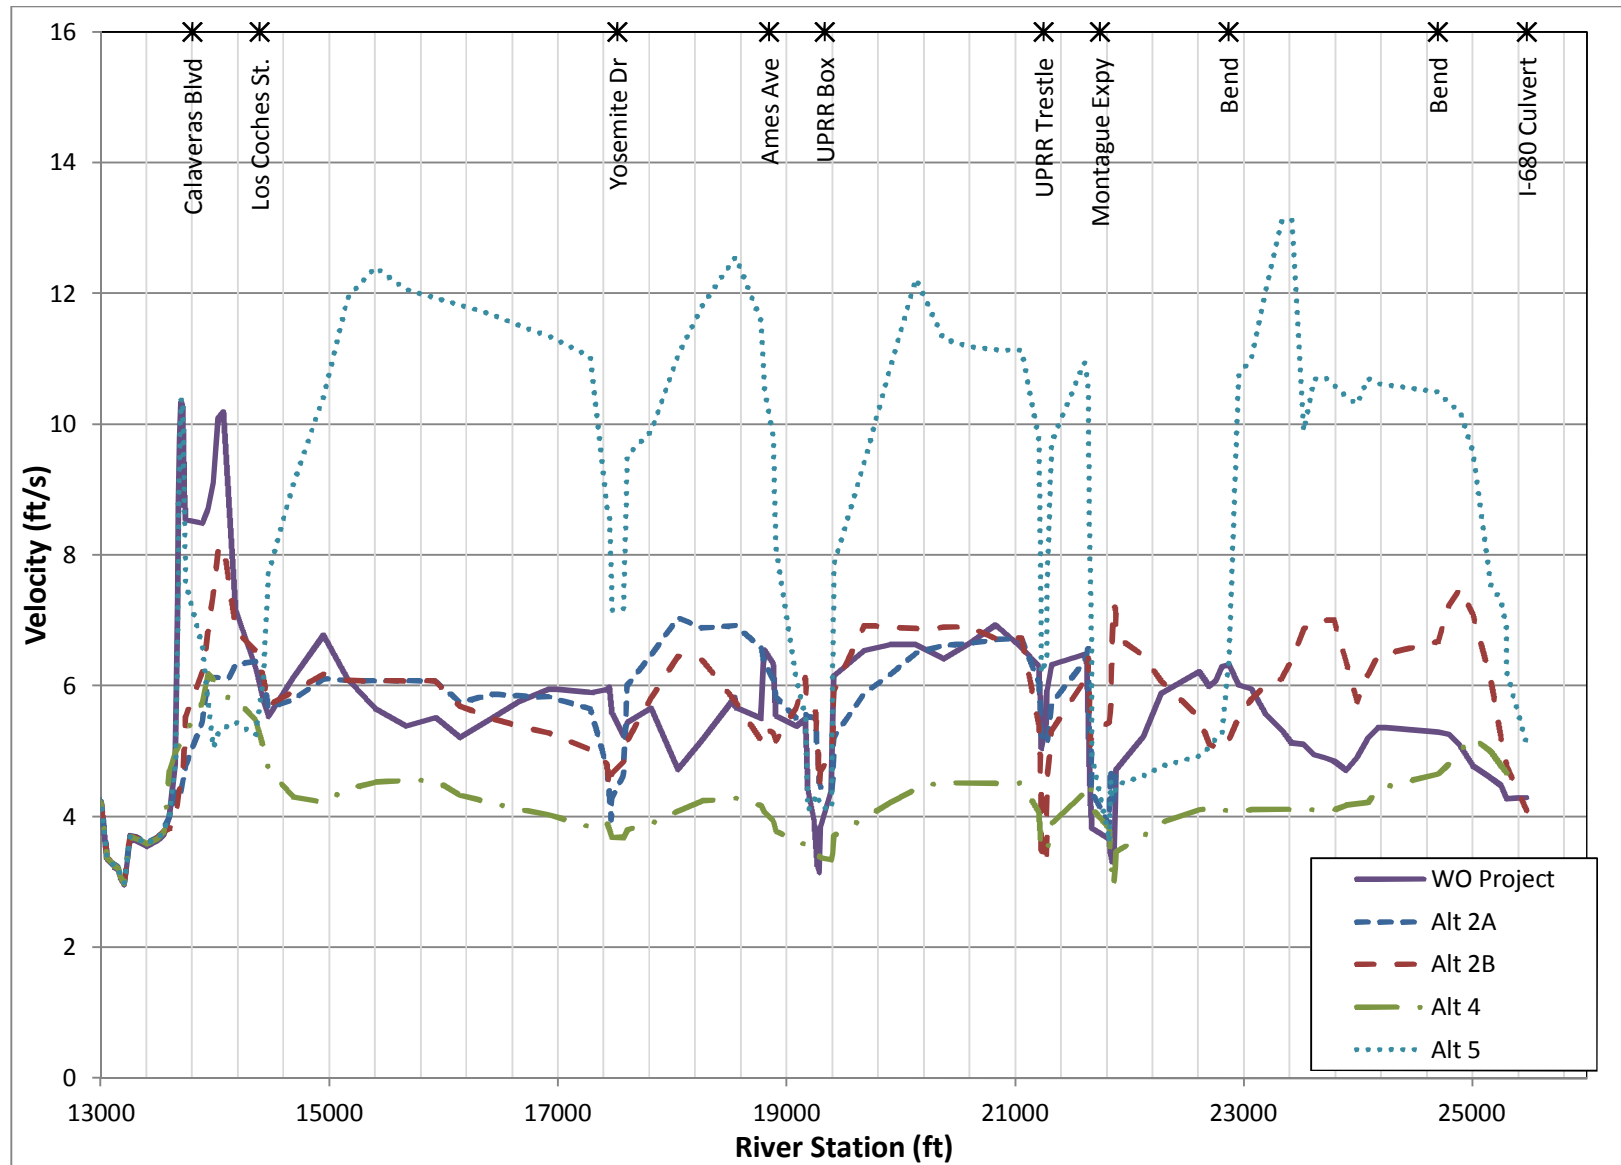
Figure 3-9 Main Channel Velocity Comparison of Without- and With-Project Conditions, 50% chance exceedance Event

The values in both sets of plots are for the main channel since this is the portion of the flow that is responsible for nearly all the bed material load transport and it is the bed material load transport that determines the aggradation and degradation characteristics within the Greenbelt and the project area. Additionally, it is the sand and larger material that has been removed from the channel and sediment basin by past maintenance activities.

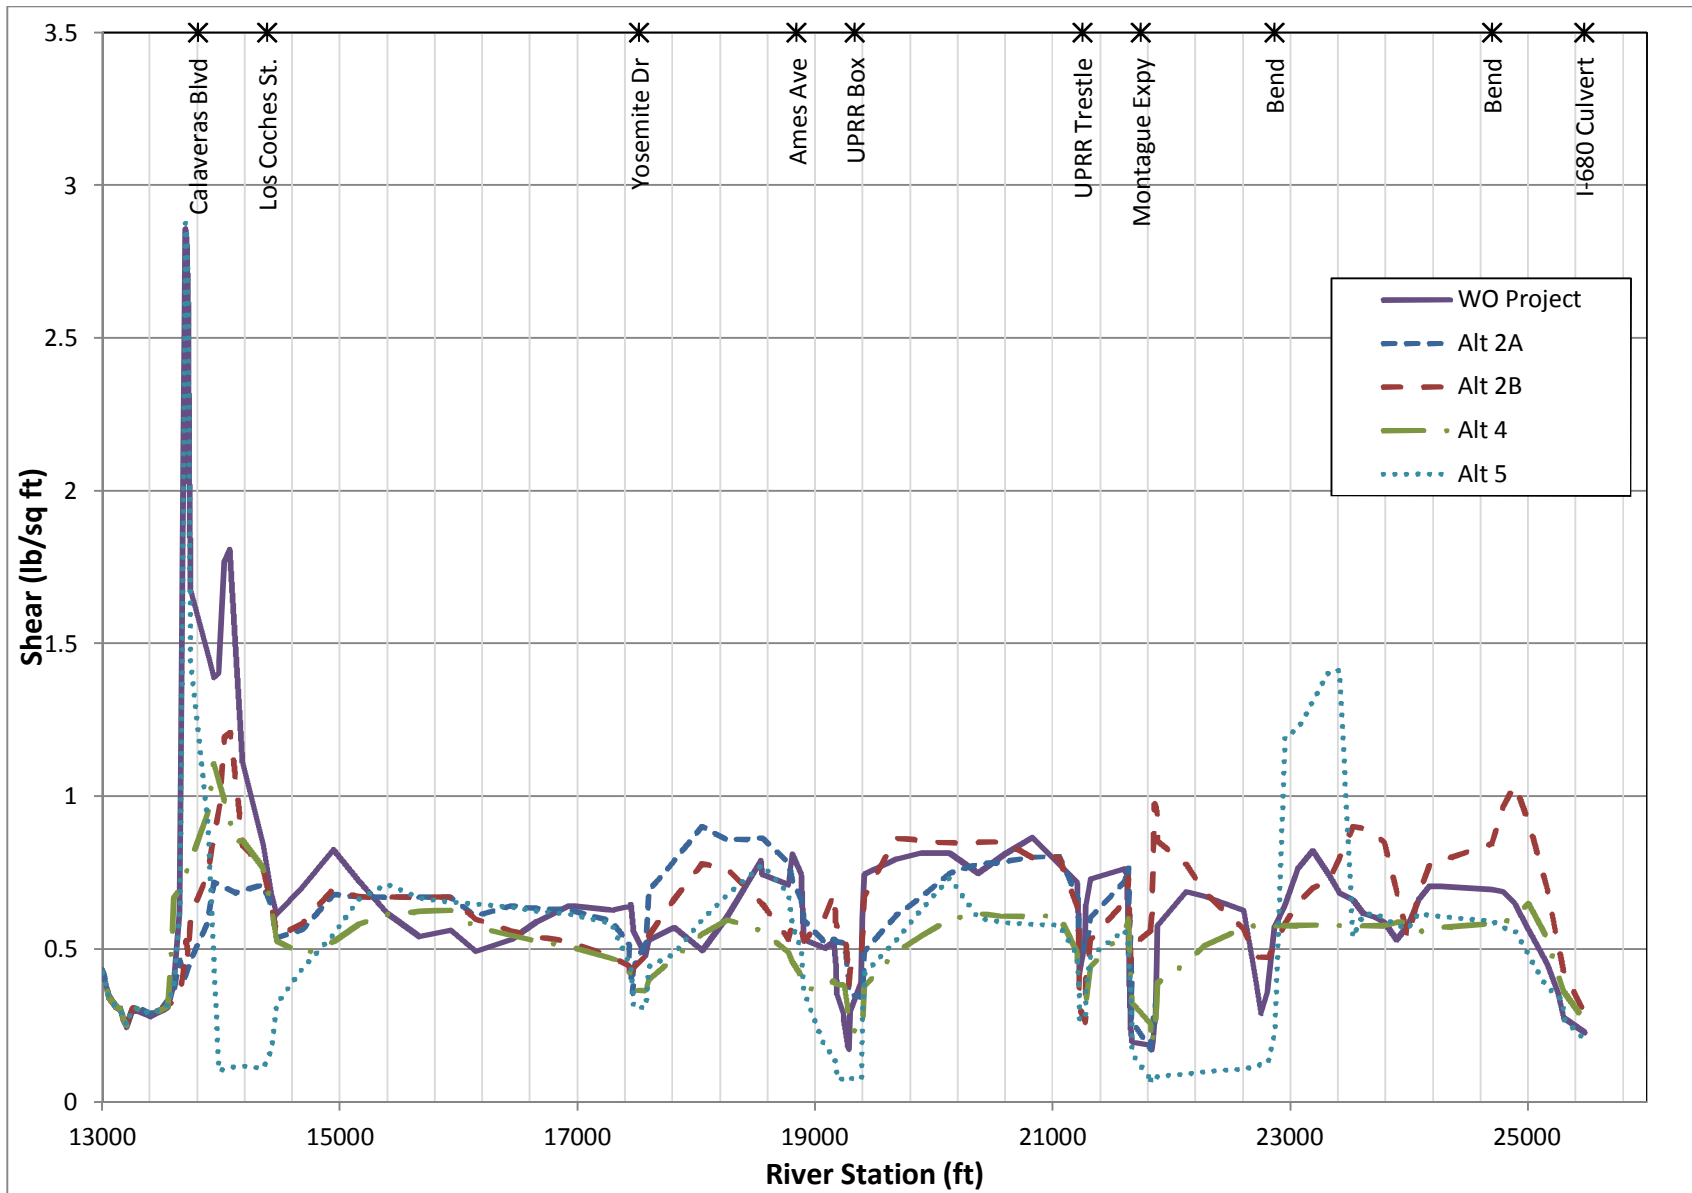
Figure 3-10 Main Channel Shear Stress Comparison of Without- and With-Project Conditions, 50% chance exceedance Event

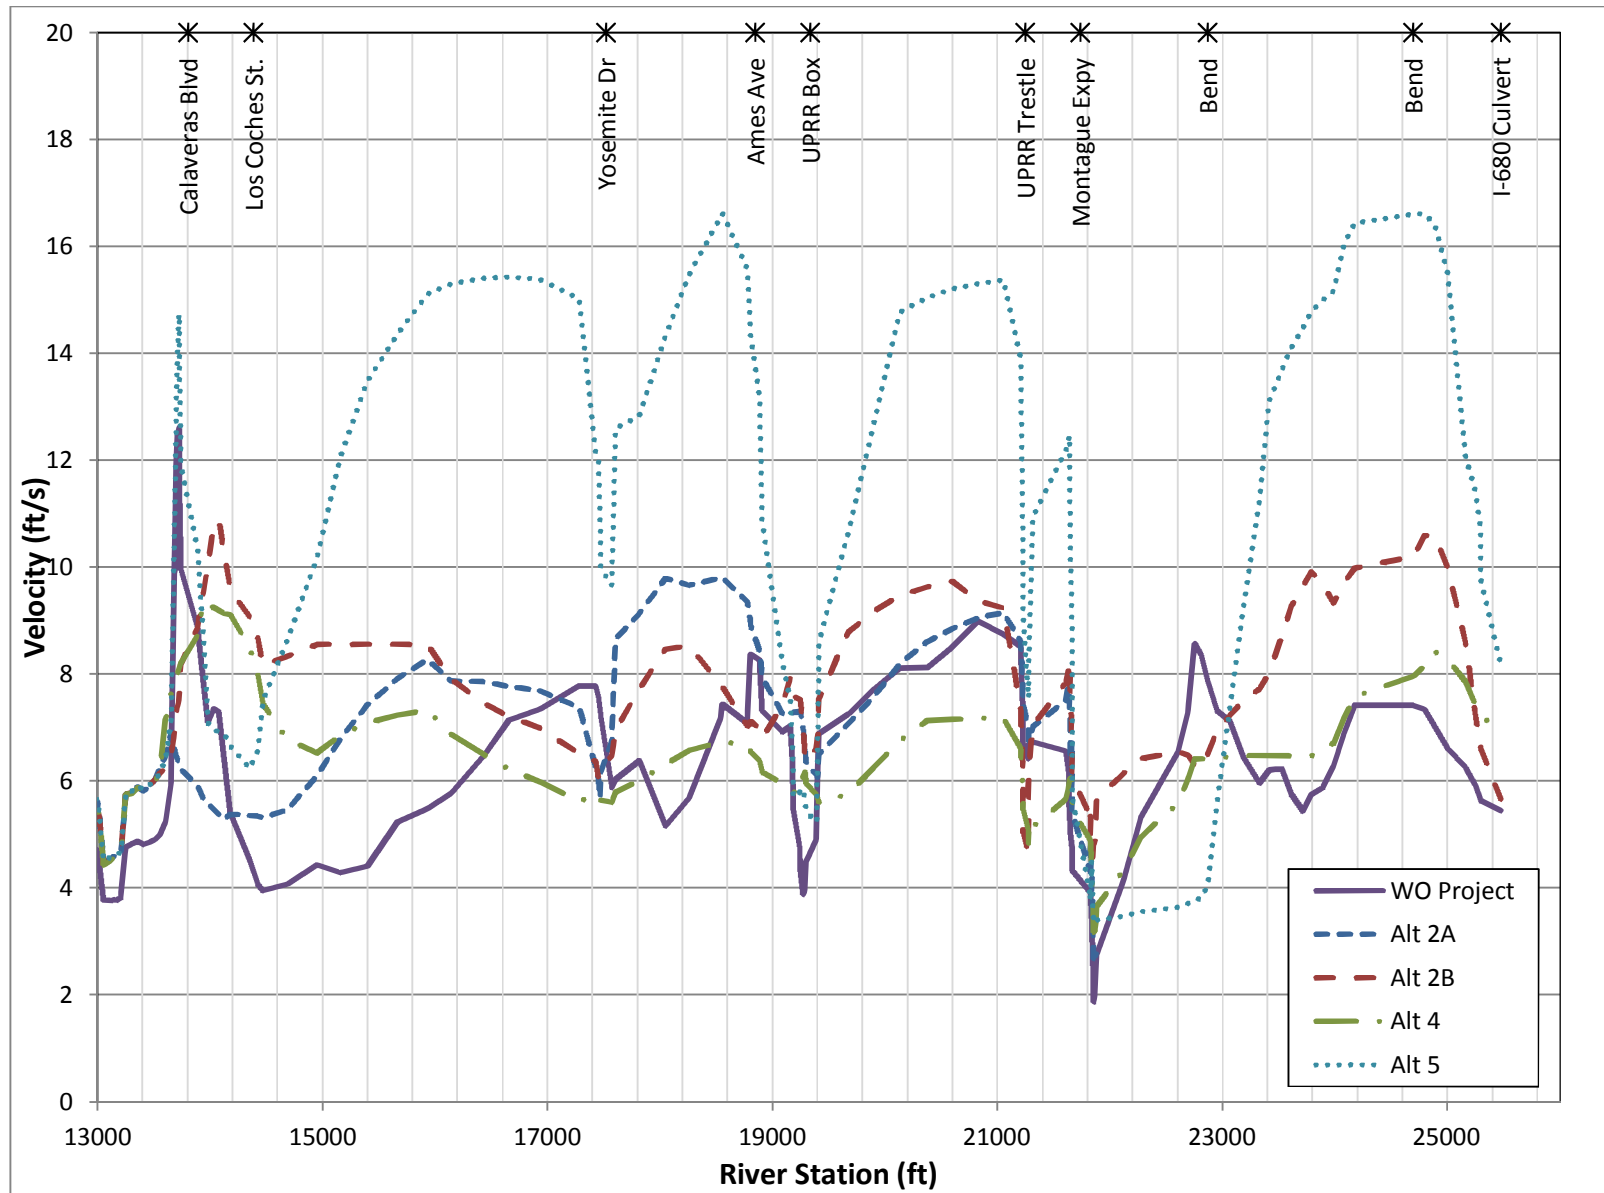
Figure 3-11 Main Channel Velocity Comparison of Without- and With-Project Conditions, 1% chance exceedance Event

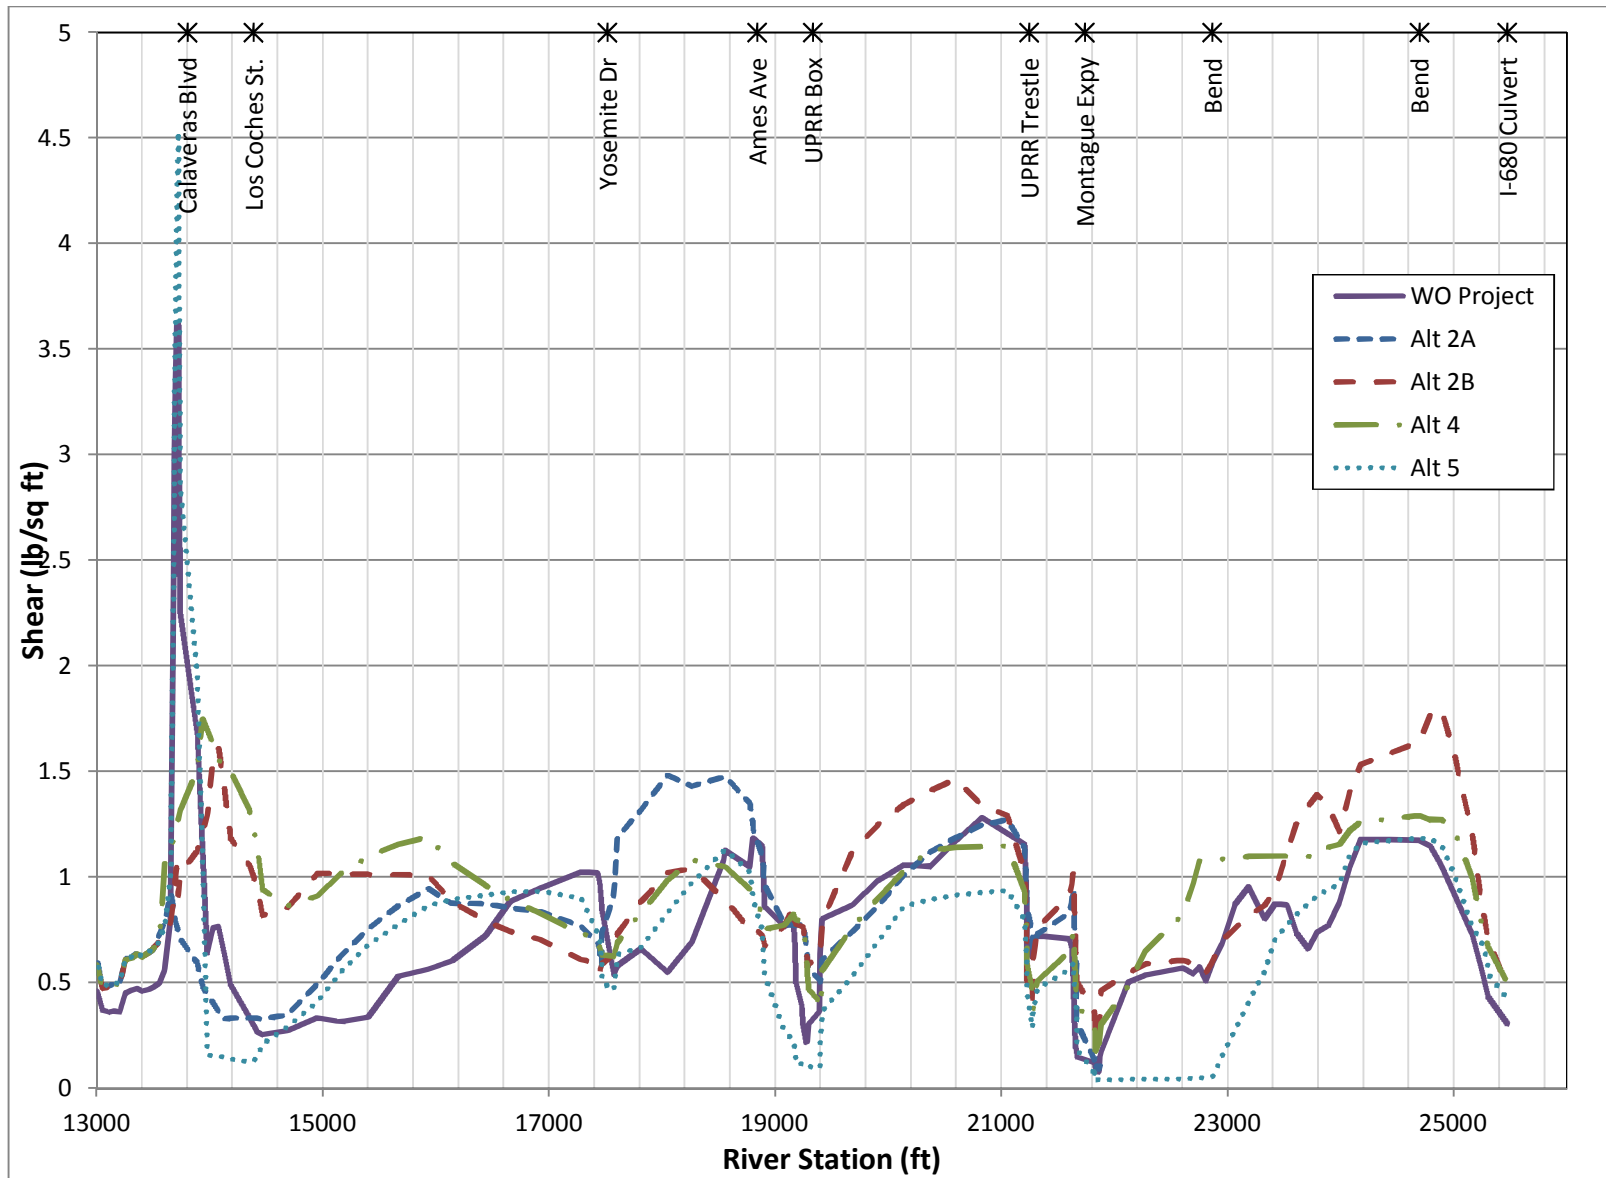
Figure 3-12 Main Channel Shear Stress Comparison of Without- and With-Project Conditions, 1% chance exceedance Event

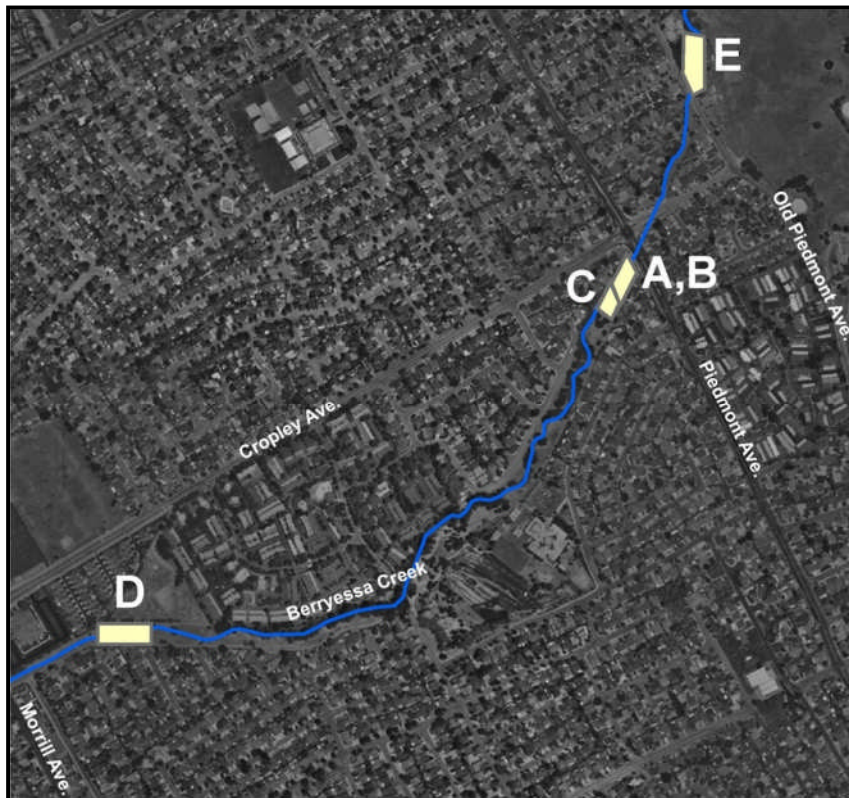
An evaluation of the advantages and disadvantages of each configuration concluded that a combination of the above alternatives would best balance maintenance needs against environmental impacts and hydraulic conveyance capacity. These alternatives are currently under consideration by others, and the design of features within the project reach should be coordinated with the design process of the upstream sediment basin in order to ensure consistent approaches. Recommendations and further details on the sediment basin evaluation are presented in a Technical Memorandum dated January 21, 2009 by Tetra Tech, Inc. (2009a).

Figure 3-13 Plan View of Alternative Sediment Basin Configurations

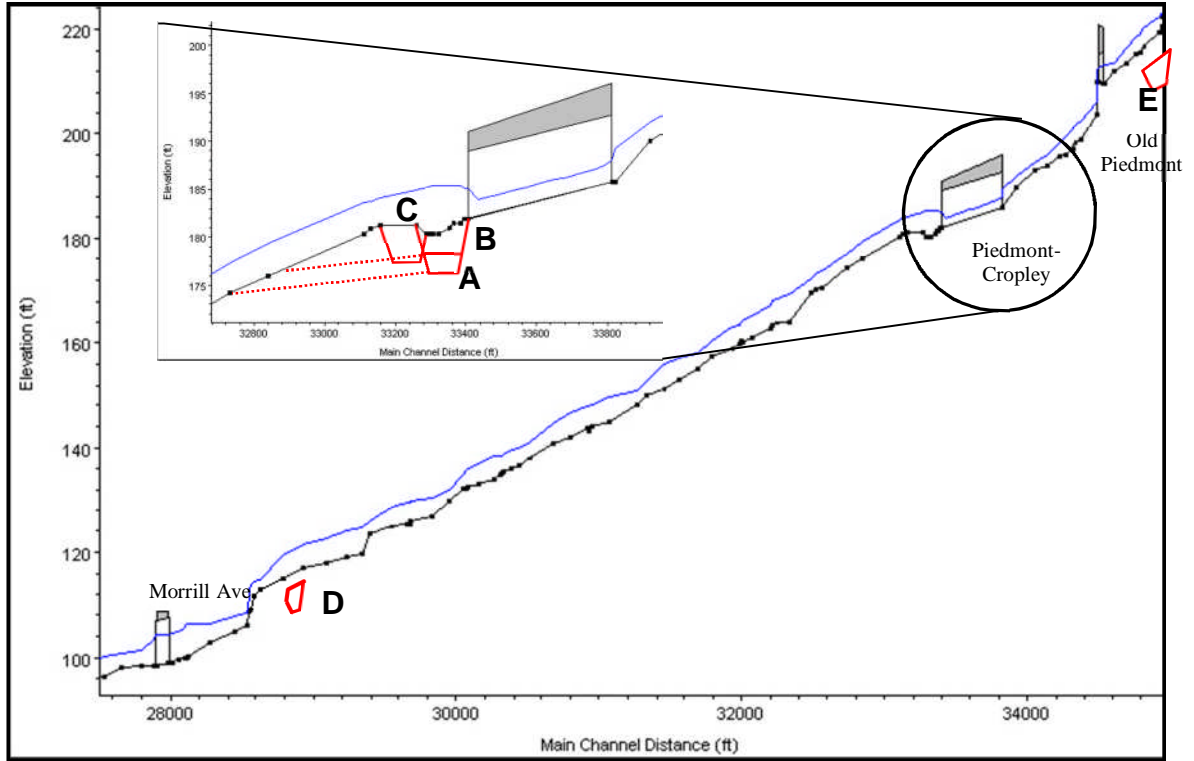
Figure 3-14 Profile View of Alternative Sediment Basin Configurations
