## **Stream and Wetlands System Protection Policy Field Trip**

### **San Francisco Bay Regional Water Quality Control Board**

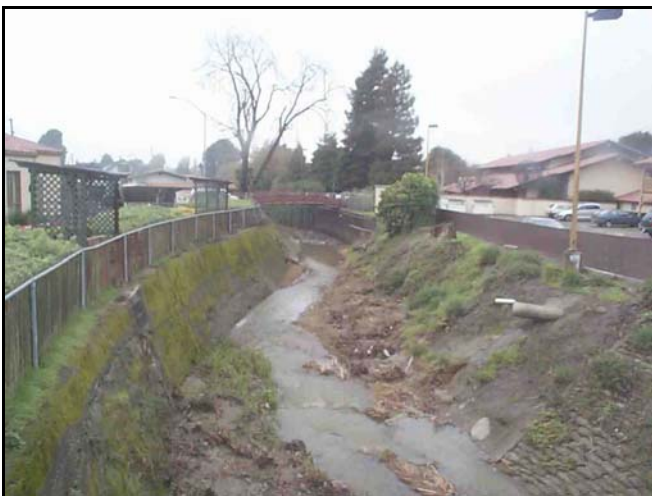
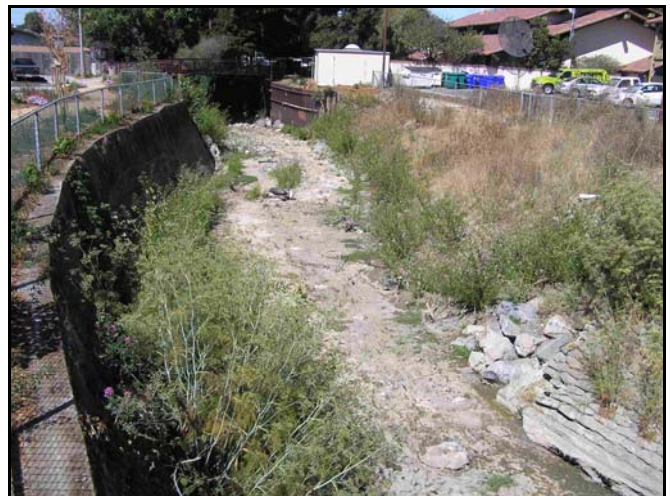
**Wildcat Creek at Church Lane looking downstream before and after restoration**

- The right bank had failing slabs of poured concrete and vertical corrugated sheet metal walls
- High flows were threatening to undermine a vertical concrete retaining wall on left bank
- Eyesore, due to the failing walls, the debris in the channel, and the dominance of exotic vegetation

- Designed and built a dynamic equilibrium channel (bankfull channel), complete with a bankfull bench to restore the appropriate width-to-depth ratio and stream profile to provide efficient sediment transport

- Failing concrete weir removed and replaced with a hydrologically and ecologically superior cross vane rock structure enhancing fish passage and improving stream stability

- Restored natural vegetation, and added in-stream siltation baffles causing slower flows reducing streambank erosion
- Removed armoring (concrete) from left and right banks and performed various soil bioengineering techniques (willow brush layering, willow pole, willow brush mattresses, erosion control blanket) to stabilize banks

- Built a low bank terrace along the base of the existing concrete wall on the left bank in an effort to direct the thalweg away from wall and to induce some deposition

- Retrofitted banks underneath 3 existing stormwater outfalls along the right bank with willow fascines, riparian plants, and small rock aprons
- Mural installed on bridge highlighting the historic, cultural and ecological value of the creek and surrounding community

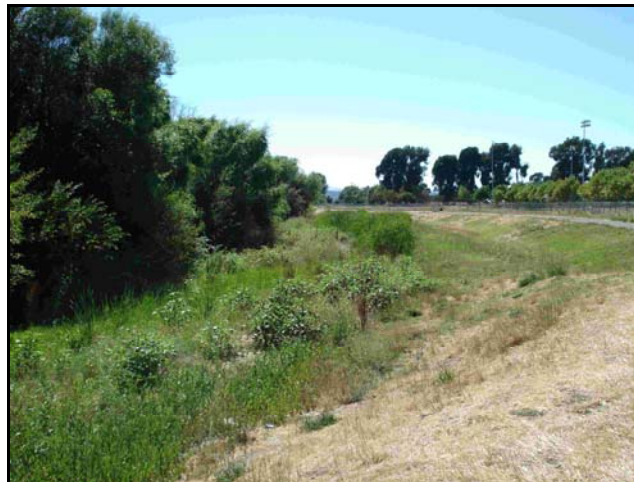
Wildcat Creek multi-objective floodplain project

The Wildcat Creek Restoration project is nationally known because it represents a pioneering attempt to substitute a conventional channelization flood control project with a project based on natural river science (geomorphic) principles. The project features an active, meandering channel, riparian forest and floodplain and has been the model for more environmentally sensitive flood control projects. The project has been monitored and modified over a period of sixteen years under the direction of a watershed council composed of all levels of government, elected representatives, non-profit groups, property owners, educators and general citizenry. The project thus serves as a case study in adaptive management from both a scientific and institutional perspective.
