319 Success Story

Preventing Pollution from Livestock in Coastal Watersheds of Santa Cruz, San Benito and South Santa Clara Counties

December 2007

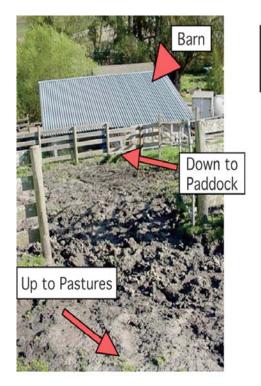
MUD MADNESS

BEFORE

The horses had to slide down this muddy slope to get from the pastures above down to the barn every night for feeding. This mud was so thick it pulled your boots right off your feet. This was dangerous for the horses and was nearly impossible to clean up the manure.

Because the barn and paddock were located at the base of the hill, all of the water that fell on the slope would flow down and collect there. This meant that as you got closer to the barn the muddier it became.

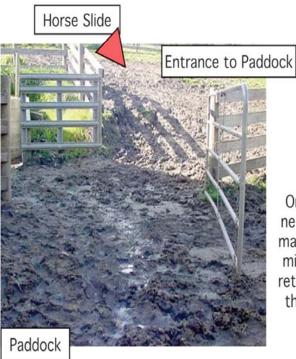
Upper entrance from the

Once it became muddy, it was nearly impossible to pick up the manure. As the manure became mixed in with the mud the area retained even more water. Thus the mud became even deeper.

BEFORE

The Participants have sacrificed a significant portion of their property in order to improve it. By taking this steeper slope permanently off-line and seeding it, the water that was sheeting down the bare muddy hill will now be partially absorbed by the grass and the rest will be captured in a French Drain buried along the new

back wall of the paddock.

A new entrance to the paddock was built that takes a much more gradual approach to the barn.

Once the wall was built and the drains were installed the paddock was ready to be regraded and resurfaced. The wall, drains and vegetation will manage the runoff so that the paddocks will stay dry. To add one more layer of protection, the owners erected a roof over their paddock and installed gutters which empty into the French Drain.

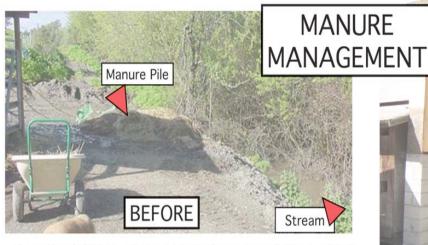
The original manure pile was located just outside the paddock beside the stream. This area has been drastically changed. Where the old manure pile was approximately located, a sediment basin has been constructed. This area is a small depression that detains the outlet from the drains and allows the sediments to filter out before the clean water is released near the stream.

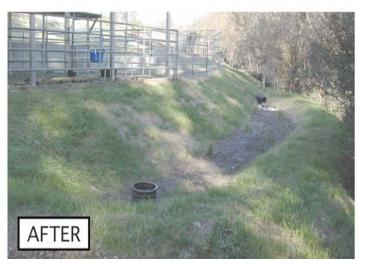
THE NEW MANURE MANAGEMENT PLAN:

AFTER

- 1. Scoop all manure from paddock and barn This was once considered impossible in the winter because of the deep mud and relentless deluge of water. With the installation of a roof over the paddock, a French Drain behind the wall and a vegetated strip above the paddock this is now a very real possibility.
- 2. Contain the manure pile in a bunker The "Manure Castle" has a concrete floor, a roof and a roll down door. This design was chosen to keep all water from mixing with the manure. Rain cannot fall on top of it, water cannot seep in the sides and pathogens and nutrients cannot leach out the bottom.
