January 30, 2005

Subject: **Comments on the 2006 303(d) List**

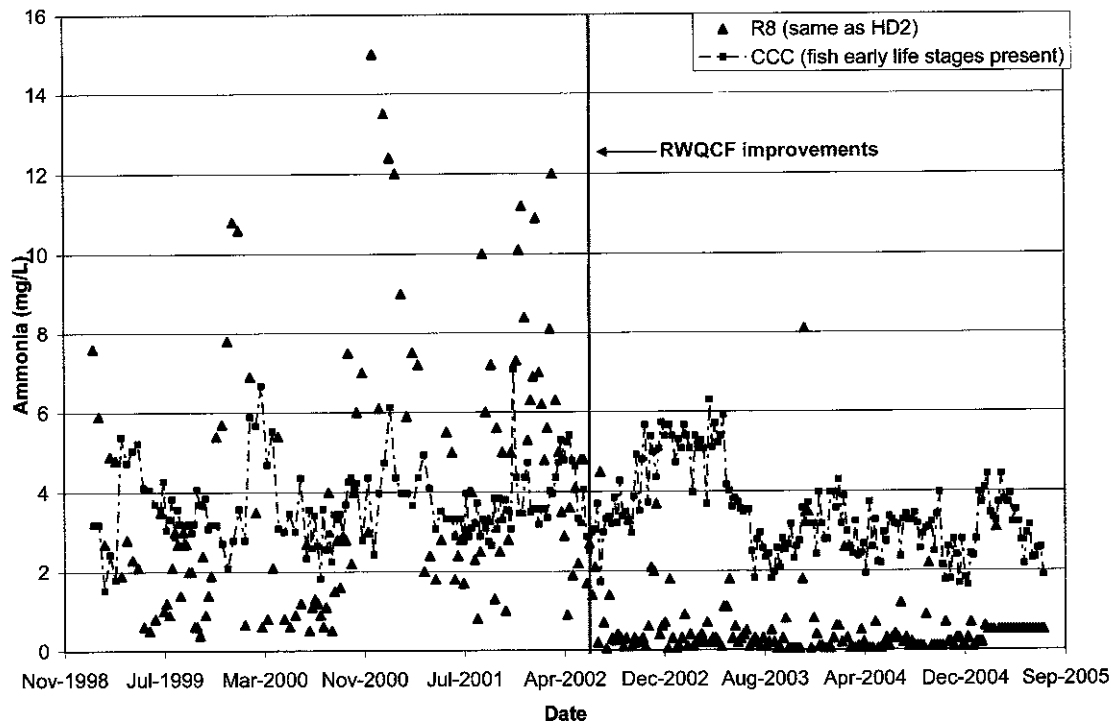
Figure B2. City of Turlock Ammonia Data for Harding Drain at Carpenter Road (HD2)

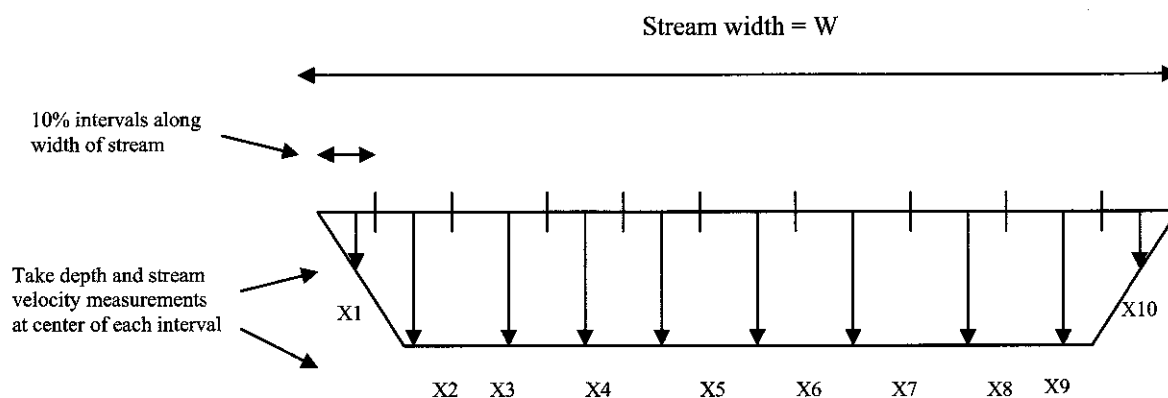
CROSS-SECTIONAL FLOW MEASUREMENTS

X1 (measured at $W/20$): Depth = _____ Velocity = _____
