**FINAL REPORT:**

**DISCHARGES INTO STATE  
WATER QUALITY  
PROTECTION AREAS**

**Southern California Coastal Water Research Project**

**Final Report to the  
State Water Resources Control Board  
Contract 01-187-250**

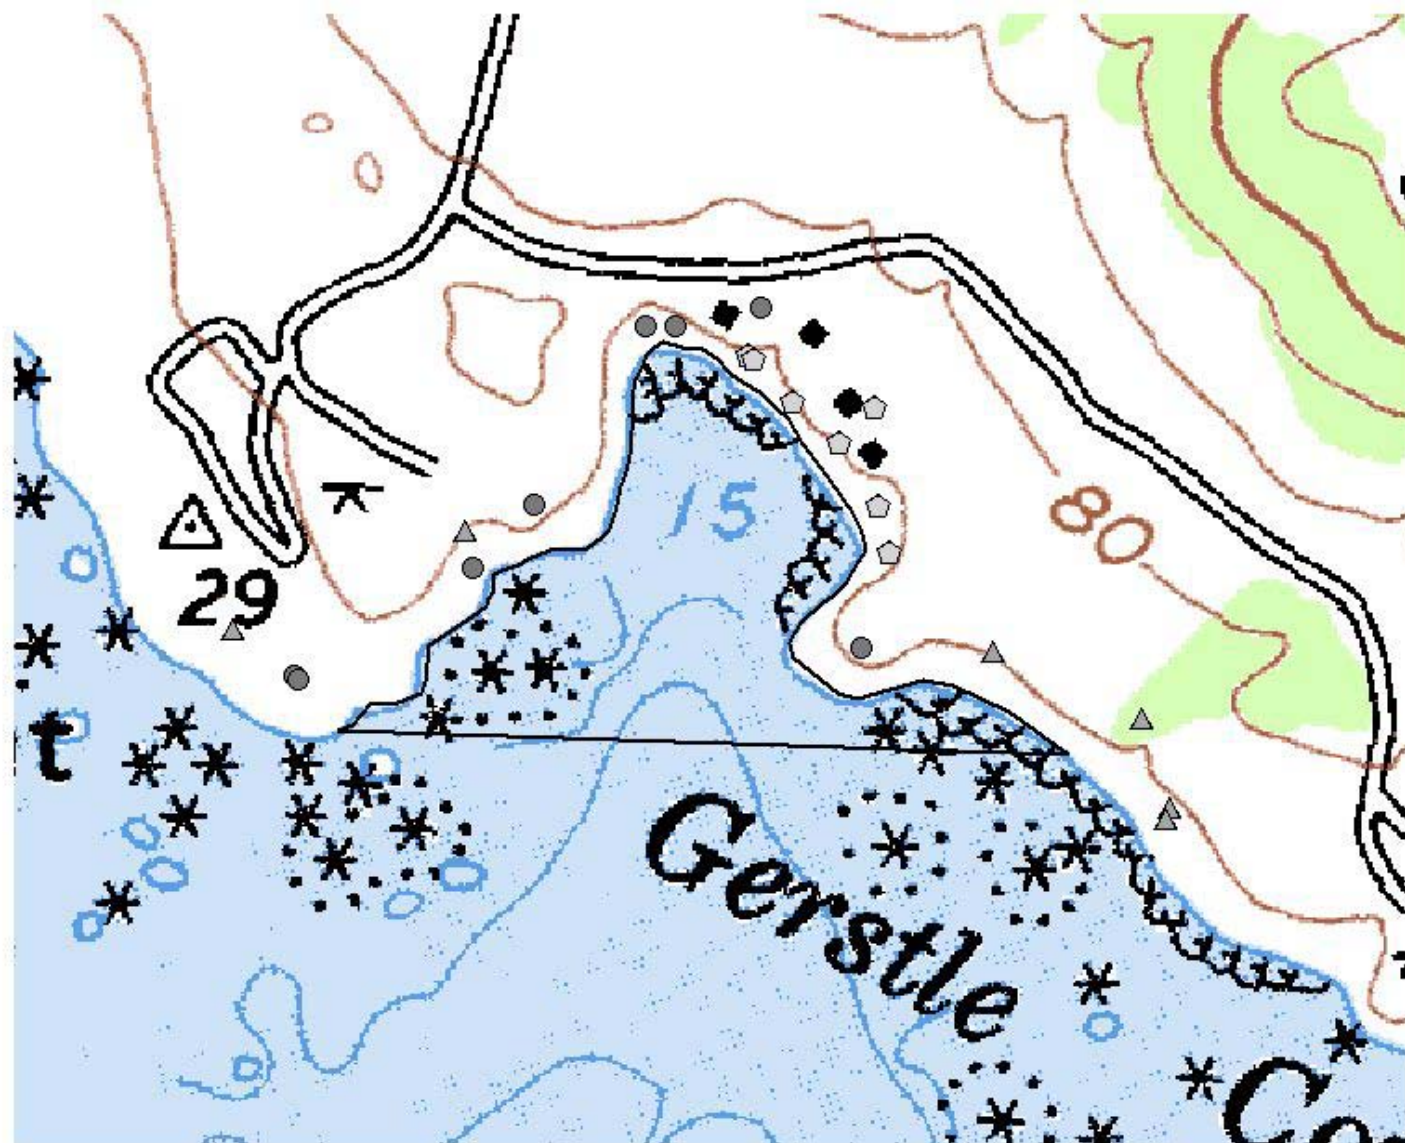
# 03-Gerstle Cove

**Gerstle Cove.** This very small SWQPA, 0.3 miles in length, lies within Salt Point State Park. A total of 21 drainages were observed, 8 discharges, 6 outlets, and 7 uncontaminated springs/seeps. A large number of these drainages were from a highly used recreation area. The State Park includes a public restroom and fish cleaning station (both apparently served by a septic tank), campground, multiple parking lots, and visitor's center above the SWQPA. The cove hosts many divers and fishermen.

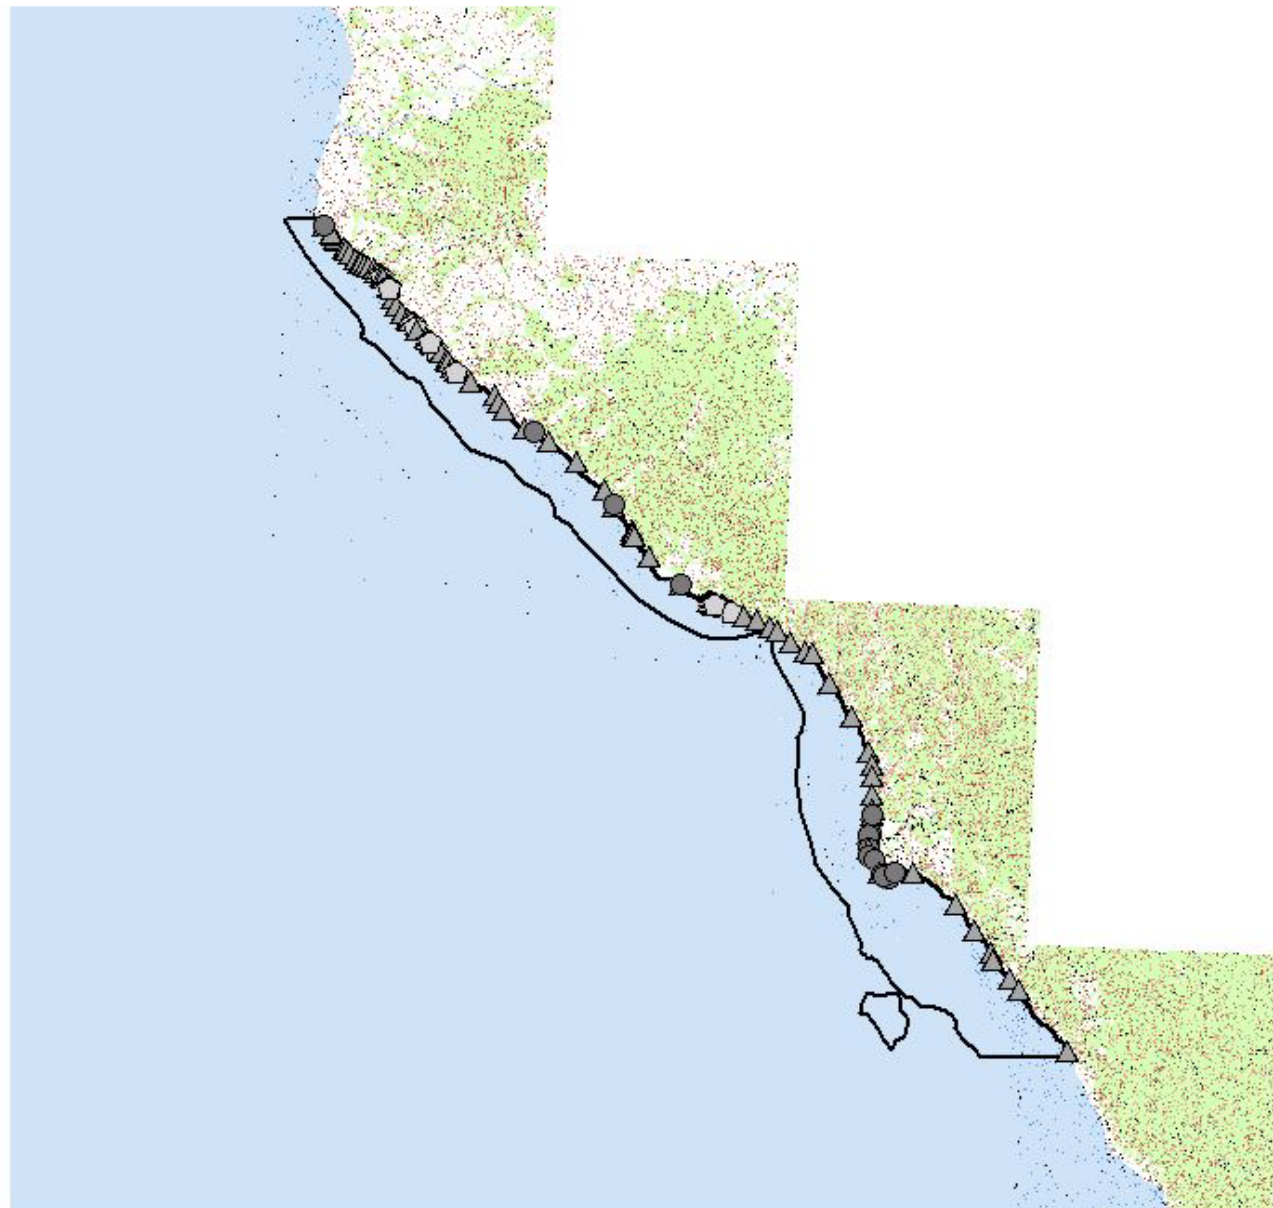
# 07-Kings Range National Conservation Area

**Kings Range National Conservation Area.** This is a large SWQPA, which covers approximately 28.4 miles and had a total of 173 drainages. Most of these drainages were from stream outlets (79) and uncontaminated springs/seeps (76), fewer were from man-made discharges (17), and there was one intake line. Most discharges in the wilderness area include perennial and ephemeral streams and natural groundwater seeps. There was virtually no development along this section of coastline except for a few sporadic cabins with outhouse facilities and some well-established campsites at the larger river mouths, Big Flat Creek being one of the largest. Most urban discharges were found toward the southern end and associated with the town of Shelter Cove. Shelter Cove has approximately 2 miles of developed coastline with houses and parking lots along the shore. The discharges in this section include runoff from a parking lot, a fish cleaning station, a boat launch, and a discharge from sewage treatment facility. It is anticipated that municipal storm water from Shelter Cove will be regulated under the new Phase II

MS4 General Permit. The sewage treatment facility is allowed under an exception issued by the State Water Board. The extremely rugged terrain of the most southerly 0.75 miles prevented surveying by foot, and since there were no urban discharge sources expected along this southern-most section, natural outlets were added during post-processing using USGS quads. The Mattole River, which was not included as an outlet for this SWQPA because it is outside this SWQPA boundary to the north, marks the beginning of a 24-mile stretch known as the Lost Coast Wilderness Area. This river is impaired due to sedimentation/siltation from nonpoint sources (SWRCB 2003 303d List, Resolution 2003-0009) and may impact this SWQPA.

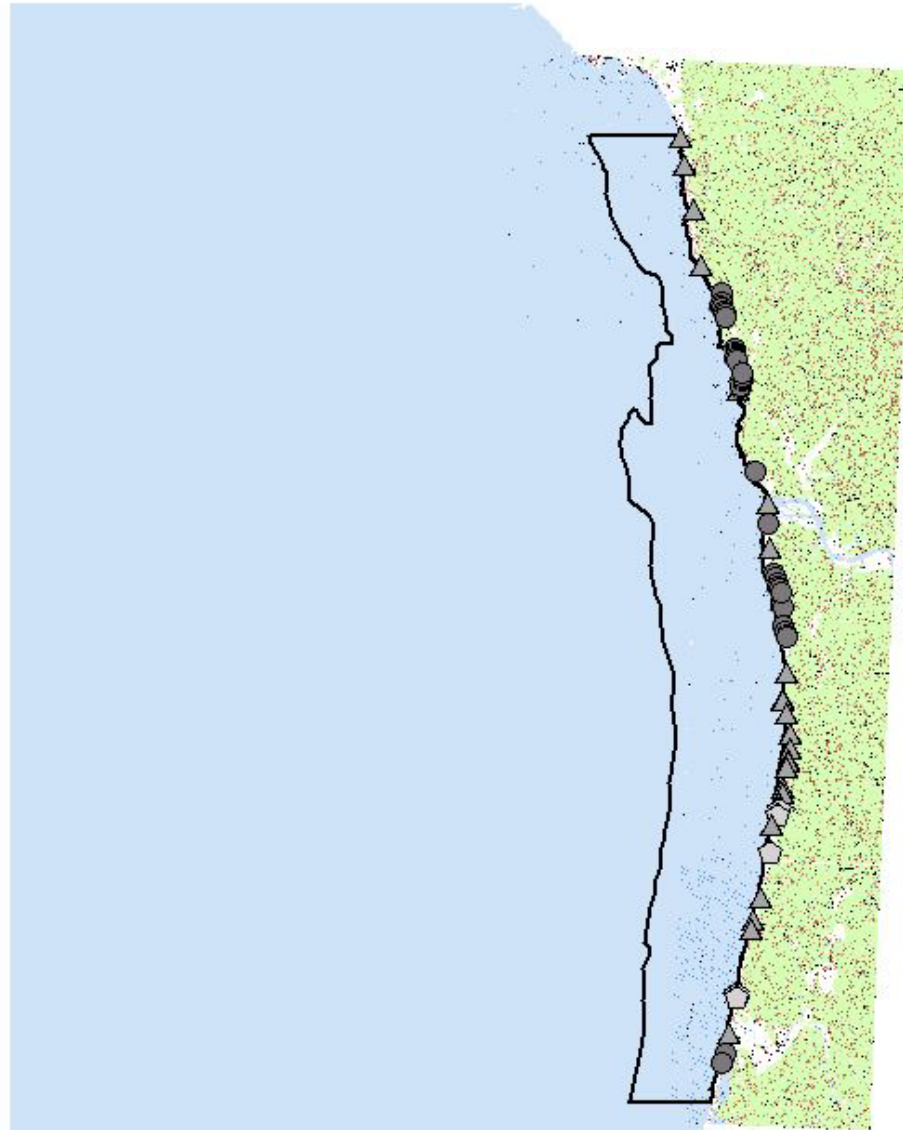
# 08-Redwoods National Park

**Redwoods National Park.** This large SWQPA, extending over approximately 34 miles of rugged coastline, had a total of 73 drainages, which included 41 discharges, 27 stream outlets and 5 springs/seeps (uncontaminated). This SWQPA includes one large river, the Klamath River, and several other perennial streams, including Cushing Creek to the north and Redwood Creek to the south. The Klamath River does not meet water quality standards for nutrients and organic enrichment/low dissolved oxygen from both point source (including storm water) and nonpoint sources, and temperature from non-point sources. Redwood Creek is impaired due to sedimentation/siltation from nonpoint sources (SWRCB 2003 303d List, Resolution 2003-0009). There were many discharges surveyed from Highway 1 (regulated under the Caltrans storm water NPDES permit), where this road parallels the cliffs along much of the coastline. The ex-military base north of Requa, currently operated by the National Park Service, appeared to have a treated wastewater discharge. This point source is not in compliance with the Ocean Plan

prohibition and needs an exception from the State Water Resources Control Board. However, most drainage into the coastal waters is runoff from rural and wilderness watersheds. Rugged cliffs and sparse primitive campgrounds dominate this region and much of the coastline is limited to foot traffic.

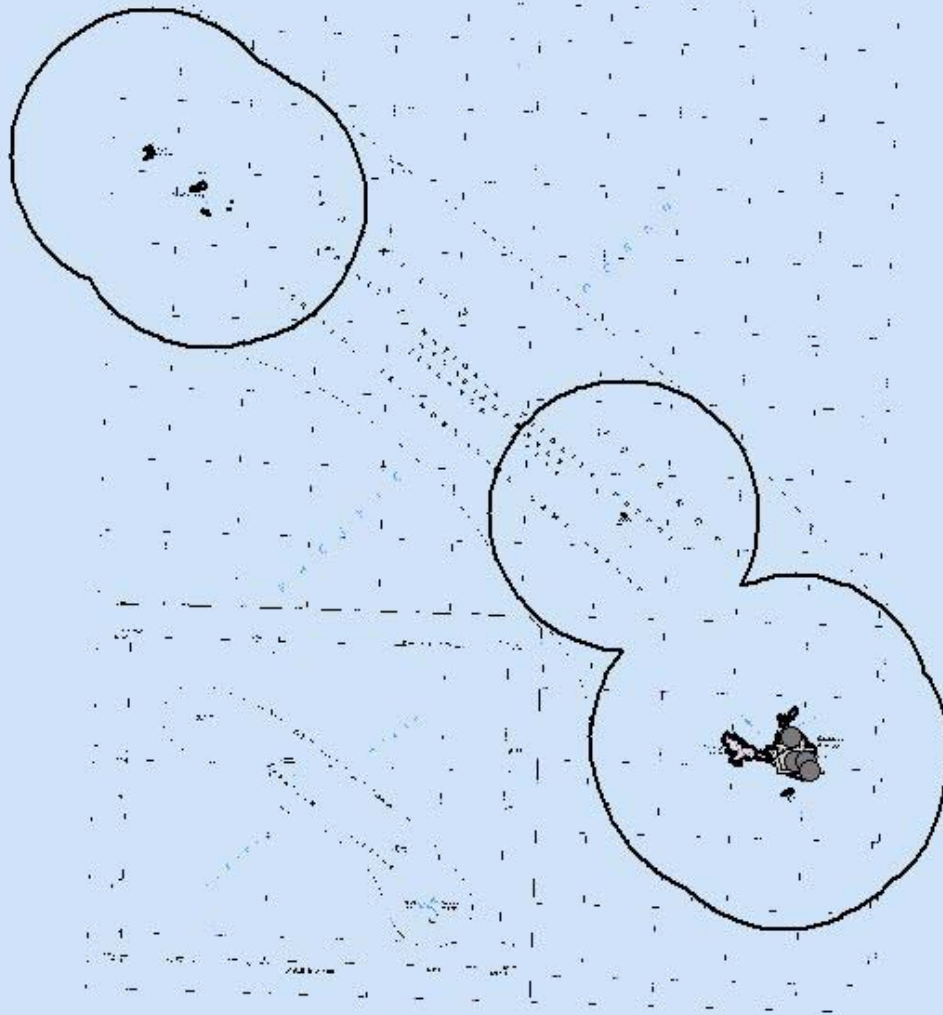
# 10-Farallon Islands

**Farallon Islands.** The Farallon Islands are a small group of rock pinnacles located about 30 miles offshore from San Francisco. This group consists of five small islands, the largest of which is Southeast Farallon. Total coastline length for the combined islands is 4.8 miles. Only Southeast Farallon Island is inhabited and that is by scientific personnel at the US Fish and Wildlife Service field station. A permanent lighthouse, maintained by the US Coast Guard, graces the island's peak. Two houses are on the island along with several small buildings for support facilities. The islands are unique biological habitats for nesting seabirds and wintering marine mammals. Access to the public is restricted. A total of 8 drainages were found, 6 discharges and 2 springs/seeps (uncontaminated). At SE Farallon Island a composting toilet does involve land disposal with potential for runoff during storms. Also at SE Farallon Island another restroom or toilet is associated within a point source discharge of human waste and grey water directly into Sewage Gulch and the SWQPA. This point source discharge is in violation of the Ocean Plan, since it does not have a permit from the Regional Board or an exception from the State Board. While not a part of this survey of discharges along the island coastline, it is worth noting that various wastes have historically been disposed of in the waters in the general vicinity of the Farallon Islands; among these wastes are radioactive wastes discharged between 1946 and 1966, from four to fourteen miles away from the Islands (California Marine Waters, Areas of Special Biological Significance Reconnaissance Report, Farallon Island, May 1979, SWRCB Monitoring Report 79-13).

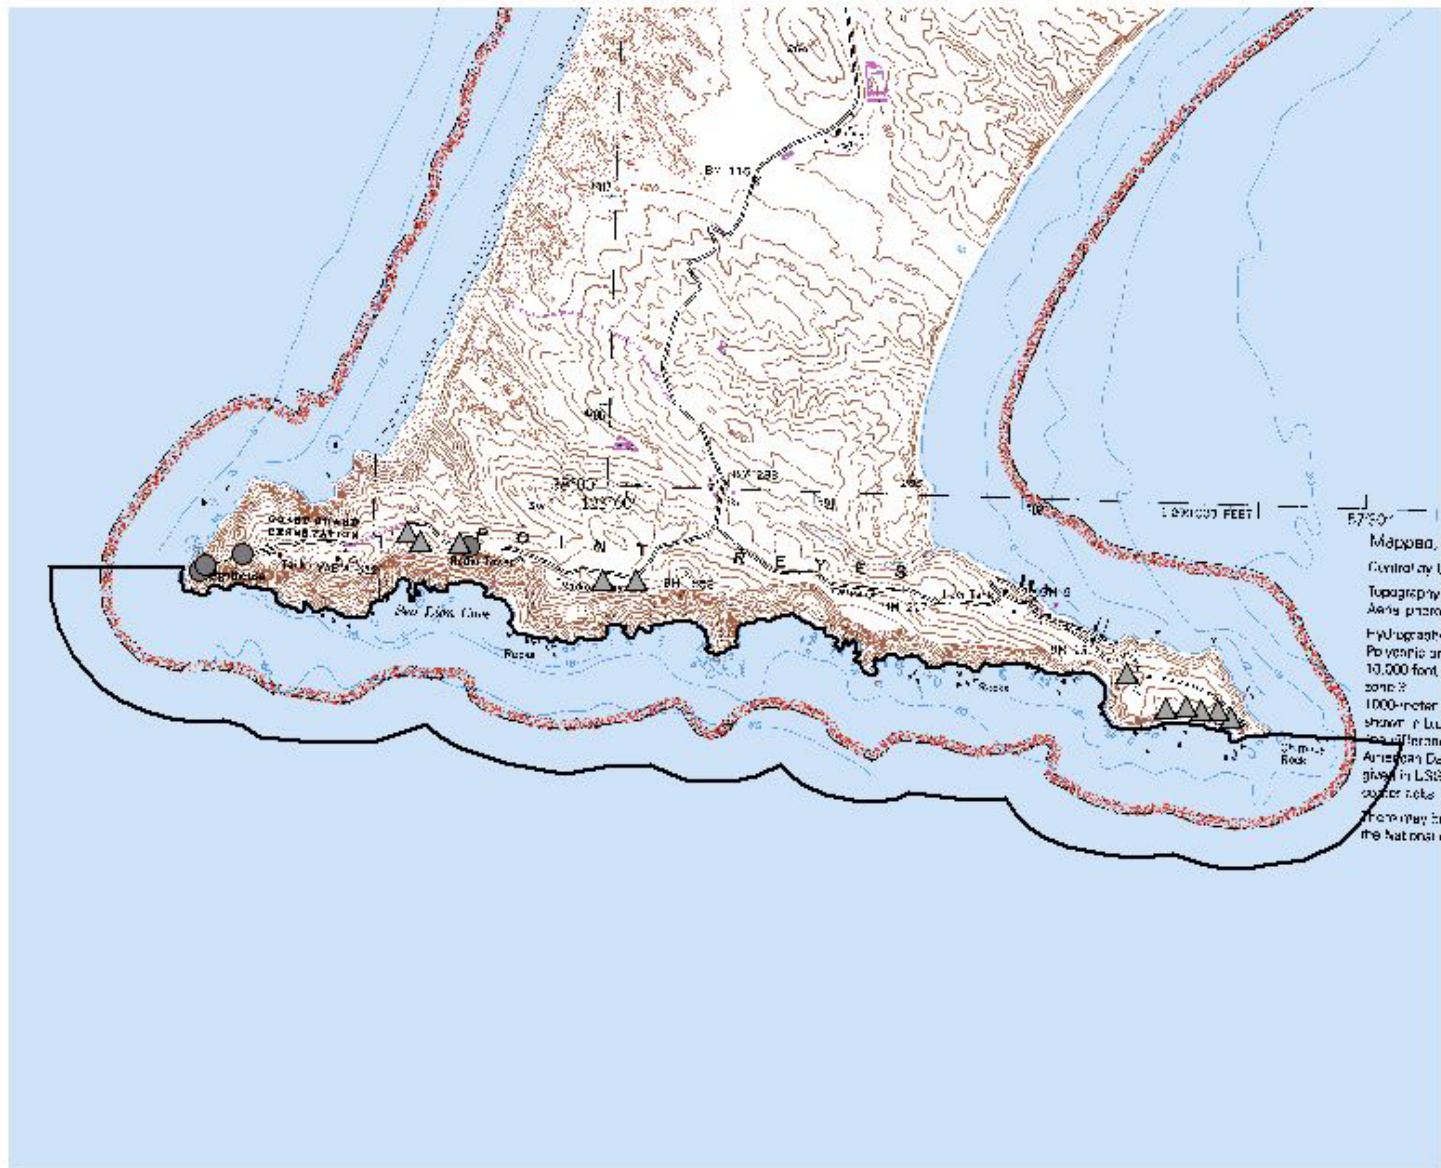
# 12-Point Reyes Headland Reserve and Extension

**Point Reyes Headland Reserve and Extension.** This SWQPA is 3.5 miles in length and had 20 outlets. Topography naturally concentrates the majority of runoff to either end. Thirteen earthen channels (gullies) were found, but the sheer walls result in sheet flow over most of the headland's cliffs. The 7 distinct discharges were at the lighthouse and visitor center. A road follows the entire SWQPA, but the slope of the headland is such that any road run-off flows away from the SWQPA. Public access is limited to walkways at the eastern end and the western end, where the Lighthouse is located. Inland from the lighthouse and visitor's center are 4 small apartments, which are serviced by an enclosed septic system.

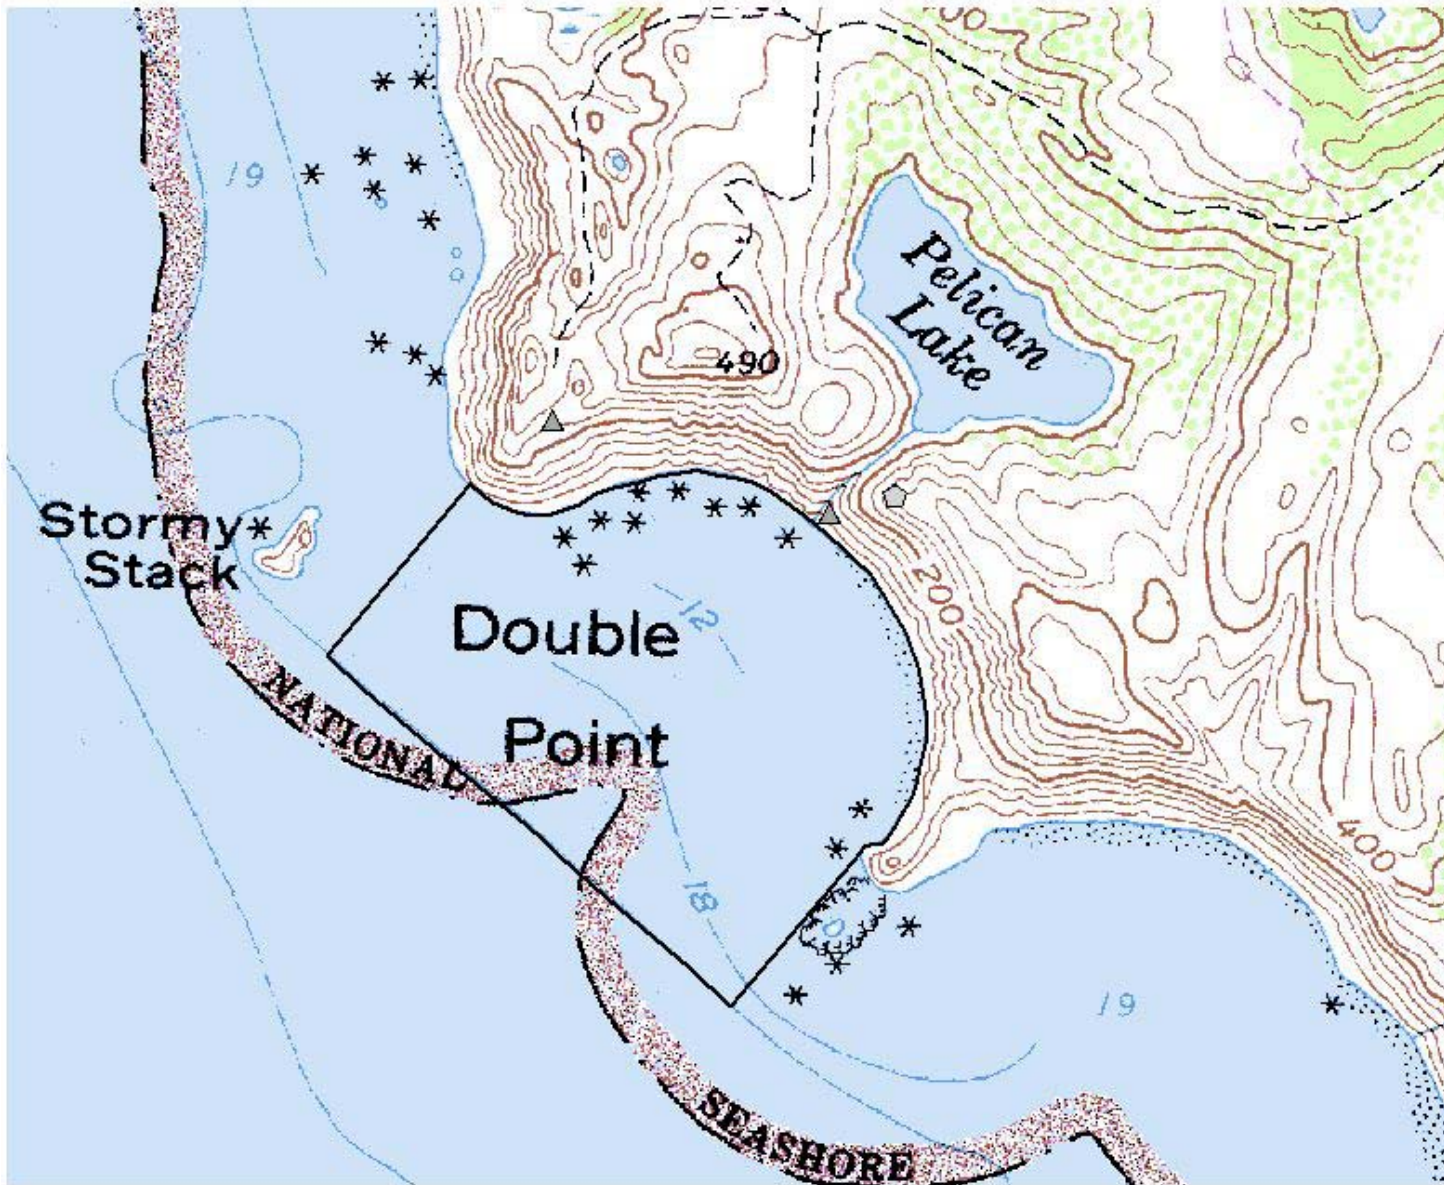
# 13-Double Point

**Double Point.** This small SWQPA of 0.7 miles lies in a rural part of the Point Reyes National Seashore. The area surrounding Double Point is accessible only to hikers and has primitive trail camps to the north and east of this SWQPA. Pelican Lake, the main drainage into this area, appears to have little or no access to hikers, highly limiting any anthropogenic influences to this SWQPA. A very steep slope walls off the cove and inhibits access to the beach below. The three drainages (2 outlets and 1 uncontaminated spring/seep) within this SWQPA are supplied primarily by rural, undeveloped watershed runoff. The entire Double Point area is a large natural landslide.

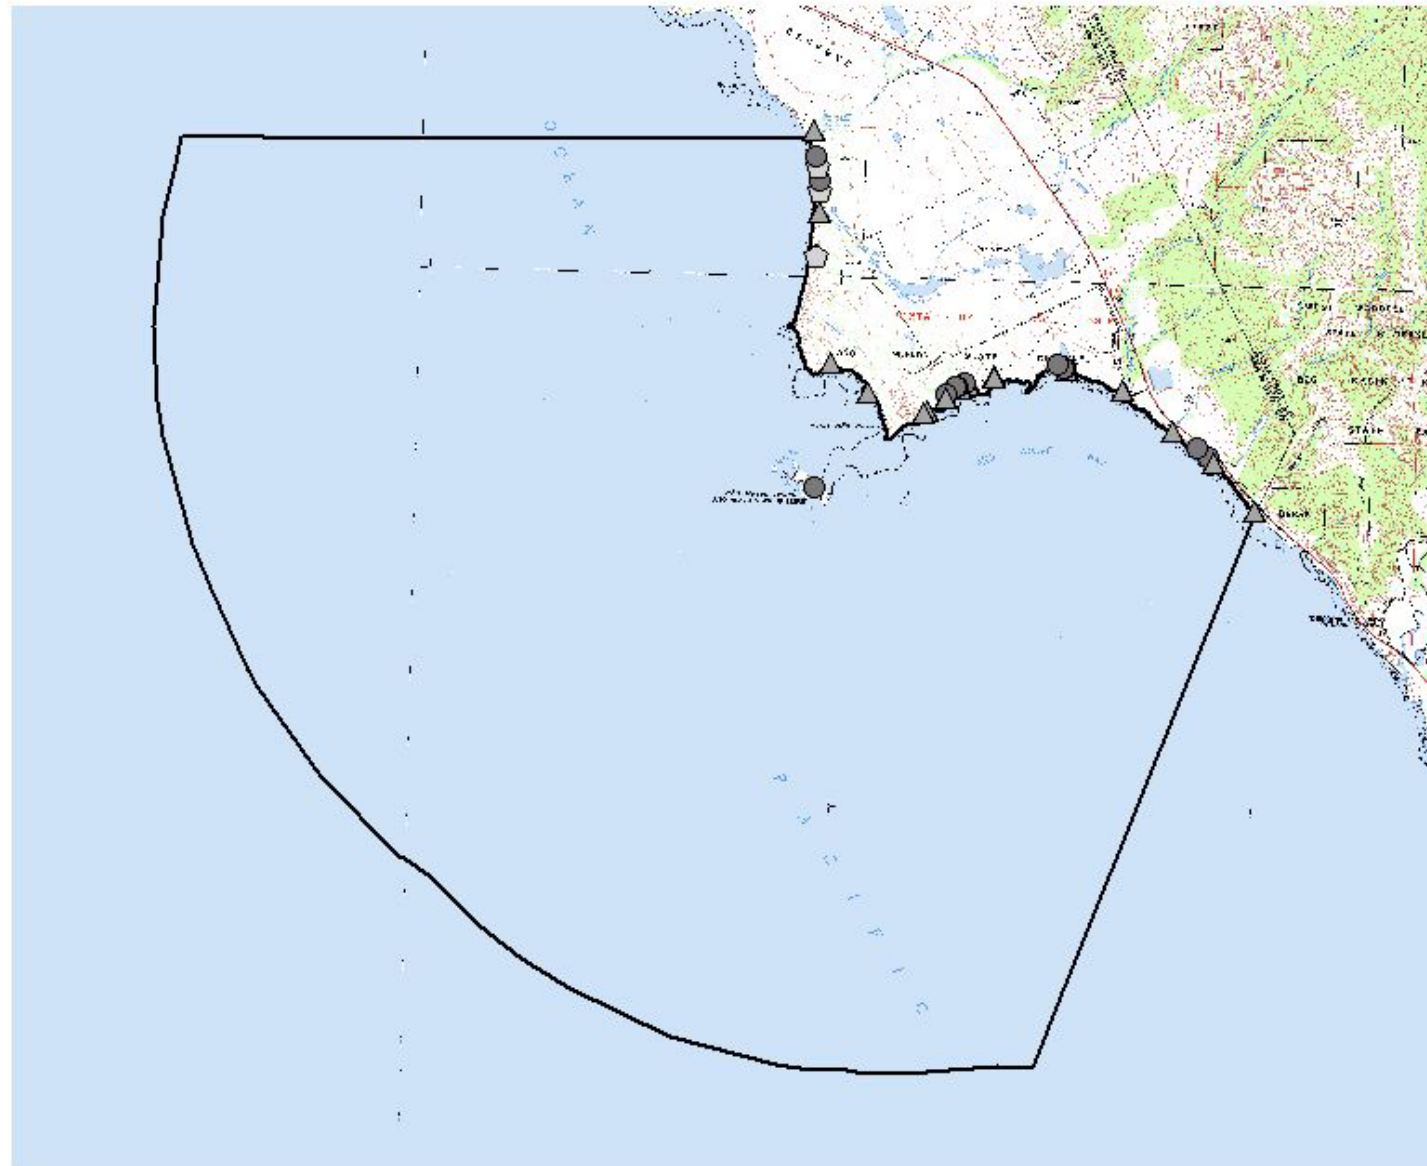
# 15-Ano Nuevo Point and Island

**Ano Nuevo Point and Island.** This SWQPA is located to the north of Santa Cruz and south of Half Moon Bay. Its coastline extends 8.0 miles and provides unique habitat for wintering sea lions and elephant seals. Access to beaches is limited and most visitors to the park are confined to marked footpaths. A total of 34 drainages were observed, the most significant being from the rural watersheds of Ano Nuevo Creek to the south and Cascade Creek to the north. Fourteen of the drainages were discharges, 17 were outlets, and 3 were uncontaminated springs/seeps. The majority of drainages were from runoff over the coastal cliffs. Some of the direct nonpoint source discharges into the SWQPA are from agricultural fields. Some farming is conducted within the park boundaries, so agricultural discharges may influence the streams as well. The primary crops grown in this area are artichokes, brussel sprouts, and flowers.

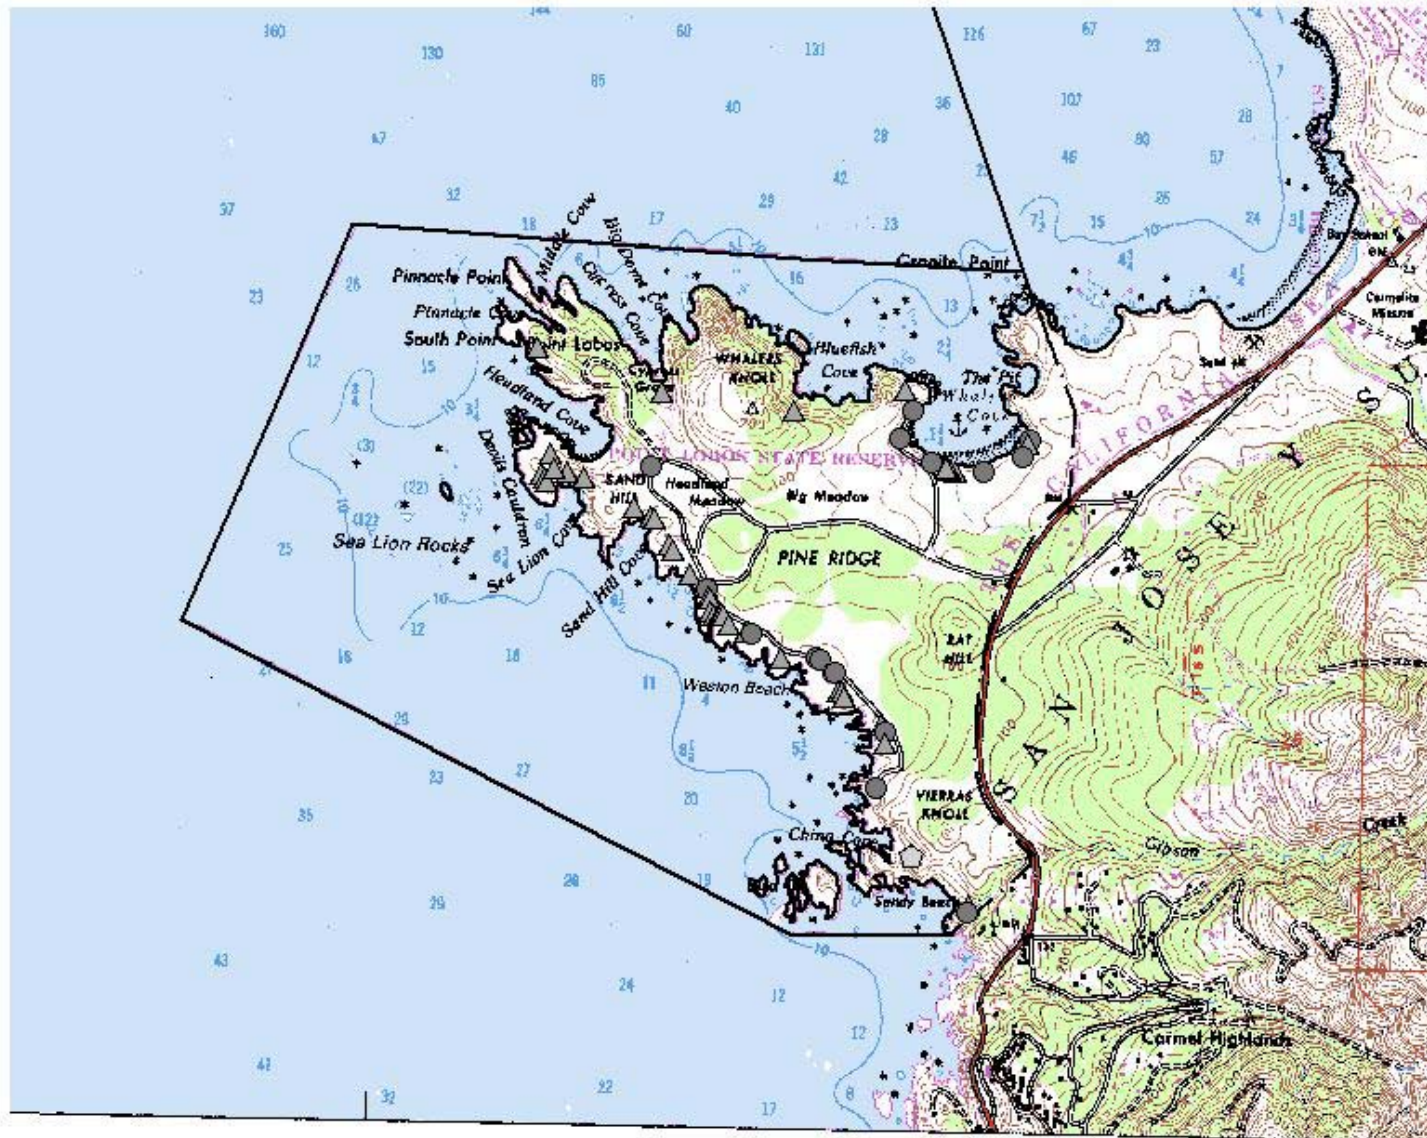
# 16-Point Lobos Ecological Reserve

**Point Lobos Ecological Reserve.** The Point Lobos Reserve protects 4.5 miles of rocky coastline to the south of the cities of Monterey and Carmel. This SWQPA is regularly visited by a large number of day hikers, and several small campgrounds and a small boat launch ramp are located within the Reserve. Fifty-six drainages were identified in this area, the majority being outlets (39) draining small watersheds and walking paths along the coastline, and the remainder being discharges (16) and a potential non-point source spring/seep (1). Land use to the north and south of this SWQPA is primarily residential. To the south the residences and hotels are serviced by two small wastewater treatment plants that discharge within a quarter mile of the SWQPA. Since these discharges are outside of 100 meters they were not included in the survey data; however, historically there has been some concern that discharges from these outfalls may enter the SWQPA waters. The Regional Board is currently working with these dischargers and the Carmel Wastewater District to divert their wastewater flows to the Carmel plant and to abandon the current outfalls employed by these facilities.

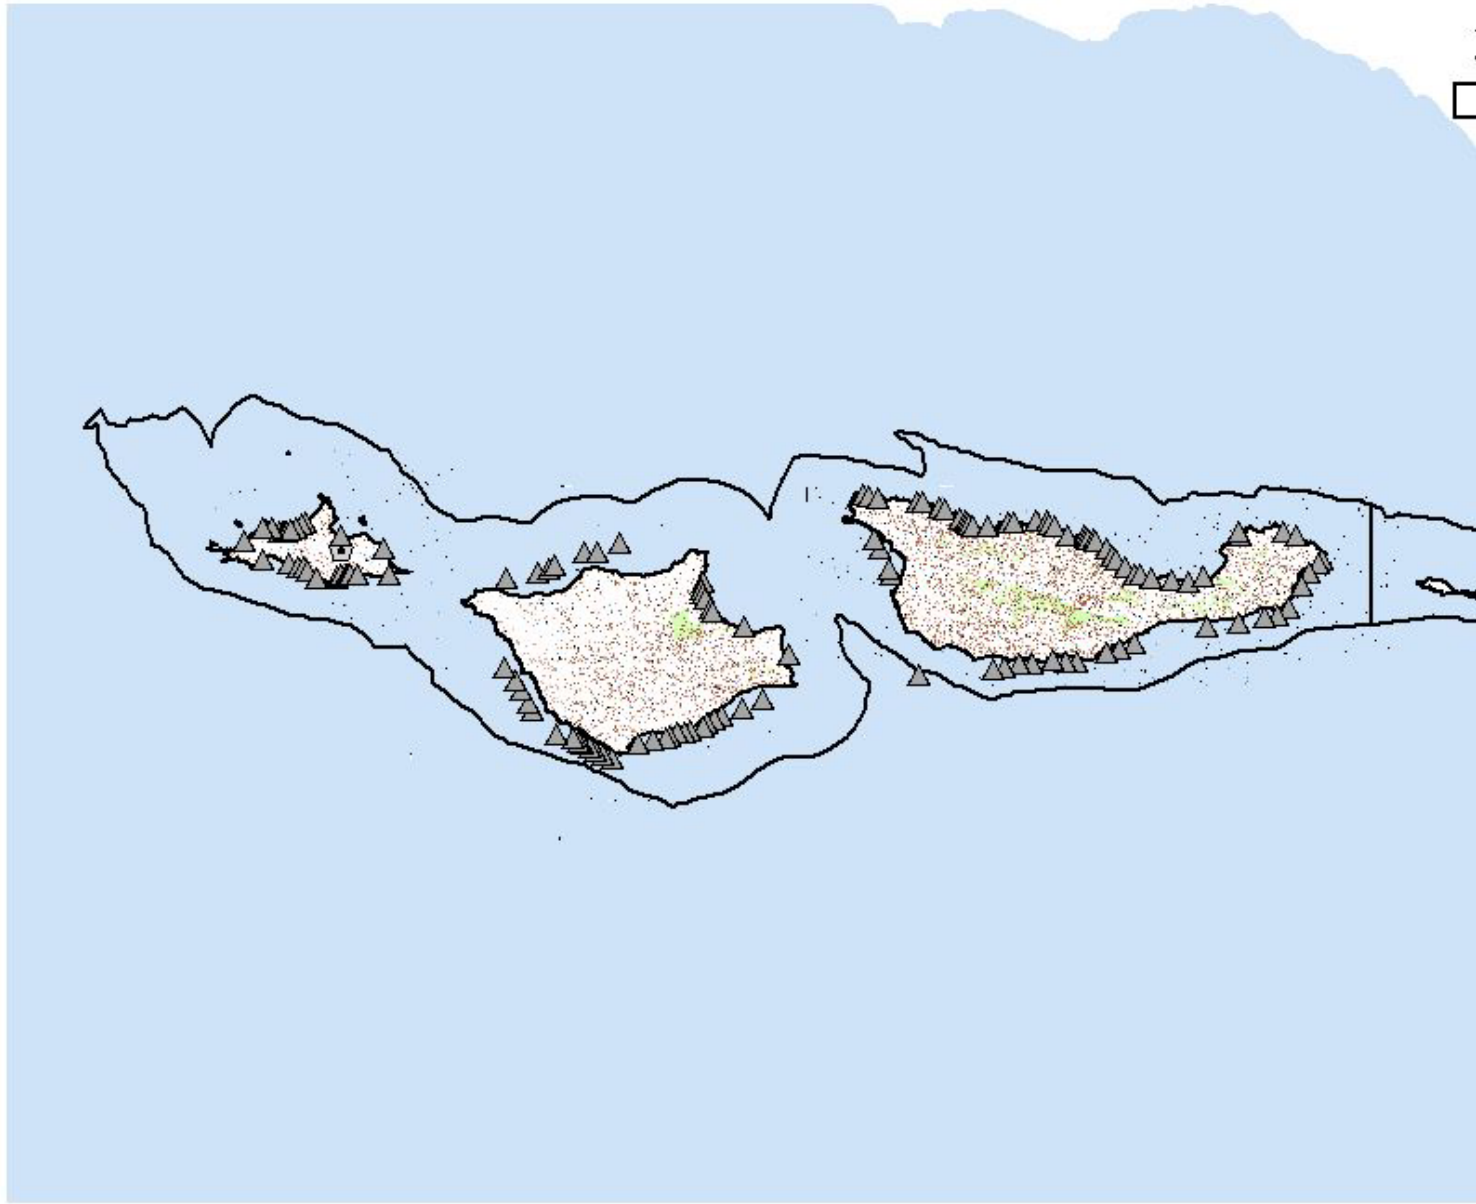
# 17-San Miguel, Santa Rosa, and Santa Cruz Islands

**San Miguel, Santa Rosa, and Santa Cruz Islands.** San Miguel Island is approximately 26 miles from the coast and is managed by the National Park Service. This island is unprotected from and directly exposed to all storms and turbulence that comes its way. There are no roads and a few structures that are well beyond 100 meters of the coast. These structures as well as a leach field located near the ranger station are not likely to contribute to discharges into the SWQPA. Although it is unlikely that the leach field could drain to the SWQPA, this area was listed as a potential source of discharge. This SWQPA was surveyed primarily from the Ranger Station and the 29 outlets were added during post-processing using USGS quads.

Santa Rosa Island is the second largest of the Channel Islands and has approximately 46 miles of shoreline. It is a diverse island of grass-covered rolling hills, steep canyons, creeks, rocky intertidal areas and sandy beaches. This SWQPA was surveyed by boat and 41 outlets (gullies or streams) were recorded. There are few potential anthropogenic sources upstream of these outlets, with the exception of road drainage and previous grazing impacts. It is known that the Central Coast Regional Board has issued a cleanup and abatement order to the National Park Service requiring them to develop a road management plan, since the roads on this island do contribute to erosion and downstream deposition of sediment. No point sources were seen from the boat on this island. Santa Rosa Island has few structures and hosts mainly campers and hikers.

Santa Cruz Island is the largest of the Channel Islands and has approximately 77 miles of shoreline. The coastline of this island is diverse, consisting of sheer cliffs and bluffs, beaches, and grasslands. The Nature Conservancy owns and manages the western 76% of the island; the eastern 24% is owned and managed by the National Park Service. Sheep ranching was historically practiced on this island and areas where vegetation was depleted are still visible. This SWQPA was sampled by boat and 65 outlets (gullies or streams) were recorded. There are few potential anthropogenic sources upstream of these outlets, with the exception of previous grazing impacts. No pipes (point sources) were seen from the boat at any point on this island. Santa Cruz Island has few structures and hosts mainly campers and hikers. The inland Central Valley, somewhat distant from the

island's coast, has a few structures which house visiting scientists doing research on island flora and fauna.

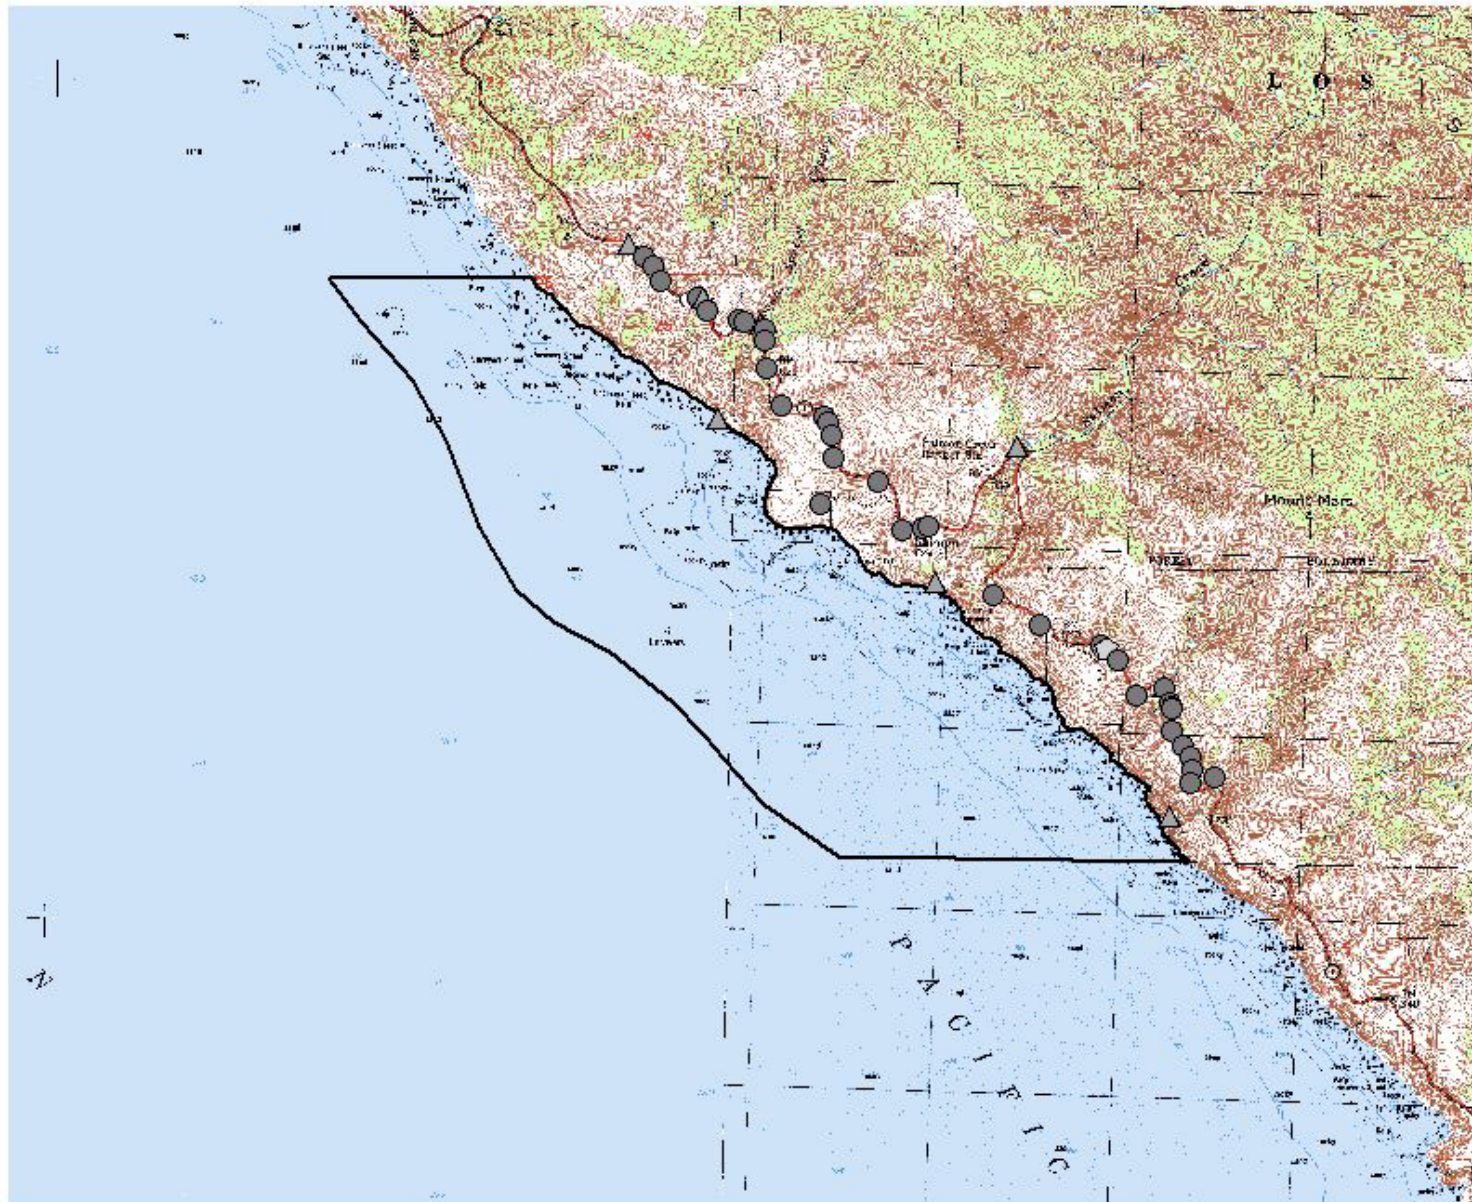
# 20-Ocean Area Surrounding the Mouth of Salmon Creek

**Ocean Area Surrounding the Mouth of Salmon Creek.** This SWQPA is located to the south of Monterey on the Big Sur coast and to the south of the Julia Pfeiffer Burns SWQPA. It is 3.2 miles in length and includes two significant perennial creeks, Soda Spring Creek and Salmon Creek, which drain large wilderness watersheds. Like the Pfeiffer SWQPA, cliffs along this stretch of coastline are rugged and steep, greatly limiting access to the waterline. A total of 44 drainages were present, consisting of 35 discharges, 8 outlets, and 1 uncontaminated spring/seep. Most drainage into the coastal waters is runoff from rural and wilderness watersheds; however, there are high numbers of road drainage discharges from Highway 1 (regulated under the Caltrans storm water NPDES permit) that parallel the coastline several hundred meters above the waterline. Several private homes are located within the SWQPA, however few discharges were observed and human impacts within most of this SWQPA appears limited.
