Total Maximum Daily Load Progress Report		Chorro Creek Nutrients TMDL	
Regional Water Board	Central Coast, Region 3	<b>STATUS</b>	<input checked="" type="checkbox"/> Conditions Improving
<u>Beneficial uses</u> affected:	COLD, WARM, MUN		<input type="checkbox"/> Data Inconclusive
Pollutant(s) addressed:	Dissolved Oxygen		<input type="checkbox"/> Improvement Needed
Implemented through:	Regulatory and non-regulatory Action		<input type="checkbox"/> TMDL Achieved/Waterbody Delisted
Approval date:	July 19, 2007

### TMDL Summary

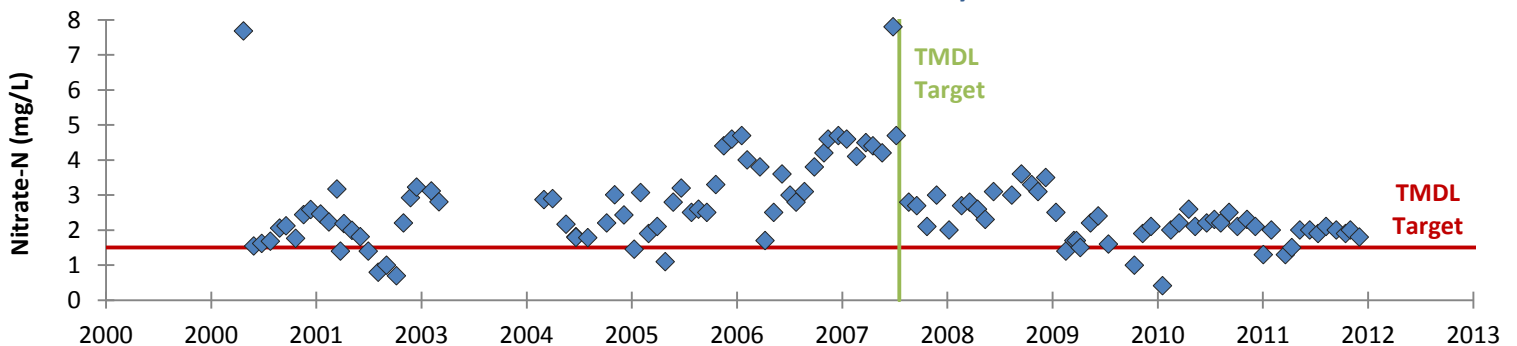
### Lower Chorro Creek Water Quality

- The CMC upgrade was completed in May 2007 resulting in significant loading reduction of nitrogen.
- Water quality data show the instream summer median for nitrate-N has declined from 4.2 mg/L in 2007 to 2.0 mg/L in 2011.
- If trends continue, the TMDL may be achieved by the proposed 2016 date.
- Wasteload allocations are not yet consistently met for sodium, total dissolved solids, and temperature.
- A shading restoration project was completed in lower Chorro Creek in 1997; stream shading is improving.
- There is insufficient data at this time to determine if the load allocation for shading or the numeric target for algae is being achieved.
