Cambria Enforcement Items

Administrative Civil Liability Complaint

Item # 10 Cease and Desist Order R3-2017-0016

Central Coast Regional Water Quality Control Board Meeting

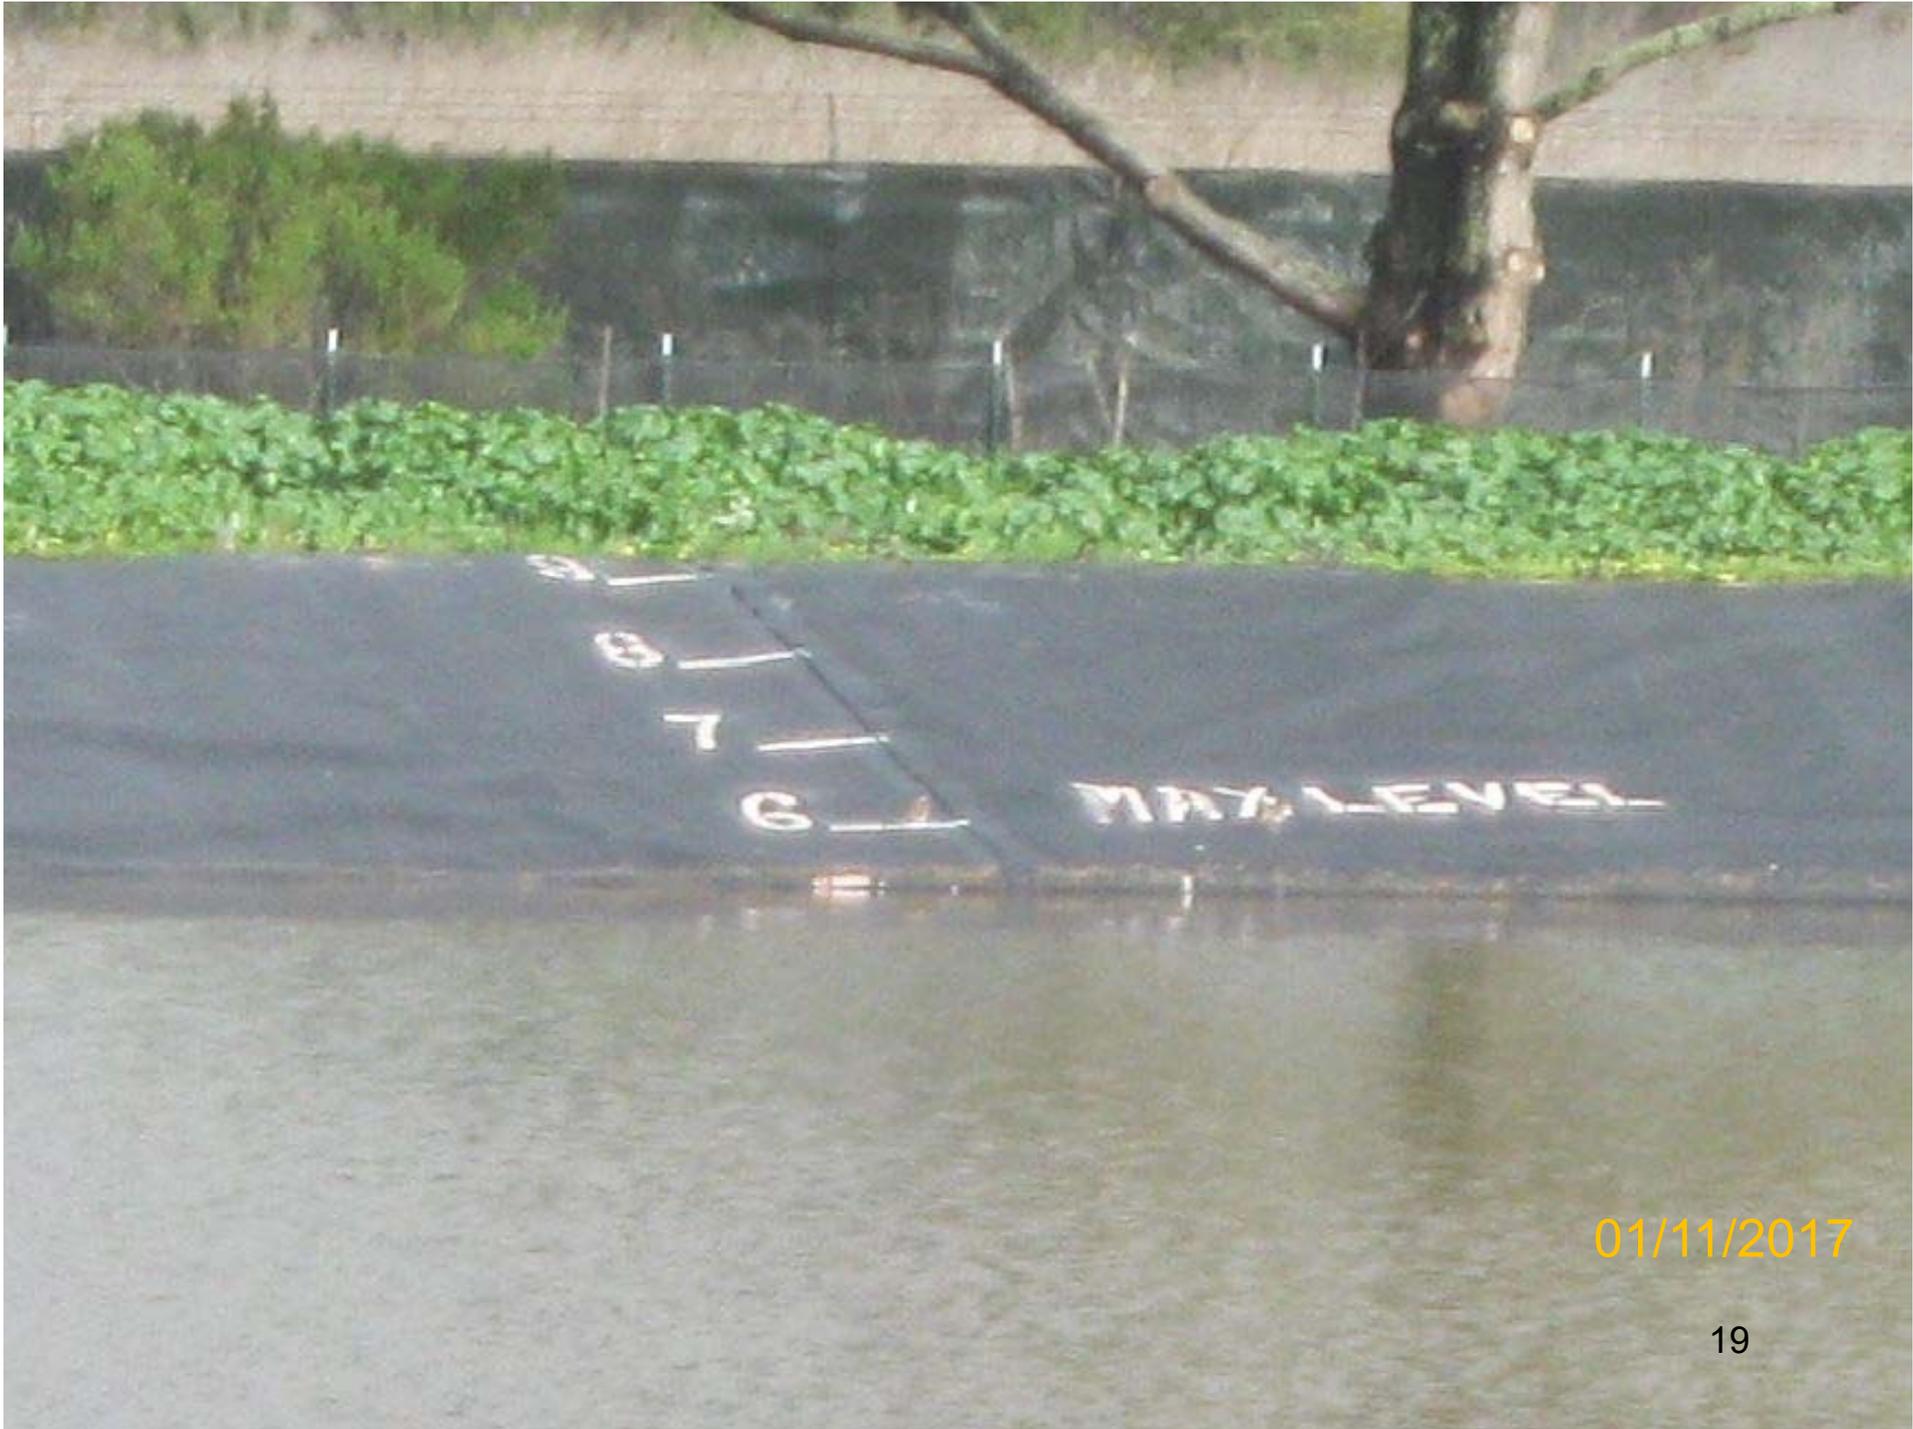
01/11/2017

- **Applies to Surface Impoundment Only**
- **Two Major Design Flaws Identified During January Storms**
- **Flooding Began on January 8, 2017**
 - **Flooding reported to Water Board on January 9, 2017**
 - **Flooding not reported by CCSD until January 11, 2017**

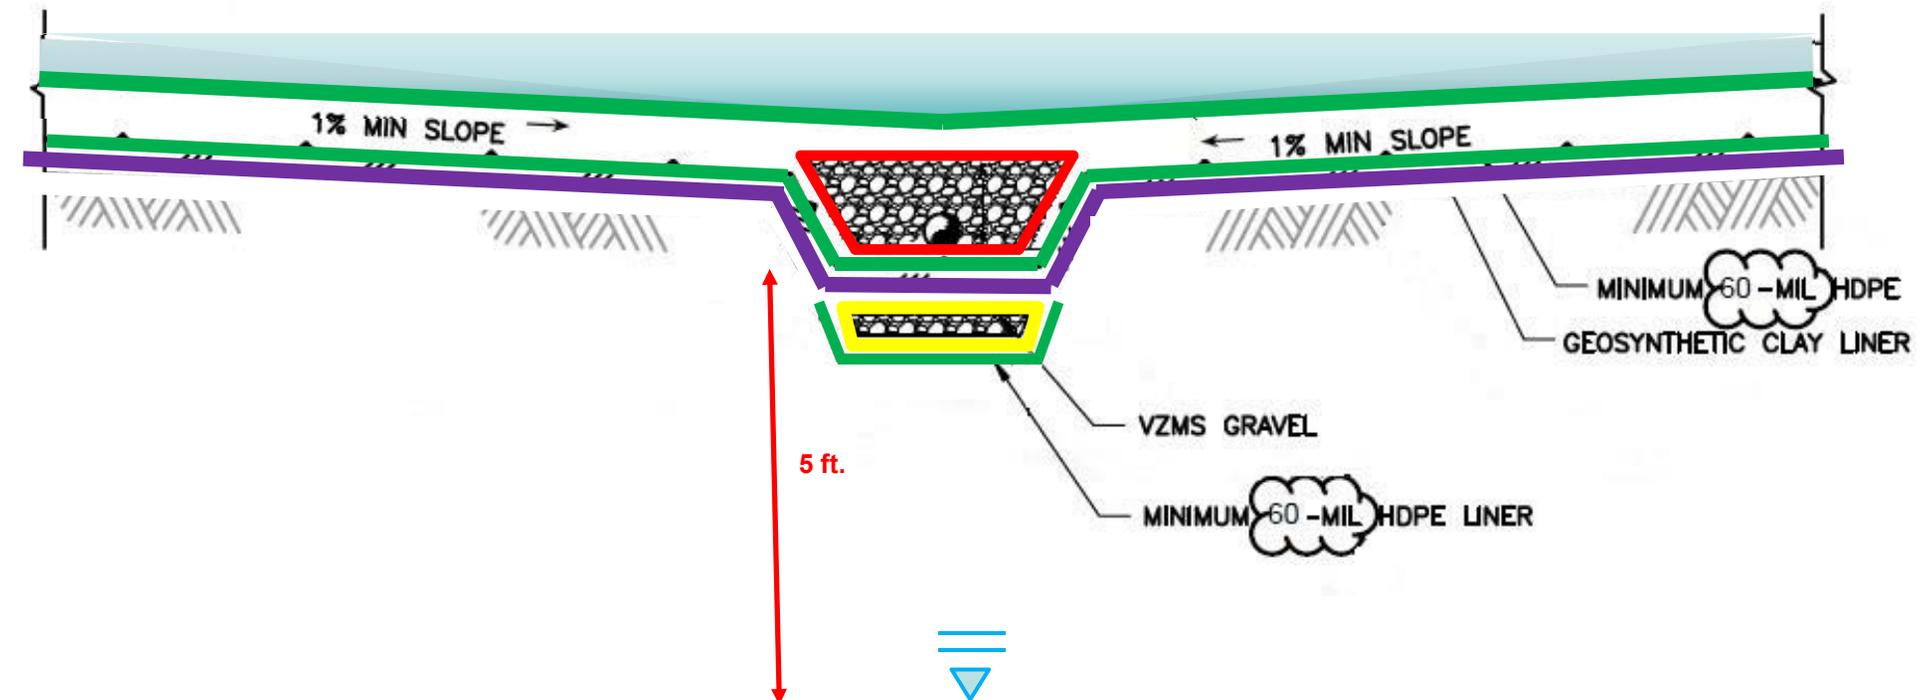
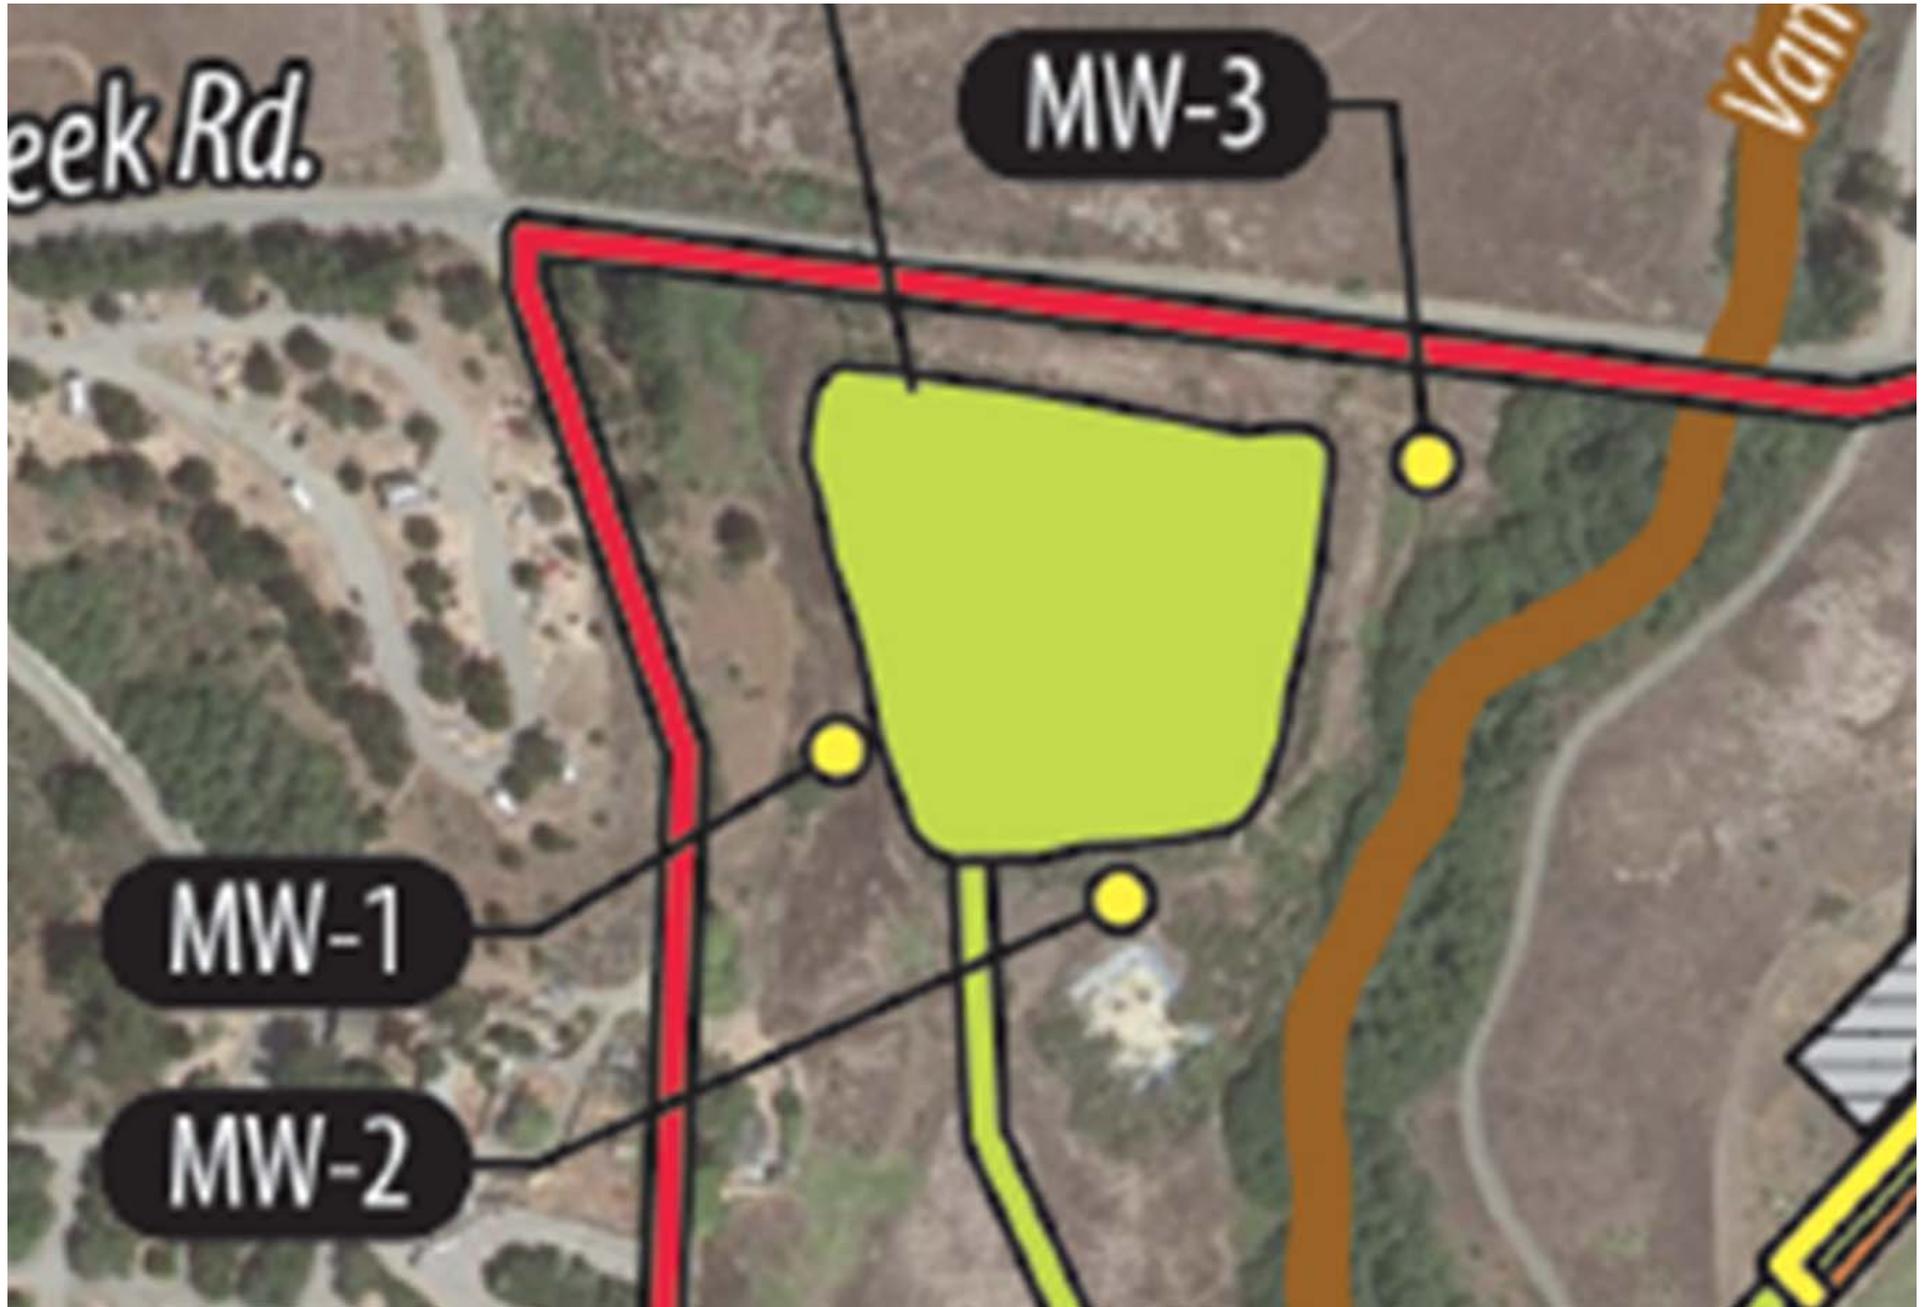
Surface Impoundment Liner System

- **Liquid in the Vadose Zone Monitoring System (VZMS)**
 - **Water detected in VZMS on January 24 through March 7, 2017**

- 1) The liner is leaking; or**
- 2) Groundwater has infiltrated into VZMS**

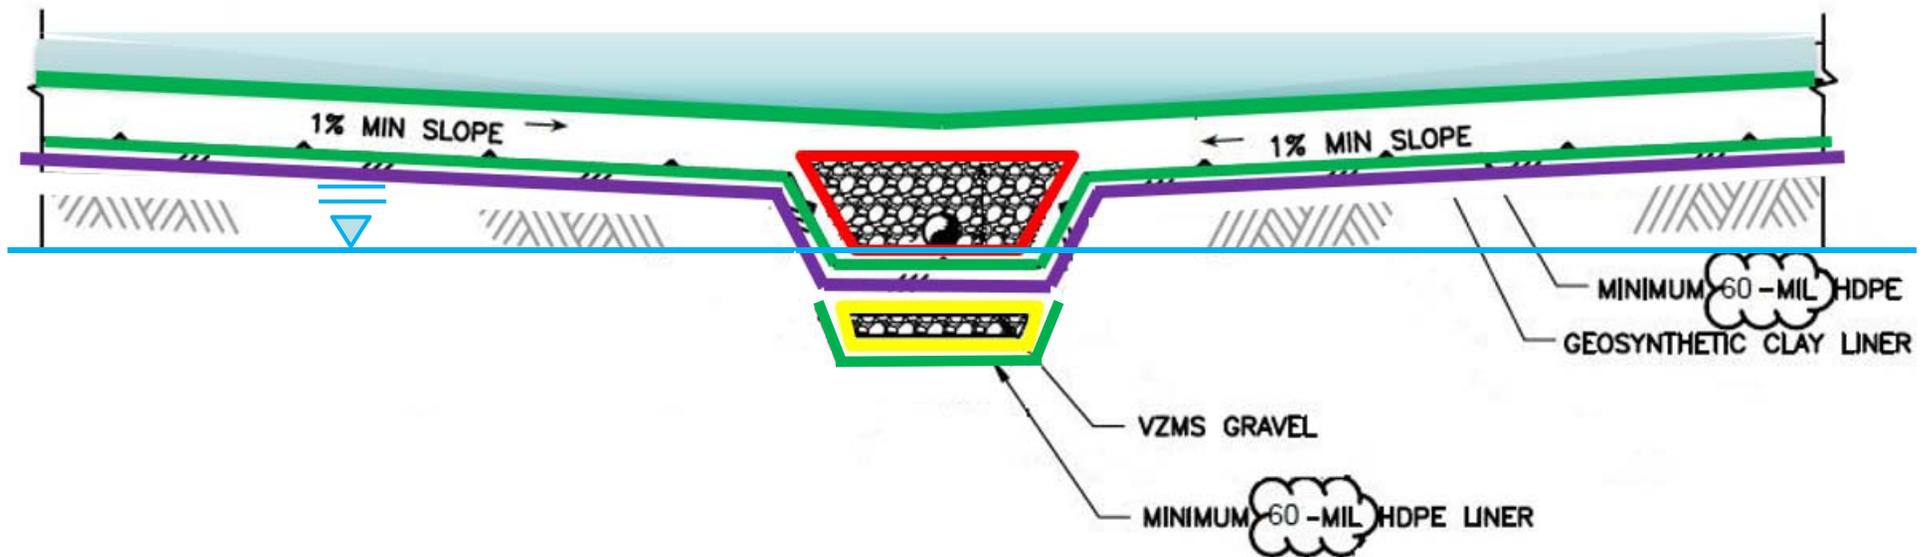
Liner System Separation from Groundwater

- **The Surface Impoundment is out of compliance with Title 27 requirements**
 - We now know that separation between the liner and groundwater will be less than 5 feet under certain conditions.
 - We should not allow CCSD to operate the impoundment in violation of the WDR.

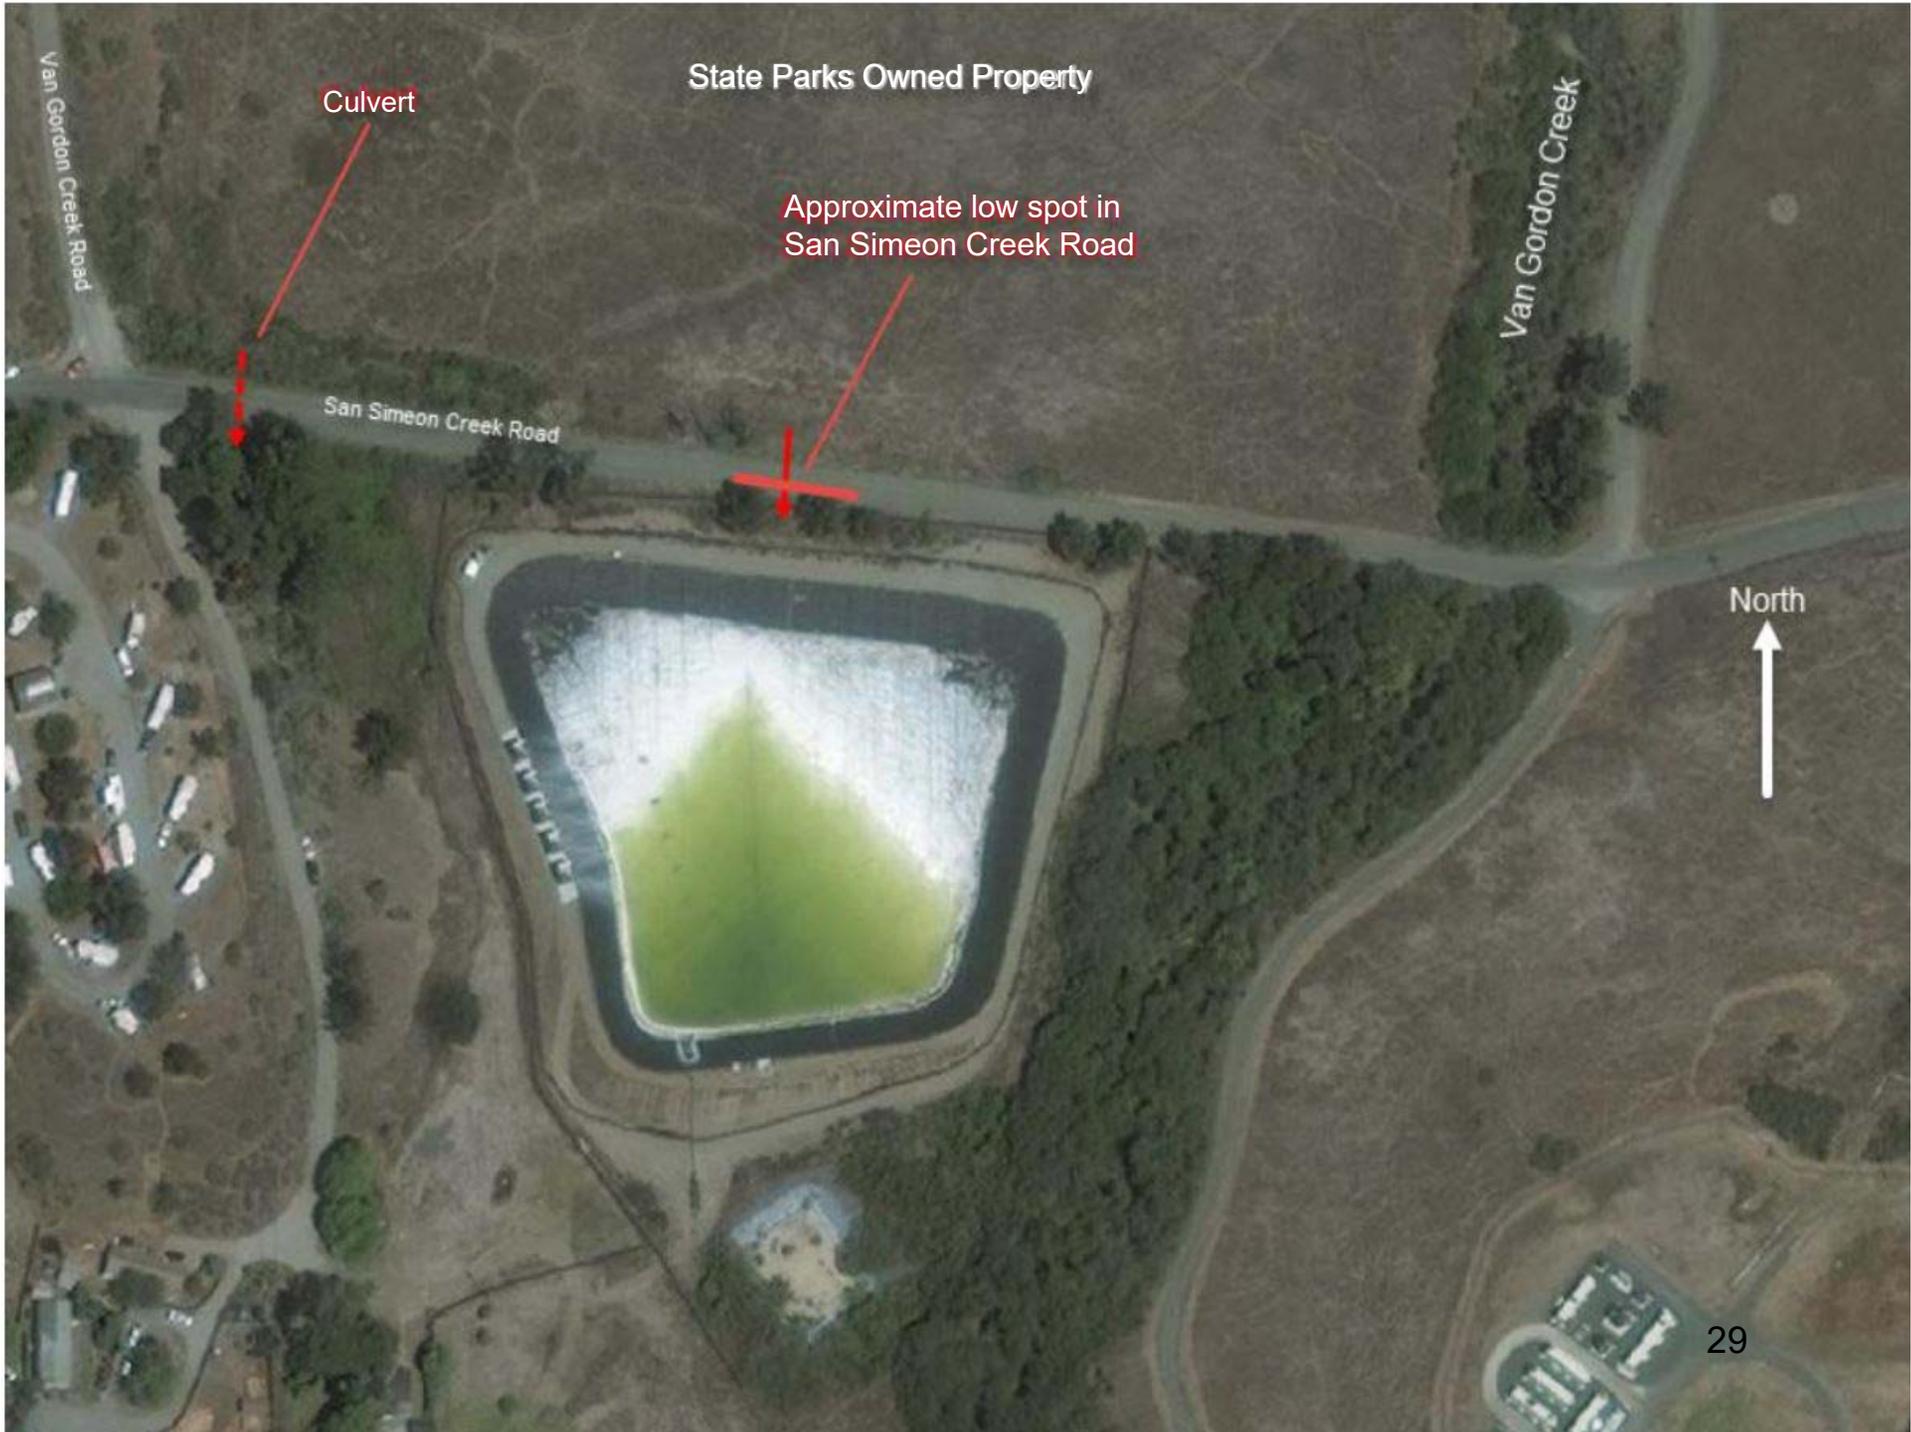
- **Surface Impoundment designed to contain a 1,000-year 24-hour storm event**
 - **Exceeded minimum freeboard on February 5, 2017 (34.2 inches required)**
 - **Design Report states:**
“...there is no anticipated stormwater flow into the evaporation pond.”

Culvert

State Parks Owned Property

Approximate low spot in
San Simeon Creek Road

Van Gordon Creek Road

San Simeon Creek Road

Van Gordon Creek

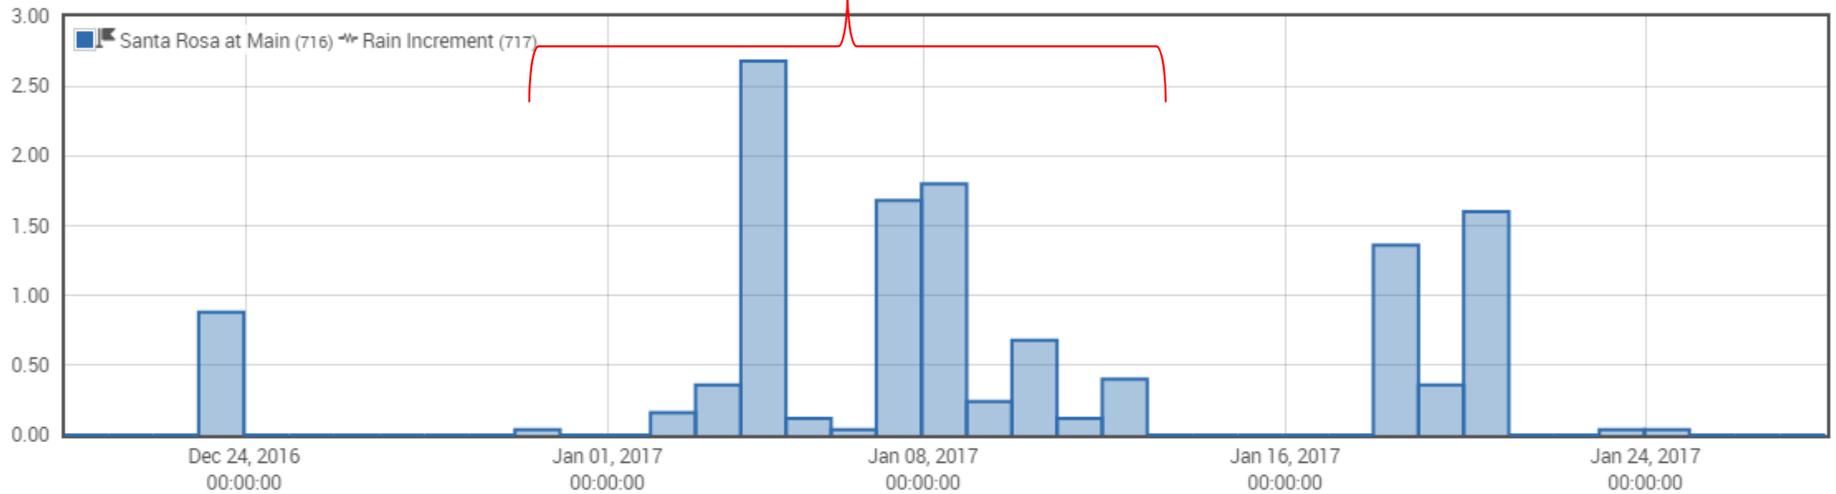
Daily Rainfall Data

8.32 inches

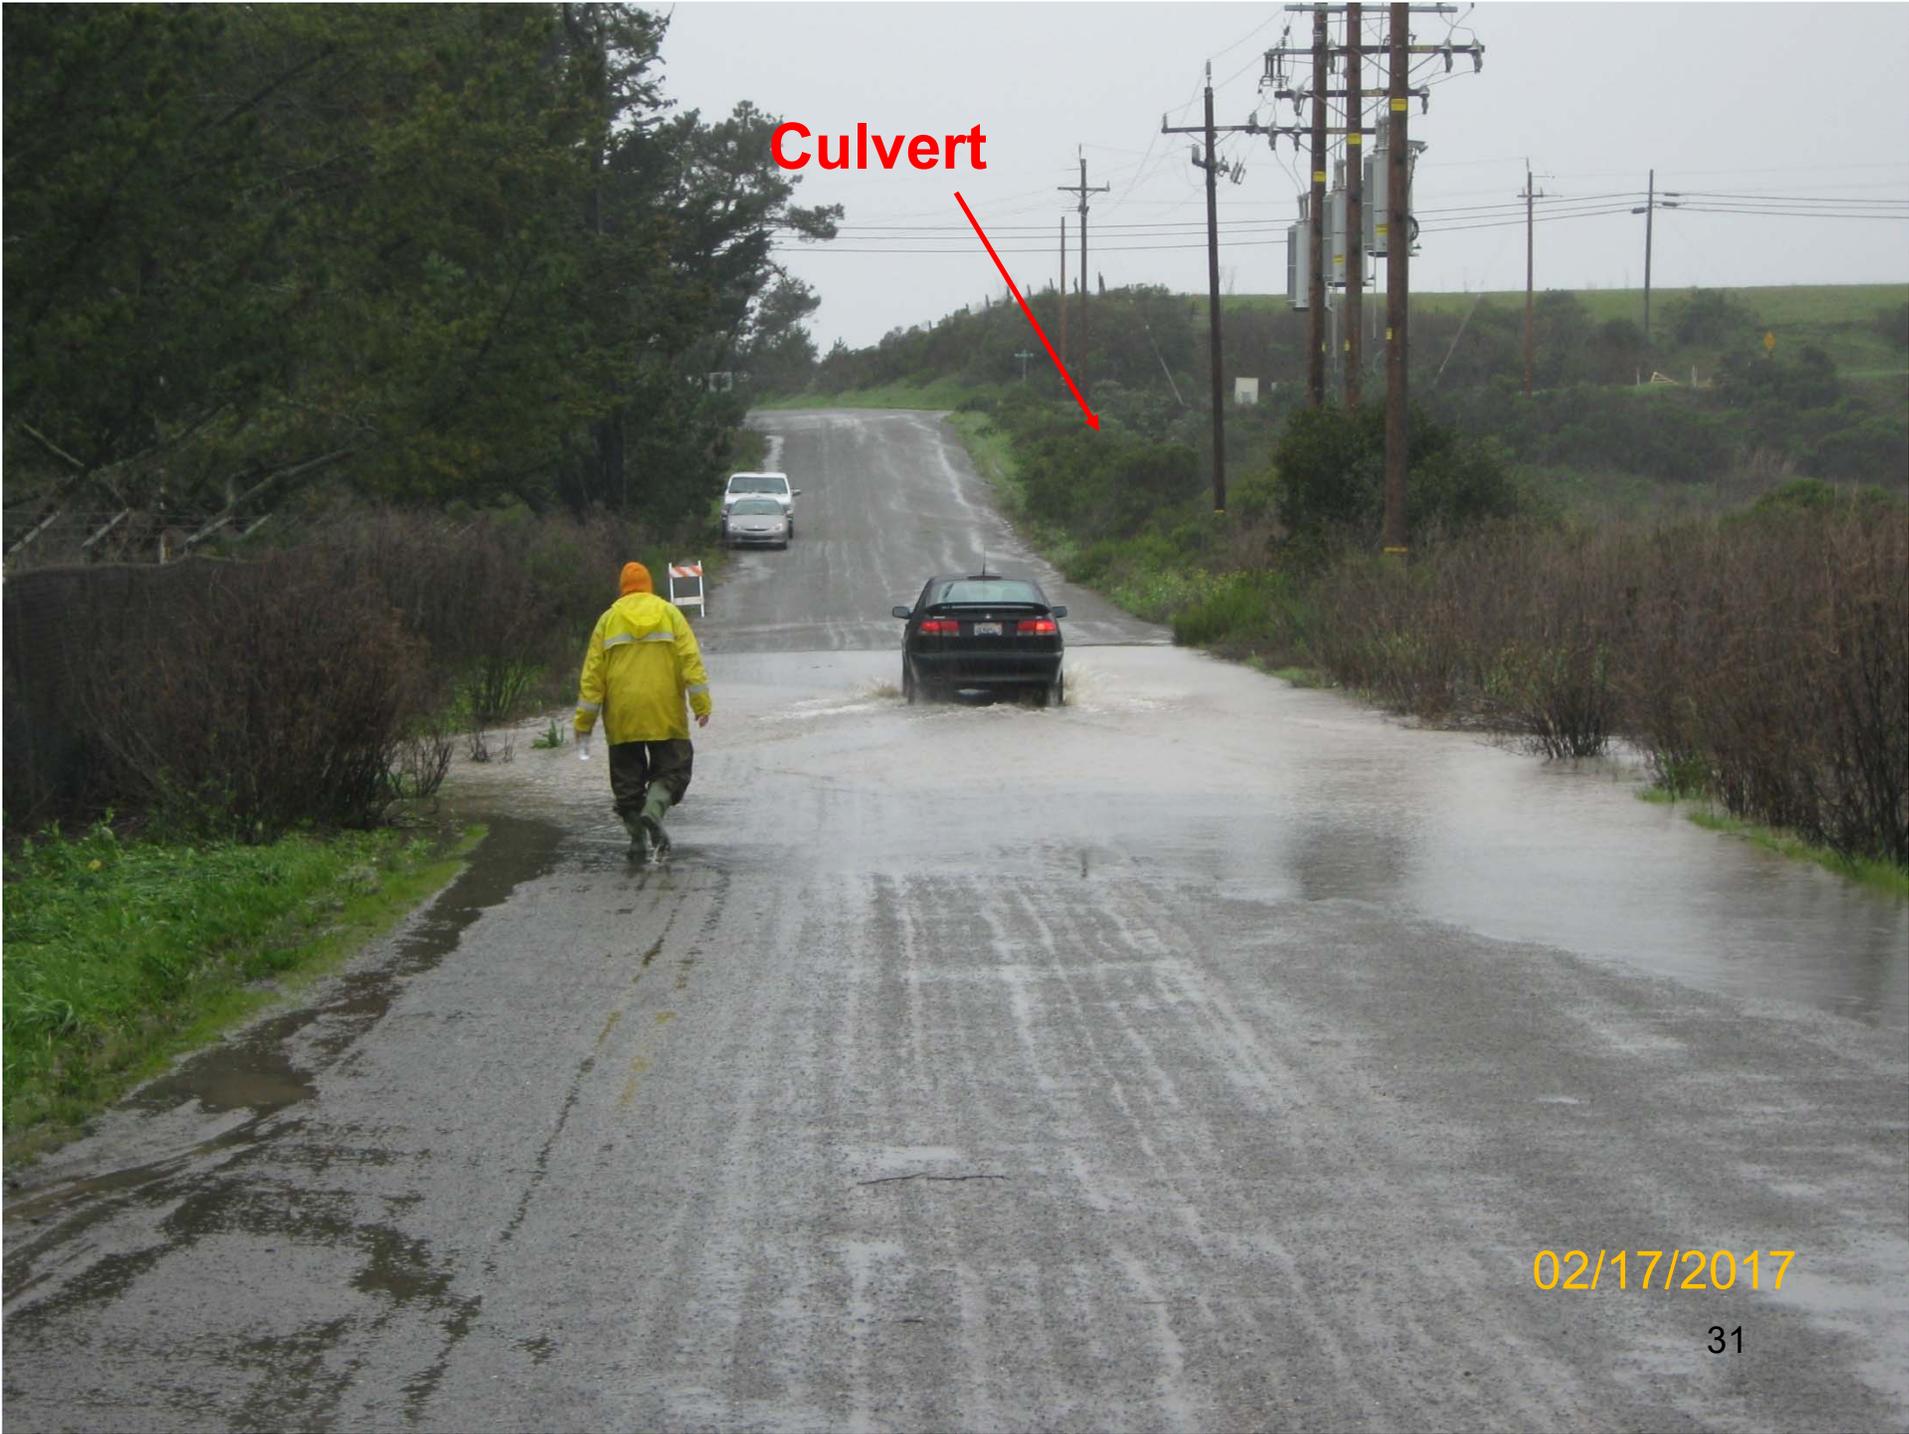
02/17/2017

Culvert

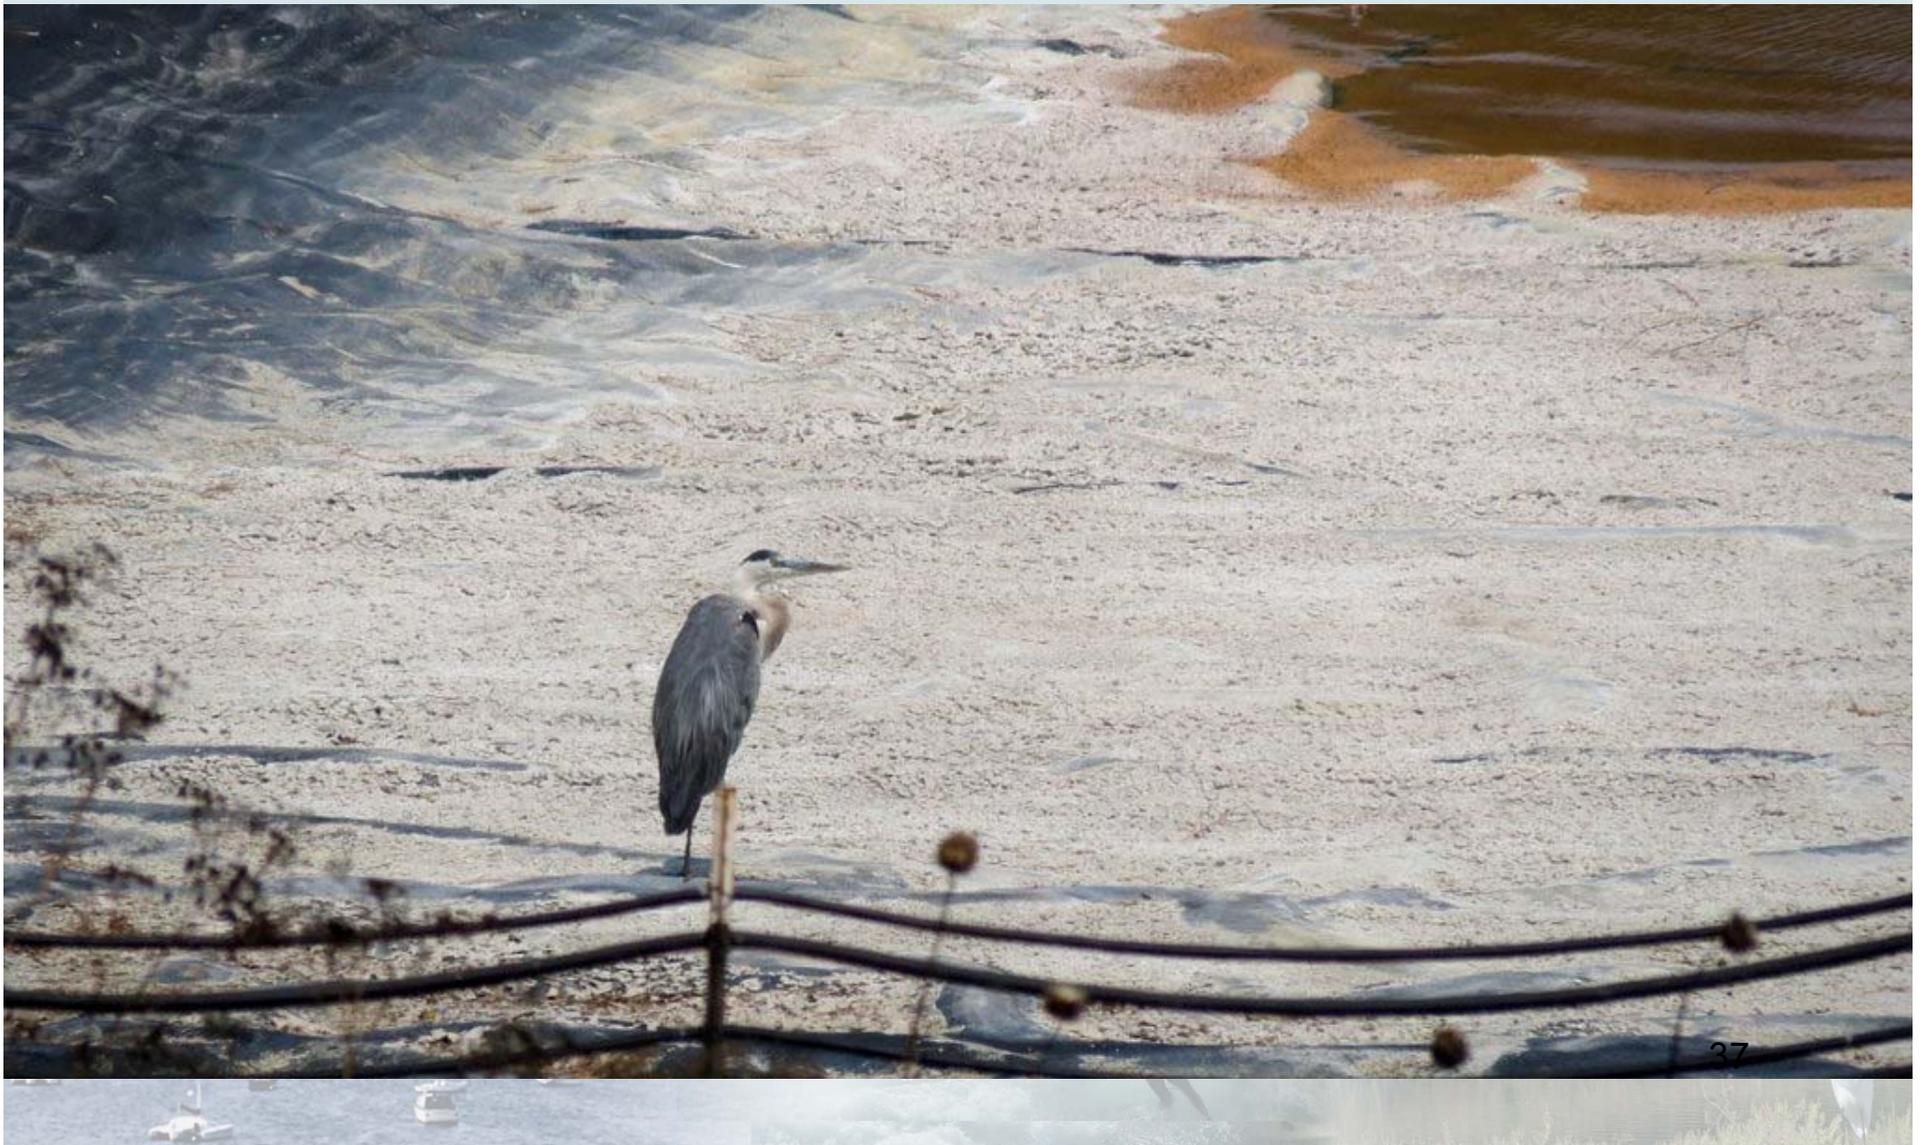
On the Bottom

- **Allowing liquids to evaporate is problematic**
 - Design evaporation rates predict approximately 11 years for liquid removal
 - Pollutant concentrations will increase over time
 - Wildlife attracted to increasingly polluted water
 - Facility would be continuously out of compliance with Title 27

- **Two options for Surface Impoundment:**
 1. **Rehabilitate**
 2. **Discontinue use**
- **CCSD is not contesting the CDO as proposed**
- **CCSD plans to discontinue use**
- **CDO requires workplan within 30 days of adoption**
