Welcome

The Lahontan Regional Water Quality Control Board developed this newsletter to communicate various efforts to protect water quality in Eagle Lake.

2025 Grazing Management Plans and Inspections

Overview of Wastewater Systems & Compliance Efforts

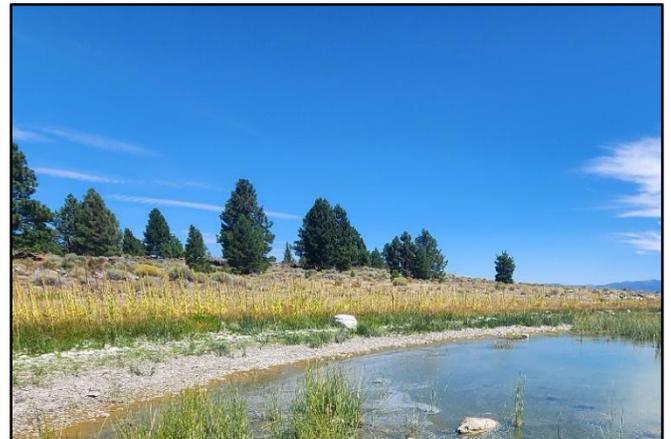
In late August, Water Board staff inspected the South Eagle Lake grazing allotment, which is managed by the U.S. Forest Service's Lassen National Forest Eagle Lake Ranger District. Historically, this area generated the most concerns about cattle. However, since 2022, no complaints have been reported for this allotment or anywhere else in the Eagle Lake area. Only eight cows utilized the allotment this season, leading to minimal cattle impact. This is evident in the photo below, where the shoreline shows no hoof prints.

During the inspection, Water Board staff noted that the allotment's only upland water source was not functioning, making Eagle Lake the primary drinking water option for livestock. Forest Service staff indicated that plans to repair the off-lake drinking water system will be considered during next year's budget discussions. Even so, Water Board staff found the grazing allotment to be responsibly managed, noting adequate stubble height along the shoreline, supplements appropriately placed to draw cattle far away from the lake, and fences and gates in good condition. No cattle grazed the North Eagle Lake allotment in 2025.

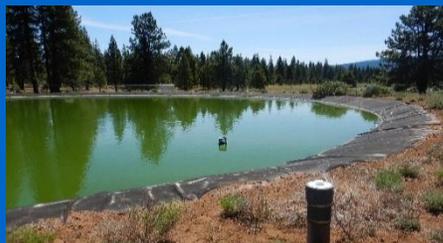
June 2025 Inspection

Eagle Lake Recreation Area Wastewater Treatment Ponds, operated by the U.S. Forest Service, provide wastewater treatment services for the south shore campgrounds and marina at Eagle Lake. Wastewater collected in the campground area is pumped uphill through a two-mile pipeline to the treatment site and then flows through two settling ponds and four evaporation ponds. The ponds are lined with heavy-duty plastic to protect groundwater, and the liners installed in 2012 continue to perform as intended. In June 2025, Water Board staff inspected the facility and confirmed compliance with its discharge permit. Although the pond liners show signs of weathering, the U.S. Forest Service closely monitors liner condition as part of routine maintenance to ensure long-term protection of water quality.

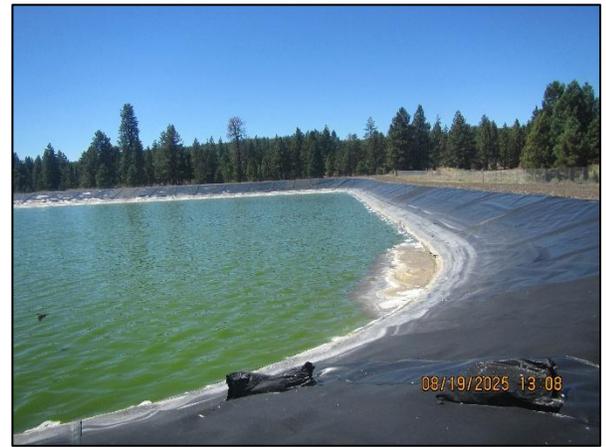
Spalding Aug 2025 Inspection

Spalding Community Services District owns and operates the sanitary sewer collection system and wastewater evaporation ponds that serve Spalding Tract. Inspection of this system occurred on August 19th. The inspection was centered around the same questionnaire developed by State Water Board staff related specifically to the sanitary sewer collection system. The goal of the inspection was to determine if Spalding CSD was complying with all components of the Sanitary Sewer General Order. While there were violations identified throughout the course of the inspection, there were no imminent water quality threats identified.

Staff at the Lahontan Water Board have also been working with the State Water Board's Division of Financial Assistance to evaluate grant opportunities for improvements to the Spalding CSD wastewater collection and treatment systems. Staff are currently reviewing eligibility criteria for Spalding to determine if the CSD would qualify for the State grant program.

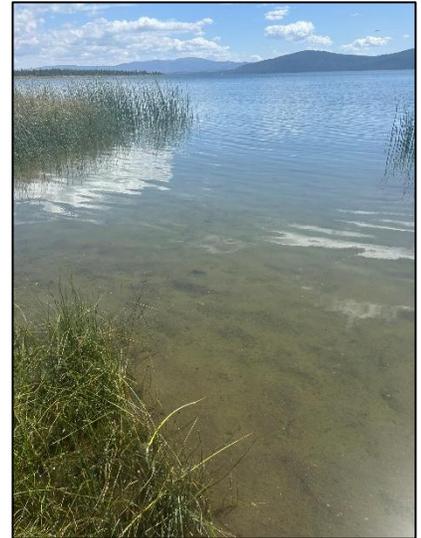
Christie Day Use June 2025

To protect public health in 2025, Eagle Lake HAB monitoring was conducted ahead of the 4th of July holiday at Spaulding Boat Ramp and Christie Day Use area. The samples showed the presence of cyanobacteria and a low amount of microcystin, a toxin they can produce, at Christie Day Use. Because microcystin can pose health risks to people and pets, a caution advisory was issued for that location.

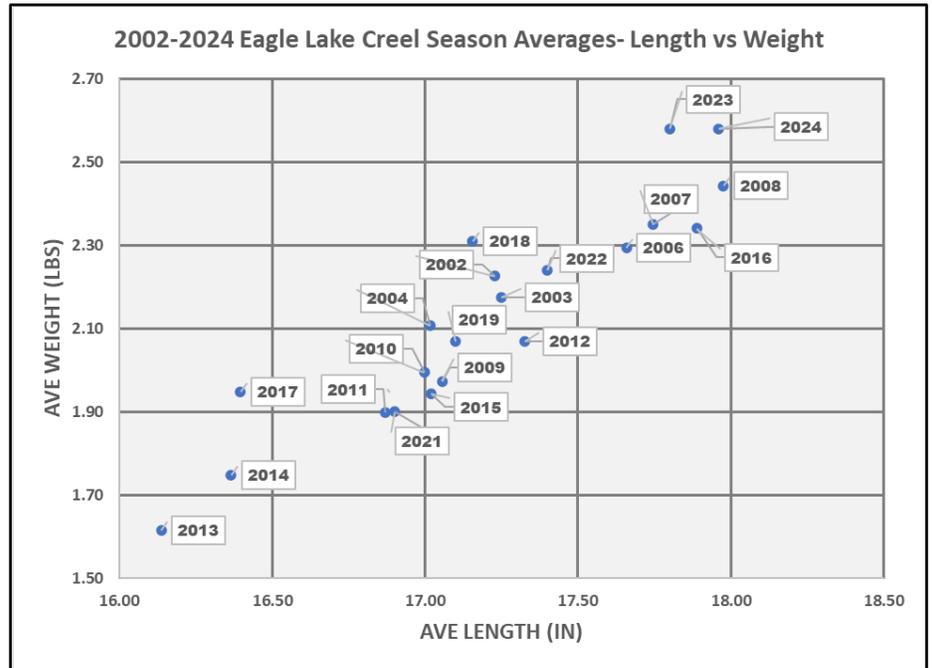
Table 1: Creel season is opening day to the end of October (no data for 2005 and 2020)

Last year's fishing season continued to provide some of the best fish quality in the last 20 years, shown by length vs weight relationships (Table 1). However, catch rates dropped substantially from 2023.
