ENHANCED WATERSHED MANAGEMENT PROGRAM (EWMP) FOR NORTH SANTA MONICA BAY COASTAL WATERSHEDS

Submitted to:
Los Angeles Regional Water Quality Control Board

Submitted by:
North Santa Monica Bay Coastal Watersheds EWMP Group

March 2016

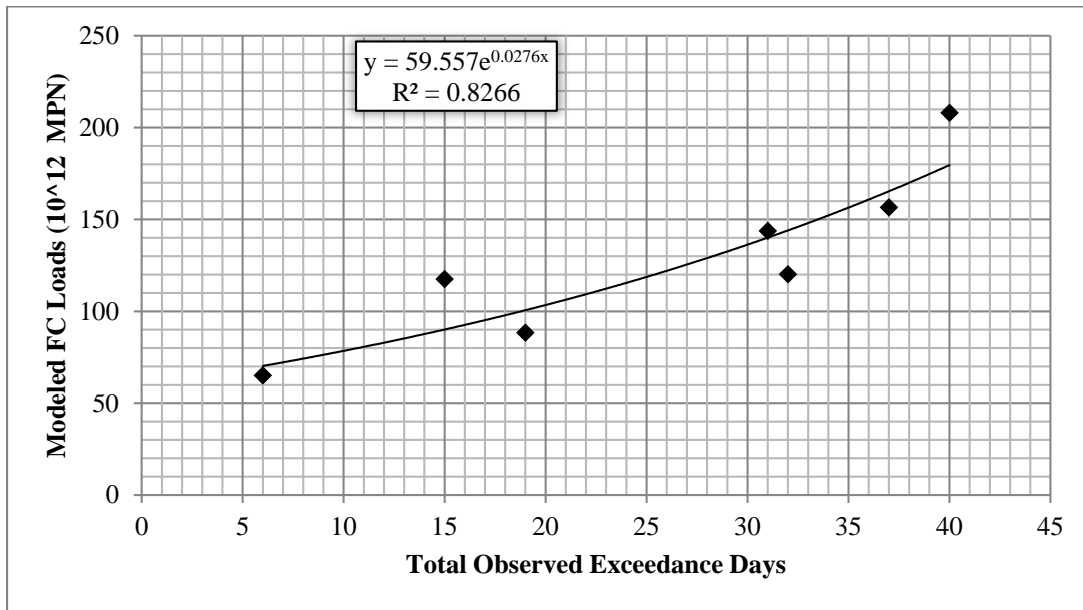
Figure 14. Correlation between Modeled Fecal Coliform Loads and Observed Exceedance Days, 2005-2013

A second methodology validation step was performed to demonstrate that modeled annual fecal coliform loads are indeed predictive of the compliance metric, or annual exceedance days for all fecal indicator bacteria. For bacteria modeling, verifying the linkage between modeled *fecal coliform loads* (i.e., discharged from the hypothetical subwatershed outlets) and total observed wet weather *exceedance days* (in the receiving water, based on REC1 daily maximum water quality objectives) is critical to establish reasonable assurance that compliance monitoring locations will be in compliance with the Permit limits. To establish this linkage, an analysis was conducted using shoreline monitoring data at Topanga Canyon²⁵ (SMB 1-18) between 2005 and 2013. **Figure 14** illustrates a reasonable correlation between total modeled annual fecal coliform loads and total annual observed wet weather exceedance days. Each point shown represents one single Model Year.

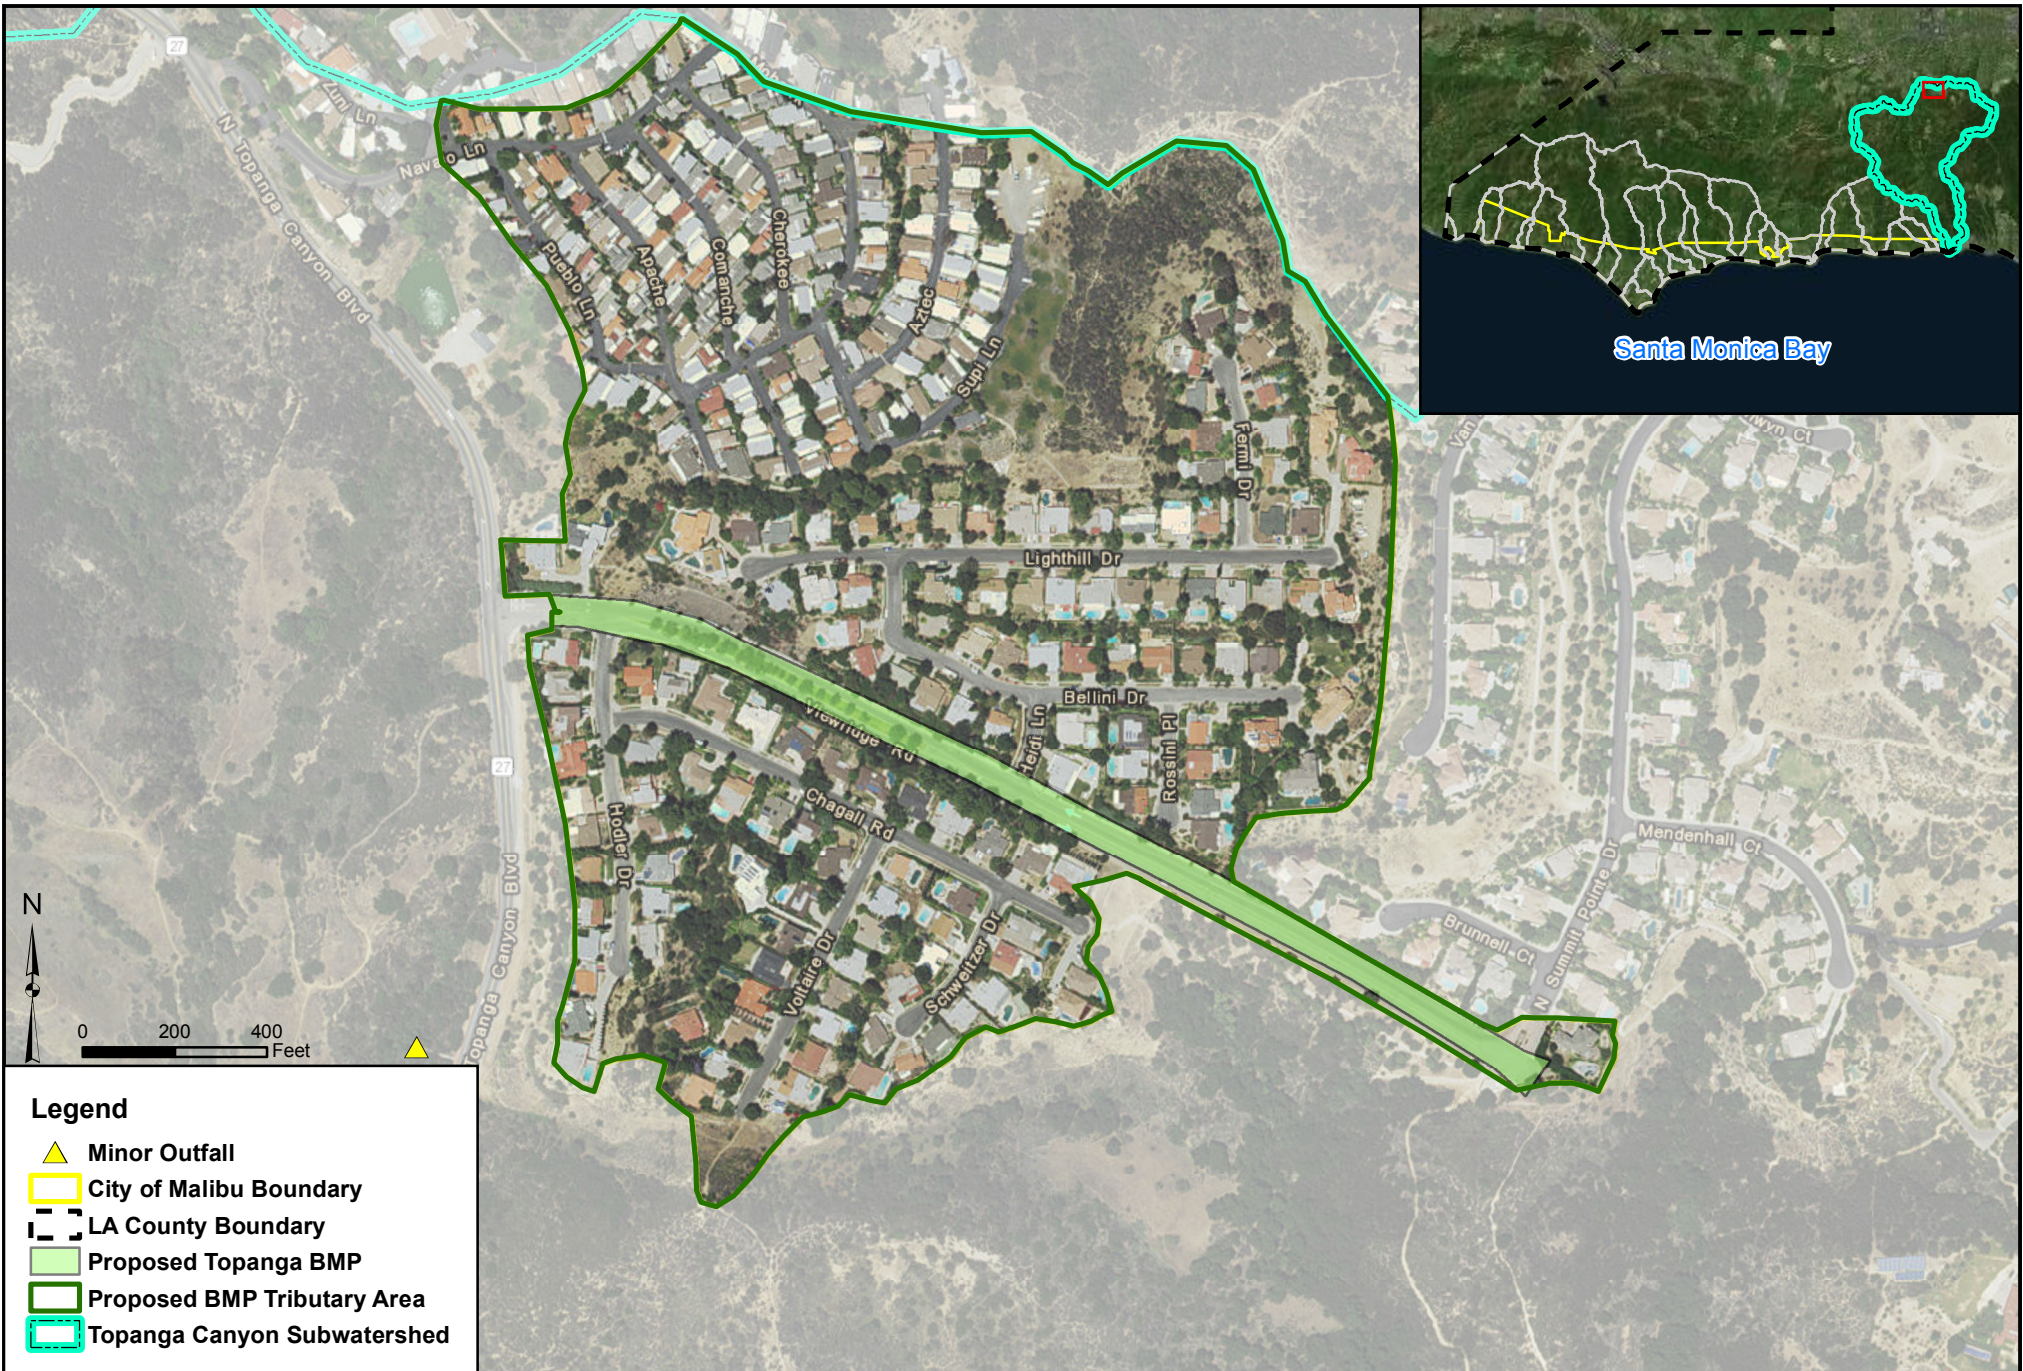
Figure 15. Topanga Canyon Subwatershed (Analysis Region S1-18)
Proposed Regional BMP
 NSMBCW EWMP
 RB-AR 5490

The Topanga Canyon Regional Super Green Street EWMP Project is a Los Angeles County project. The County has initiated the planning phase for this project. The proposed project is estimated to be completed by 2021.
