ENHANCED WATERSHED MANAGEMENT PROGRAM (EWMP) FOR NORTH SANTA MONICA BAY COASTAL WATERSHEDS

Submitted to:
Los Angeles Regional Water Quality Control Board

Submitted by:
North Santa Monica Bay Coastal Watersheds EWMP Group

March 2016

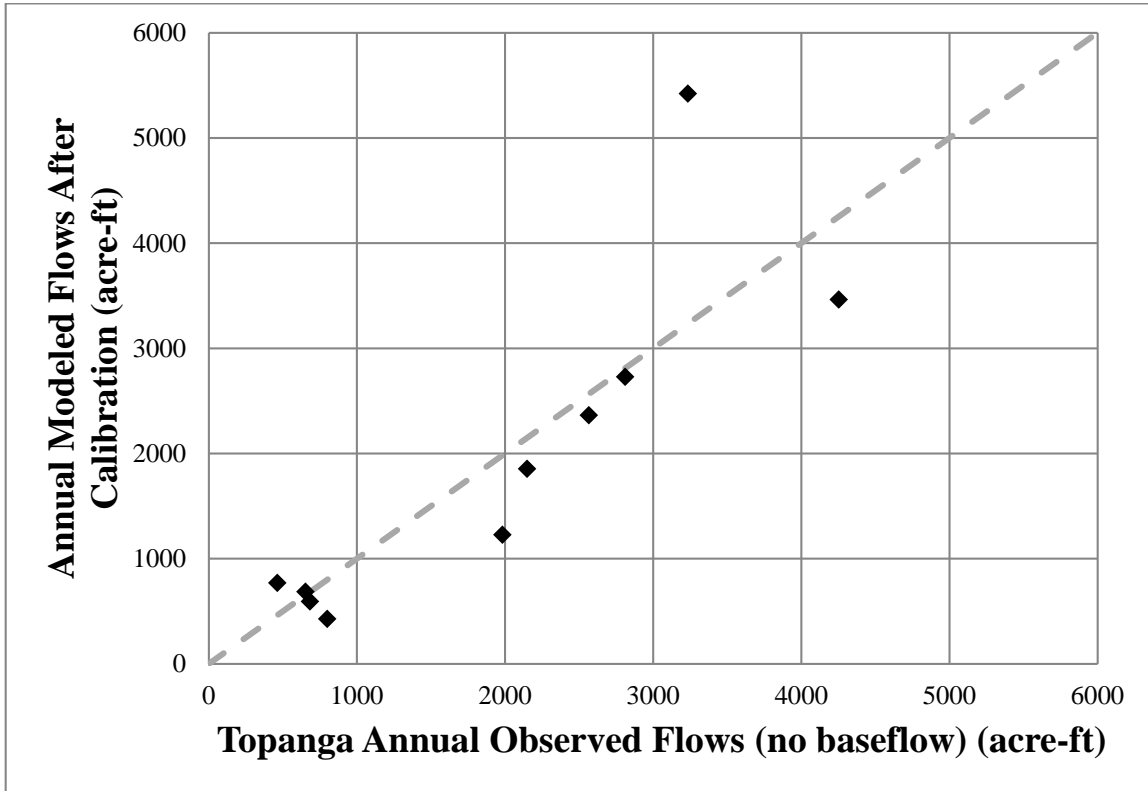
Figure 11. Annual Runoff Volumes for Topanga Subwatershed: Modeled vs. Observed, 2001-2012

results.²¹ These calibrated input parameter values were used throughout all SMB watersheds in the wet weather RAAs. Figure 12 presents these same results in a flow duration curve format, which compares the distribution of annual discharge volume magnitudes throughout the period analyzed between the modeled and observed data.

²¹ The stream gauge annual volume measurement in 2008 was unexplainably high (corresponding to a runoff coefficient greater than one), and the 2005 year included a 15-day period of near-record rainfall levels that were anomalously high (where the mean annual rainfall depth fell between December 27 and January 10, and major landslides were reported in nearby coastal Ventura County).

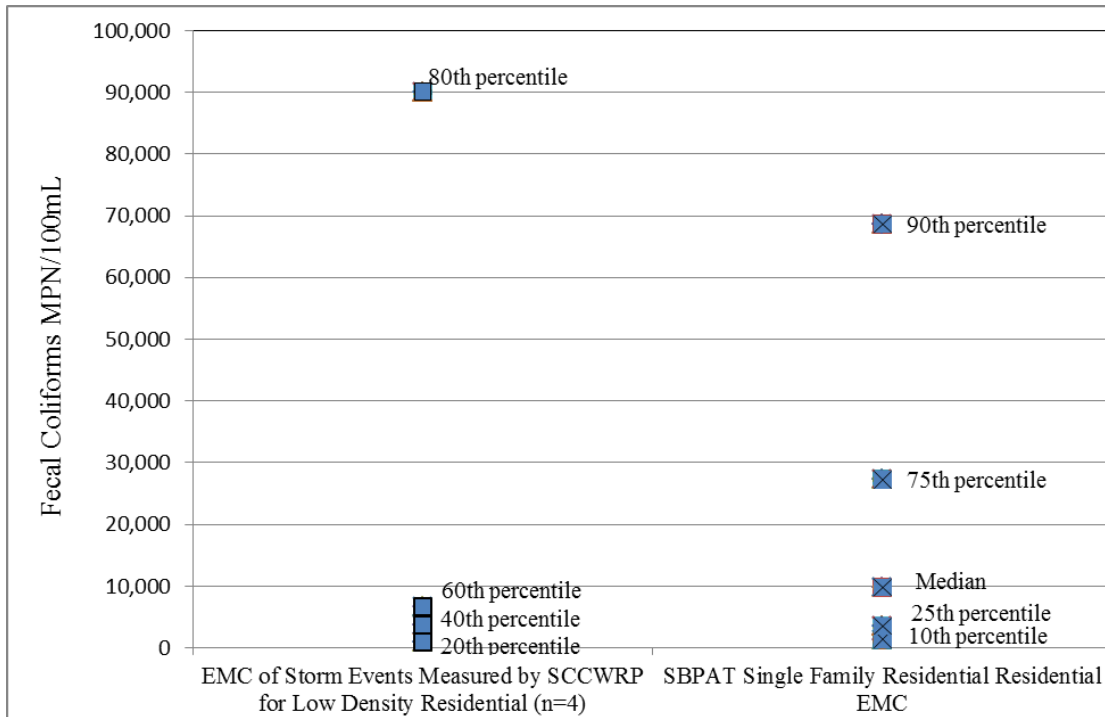
found for each modeled pollutant in **Appendix C**. Modeled EMC values are consistent with the recommended values for land use-specific loading in Table 3.3 of the RAA Guidelines.²² In the future, as new local monitoring data become available, EMCs may be reevaluated as part of the EWMP adaptive management process.

Figure 13. Comparison of Fecal Coliform Low Density Residential EMC Values Between SCCWRP Measurements (n=4) and SBPAT Modeled Values (a full log distribution is used by the model, but non-parametric summary statistics are shown for comparison)

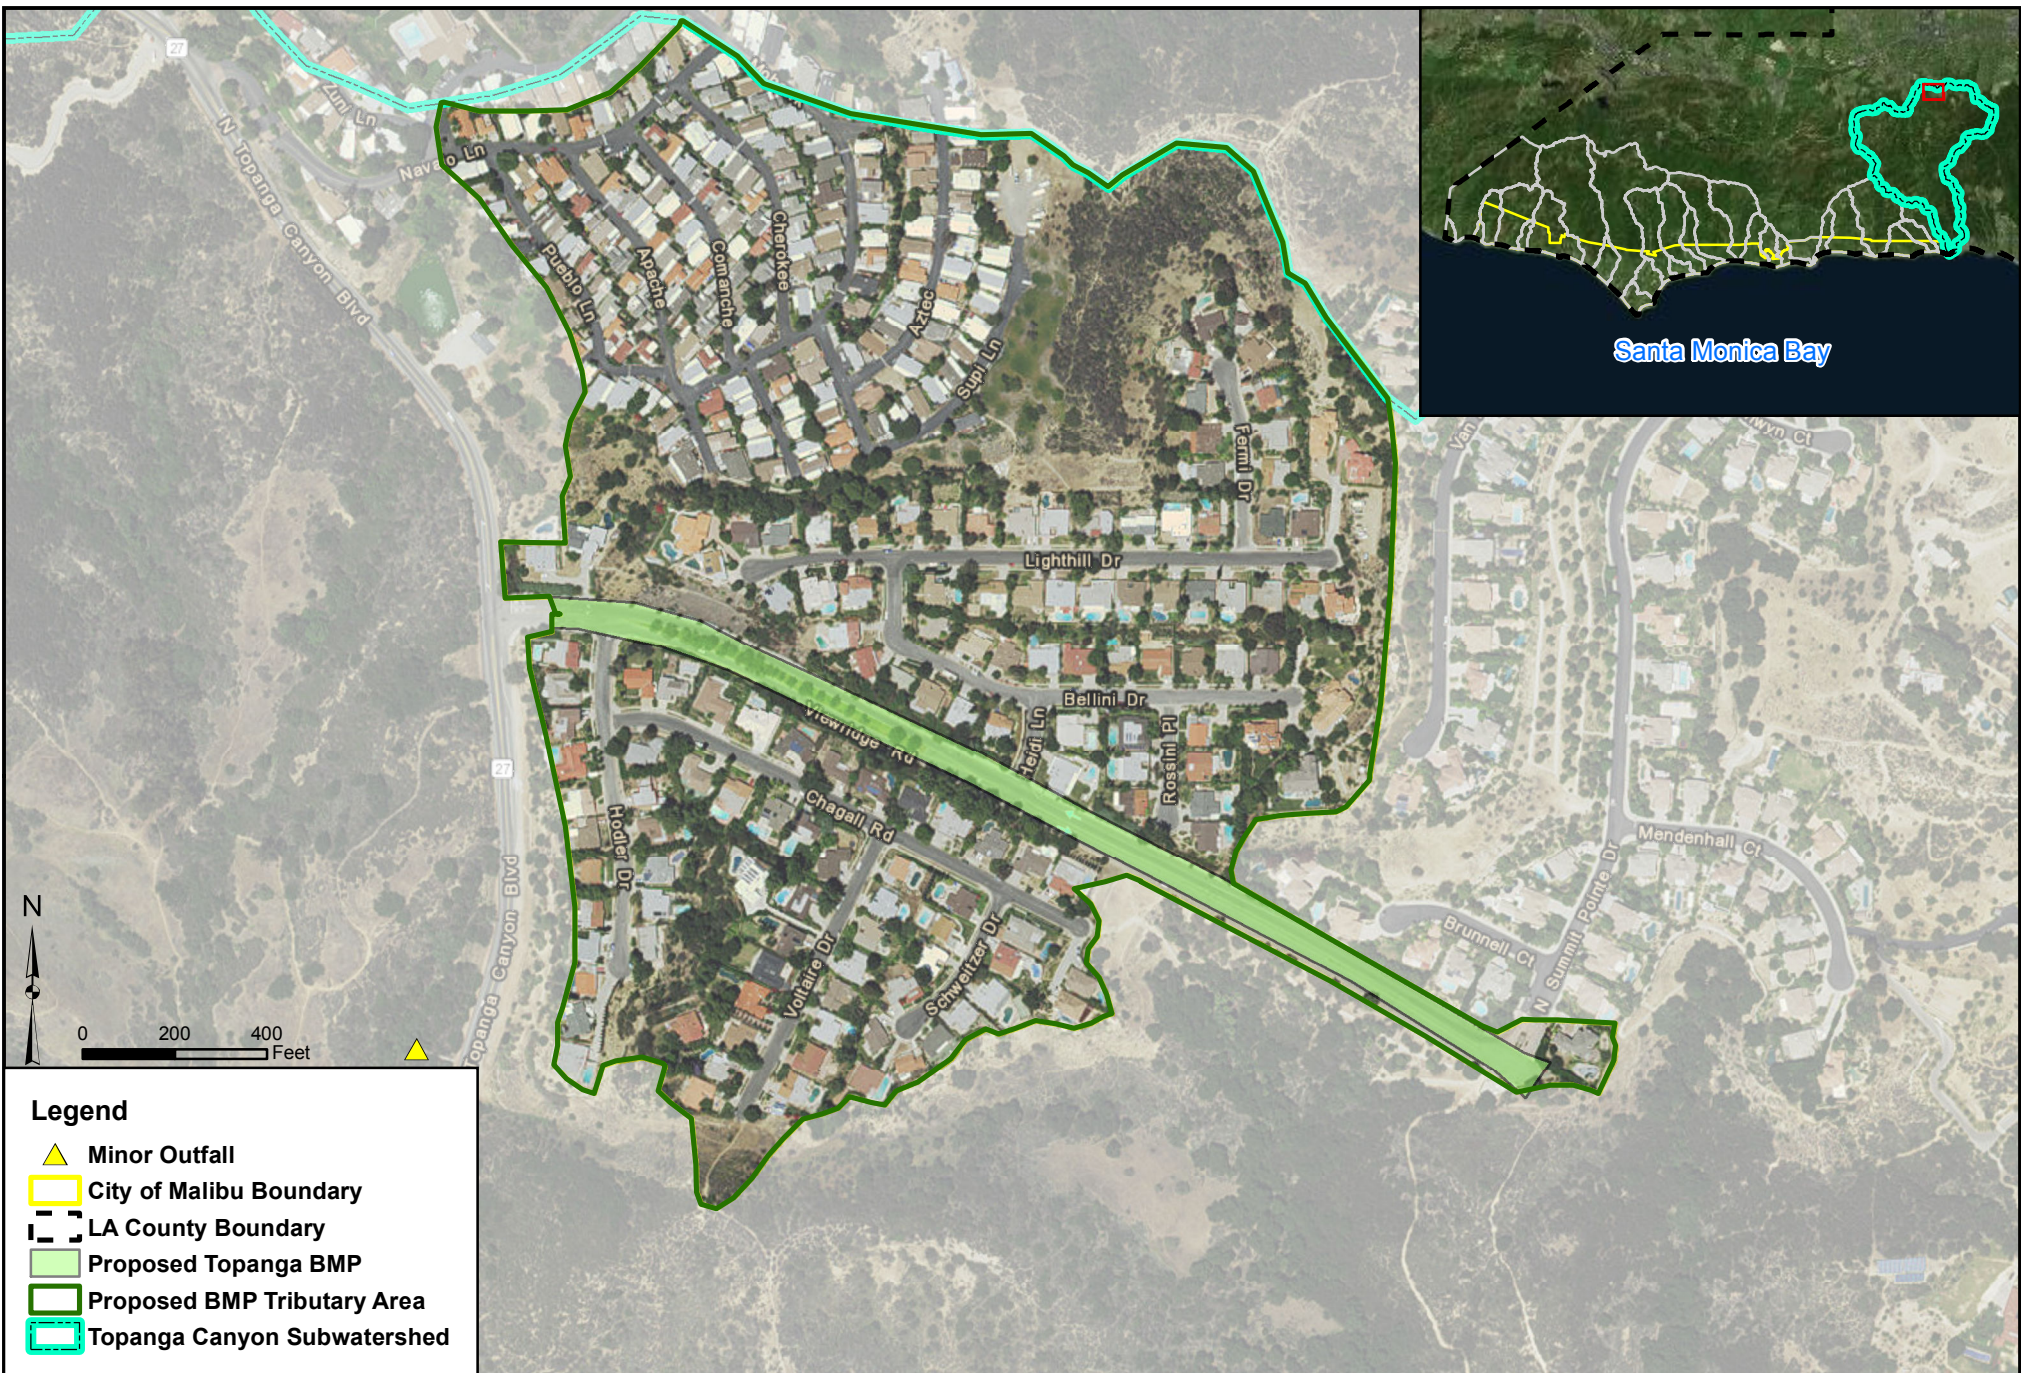
The Topanga Canyon Regional Super Green Street EWMP Project is a Los Angeles County project. The County has initiated the planning phase for this project. The proposed project is estimated to be completed by 2021.

**Figure 15. Topanga Canyon Subwatershed (Analysis Region S1-18)
Proposed Regional BMP
NSMBCW EWMP**
