California Regional Water Quality Control Board  
North Coast Region

Cleanup and Abatement Order No. R1-2006-0044

Unauthorized Discharges of Waste to Upper Dry Creek,  
Yorkville, Mendocino County

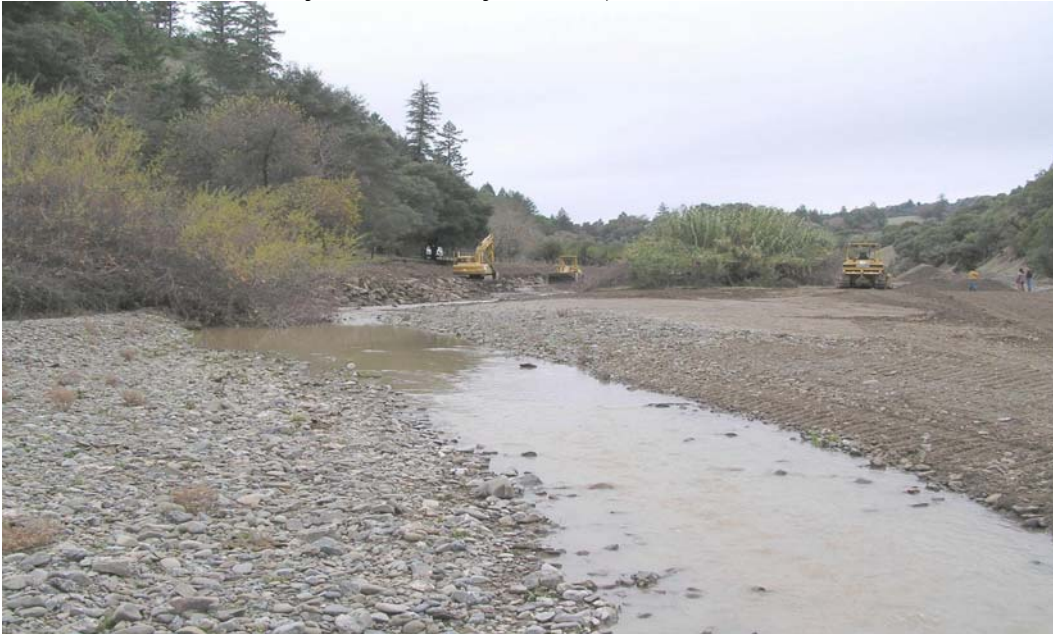
**Photo 1.** View facing upstream towards active work in the Upper Dry Creek Channel. December 2005 (Photo taken by Corrine Gray of DFG)

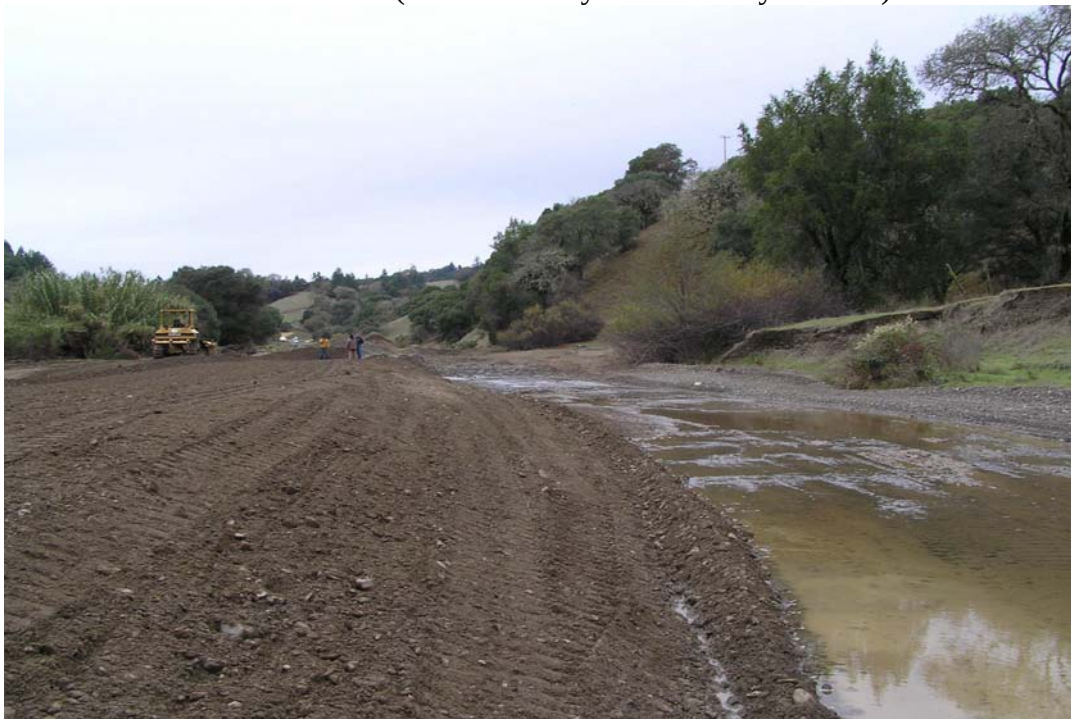
9. On November 27, 2005, DFG staff took photos of the work being done within the creek and along Site 2, which included dredging of the channel to create a new wetted channel. The performed work did not follow the submitted Workplan for Site 2, and resulted in significant discharges and impacts to Upper Dry Creek. There were large piles of earthen material that had been dredged out of the newly constructed channel that were left within the channel and would mobilize during the next rainfall event (See photographs in Exhibit 1).

**Photo 2.** View facing downstream towards heavy equipment constructing a new channel that was not authorized. December 2005 (Photo taken by Corrine Gray of DFG).

1. Submit a Workplan, prepared by a qualified individual with background in stream morphology and restoration, to deal with the long-term stabilization and restoration of the entire reach of affected stream on this Site (Sites 1 and 2), with mitigation measures to address the recent sediment discharges and related impacts to the beneficial uses of Upper Dry Creek, for Executive Officer concurrence, on or before May 5, 2006, that includes the following:

- a. A detailed stabilization, restoration and mitigation plan that remediates the damage from the unapproved instream activities, and addresses the timely stabilization, restoration and mitigation of the affected stream habitat. The plan shall contain a time schedule for all activities, success criteria to judge the success of the overall project, and a monitoring proposal to evaluate whether the success criteria are being met. The plan shall encompass the entire affected reach of stream on this Site, including Sites 1 and 2. In addition, the plan shall support the beneficial uses of Upper Dry Creek.

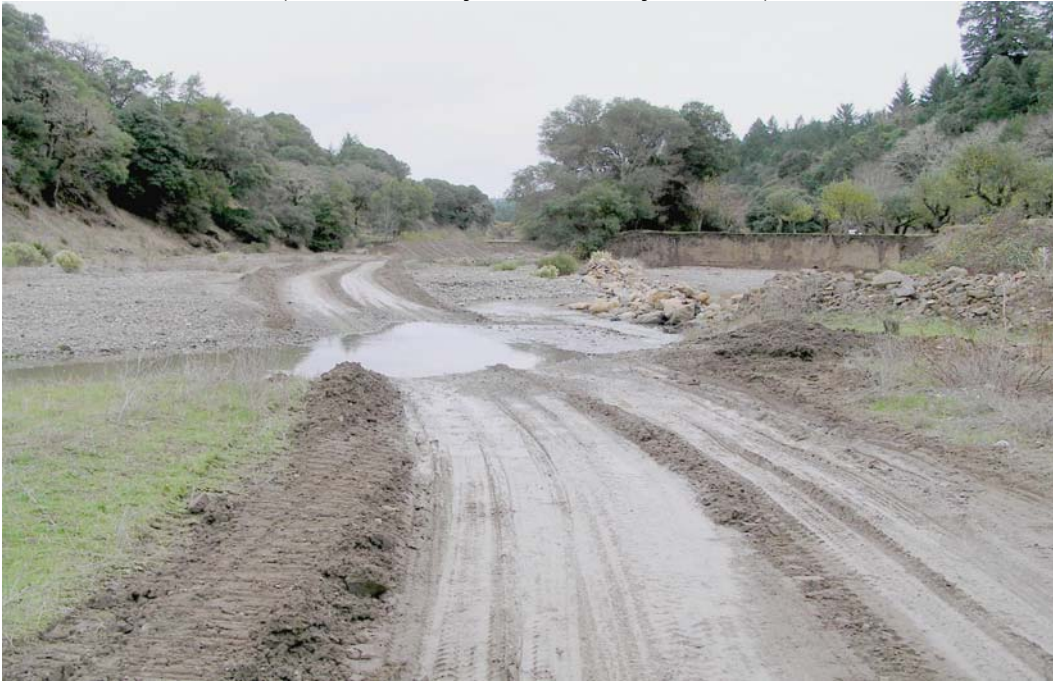
Photo 3. Unauthorized construction of a temporary road through active wetted channel of Upper Dry Creek. December 2005 (Photo taken by Corrine Gray of DFG).

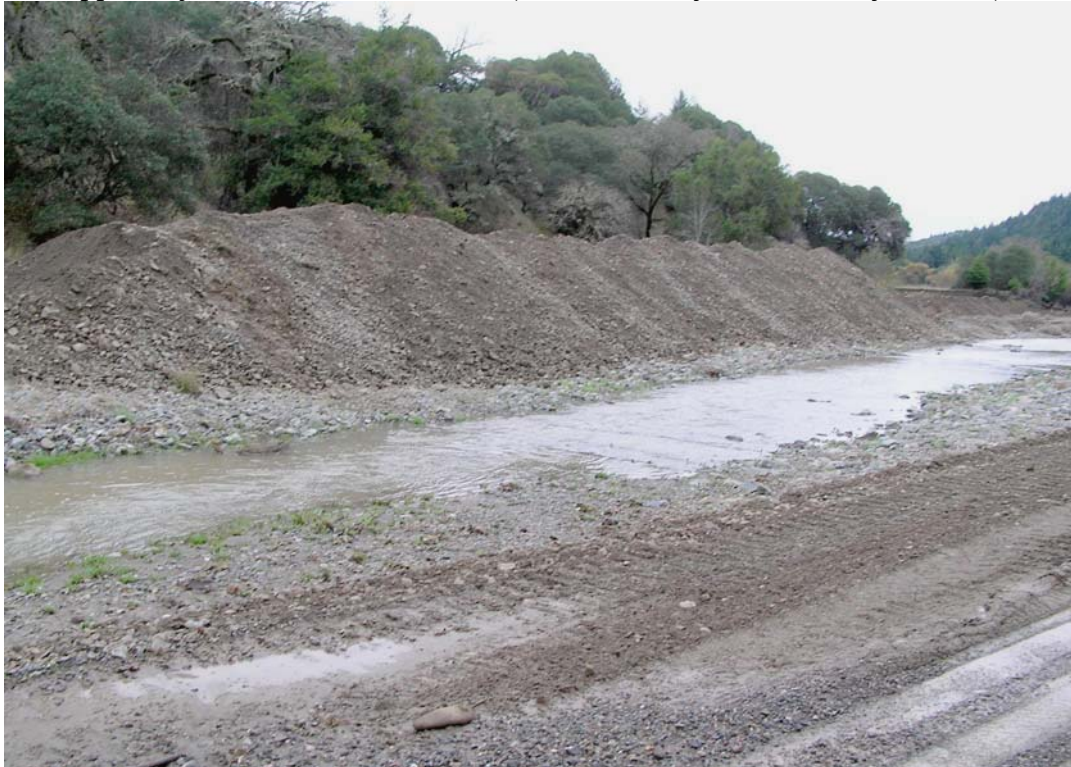
19. The discharge of sediment into Upper Dry Creek related to the excavation, new channel construction, stockpiling of gravel material, and inadequate stabilization measures, and subsequent direct loss of stream habitat and its associated functions was in amounts deleterious to wildlife, and other beneficial uses, and therefore violates Prohibitions 1 and 2 in the Action Plan. These detrimental effects also constitute the creation of pollution or nuisance. The discharge of the sediment material is therefore subject to cleanup and abatement under California Water Code Section (CWC) 13304.

Photo 4. Stockpiled sediment and gravel from unauthorized construction of a new active wetted channel in Upper Dry Creek. December 2005 (Photo taken by Corrine Gray of DFG).

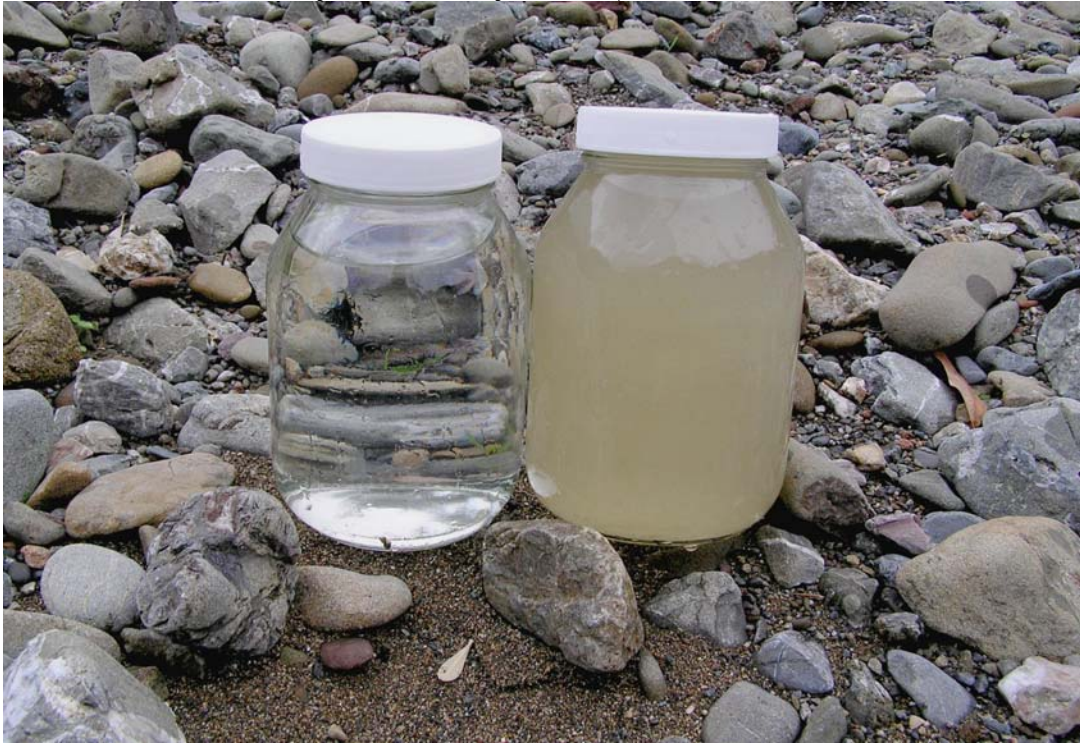
10. Turbidity samples were taken by DFG staff on November 29, 2005, above and below the work area and results include:

1.82 NTUs above work area (baseline)

171 NTUs below work area
11. On November 30, 2005, Ms. Corrine Gray of California Department of Fish and Game **conducted** a field inspection, work was still being conducted in the active channel, and Ms. Gray told Mr. Barr to cease operations and restore the stream channel.

Photo 5. Turbidity samples taken by DFG staff above (left) and below (right) active work area. December 2005 (Photo taken by Corrine Gray of DFG).

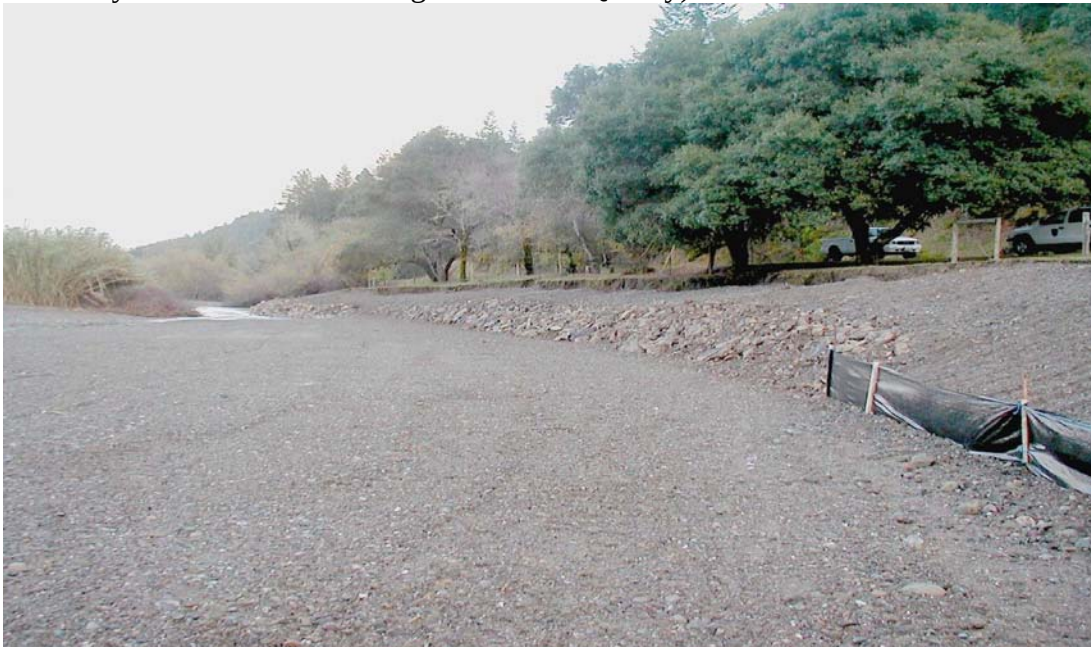
12. Pictures taken on December 1, 2005 by DFG staff, made clear Mr. Barr was not following his submitted Workplan, agreements that had made with him in the field during the earlier October 25, 2005 inspection, or the November 16, 2005 informal staff agreement. From the date the discharges commenced on November 23, 2005, up to and including the date of the issuance of this order, there was and is no complete 401 permit application or approved permit.

Photo 6. Work completed along Site 2 that was not performed as proposed in the Clean Water Act Section 401 permit application submitted to the Regional Water Board. December 2005 (Photo taken by Andrew Jensen of Regional Water Quality).

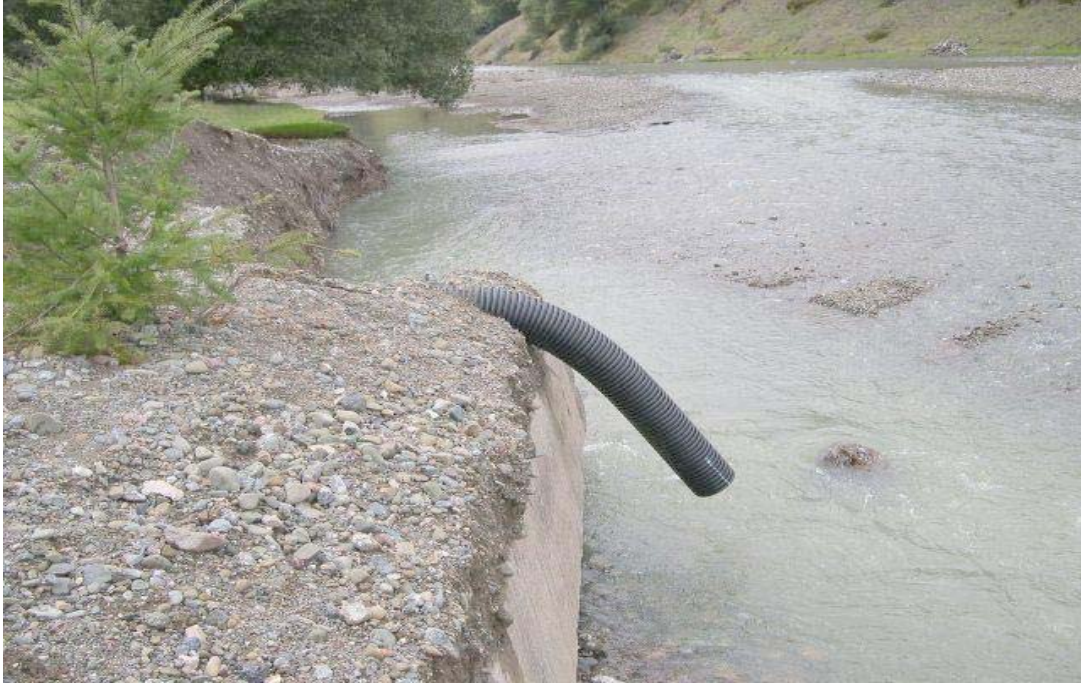
13. On March 6, 2006, DFG Game Warden Karen Maurer observed concrete K-rails in the recently pushed up gravels along the bank of Site 2 (See photos in Exhibit 2). It appears

that concrete K-rails and potentially other debris have been deposited to and buried in the gravels pushed up against the bank of Site 2. Placement of such waste was not approved and would not be a permissible activity.

Photo 1. View of concrete K-rail buried in the gravels that were pushed up against the bank along Site 2. (Photo by Karen Maurer, March 6, 2006)

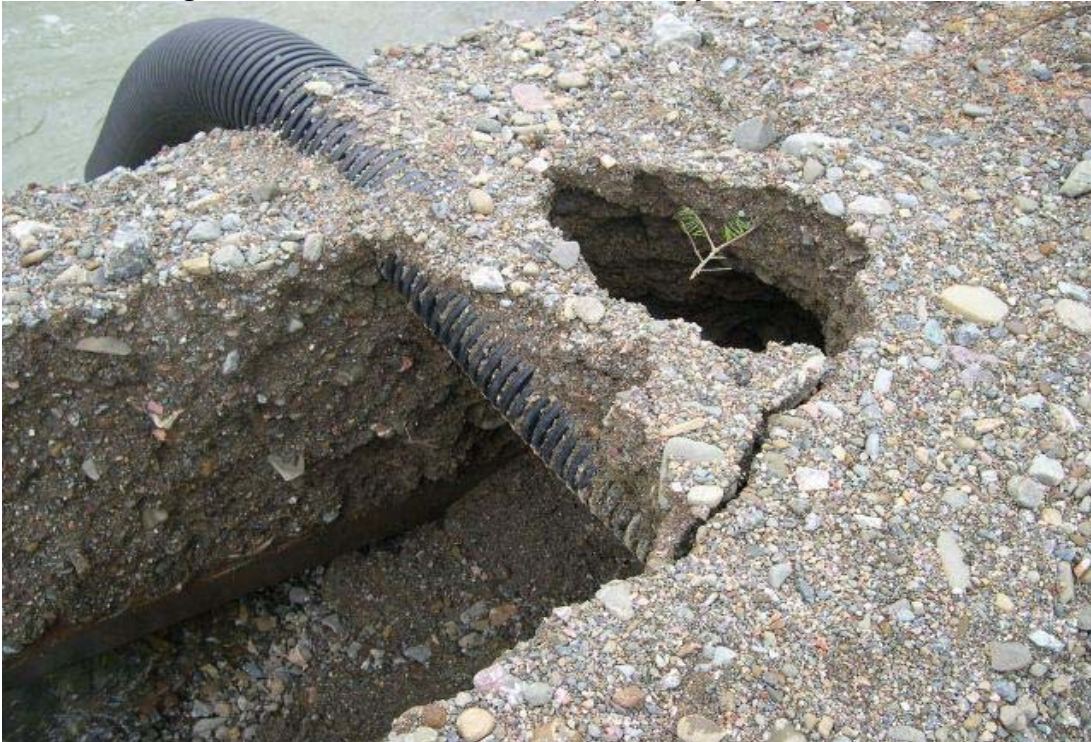
Photo 2. Erosion of gravels behind concrete K-rail. (Photo by Karen Maurer, March 6, 2006)

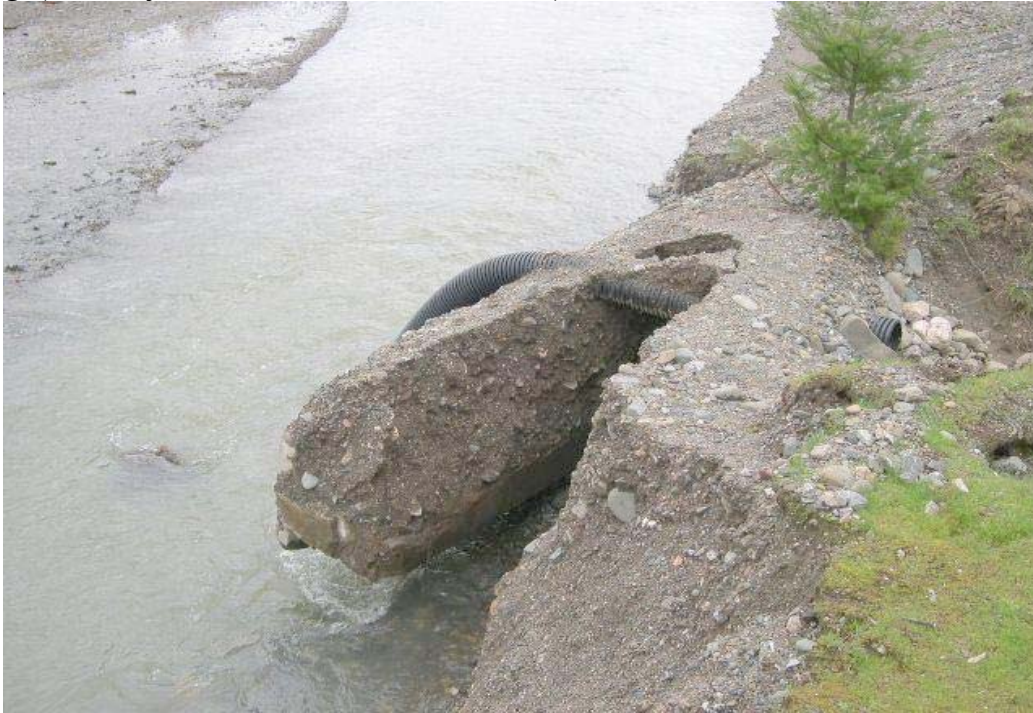
Photo 3. Overview of concrete K-rail buried in the streambank, with active erosion of gravels occurring. (Photo by Karen Maurer, March 6, 2006)

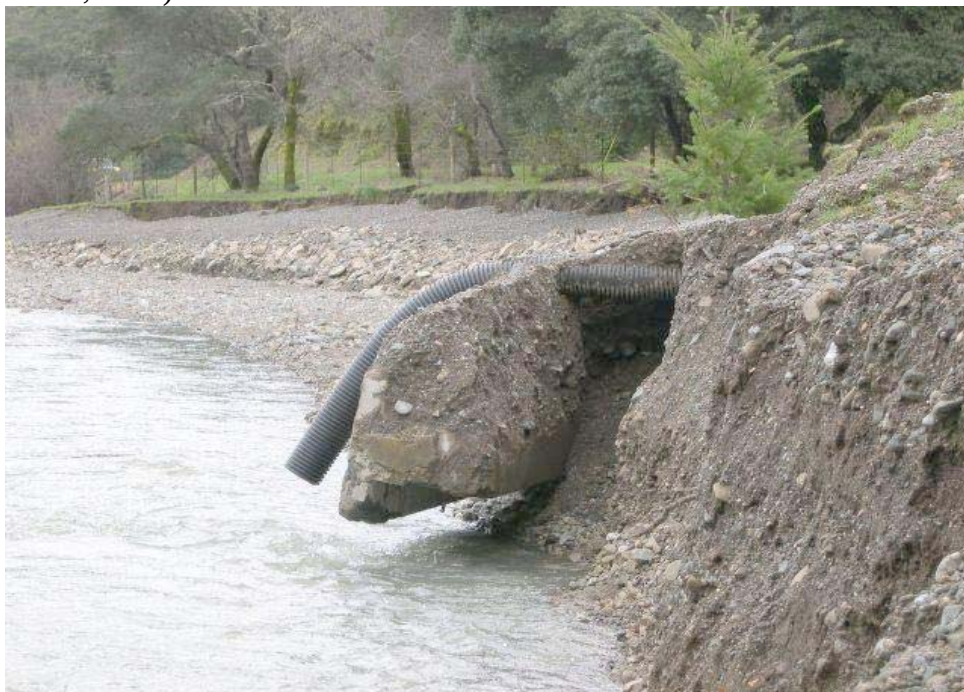
Photo 4. View facing downstream towards K-rail buried in the streambank. (Photo by Karen Maurer, March 6, 2006)
