North Coast Regional Water Quality Control Board

Subject: **Notice of Violation** of State Water Resources Control Board Order No. 2009-0009 DWQ as amended by Orders 2010-0014 DWQ & 2012-0006 DWQ *General Permit for Storm Water Discharges Associated with Construction and Land Disturbance Activities* (Construction General Permit), **and Confirmation of Subsequent Corrective Actions**

File: Mary Court Subdivision, Eureka (Site and Project), Humboldt County, Construction General Permit, WDID 1 12C376633

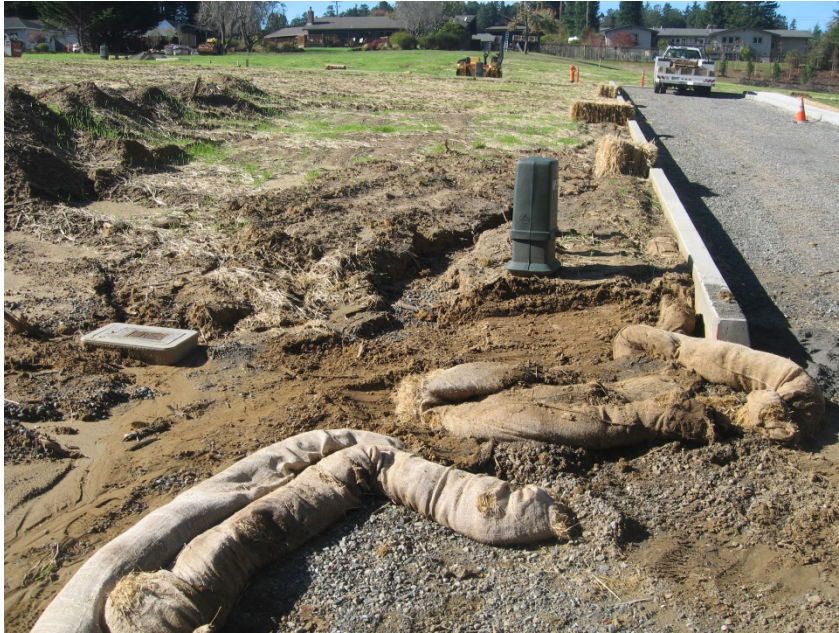
Photograph 1. Mary Court Subdivision – 11/02/16: Curb and gutter alignment that concentrated storm water runoff. Photograph by Paul Keiran, Regional Water Board staff

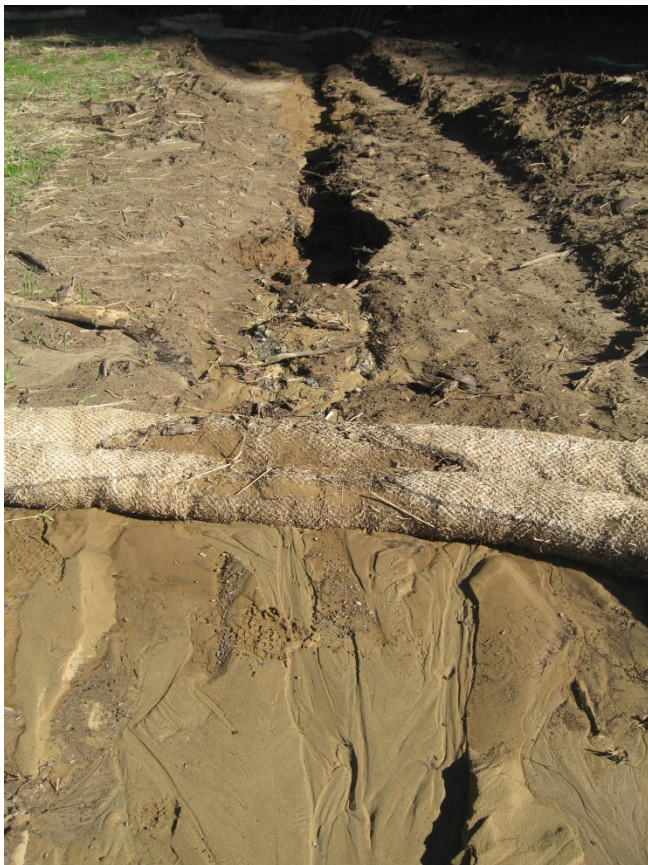
Photograph 2. Mary Court Subdivision – 11/02/16: Discharge of sediments from the Site into a small ravine. Photograph by Paul Keiran, Regional Water Board staff

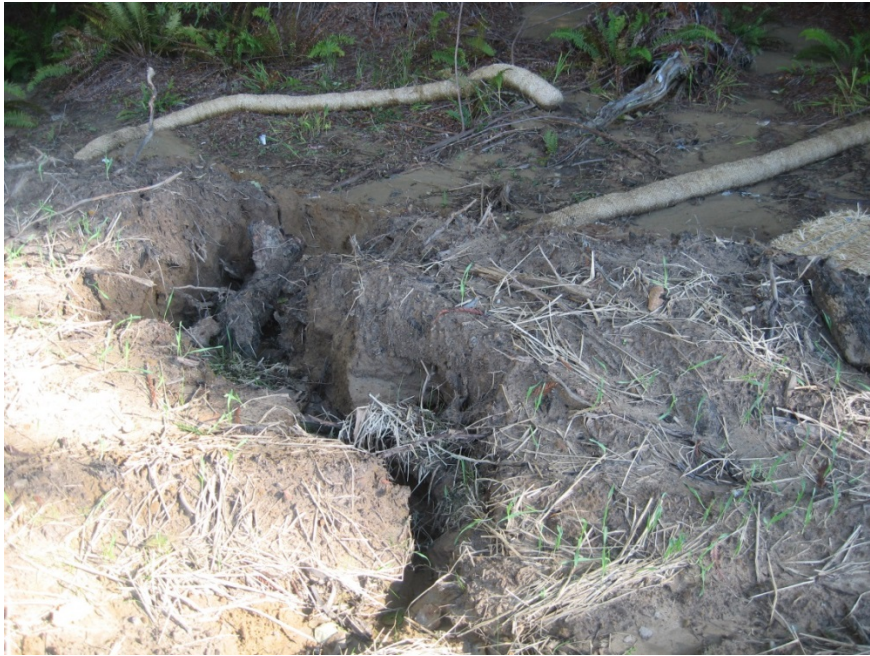
Photograph 3. Mary Court Subdivision – 11/02/16: Large gullies formed by high velocity flowrate. Photograph by Paul Keiran, Regional Water Board staff

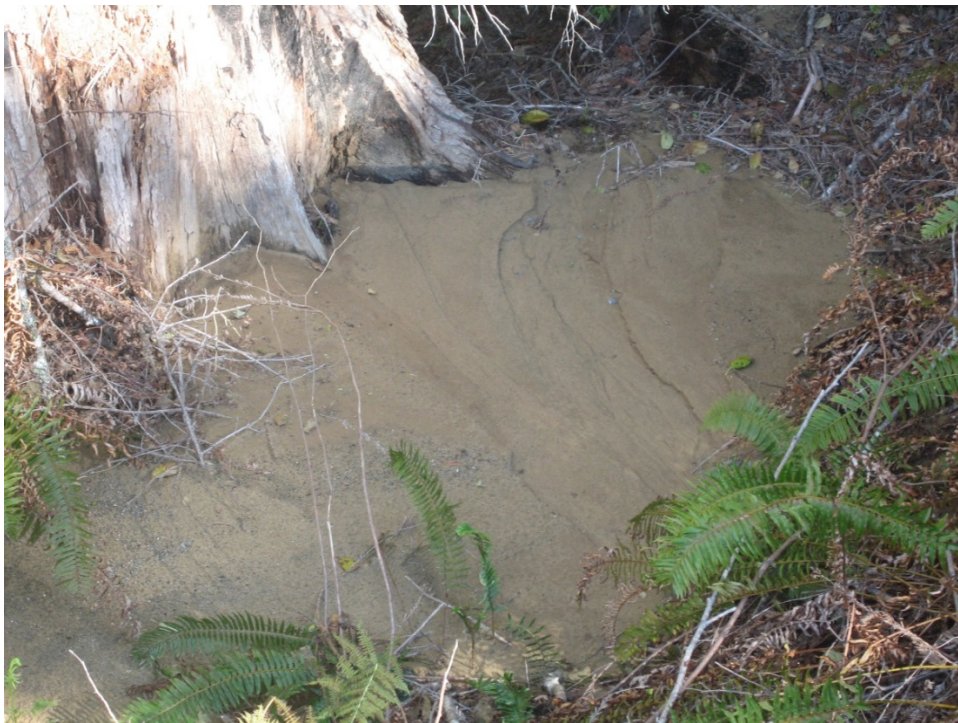
Photograph 4. Mary Court Subdivision –11/02/16: Offsite discharge of sediments adjacent to bank of tributary drainage. Photograph by Paul Keiran, Regional Water Board staff
