Re: Douglas and Heidi Cole, Marble Mountain Ranch
Progress Report June 2017 and Partial Response to Notice of Violation No. 3 of
Order R1-2016-0031
Cleanup and Abatement Order R1-2016-0031 and Draft Order WR 2017-00XX-
DWR, issued on August 30, 2016

APPLICATION/REPORT OF WASTE DISCHARGE GENERAL INFORMATION FORM FOR WASTE DISCHARGE REQUIREMENTS OR NPDES PERMIT

Example Rootwad Revetment Installation

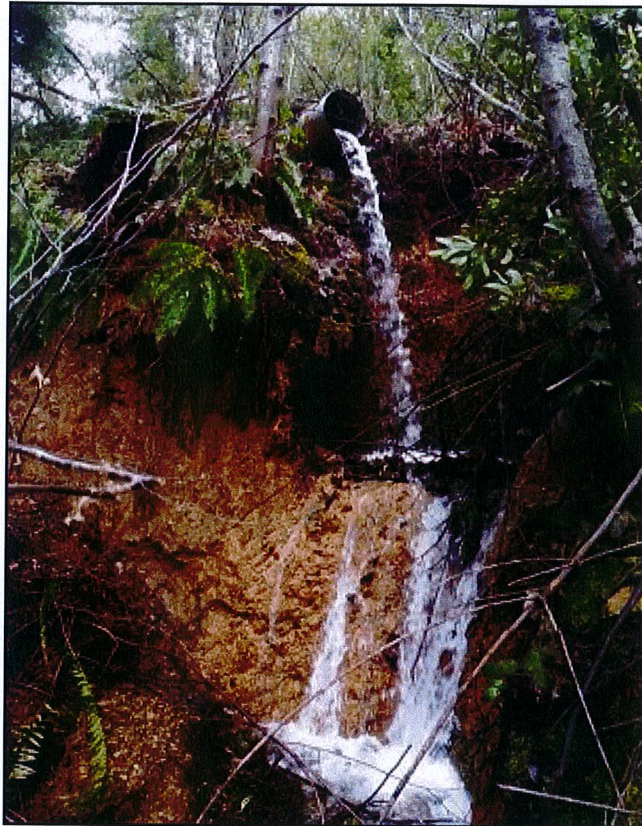
Photo #1. Existing Irving Creek Outfall. Taken by Fiori Geosciences.

A Sediment Source Assessment (*Stanshaw Creek Diversion Ditch Sediment Source Assessment*; Fiori GeoSciences, April 04 2017) has been prepared to identify sources of erosion and sedimentation and to recommend remedial measures. According to the Sediment Source Assessment, the outfall was estimated to have an erosion rate of 0.3 cubic yards per year and an incision rate of approximately 4 inches per year over the 21-year period since the culvert was installed in 1996. However, this feature may now have a reduced incision rate due to erosion into more resistant material. A photograph of the existing outfall is provided in Attachment A. ECORP is providing information on proposed remediation actions for this outfall.

The Sediment Source Assessment recommends simple, low cost actions to address erosion at outfall. To implement this suggested approach, a new culvert designed to direct flows away from the edge of slope will be installed. In addition, several large rootwads from downed trees on the property will be installed at the base of the outfall to serve as flow velocity dissipation devices and reduce erosional activity. The culvert will be designed such that flows are directed onto the rootwads for maximum energy dissipation, in order to reduce scouring and sediment production.

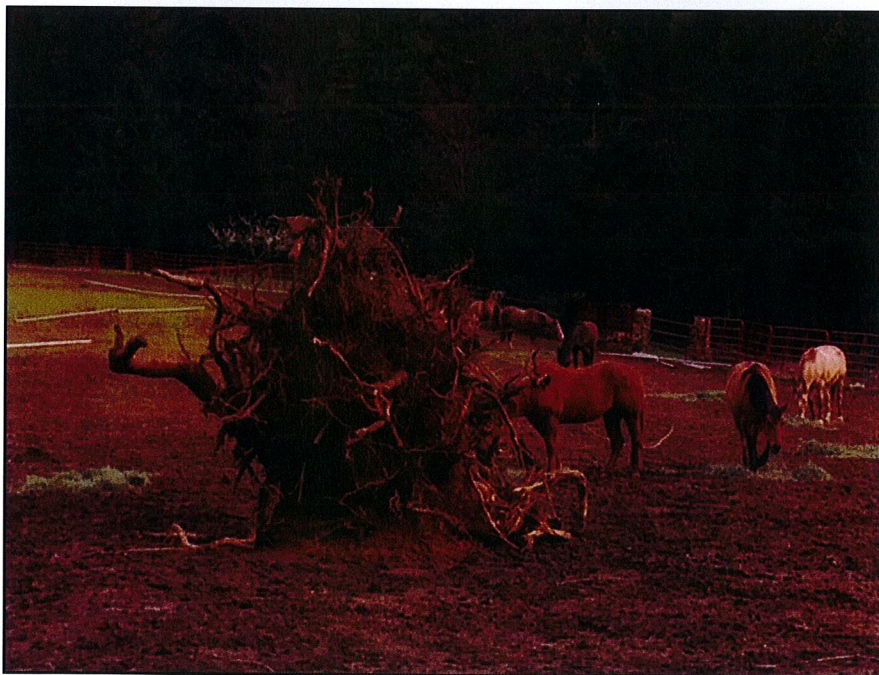
Photo #2. Example Rootwad. Photograph taken 28 March 2017.

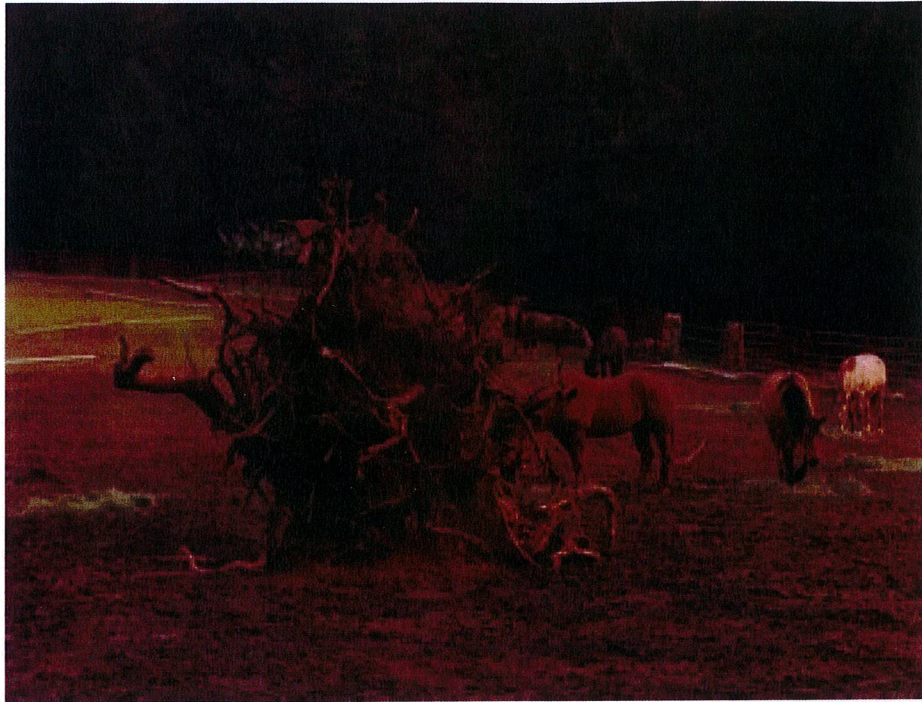
Photo #3. Example Rootwad. Photograph taken 28 March 2017.
