North Coast Regional Water Quality Control Board

Subject: **NOTICE OF VIOLATION:** Unauthorized activities involving the placement of fill in waters of the State in violation of the Federal Clean Water Act and California Water Code.

File: Andrew Pillet 11208 Loch Haven Dr, Santa Rosa,  
Sonoma County, WDID No. 1B20198WNSO

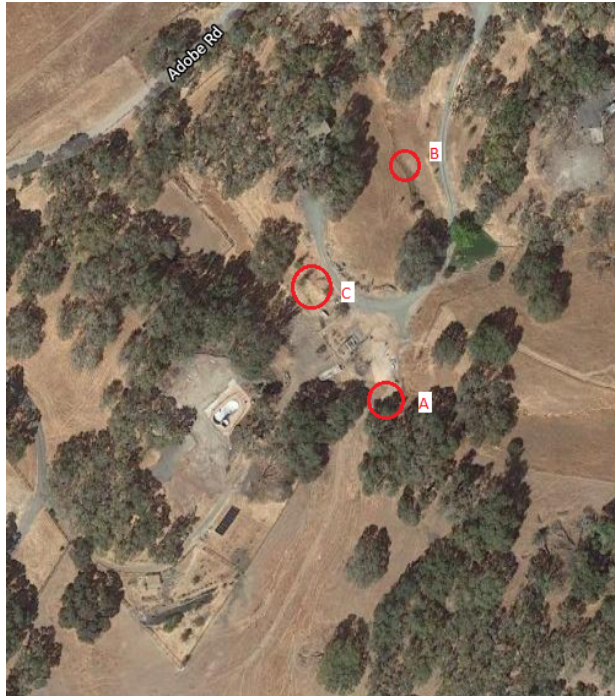
Figure 1: Overview of property and site map

material threatening or potentially threatening to discharge to watercourses. Regional Water Board staff communicated to the DFW that we would be conducting our own investigation of the complaint and potentially pursuing enforcement if warranted. The three sites described on the property will be keyed to the map provided below (Figure 1).

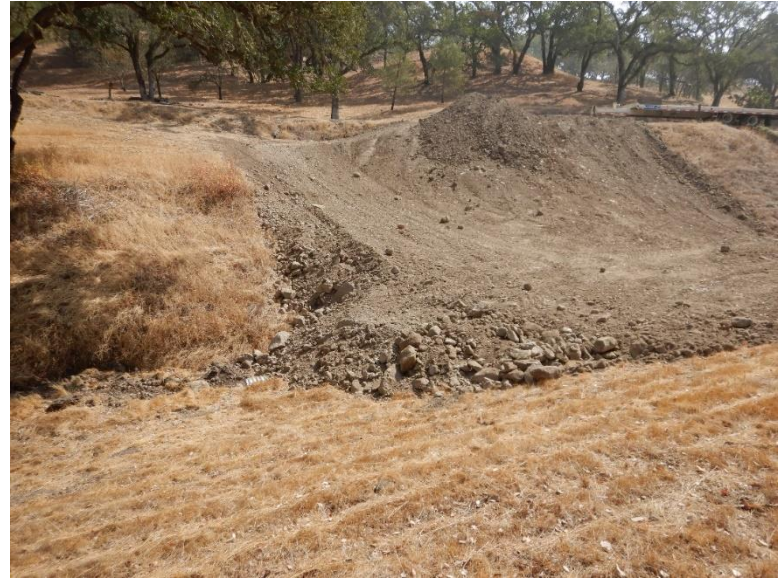
Figure 2: Site B

On September 14, 2020, Regional Water Board staff Justin Fitt and I inspected the property. At Site B, we observed fill, including soil and a culvert placed in a watercourse to cross a small ephemeral stream to enhance access to the landowner's parcel. Associated spoils were perched above the watercourse and bare earth related to the crossing construction (Figure 2).

Be advised that, as set forth above, you have discharged without a permit in violation of state and federal law and could be subject to administrative civil liability pursuant to Water Code sections 13350 and 13385 in the amount of up to \$10,000 per day of violation. We advised you that material that had been placed in the channel (site B), or in a position where it could discharge to the channel (site A) must be removed and stabilized with erosion/sediment control measures prior to the onset of the rainy season. Long term remediation of site A would entail redirecting the head of the

ephemeral watercourse to its original channel by installation of an appropriately designed crossing structure. Such work is beyond the scope of the current process and will require that you apply for and receive the appropriate water quality permit.

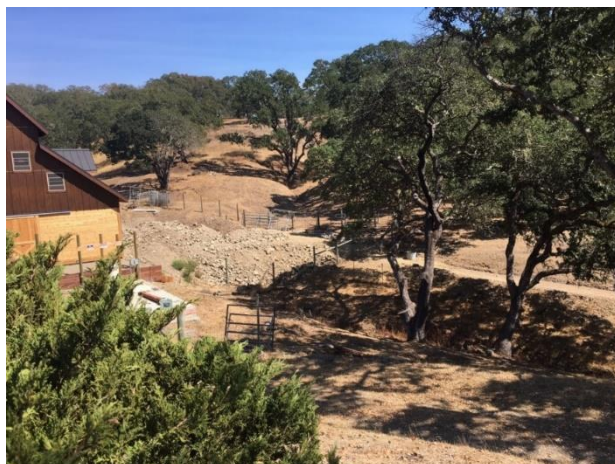
Figure 3: Site A

We also inspected other sites of concern identified by the Warden. Site A is a historic crossing of a class III watercourse by a dirt road that was constructed to access a livestock coral on the property. Flow from the head of this class III watercourse is diverted from its historic channel to an inboard ditch before dispersing into a flat animal pasture. Evaluating historic aerial imagery was inconclusive to determine the date of the initial diversion. Recent work at this site has expanded the crossing and a flat area beside the landowner's barn (Figure 3). This expansion resulted in fill material being placed above the head of the cutoff channel where the material could be transported to the channel. We inspected site C, a recently compacted hillside adjacent to a swale feature on the landscape. We concluded that with the installation of erosion and sediment control, there was no risk of sediment discharge (Figure 4).
