North Coast Regional Water Quality Control Board

**Subject: Notice of Violation, Transmittal of Inspection Report for July 22, 2021
Inspection of Humboldt County Assessor's Parcels 532-055-009-000 and
532-056-009-000, and Directive to Respond within 30 days**

FACILITIES INSPECTION REPORT

Graves July 22, 2021 Inspection Photo Log
Photos Taken by Kate Hawken

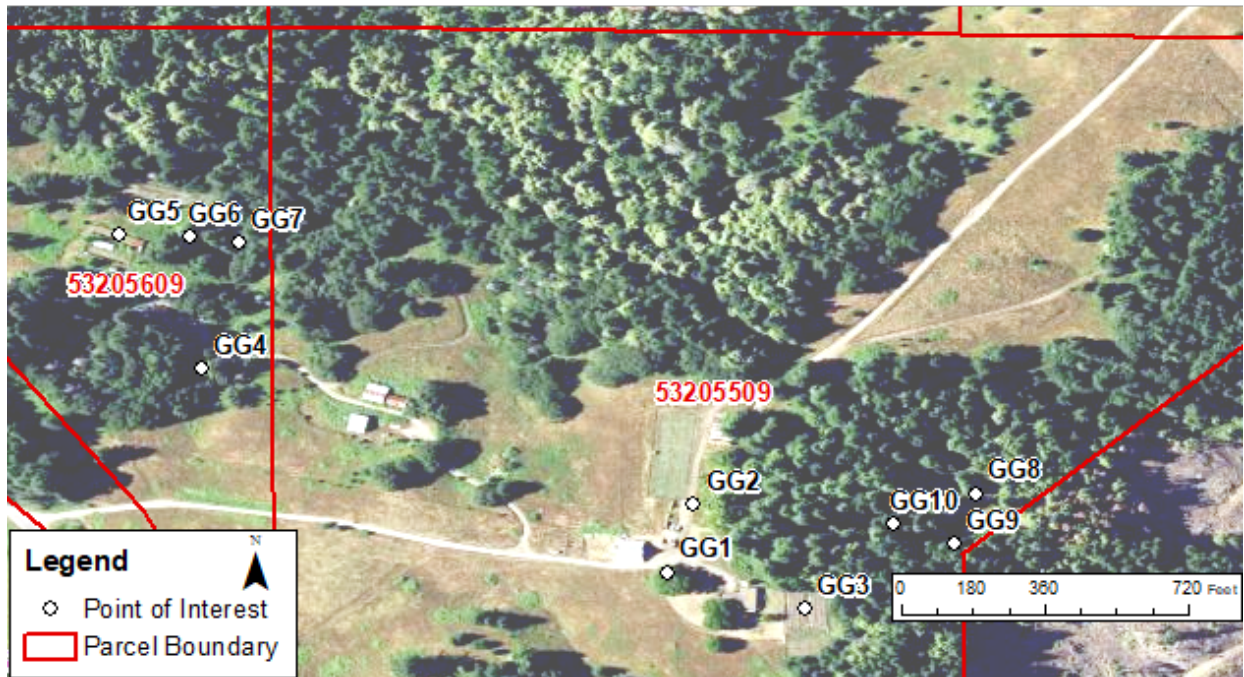
Graves Inspection Map

Map of property with inspection points of interest and parcel boundaries created by Kate Hawken. Background is 2020 NAIP Imagery

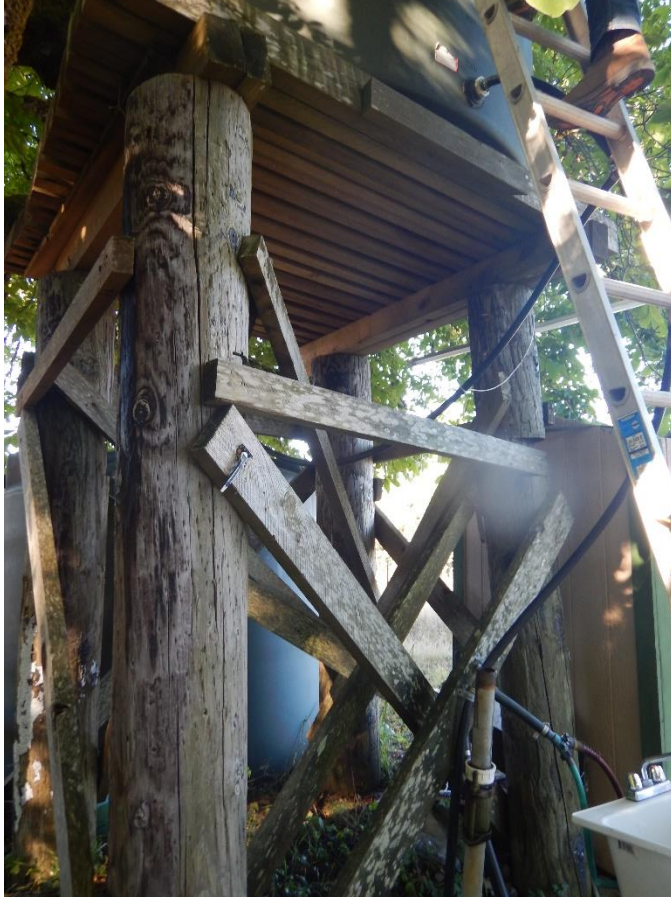
GG1: I observed a water tank with a leaking hose connector on a platform with another water tank below it (Photo 1).
 GG2: I observed an outdoor cultivation area with cannabis plants in grow bags (Photo 2).
 GG3: I observed an outdoor cultivation area with cannabis plants in pots (Photo 3).
 GG4: I observed a squashed, blocked culvert stream crossing (Photo 4).
 GG5: I observed three small outdoor cultivation areas with mixing tanks, fertilizer, and petroleum products left open (Photo 5).

Photo 1: GG1: Two water tanks with leaking connection

4. Regularly inspect water diversion and storage system, and fix leaks promptly.
5. Work with the California Department of Fish and Wildlife and the State Water Board Division of Water Rights on permitting options for instream diversions.

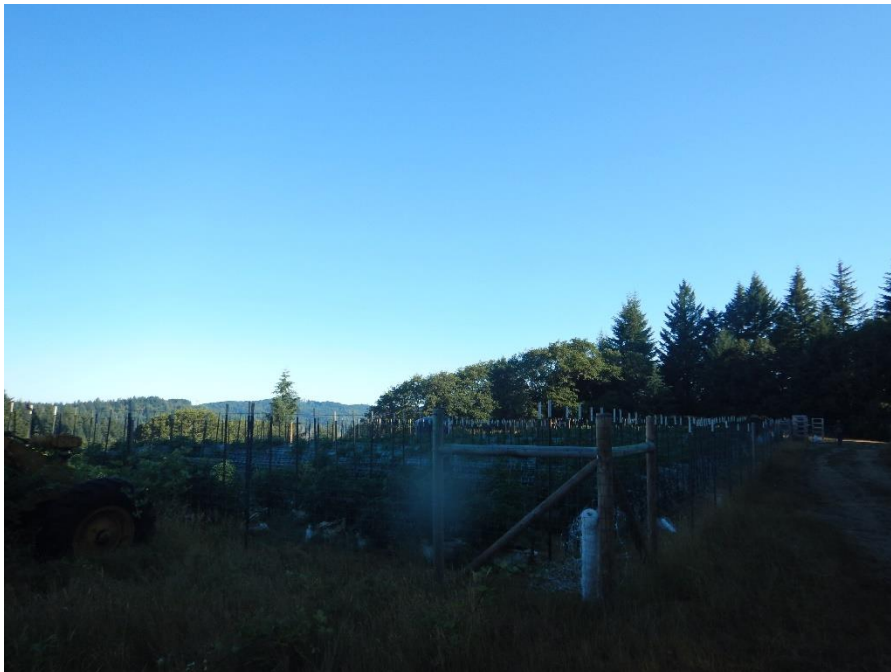
Photo 2: GG2: Outdoor cultivation area with cannabis plants in grow bags

1. If the property owner and/or tenant(s) plan to continue cultivating cannabis on the Property, enroll for coverage under the State Water Board’s Order WQ 2019-0001-DWQ here: <https://public2.waterboards.ca.gov/cgo>

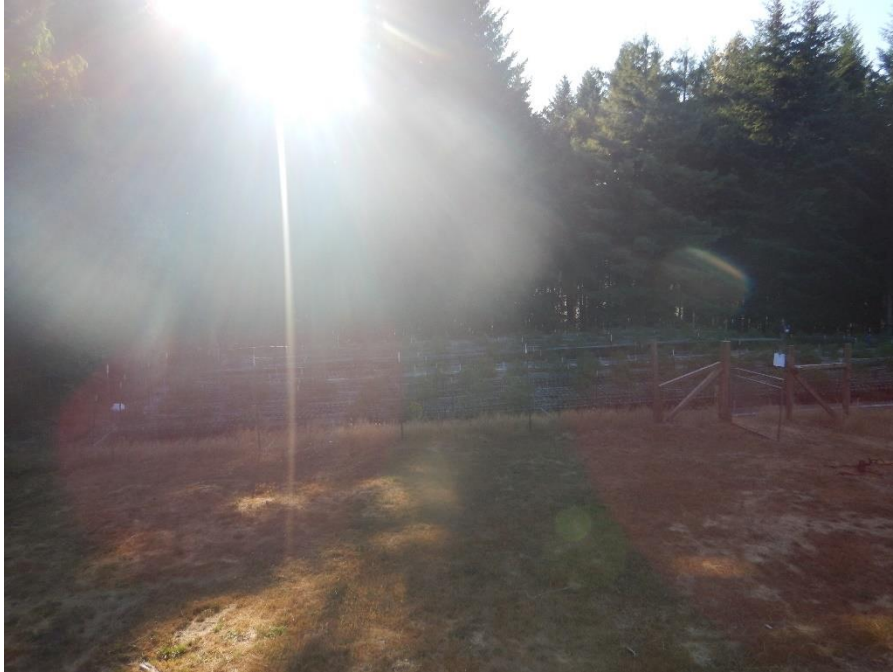
Photo 3: GG3:
Outdoor cultivation
area with cannabis
plants in pots

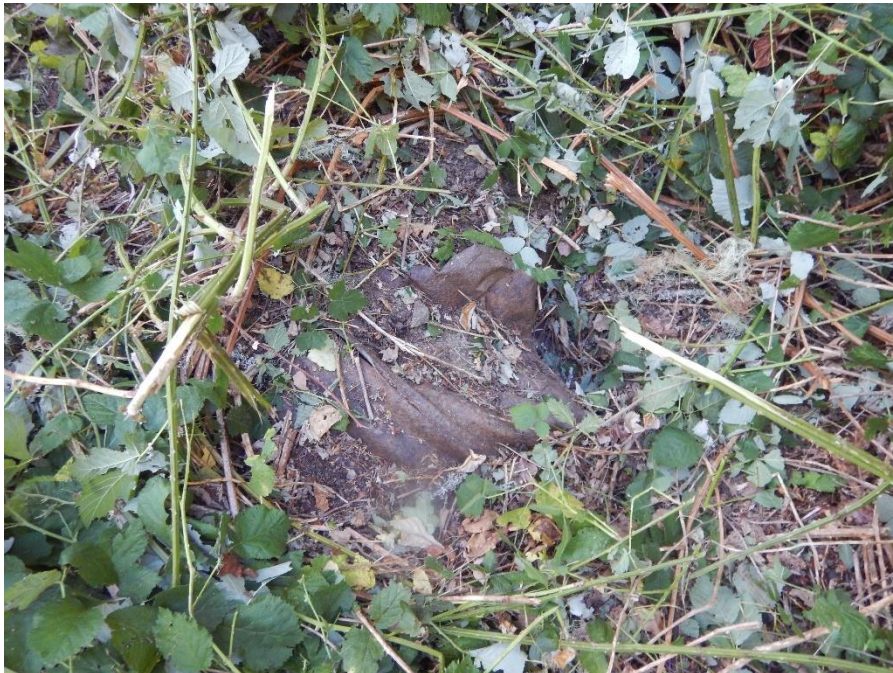
Photo 4: GG4:
Squashed, rusted
culvert inlet

2. Retain a licensed professional to develop a workplan and schedule to:
 - a. Install stream crossings with the capacity to convey the 100-flood flow at GG4 and GG7.

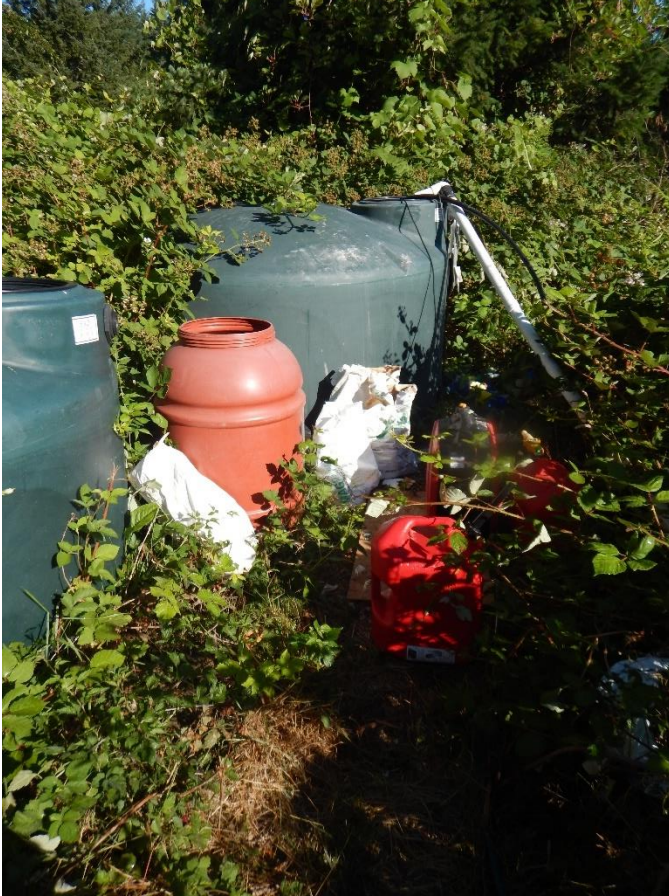
Photo 5: GG5: Mixing tanks, fertilizer, and petroleum products near outdoor cultivation area

6. Store and dispose of petroleum products, domestic waste, and cultivation waste properly to prevent spillage and potential for migration/transport into receiving waters.

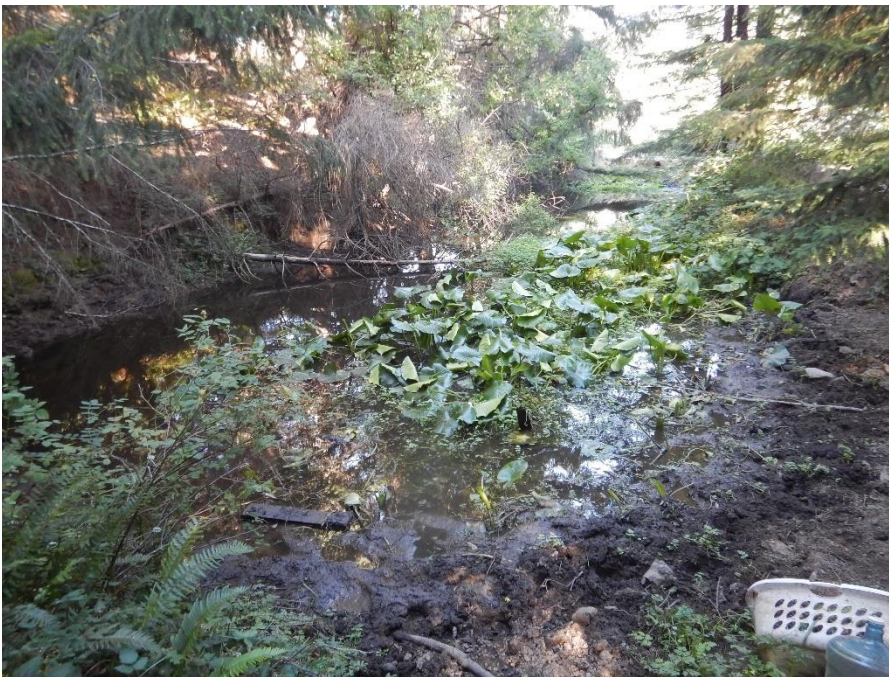
GG6: I observed an unlined pond with an outlet culvert in the berm (Photo 6). The pond was fed by a spring. I observed a water diversion line in the pond and a pump on the bank. The pond appeared to be leaking with wet areas evident around the base.
 GG7: I observed a misaligned culvert stream crossing receiving road runoff (Photo 7).
 GG8: I observed an outdoor cultivation area with cannabis plants in terraced raised beds (Photo 8).
 GG9: I observed an unlined pond in a low-lying area (Photo 9). The pond was fed by a spring (GG10). Flow overtops the pond berm and discharges to a watercourse channel downhill.
 GG10: Uphill of the pond (GG9) I observed a spring with a constructed pump shed and diversion line in the springhead (Photo 10).

Photo 6: GG6: Onstream, unlined pond with culvert set high in berm

- b. Hydrologically disconnect access roads from watercourses.
 - c. Improve instream impoundments GG6 and GG9 so they are not at risk of failing and discharging sediment; or remove the ponds and restore the riparian areas.

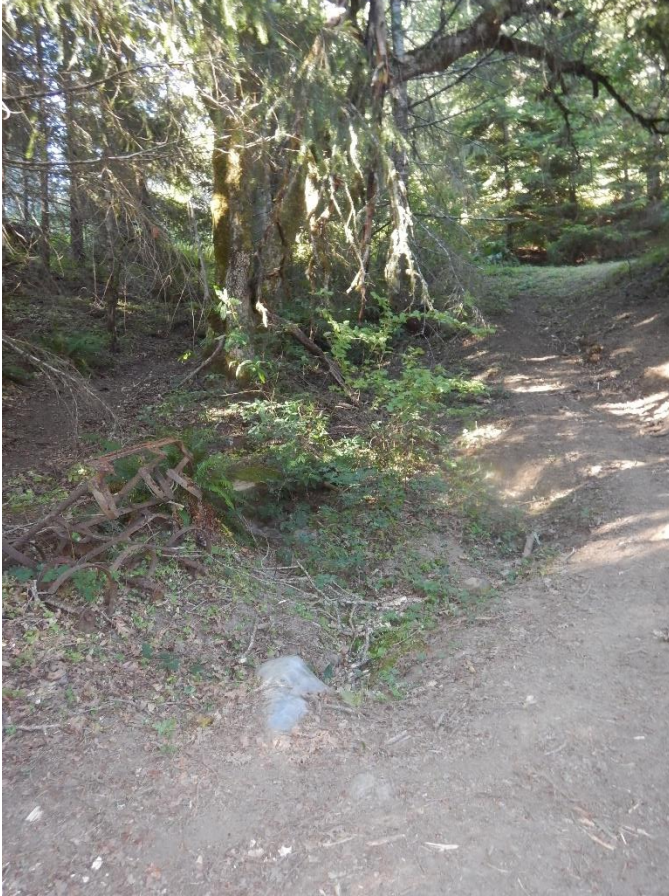
Photo 7: GG7: Misaligned culvert receiving flow from a Class III watercourse and road runoff

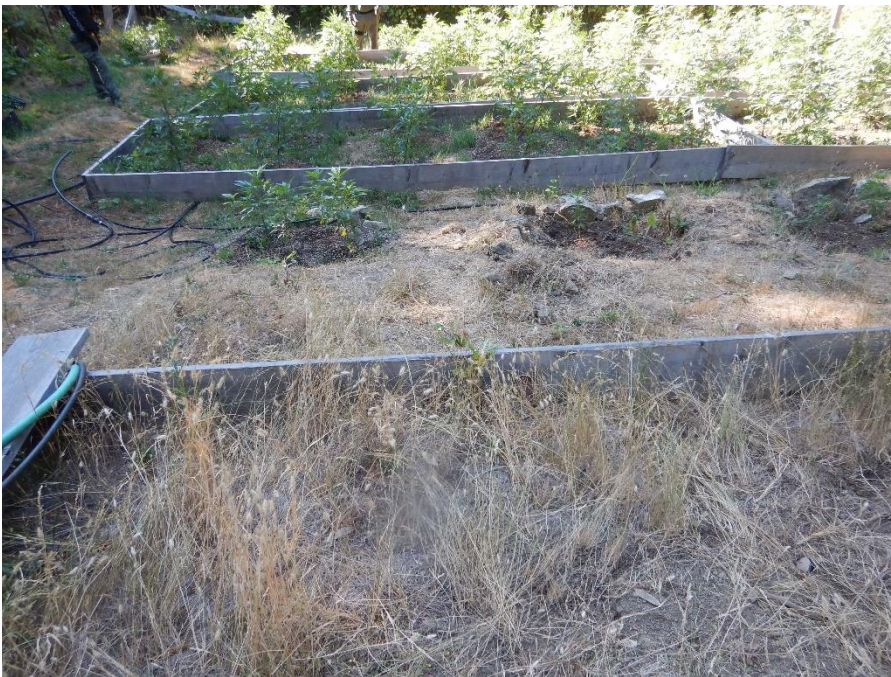
Photo 8: GG8: Cannabis plants in terraced raised beds

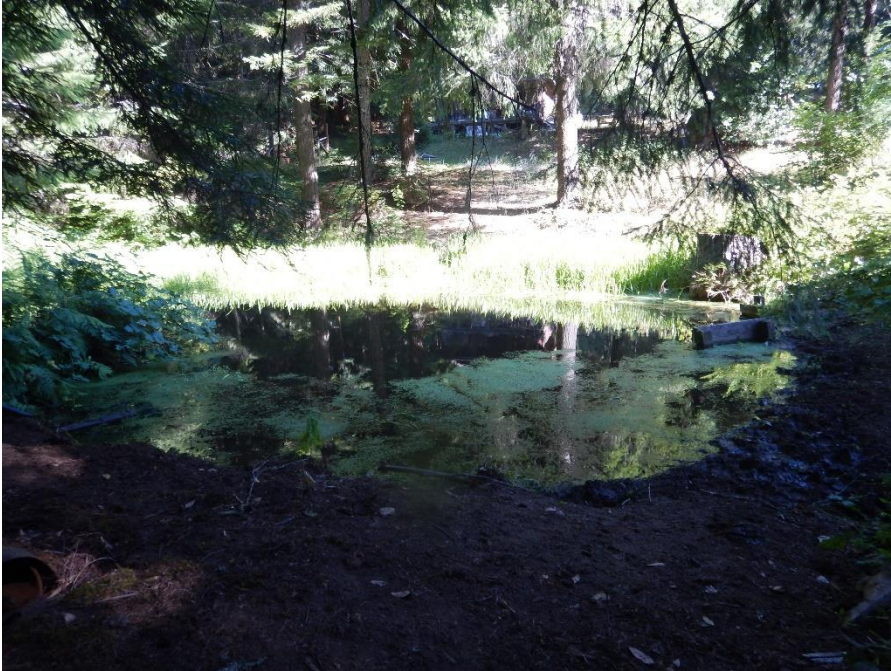
Photo 9: GG9: Unlined onstream pond fed by uphill spring

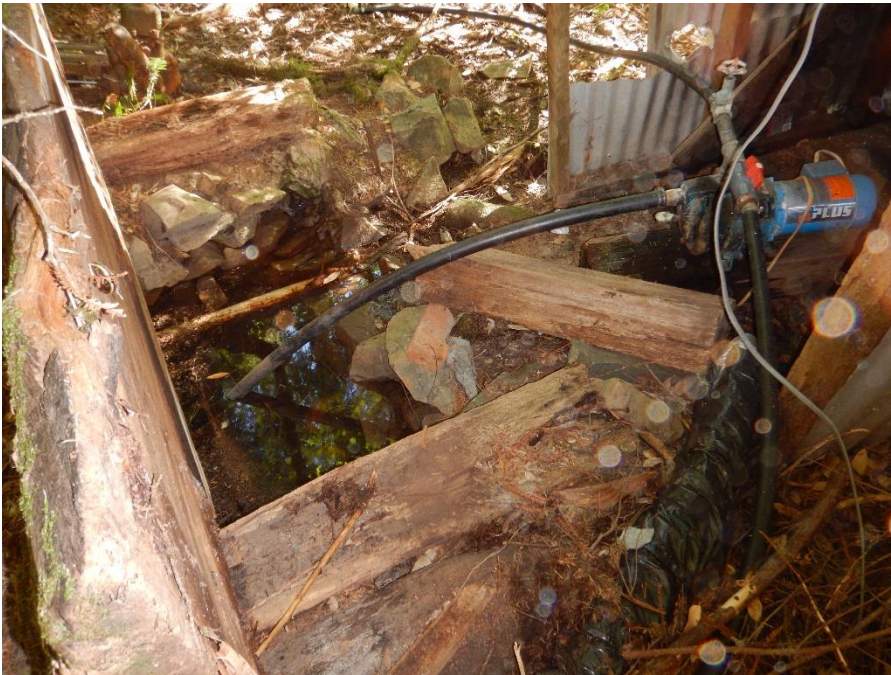
Photo 10: GG10: Shed, pump, and black poly diversion line in spring above pond
