Subject **Notice of Violation, Transmittal of Inspection Report of July 11, 2023
Inspection of Siskiyou County Assessor's Parcel Number 100-452-080**

**North Coast Regional Water Quality Control Board
Attachment B**

Cannabis Water Quality Inspection Report

Vue Yang Property, Siskiyou County APN 100-452-080, WDID No. 1_47MJ000368

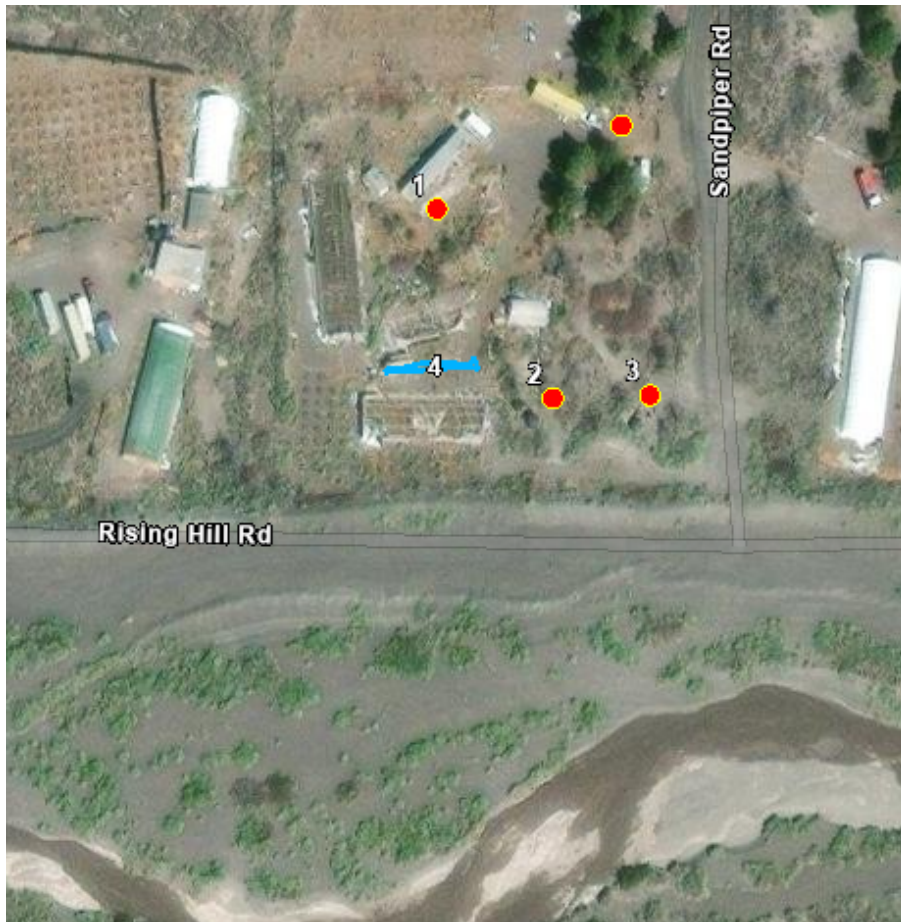
Figure 2. Inspection map.

The inspection map is shown in Figure 2 and includes the locations referenced at the following features of concern to water quality.

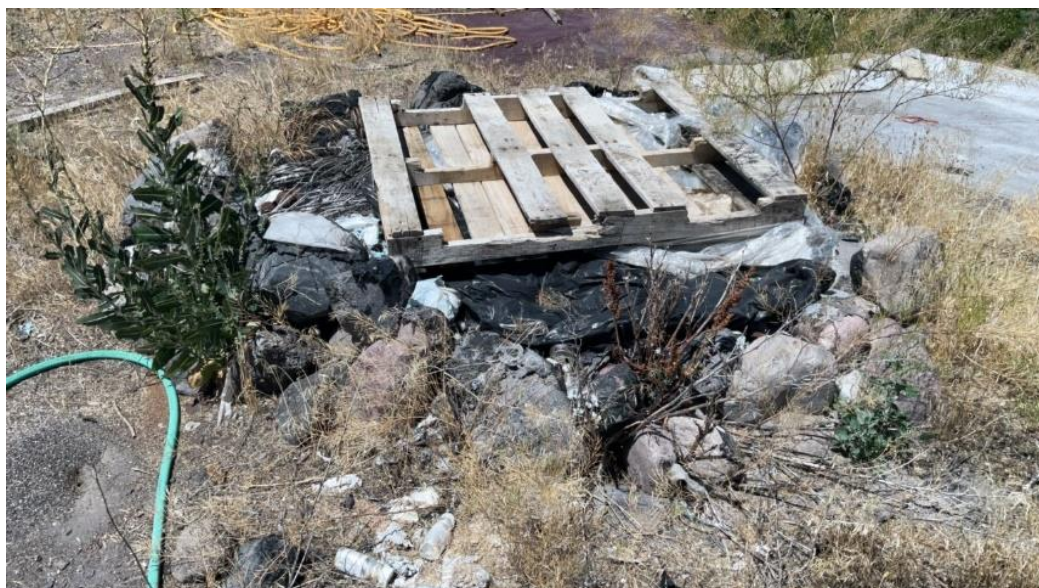
Location 1: Burned plastic trash at residences.

Figure 3. Trash burn ring at Location 1.

1. Cease unauthorized cannabis cultivation.
2. Cease burning and land disposal of household and cultivation-related trash and properly dispose all refuse at a legal disposal facility.

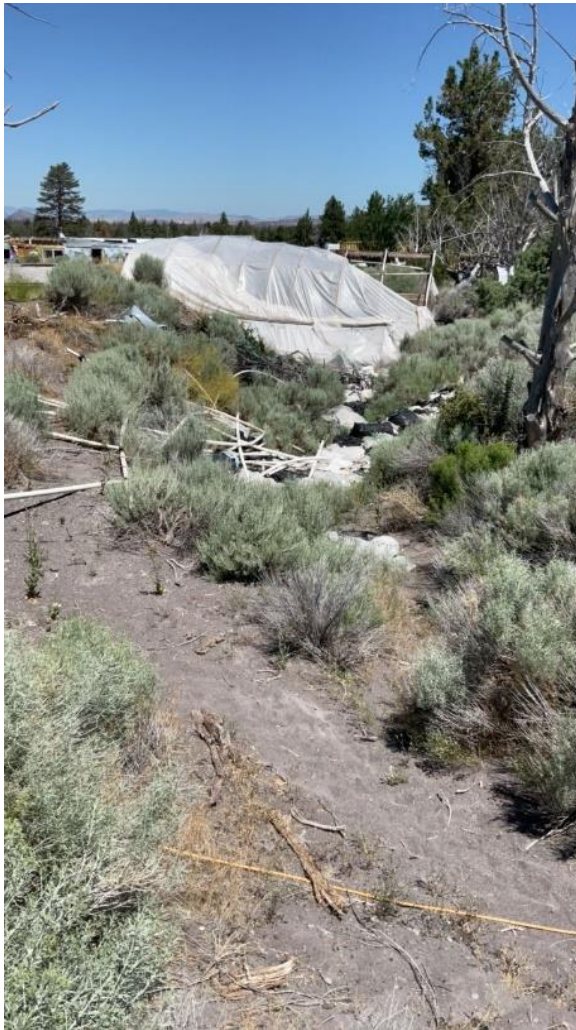
As document in the inspection report, Staff observed plastic cultivation waste burned on the ground at Location 2, threatening the quality of waters of the state in violation of Water Code section 13264.

Location 2: Accumulation of cultivation-related plastic refuse.

Figure 4. Accumulation of cultivation related plastic trash at Location 2.

3. Remove cultivation infrastructure and properly dispose of waste including but not limited to trash, fertilizer, pesticide and petroleum containers, plastic tarps and sheeting at a legal facility.

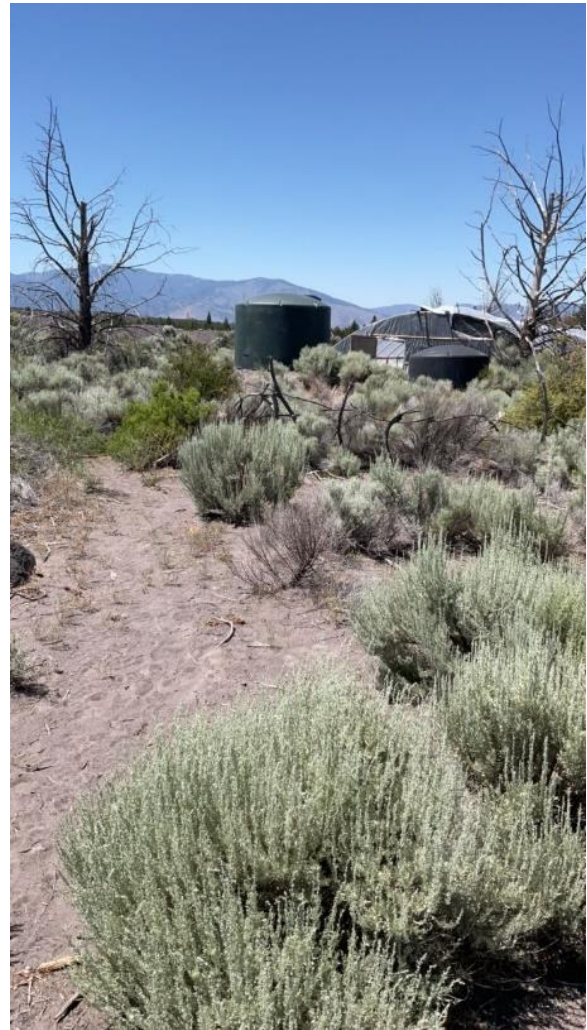
Figure 5. Water tank filled from well. A charged water line from the tank was going to an adjacent property, APN 100-453-070.

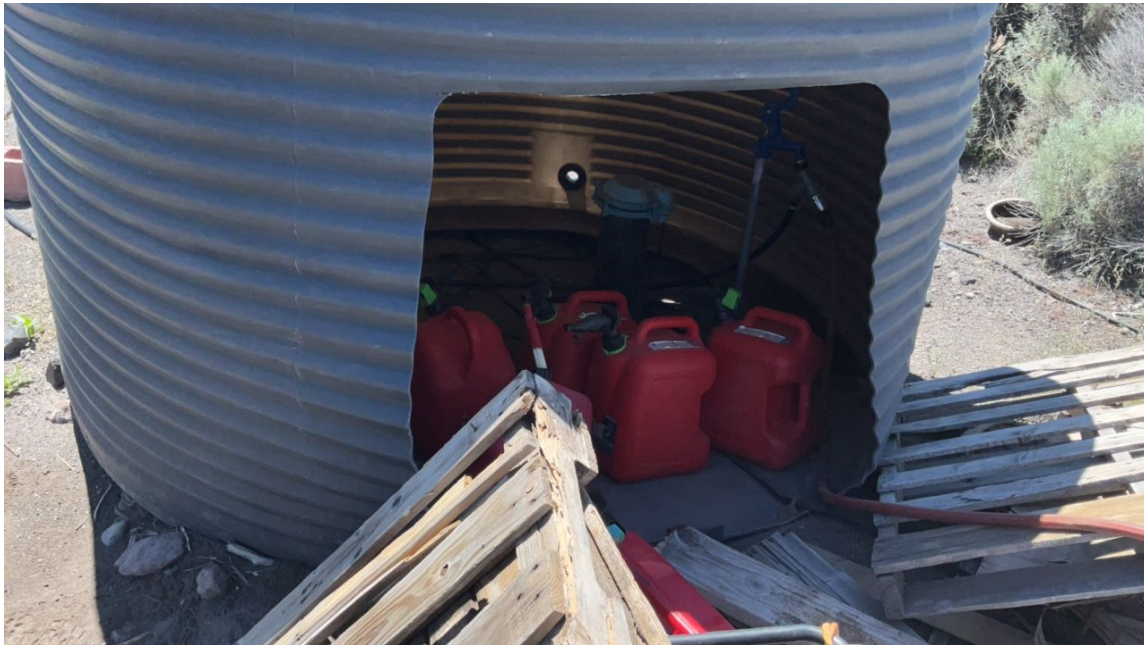
Location 3: An Irrigation well with gas pump was actively filling a water tank. Petroleum containers are stored next to the well. A charged water line from the tank was going to an adjacent property, APN 100-453-070.

Figure 6. At Location 3, an irrigation well with gas pump was actively filling a water tank. Petroleum containers are stored next to the well.

4. Properly dispose of all pesticides and fertilizers at a legal disposal facility.
5. Properly contain generators, pumps and petroleum products to prevent spillage and discharge; properly dispose of waste oil at a legal disposal facility.

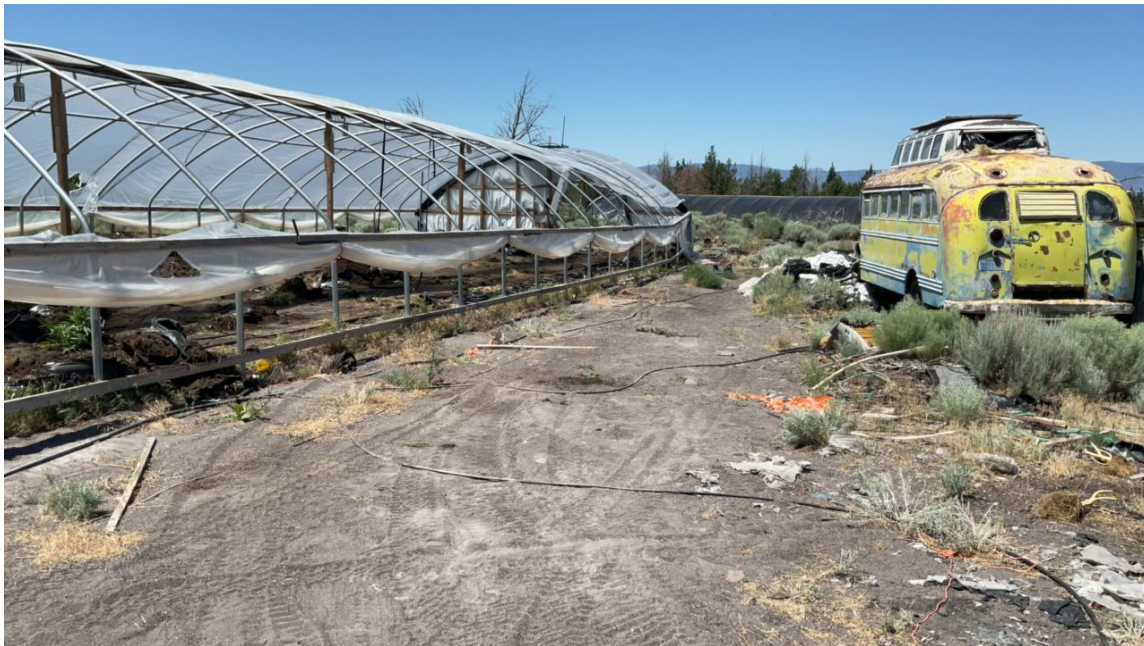
Location 4: Commercial scale cannabis cultivation in four greenhouses.

Figure 7. Cultivation in four greenhouses at Location 4.
