North Coast Regional Water Quality Control Board

Subject: Notice of Violation, Transmittal of Inspection Report for August 1, 2023, Inspection of Trinity County Assessor's Parcel Number 019-640-028, and Requirement to Respond within 30 days

FACILITIES INSPECTION REPORT

Bao Vue Inspection Photo Log
Photos taken by Kate Hawken on August 1, 2023

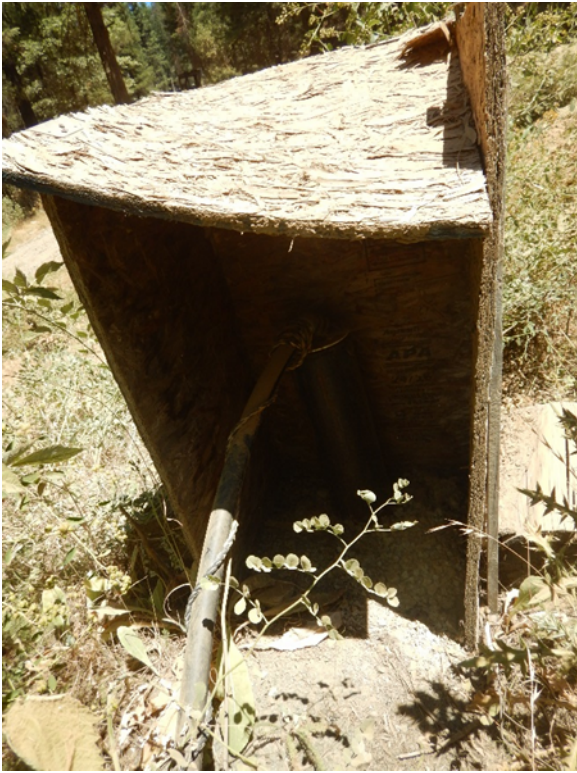
Observations:
 I observed a well under wood boards (Photo 1). I observed a 12" diameter plastic culvert stream crossing under the driveway accessing the property, with the top exposed, and the inlet blocked by a log round (Photos 2 and 3). I observed cannabis plants in grow bags 5 feet from a stream, and in raised beds (Photos 4 and 5). I observed trash bags and a burn barrel adjacent to the stream (Photos 6 and 7). I observed a burn pile in the stream (Photo 8).

Photo 1: Groundwater well

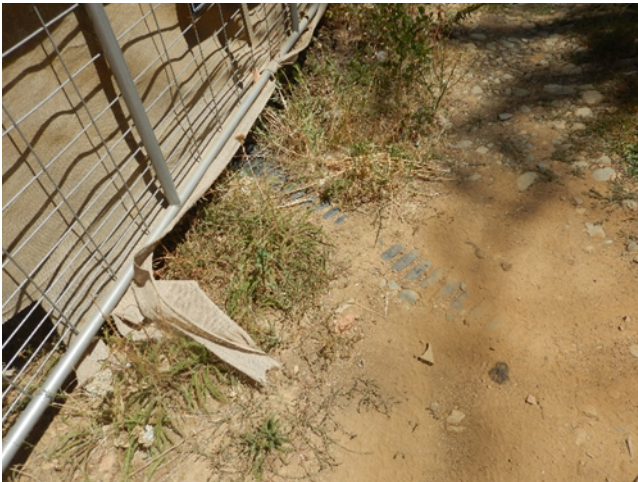
Photo 2: Exposed culvert

2. Regularly inspect and cleanout culvert to prevent blockage. Retain a qualified professional to assess the culvert's capacity to convey the 100 year flood flow, and apply for a 401 Water Quality Certification prior to culvert replacement.

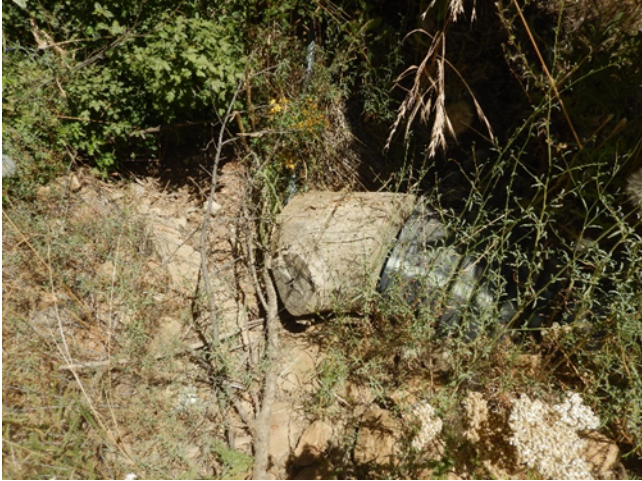
Photo 3: Culvert stream crossing with blocked inlet

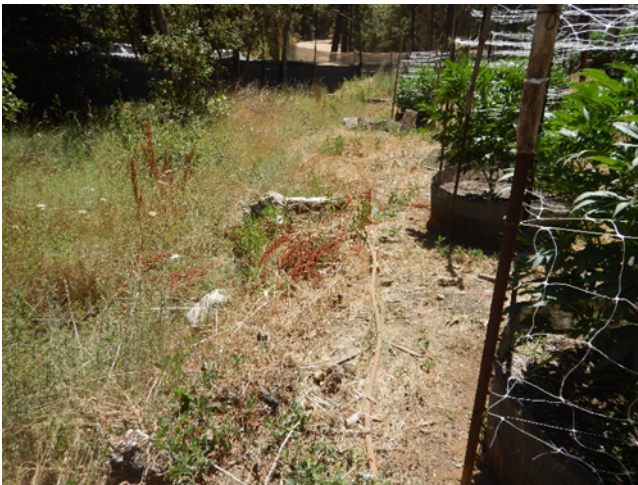
Photo 4: Cannabis plants in grow bags adjacent to a stream

3. Relocate all cannabis cultivation activities, supplies, and trash outside of the riparian setbacks (50 feet from Class III, 100 feet from Class II, 150 feet from Class I).

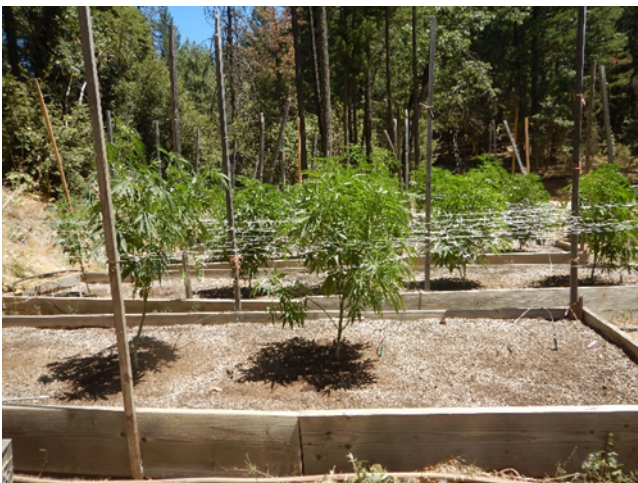
Photo 5: Raised Beds

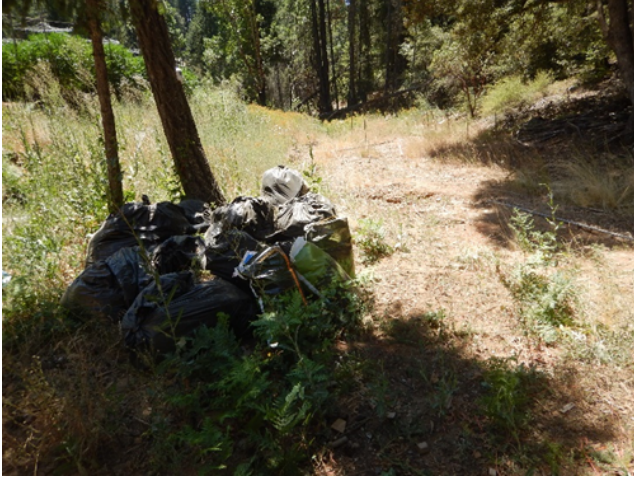
Photo 6: Trash placed near dry streambed

4. Discontinue burning of trash. Regularly contain and dispose of trash at a licensed transfer site.
 5. Discontinue use of outhouse discharging to ground. Adhere to Trinity County regulations on human waste management.

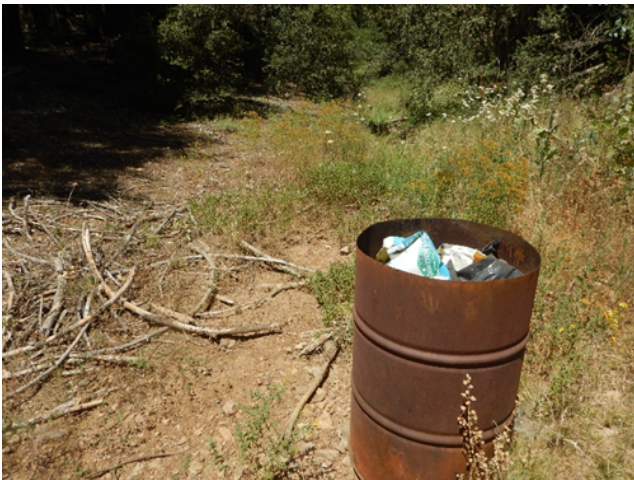
Photo 7: Trash placed near dry streambed

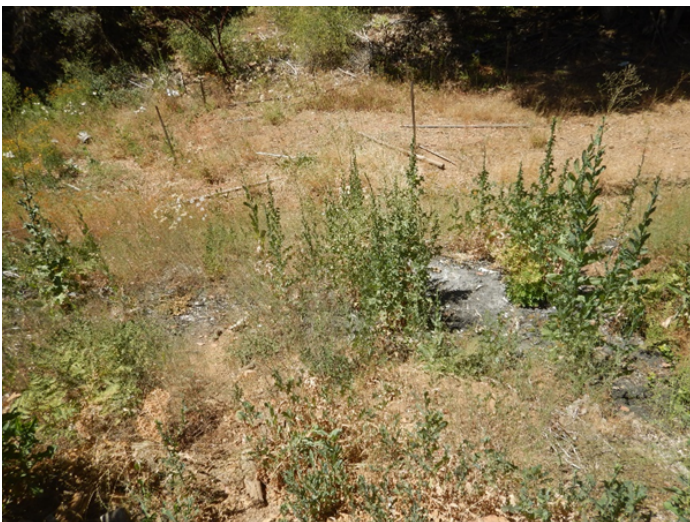
Photo 8: Burn pile in stream

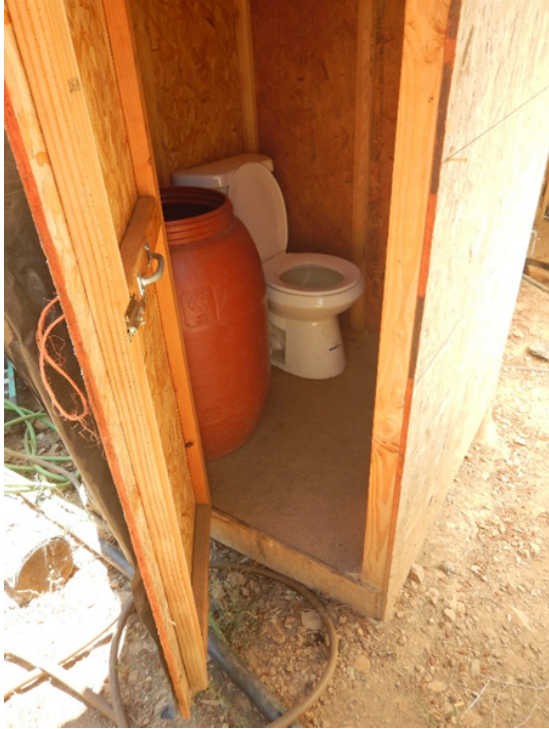
Observations continued:
 I observed an outhouse with a black pipe discharging to land approximately 20 feet from the stream (Photos 9 and 10). I observed pesticides including Sevin and Malathion (Photo 11). I left a field notice on the property with the warrant (Photo 12).

Photo 9: Outhouse with black pipe discharging human waste to land

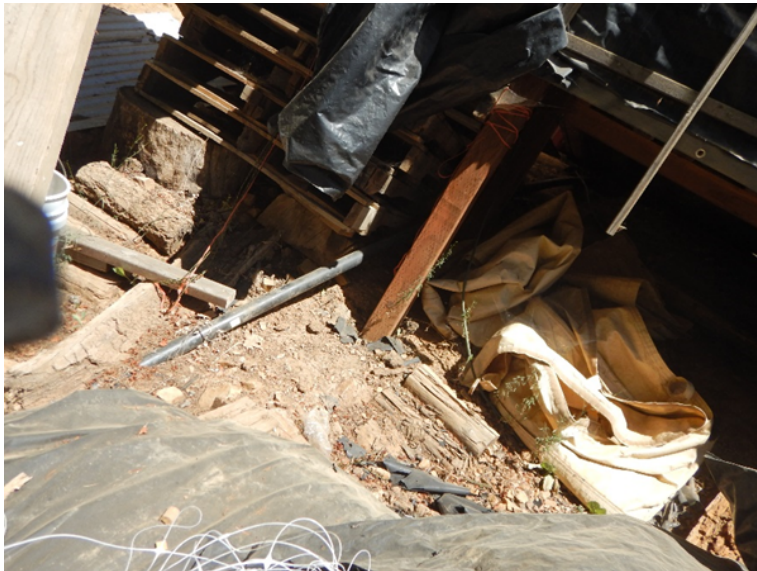
Photo 10: Outhouse with black pipe discharging human waste to land

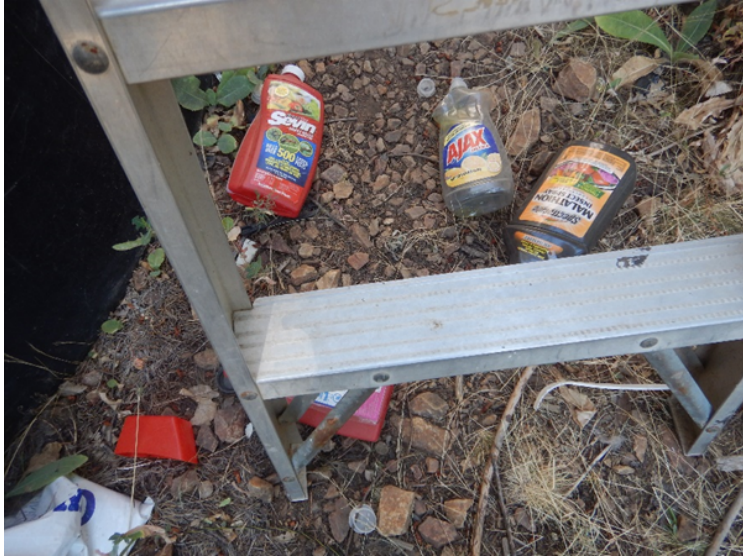
Photo 11: Pesticides Sevin and Malathion found near a water storage tank

6. Adhere to the California Department of Pesticide Regulation guidance on appropriate pesticide use for cannabis cultivation.
