Media Release

Harmful algal blooms reported at Mono County's Crowley Lake; Caution urged for all water users

August 19, 2021

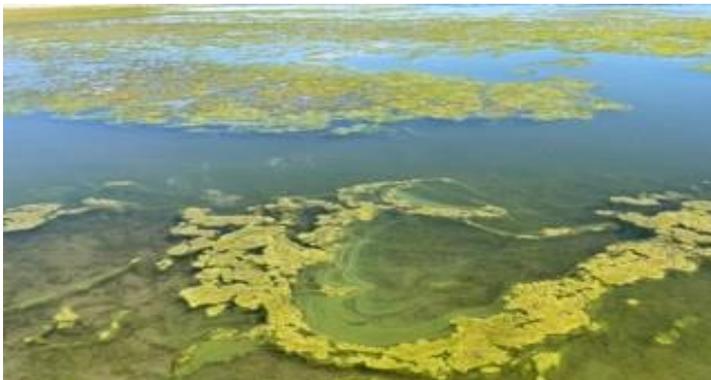
Figure 1: Image of the danger level harmful algal bloom at Crowley Lake.

bloom may proliferate and alter its potential to produce toxins. The recommendation to use caution is based on the potential health risks produced by cyanobacteria, a group of organisms that form HABs. The bloom occurring in the lake appears suspended on the water's surface (Figure 1). Bloom conditions can change rapidly, as the winds and waves move or concentrate the bloom into different regions of the lake. In some areas, the bloom may concentrate and form a film or scum on the water surface. The color of the water may also appear

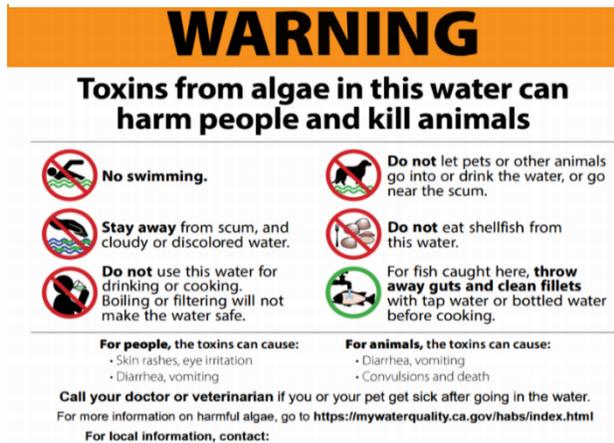
Figure 2: Warning sign posted at Crowley Lake.

Mono County Environmental Health has posted advisory signs at the entry points to the recreational areas to notify recreational users of the bloom (Figure 2 and Figure 3). The Regional Board will provide updates

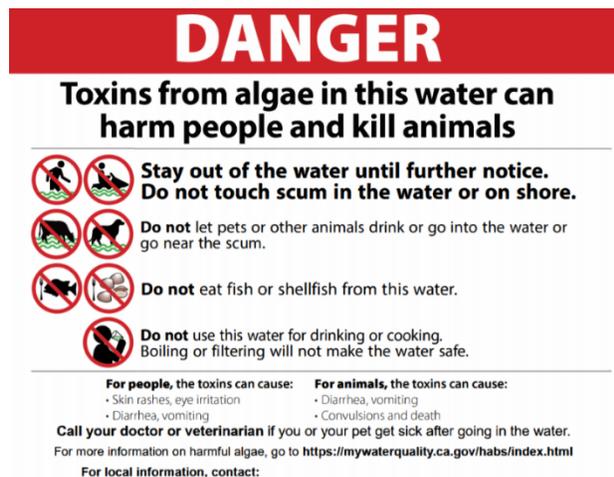
Figure 3: Danger sign posted at Crowley Lake.
