**DECEMBER 12, 2012 SAN DIEGO RWQCB WORKSHOP:**  
**Will tentative storm water regulations be applicable to controlling**  
**Sunset Cliffs Natural Park erosion and marine pollution?**

D. Craig Barilotti, Ph. D  
Scientific Project Director  
Sunset Cliffs Association (SCA)  
(619) 592-8681, cbarilotti@cox.net

STORMWATER EROSION IN SUNSET CLIFFS SHORELINE PARK AND RESULTING  
SEDIMENTATION OF ADJACENT TIDE POOL HABITATS

**FIGURES FOR SCA CCC OCTOBER 3, 2012 PLNU CUP LETTER**

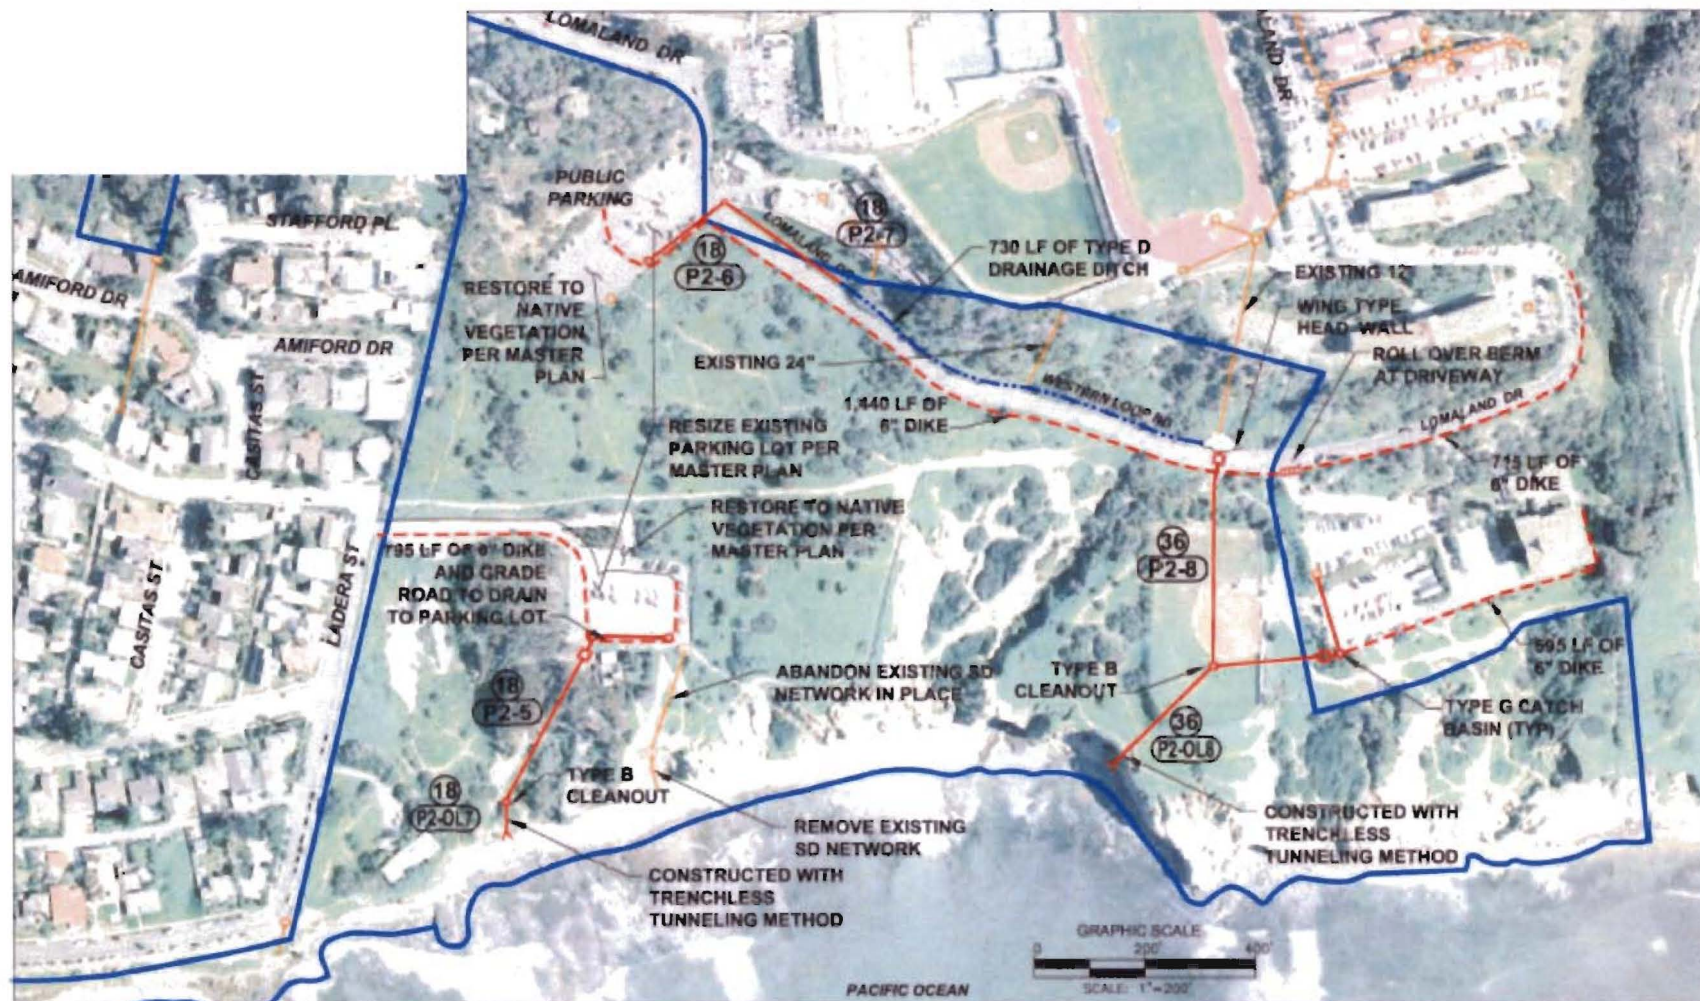
**FIGURE**  
**ES-4**

**Master Drainage Exhibit**  
**Sunset Cliffs**  
**Selected Alternative: Hillside Park**

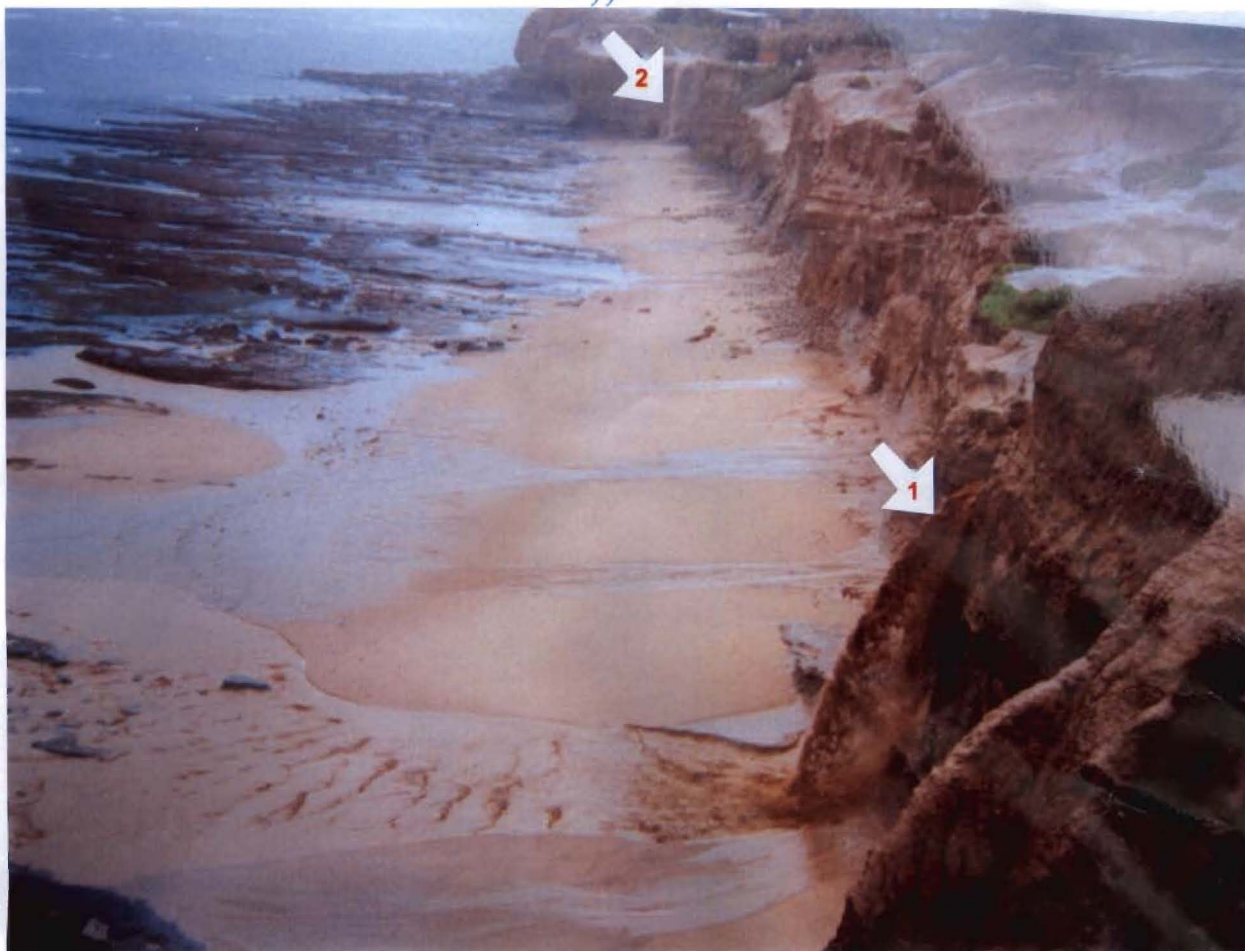
**Figure 1. Garbage Beach waterfalls due to uncontrolled runoff.** In this undated photograph provided by Ann Swanson, runoff, mostly from PLNU, that is channeled down the major erosion gully running through the middle of the Hillside Park that is often called "Culvert Canyon", forms the waterfall that is shown discharging at the south end of Garbage Beach pointed out by Arrow 1. Arrow 2 points to the location of a waterfall made up mostly of runoff generated on SCNP impervious surfaces including the park Lower Parking Lot, roofs, and trails where the soil is compacted by pedestrian traffic. Smaller flows from storm water flowing over the cliffs between Arrows 1 and 2 can also be seen. These runoff flows add erosion sediments to the near shore zone that impact marine plants and animals in intertidal and sub – tidal habitats including surf grass (*Phyllospadix*) beds that provide a nursery habitat for juvenile lobsters during the first 1 – 2 years after they settle out of the plankton. The San Diego Regional Water Quality Control Board Executive Officer in a May 26, 1992 letter to the City of San Diego NPDES Program Coordinator requested that the discharge of sediment laden runoff to the marine water adjacent to the SCNP be abated before the next rainy season.

The park is a 50 – acre site at the lower portion of a watershed. The upper portion of the watershed is a 90 – acre college campus largely developed with lots of building footprints and hardscape from which storm water is collected and directed into the park. This storm water runoff has resulted in erosion and marine pollution due to the runoff transporting eroded sediments over Sunset Cliffs (See Figure 1) for more than twenty years.

**Figure 1.** Garbage Beach waterfalls due to uncontrolled runoff.

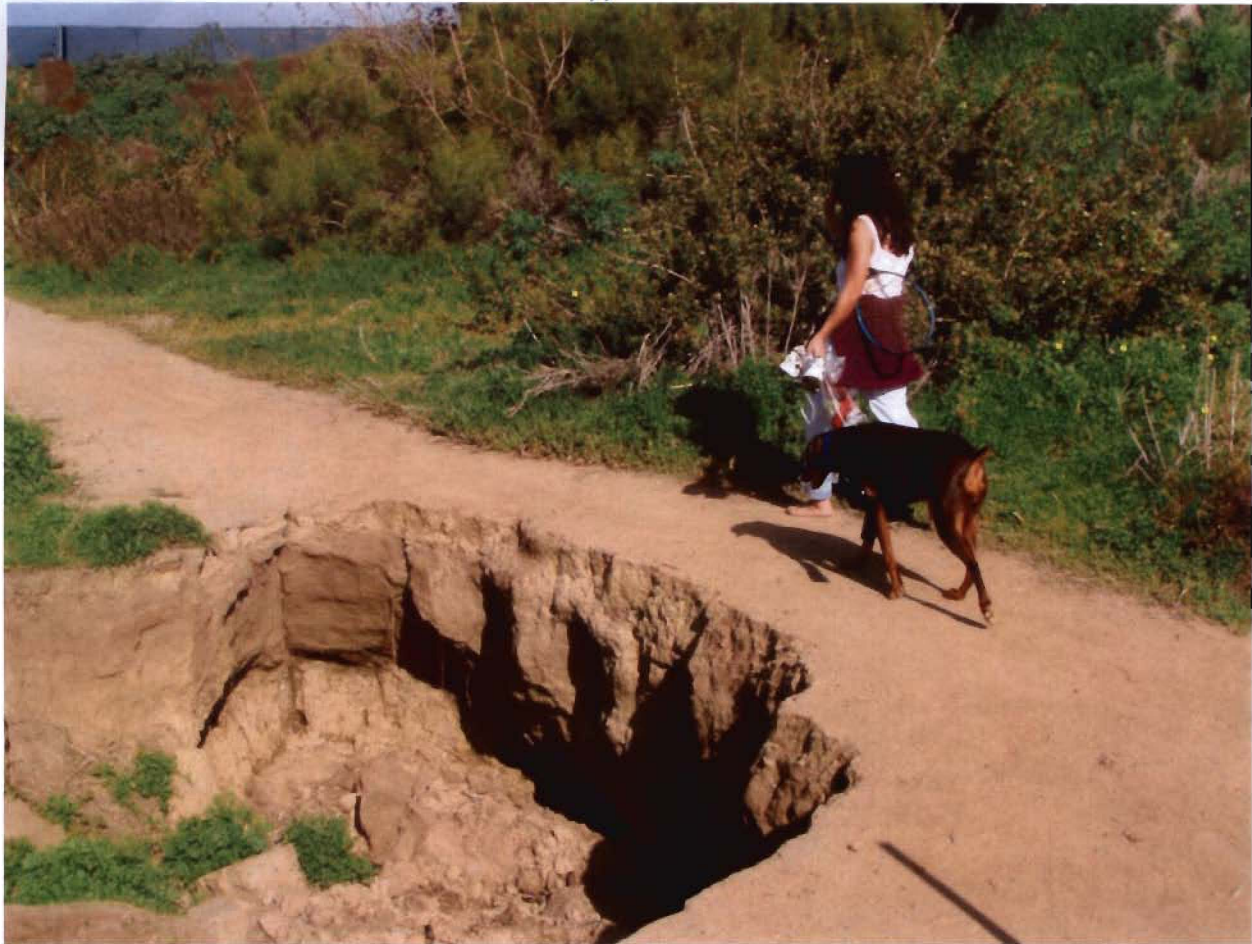
**Figure 2. Erosion caused by PLNU Young Hall dormitory runoff during December 2004.** The runoff caused erosion that partially severed the main trail many park users follow to the shoreline access point called "Ab Trail" by local surfers. This erosion was rapid and deep enough that there was concern it would washout the high pressure force main that transports digested sludge from the Point Loma Water Treatment Plant to the Miramar Sludge processing plant 23 miles away. The runoff causing this erosion in December 2004 originated from the same runoff sources that the contemporary PLNU Drainage system is designed to capture and infiltrate into the soil. Infiltration of runoff into the soil could be problematic if the soil down slope in the SCNP lost its strength, as the soil did in part in the 2004 – 2005 rainy season as evidenced by piping and slumping, exacerbating erosion in the SCNP archeological sites.

**Figure 2.** Erosion caused by PLNU Young Hall dormitory runoff during December 2004.

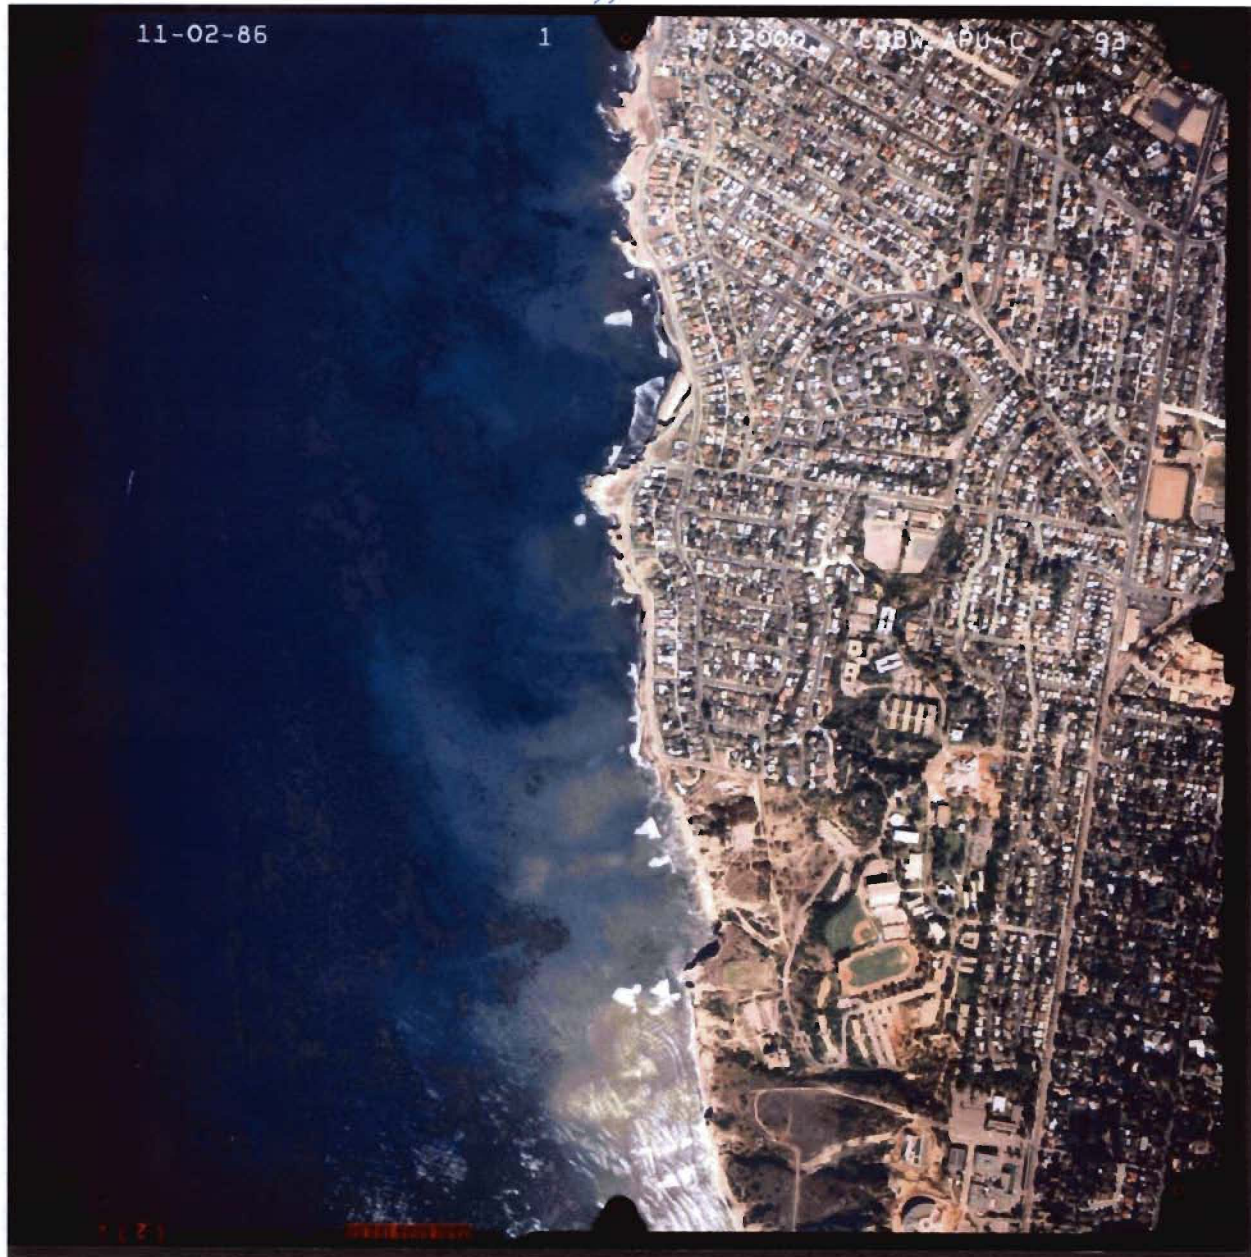
**Figure 3. Aerial photograph taken November 2, 1986 of the SCNP area and turbid ocean waters.** The turbidity of the ocean waters that is greatest off the southern areas of the SCNP Hillside Park, presumably due to erosion sediments that have been transported to the sea by runoff from SCNP and PLNU. Currents will move the turbidity plume north and southward along the coastline by a number of factors including: tides, wind and prevailing alongshore currents. This photograph is part of an aerial photographic time series for the California coastal zone that is available online, and is compiled by the California Coastal Records Project.

With an average annual rainfall of about ten inches, based on a comparison to native vegetation on adjacent Navy property, SCNP can absorb its ten inches of annual rain with zero discharge to the beach. Properly restored with coastal sage plants it may absorb more, but the park as is has periodically been overwhelmed with storm water runoff from the PLNU campus as noted in a 1992 letter from the Regional Water Quality Control Board asking the City to abate the erosion before the next rainy season. The volume and relatively high velocity of the runoff has caused the erosion (See Figure 2) and marine pollution due to sediment discharges (see Figures 3 and 4) that has been apparent throughout the SCNP Hillside Park since 1975.

**Figure 3.** Aerial photograph taken November 2, 1986 of the SCNP area and turbid ocean waters.

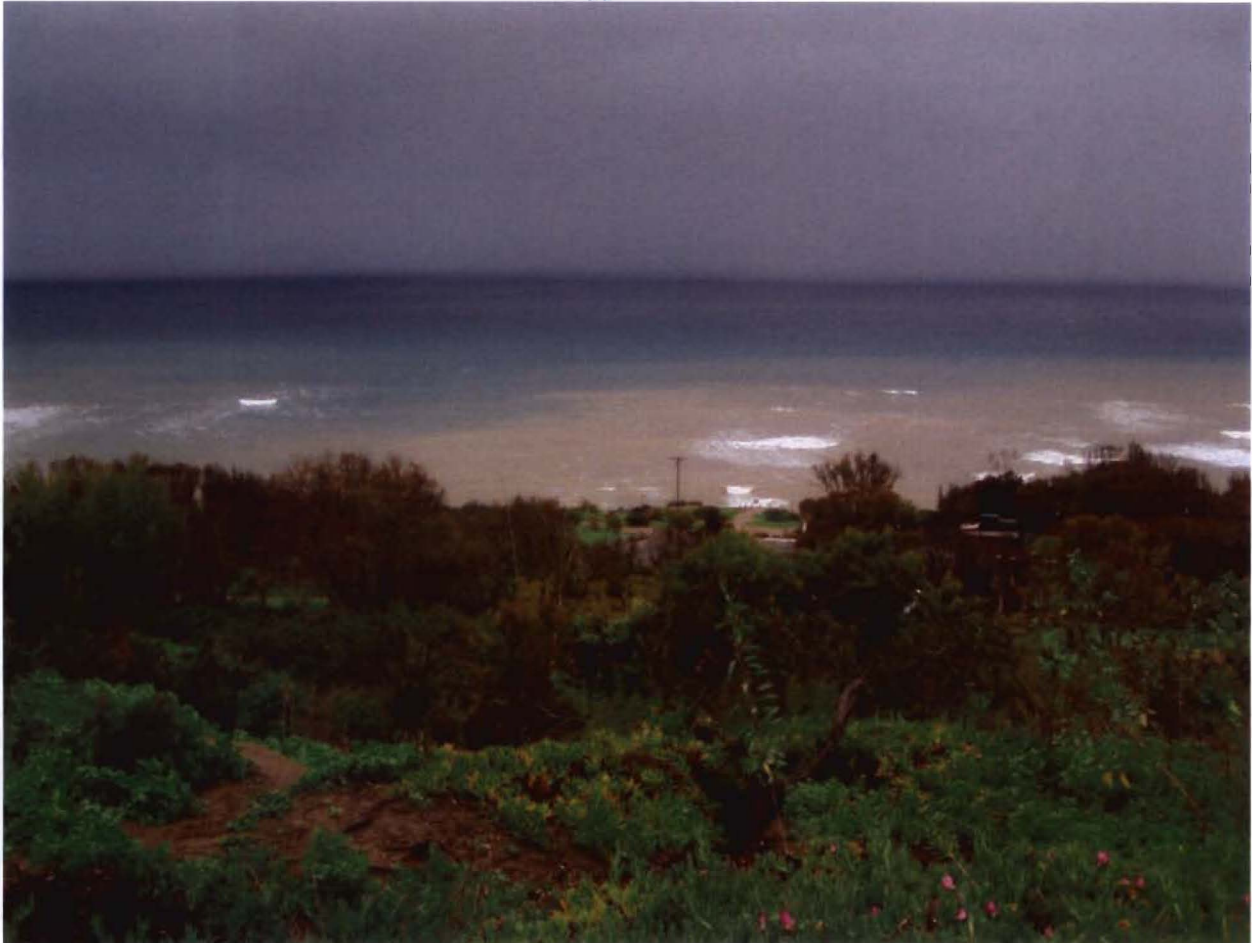
**Figure 4. February 2, 2003 photograph of Culvert Canyon turbid storm water runoff discharges.** This photograph, taken by Craig Barilotti, shows how turbidity due to sediment discharges from Culvert Canyon after being introduced into the coastal waters, moves offshore and alongshore depending on prevailing currents, in this case northward towards Ocean Beach.

**Figure 4.** February 2, 2003 photograph of Culvert Canyon turbid storm water runoff discharges.

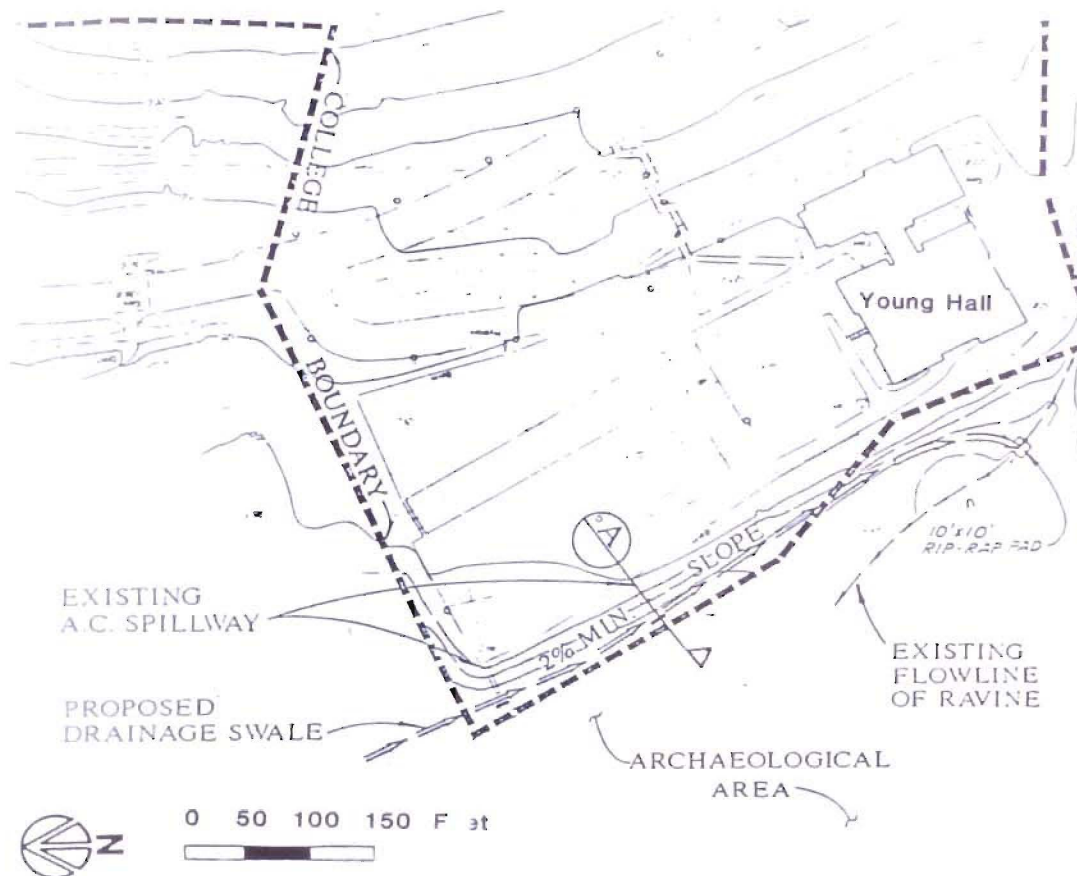
**4-15**

Pt. Loma Nazarene College CUP  
Location of Mitigation Measures to  
Protect Off-Site Archaeological Site

**Figure 5. Diagram from the 1992 PLNU Young Hall drainage plan EIR.** This design was prompted by concerns for protecting the California registered Native American archeological sites that are just to the west of Young Hall on SCNP property. The discharge structure shown in this diagram and page 3 of the 1992 Drainage System Plans was to have been on SCNP property where it discharged into South Canyon, in part to protect the archeological sites from the Young Hall runoff. The 2012 PLNU Drainage Plan proposes to discharge into velocity dissipaters located on PLNU property, and during periods of heavy rainfall when the drainage system retention capacity is reached, runoff is expected to flow across the PLNU/SCNP property line with a velocity of 2.5 feet per second and into the parkland where the archeological sites are located. The potential for erosion due to Young Hall runoff was demonstrated during the 2004 – 2005 wet season (see Figure 2), when runoff from the Young Hall caused major erosion in the archeological area shown on the EIR diagram.

**Figure 5.** Diagram from the 1992 PLNU Young Hall drainage plan EIR.
