RE: NOTICE OF VIOLATION NO. R9-2008-0099

1. Faraday Avenue Extension and Carlsbad Oaks North Business Park
2. Agua Hedionda Channel Dredging Project

FACILITY INSPECTION REPORT

FACILITY: City of Carlsbad 401 Certification Compliance Review

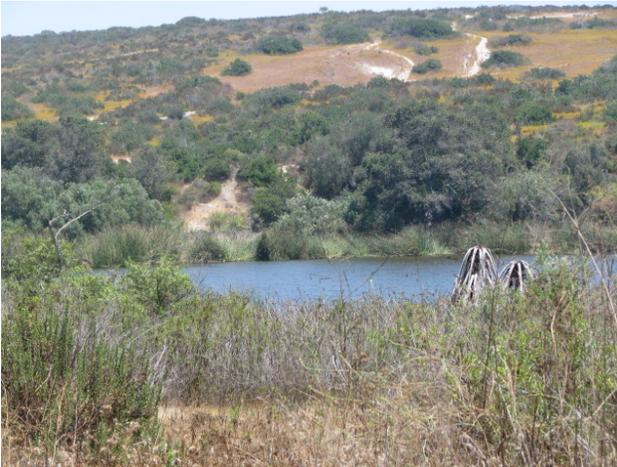
On 7/2/2008 the Regional Board inspected the proposed mitigation site at Lake Calavera. Visual observation indicated that no work has been conducted in the area as proposed in the *Draft 1 Compensatory Habitat Mitigation and Monitoring Plan*. These observations are supported by the lack of reporting as required by the 401 Certification.

Picture above (IMG_0487.JPG): Photograph of proposed enhancement area, on eastern side of northward extending finger, at Lake Calavera. Two Palm trees are visible.

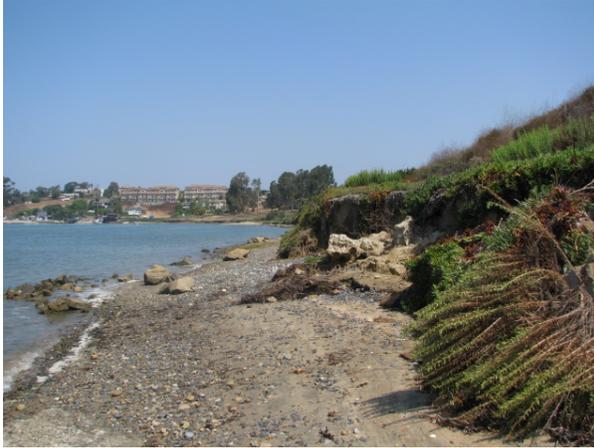
Inspection Results: The access road, vegetated swales, drainage inlets, and proposed cribwall were not constructed.

Picture on left (IMG_0507.JPG): Location of the western most proposed cribwall and access road.

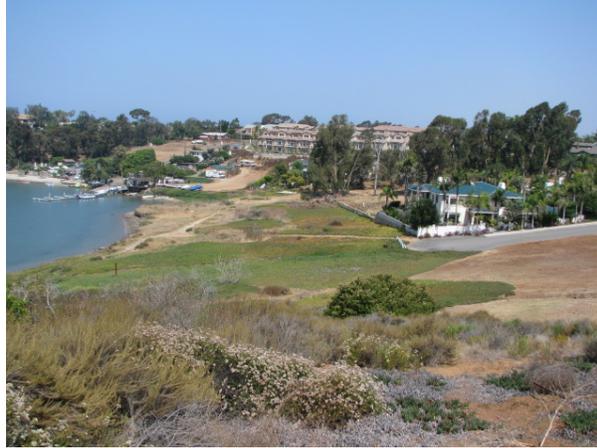
Picture on right (IMG_0508.JPG): End of Hoover Street, proposed new trail head, beginning of the new access road, and beginning of the shoreline protection wall.

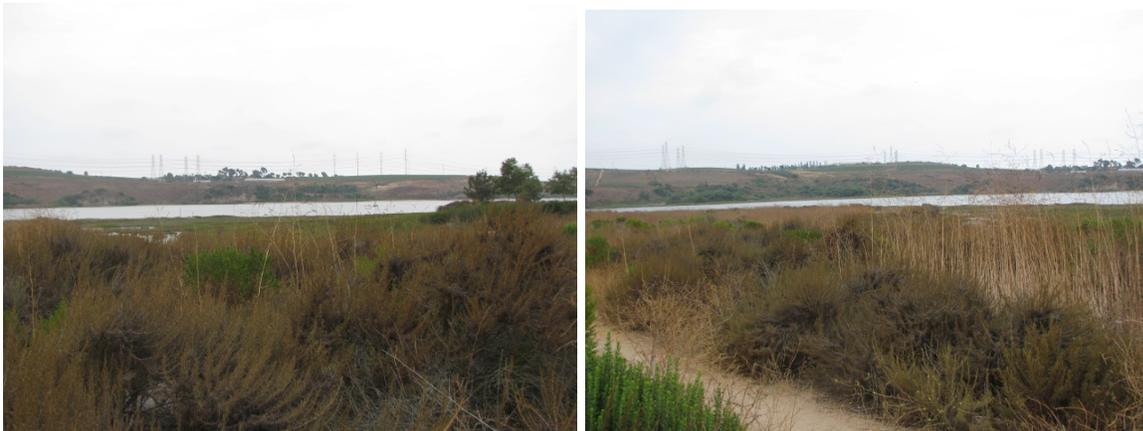
On 7/2/2008, 7/11/2008, and 7/15/2008 the Regional Board inspected the proposed mitigation area in the *Draft Conceptual Habitat Revegetation Plan North Agua Hedionda Interceptor Western Segment Sewer Maintenance, Access Road & Shoreline Protection Project*. The property was fenced off, with one opening created near a trail head on Park Drive on the western side of the property, with a trash can on the road side of the fence. Visual observations were inconclusive to determine whether mitigation activities were conducted. Due to the lack of reporting and clear visual appearance of mitigation activities, it is assumed the mitigation requirements of the 401 Certification have not been conducted.

Picture on left (IMG_0503.JPG): Proposed wetlands 0.6 acre creation area.

Picture on right (IMG_0504.JPG): Area to the east of the proposed creation area.
