SUBJECT: Notice of Violation No. R9-2013-0028, City of San Diego, General Order No. R9-2012-0001 and Monitoring and Reporting Program R9-2012-0002, for the Arizona Street Landfill

NOTICE OF VIOLATION

No. R9-2013-0028

Landfill Inspection Report

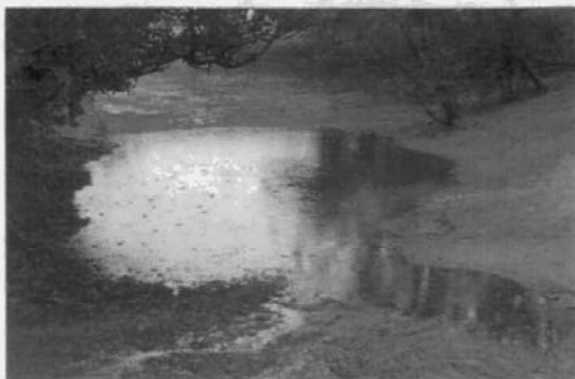
During the December 13, 2012 site inspection, San Diego Water Board staff observed numerous instances of ponding (see photographs 1 through 3 below, and Enclosure 1) at the ASL site.

Photograph 1 – ASL cover ponding

Pursuant to section C.4.b of General Order No. R9-2012-0001, please take immediate step to implement measures to mitigate these areas. In addition the City is required to provide the San Diego Water Board with a *Site Conditions Certification Report*, documenting the details of any temporary and permanent steps taken (either through photographs or an inspection report) to mitigate the areas of non-compliance, and correct existing site conditions so that the cover system is protective of water quality in compliance with General Order No. R9-2012-0001. The *Site Conditions Certification Report* must be received by the San Diego Water Board within 30 days of completing all mitigation measures, or by 5:00 pm on June 30 of this year, whichever is earliest.

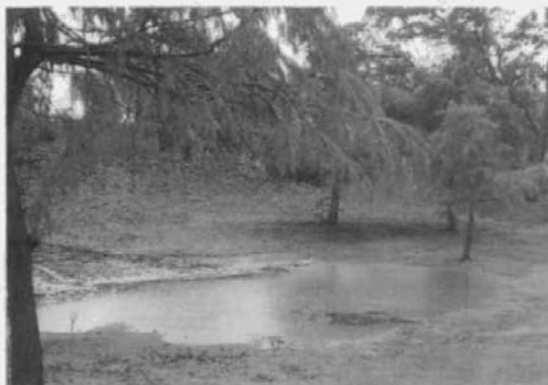
Photograph 2 – ASL cover ponding

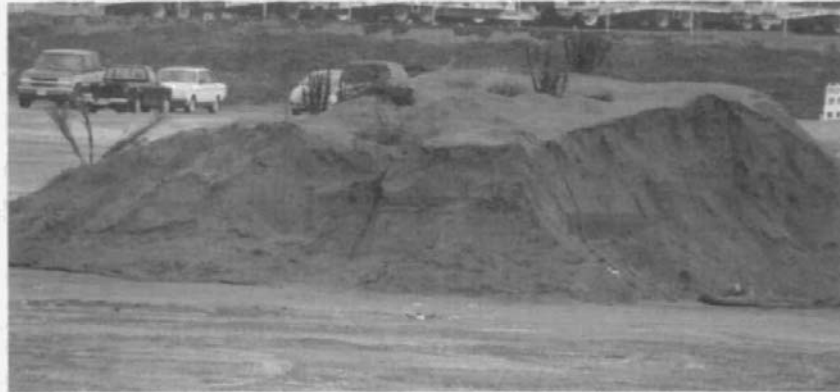
During the December 13, 2012 site inspection, San Diego Water Board staff observed that the wattles used to control runoff/erosion from the ASL soil stockpile were crushed or otherwise diminished, and did not completely encircle the soil stockpile (see photograph 4 and Enclosure 1).

Photograph 4 – ASL Soil Stockpile

In accordance with section C.5.c of General Order No. R9-2012-0001, the City shall ensure that all stockpiles are adequately protected from erosion by storm water. Moreover, all soil stockpiles shall be overlain by plastic sheeting¹ or managed with adequately maintained runoff/erosion control best management practices (i.e., tackified straw, bonded fiber matrix, wattles, silt fence).
