**Appendix F**  
First Flush Ratio Figures

**Appendix F-1**  
Agua Hedionda Mass Emission Station  
First Flush Ratio Figures

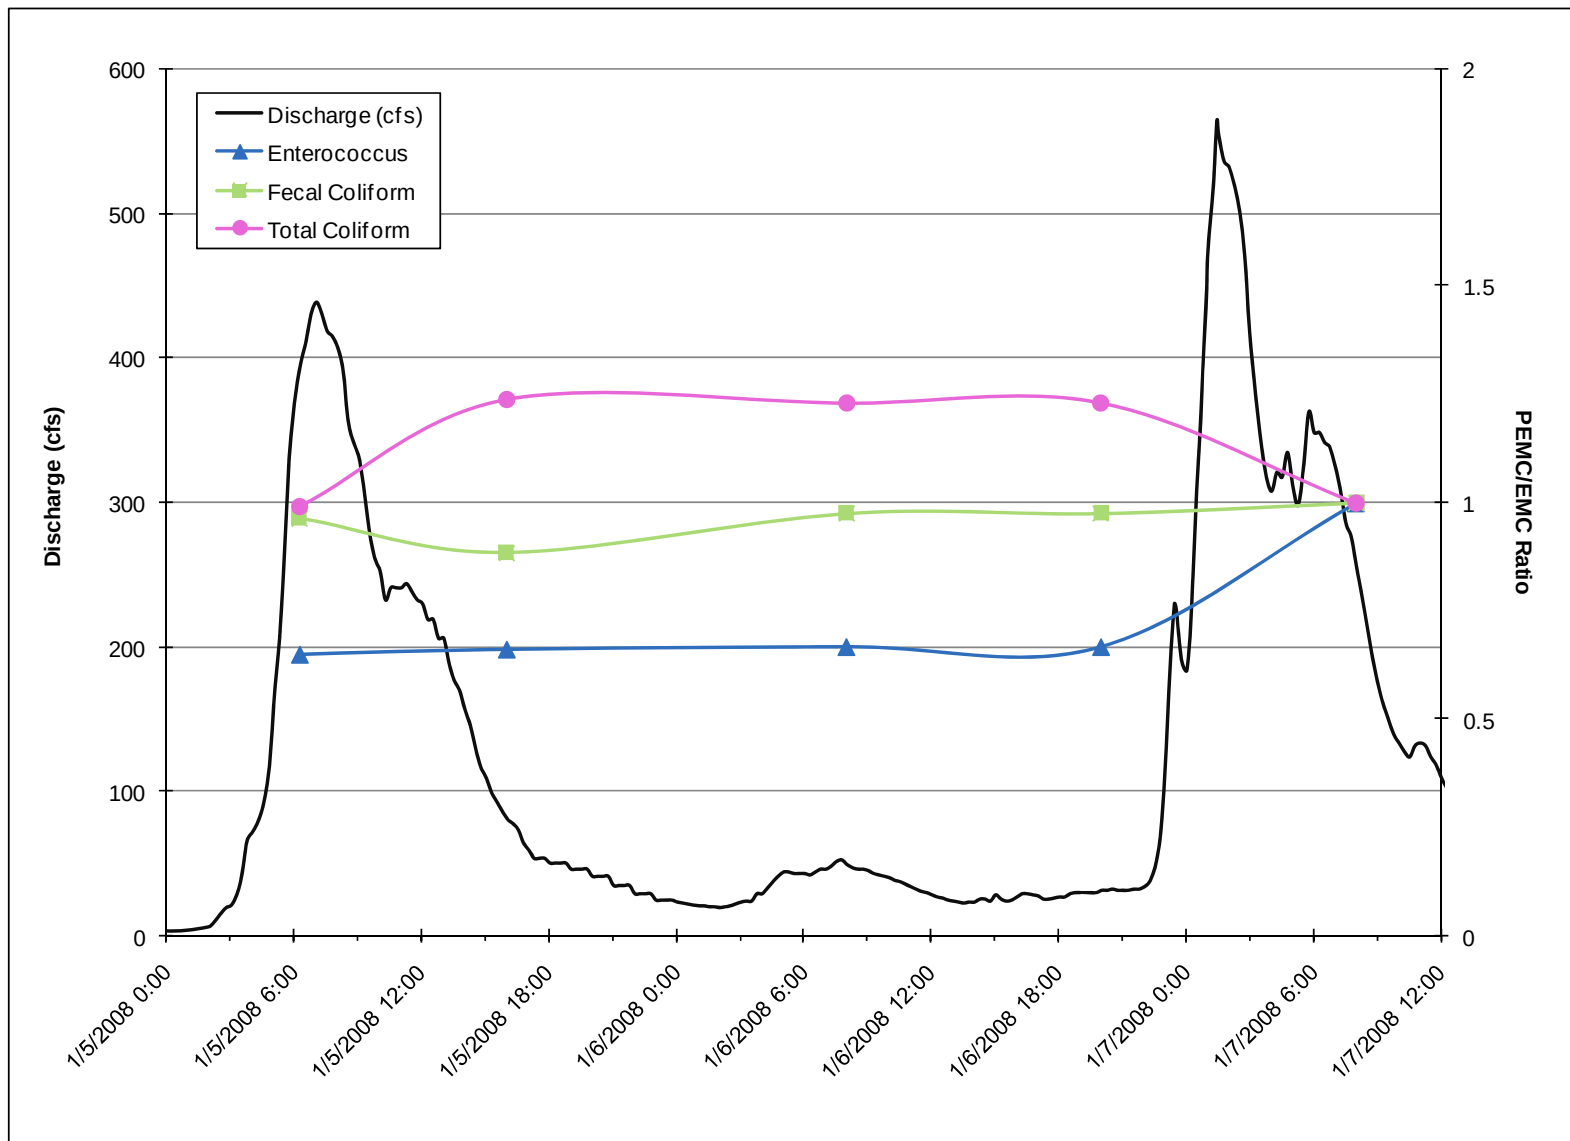
Agua Hedionda Mass Emission Station Wet Weather 1  
First Flush Ratios - Bacteria

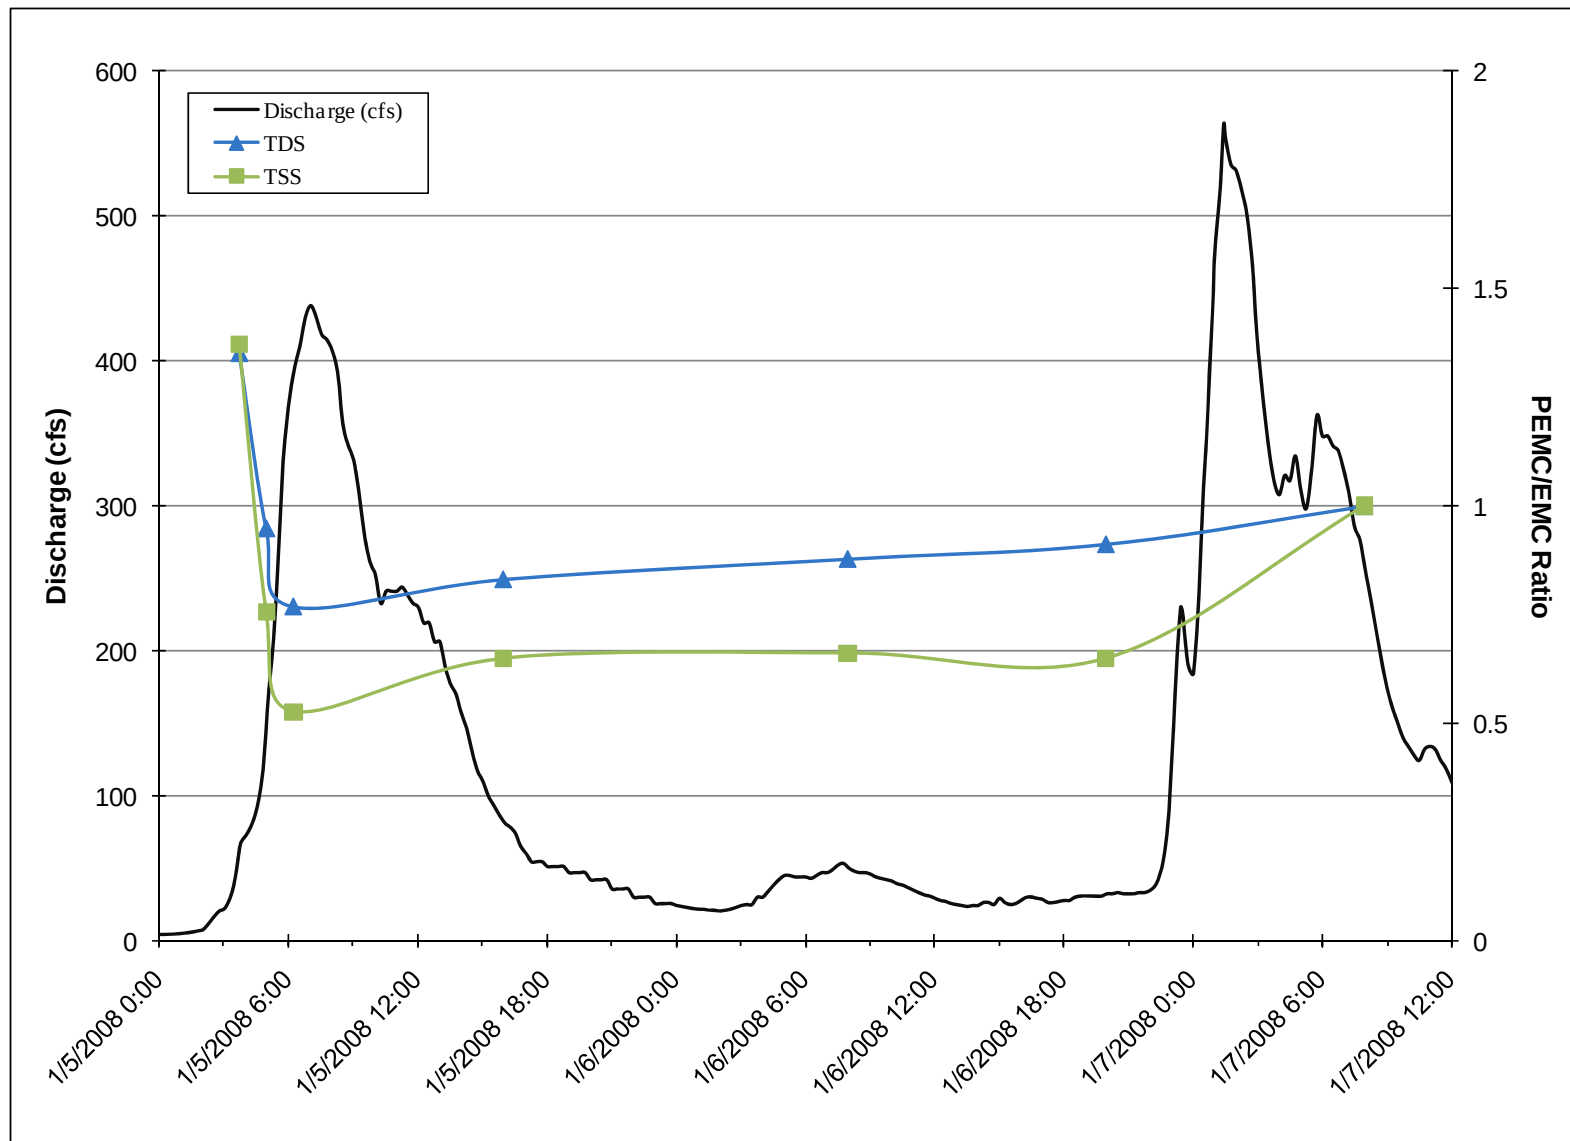
Agua Hedionda Mass Emission Station Wet Weather Event 1  
First Flush Ratios – TDS and Sediment

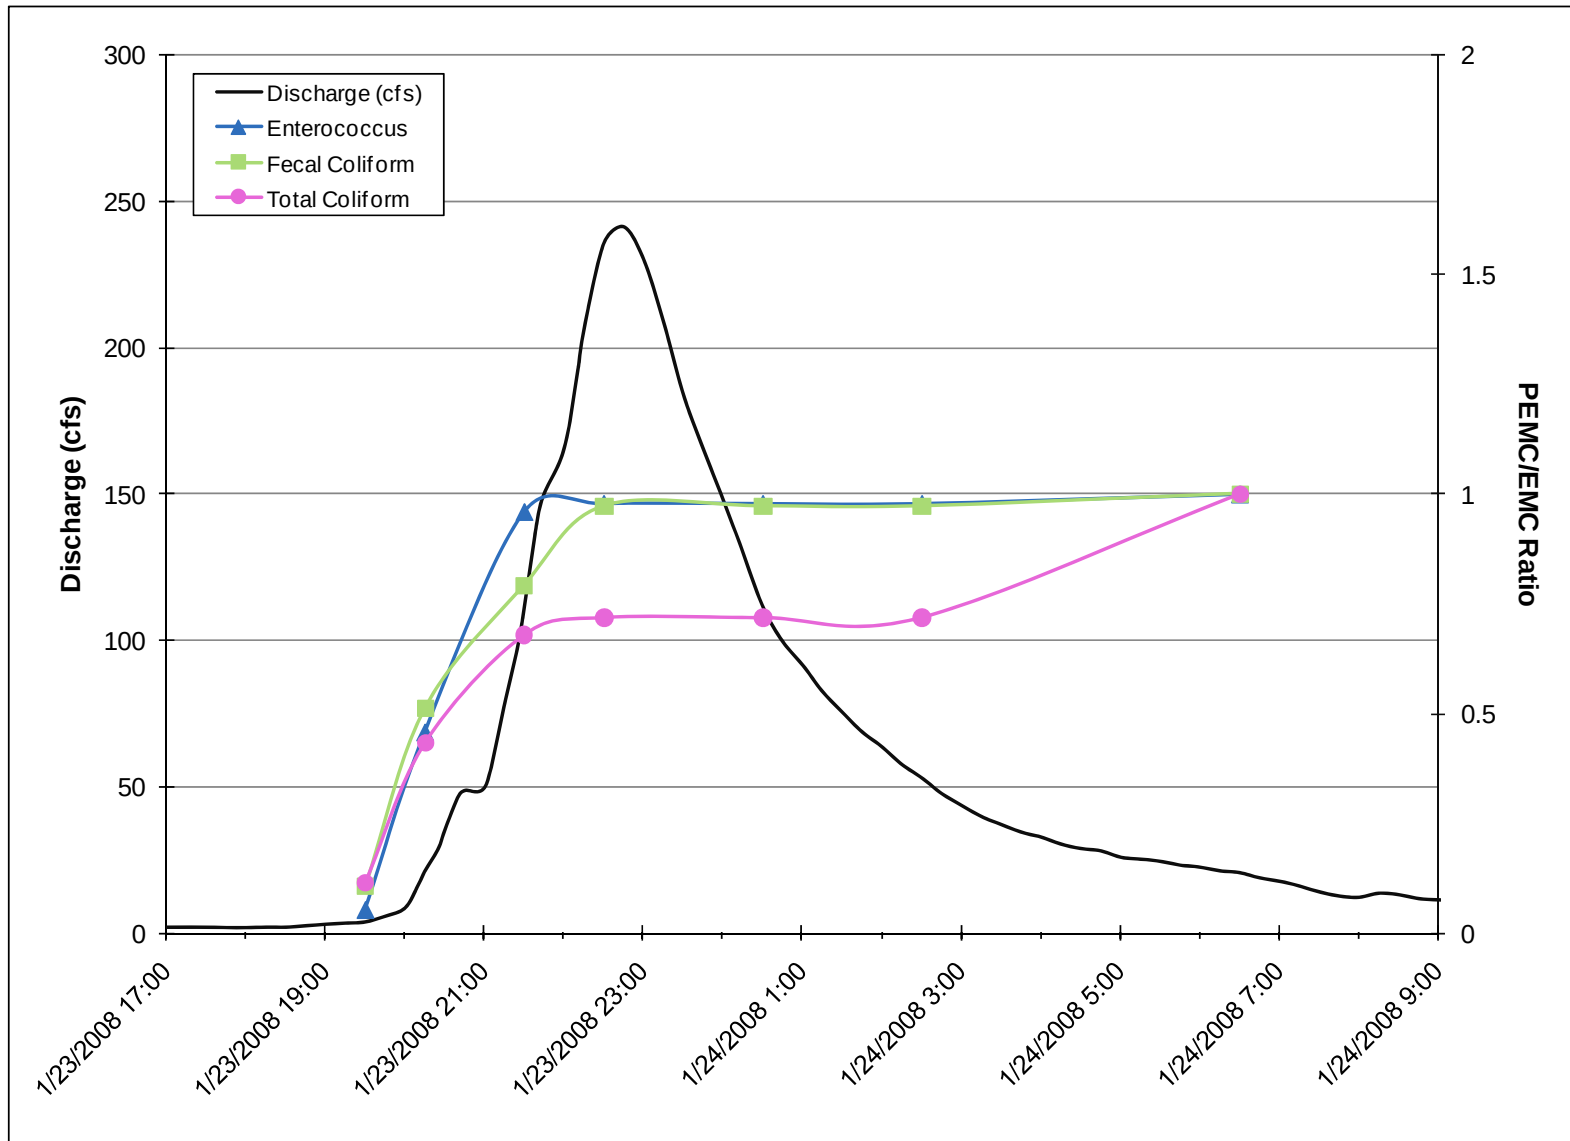
Agua Hedionda Mass Emission Station Wet Weather Event 2  
First Flush Ratios - Bacteria

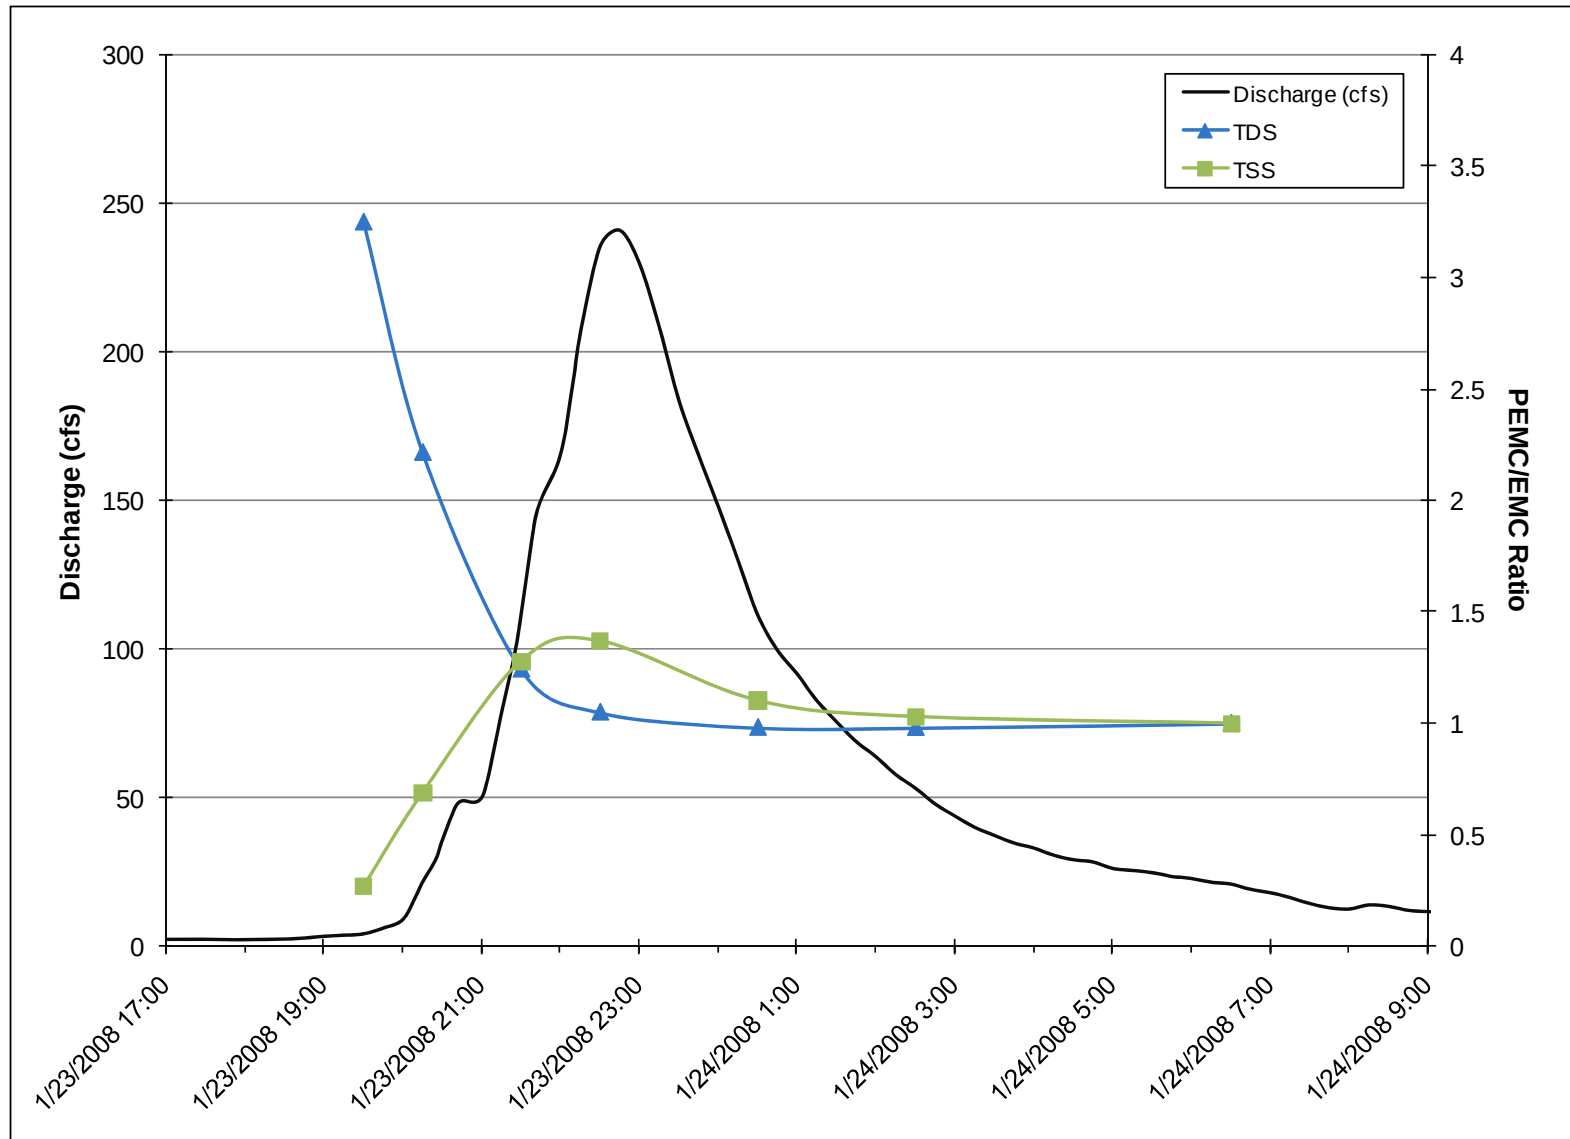
Agua Hedionda Mass Emission Station Wet Weather Event 2  
First Flush Ratios – TDS and Sediment

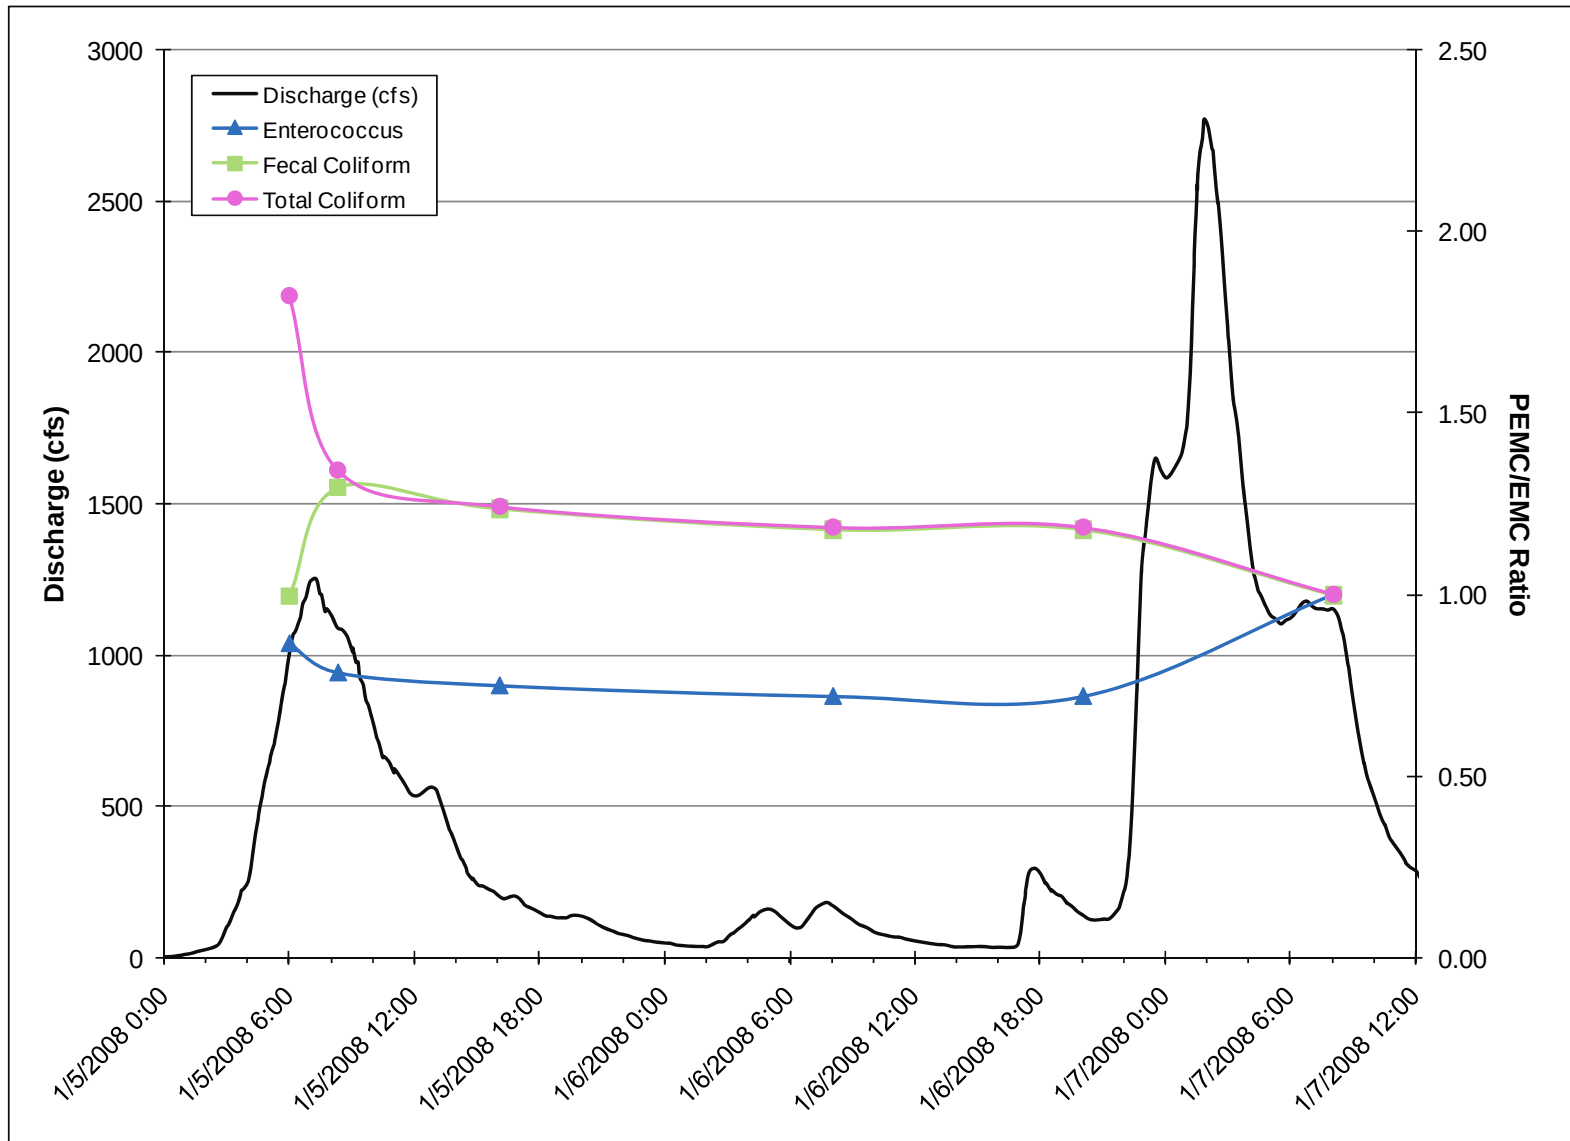
Buena Vista Mass Emission Station Wet Weather Event 1  
First Flush Ratios - Bacteria

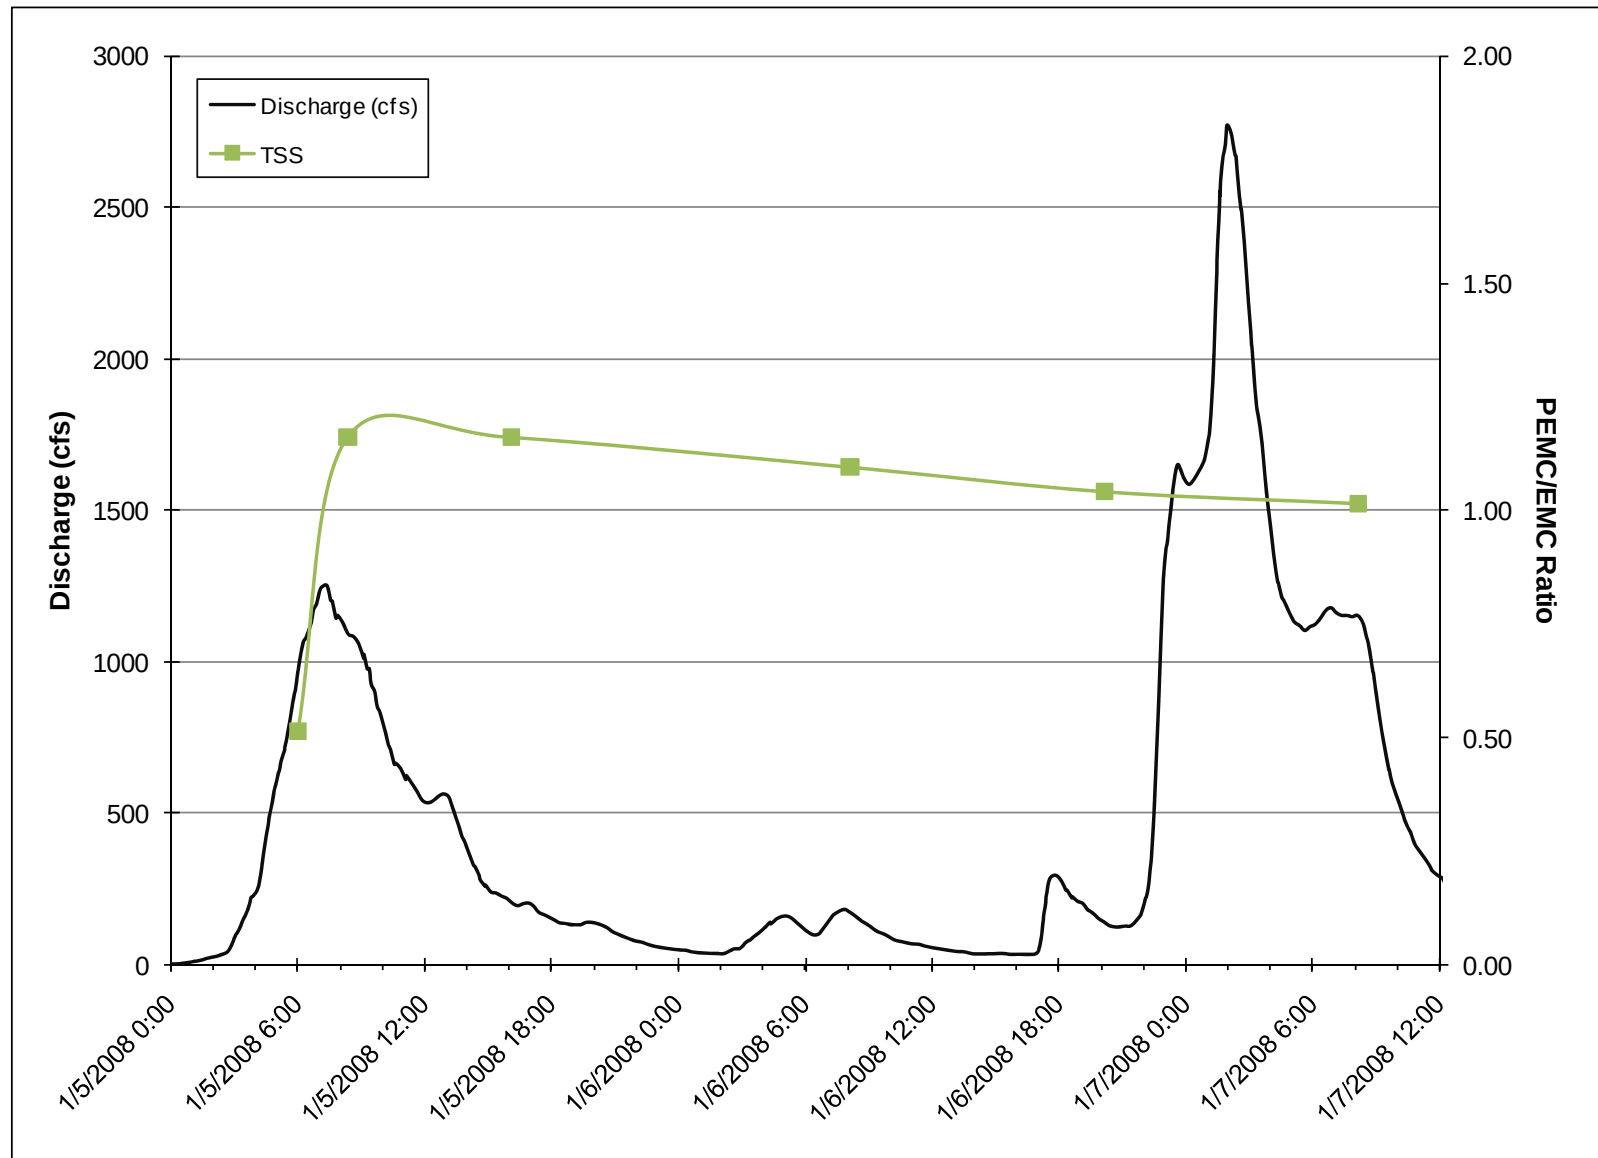
Buena Vista Mass Emission Station Wet Weather Event 1  
First Flush Ratios – Sediment

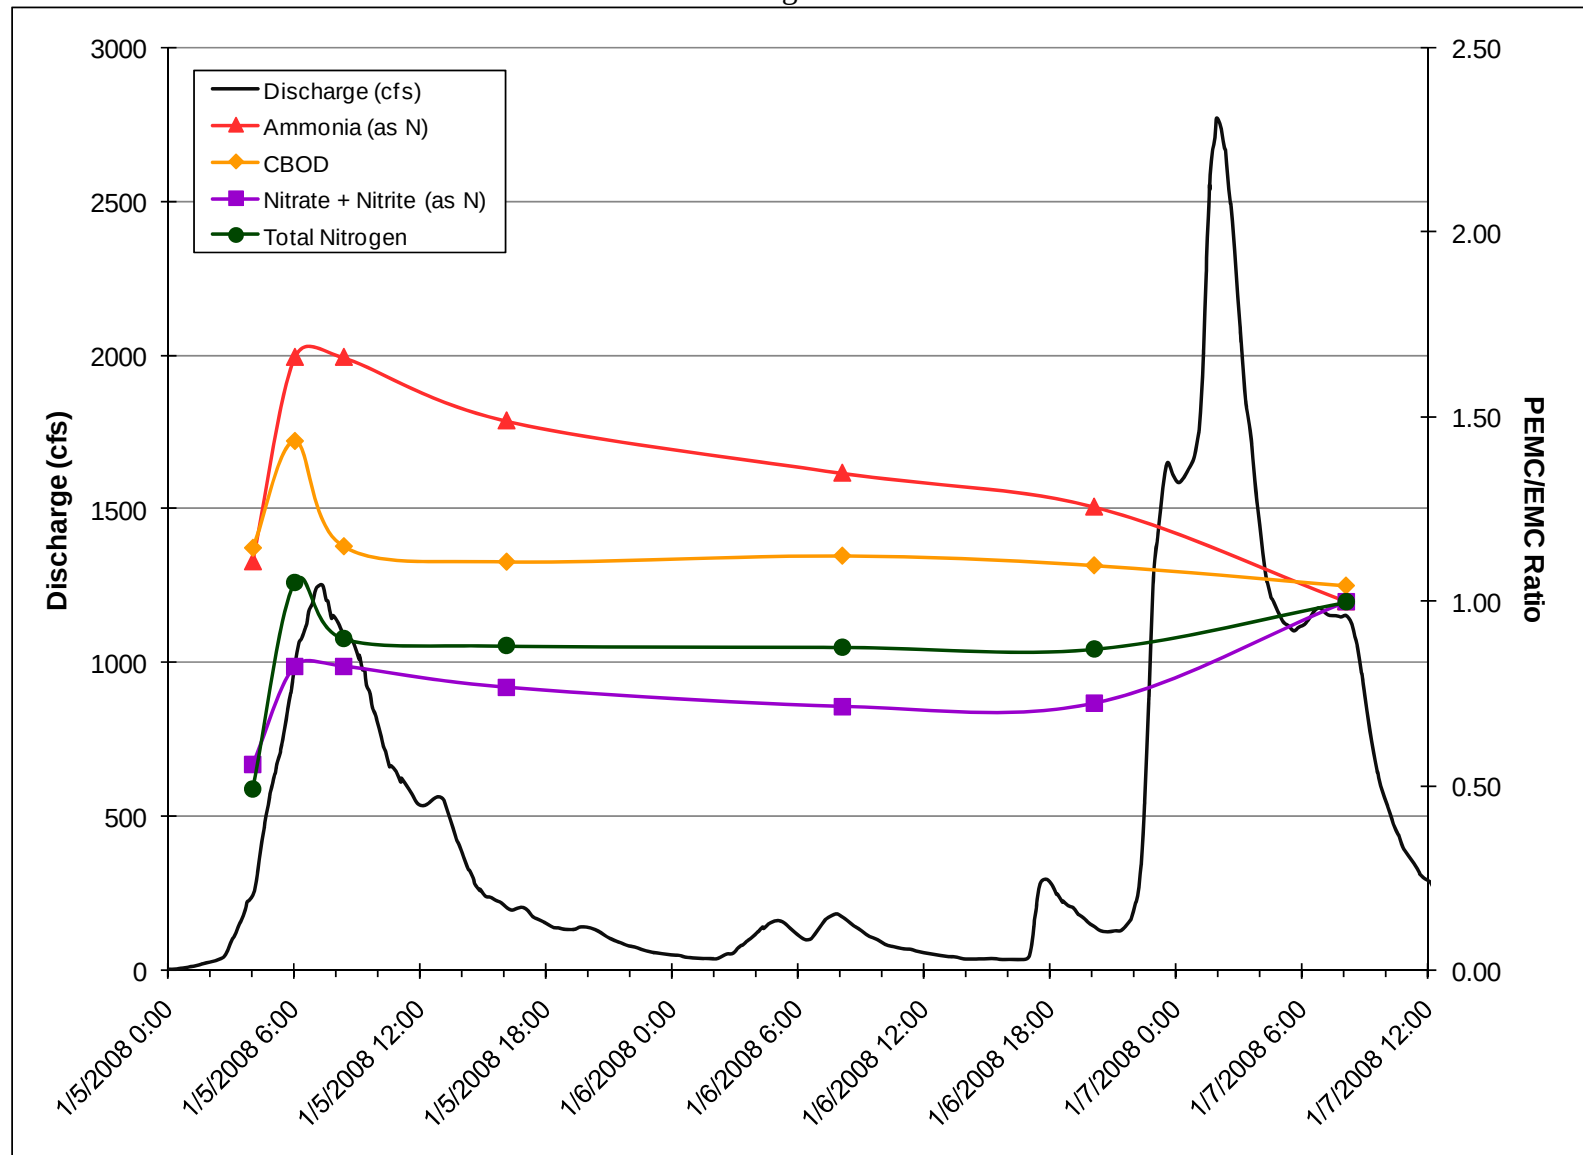
Buena Vista Mass Emission Station Wet Weather Event 1  
First Flush Ratios – Nitrogen Constituents and CBOD

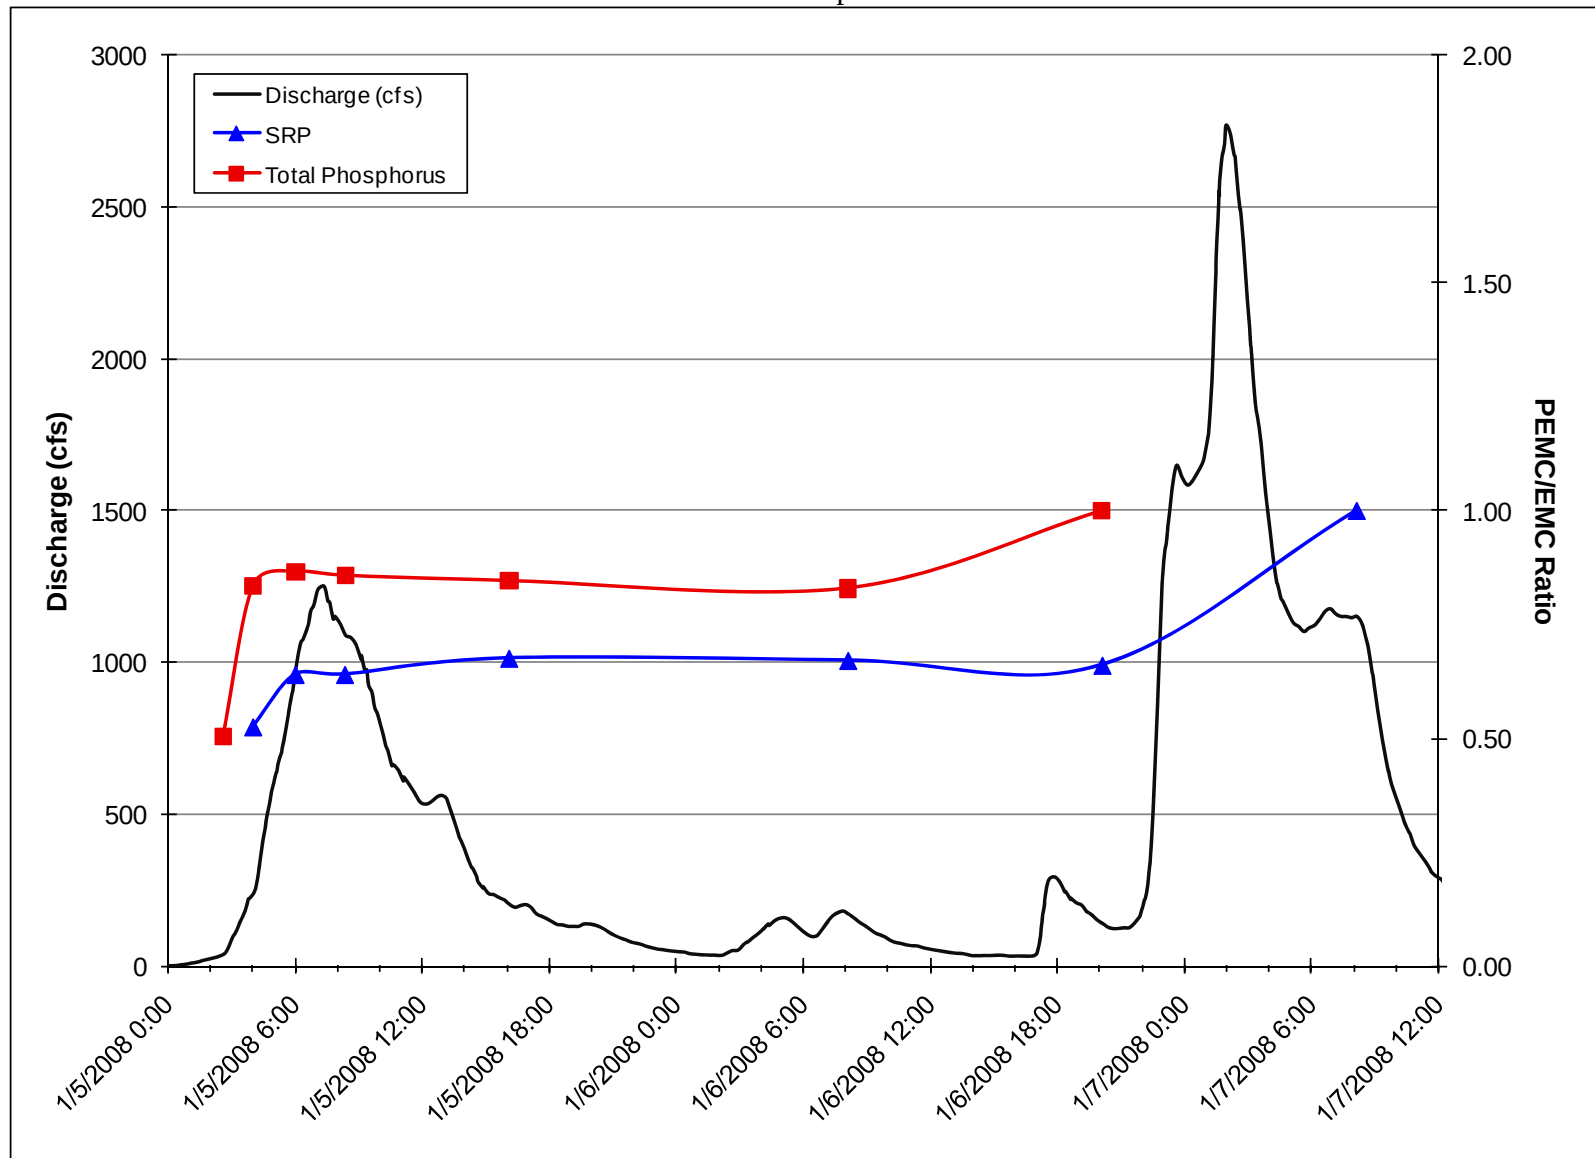
Buena Vista Mass Emission Station Wet Weather Event 1  
First Flush Ratios – Phosphorus Constituents

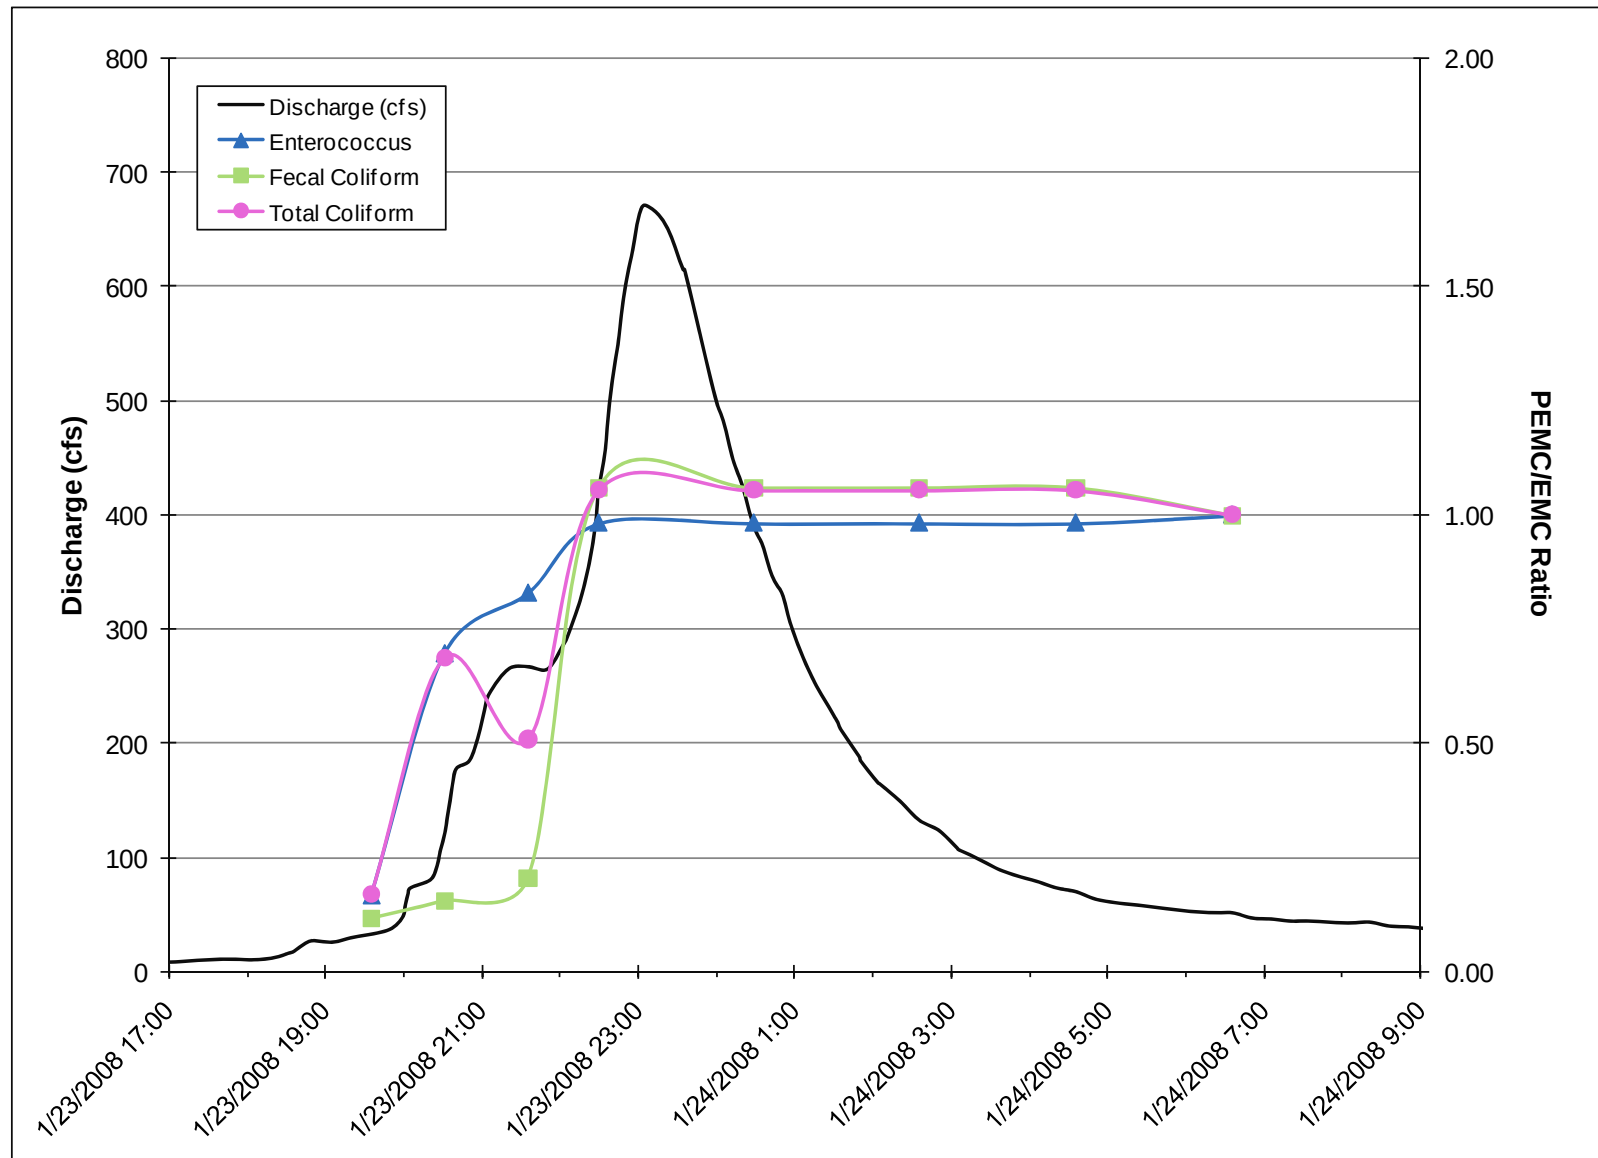
Buena Vista Mass Emission Station Wet Weather Event 2  
First Flush Ratios – Bacteria

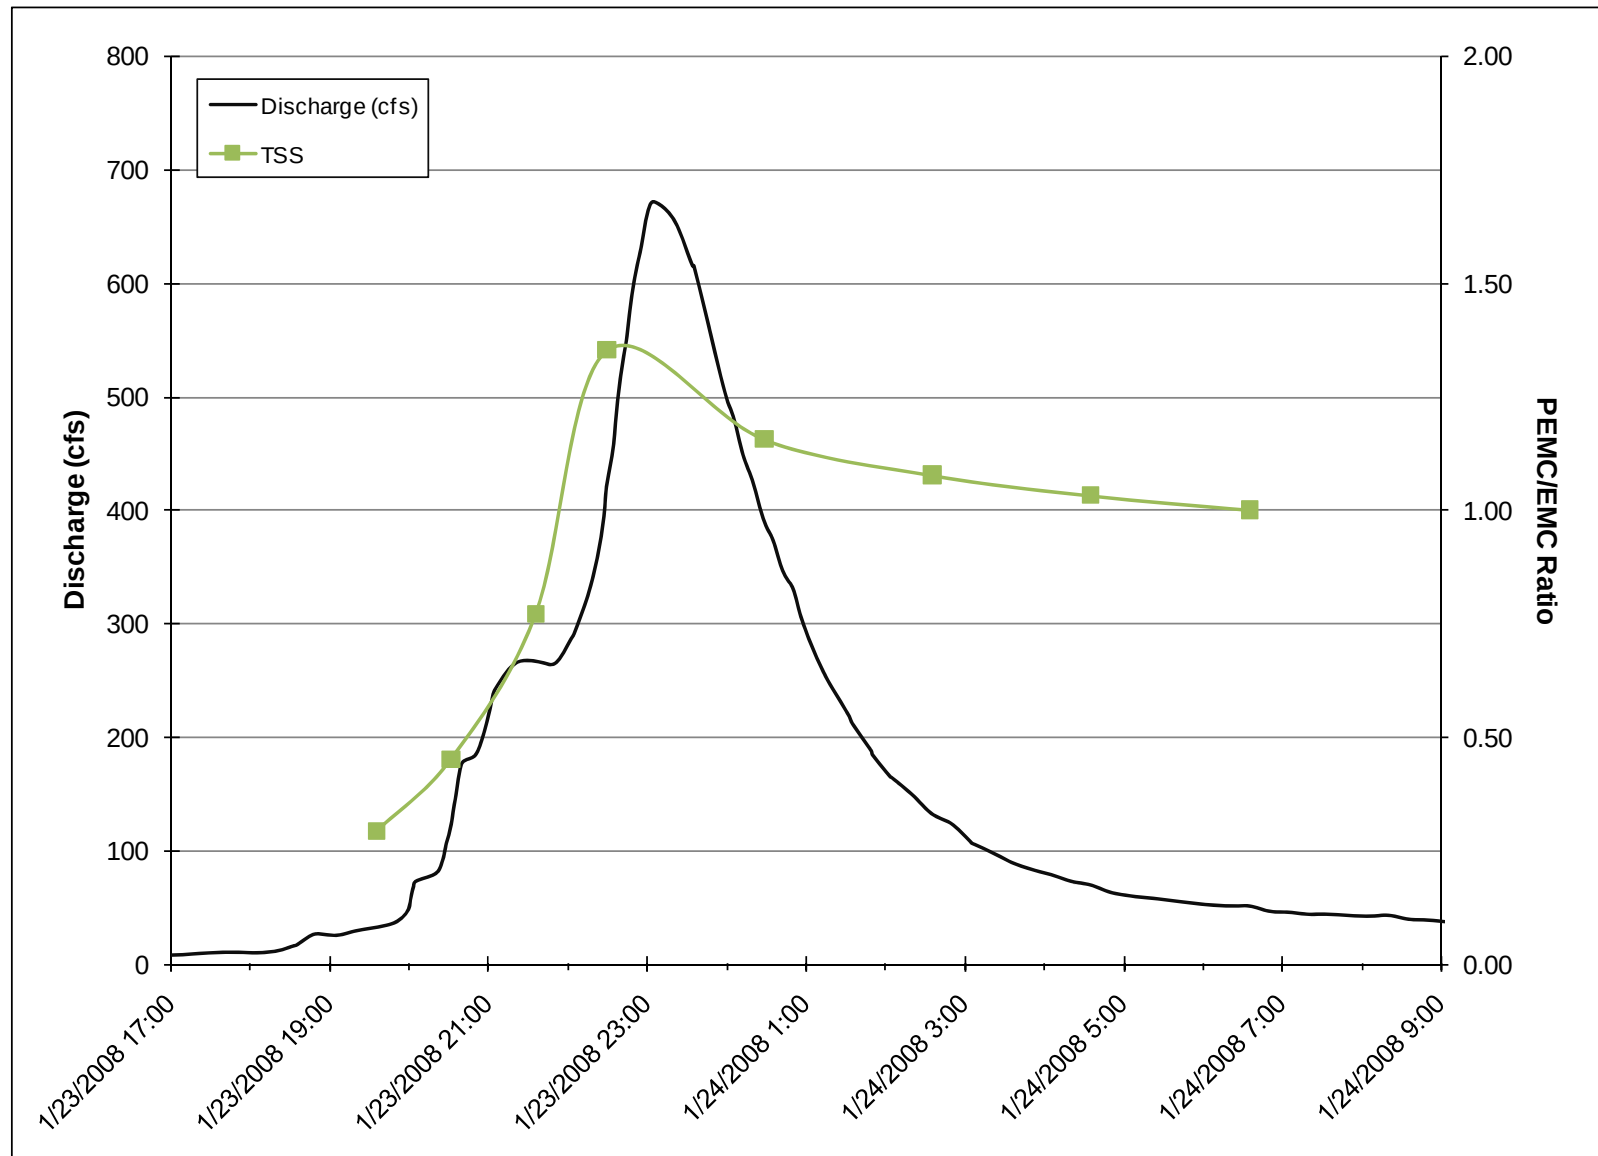
Buena Vista Mass Emission Station Wet Weather Event 2  
First Flush Ratios – Sediment

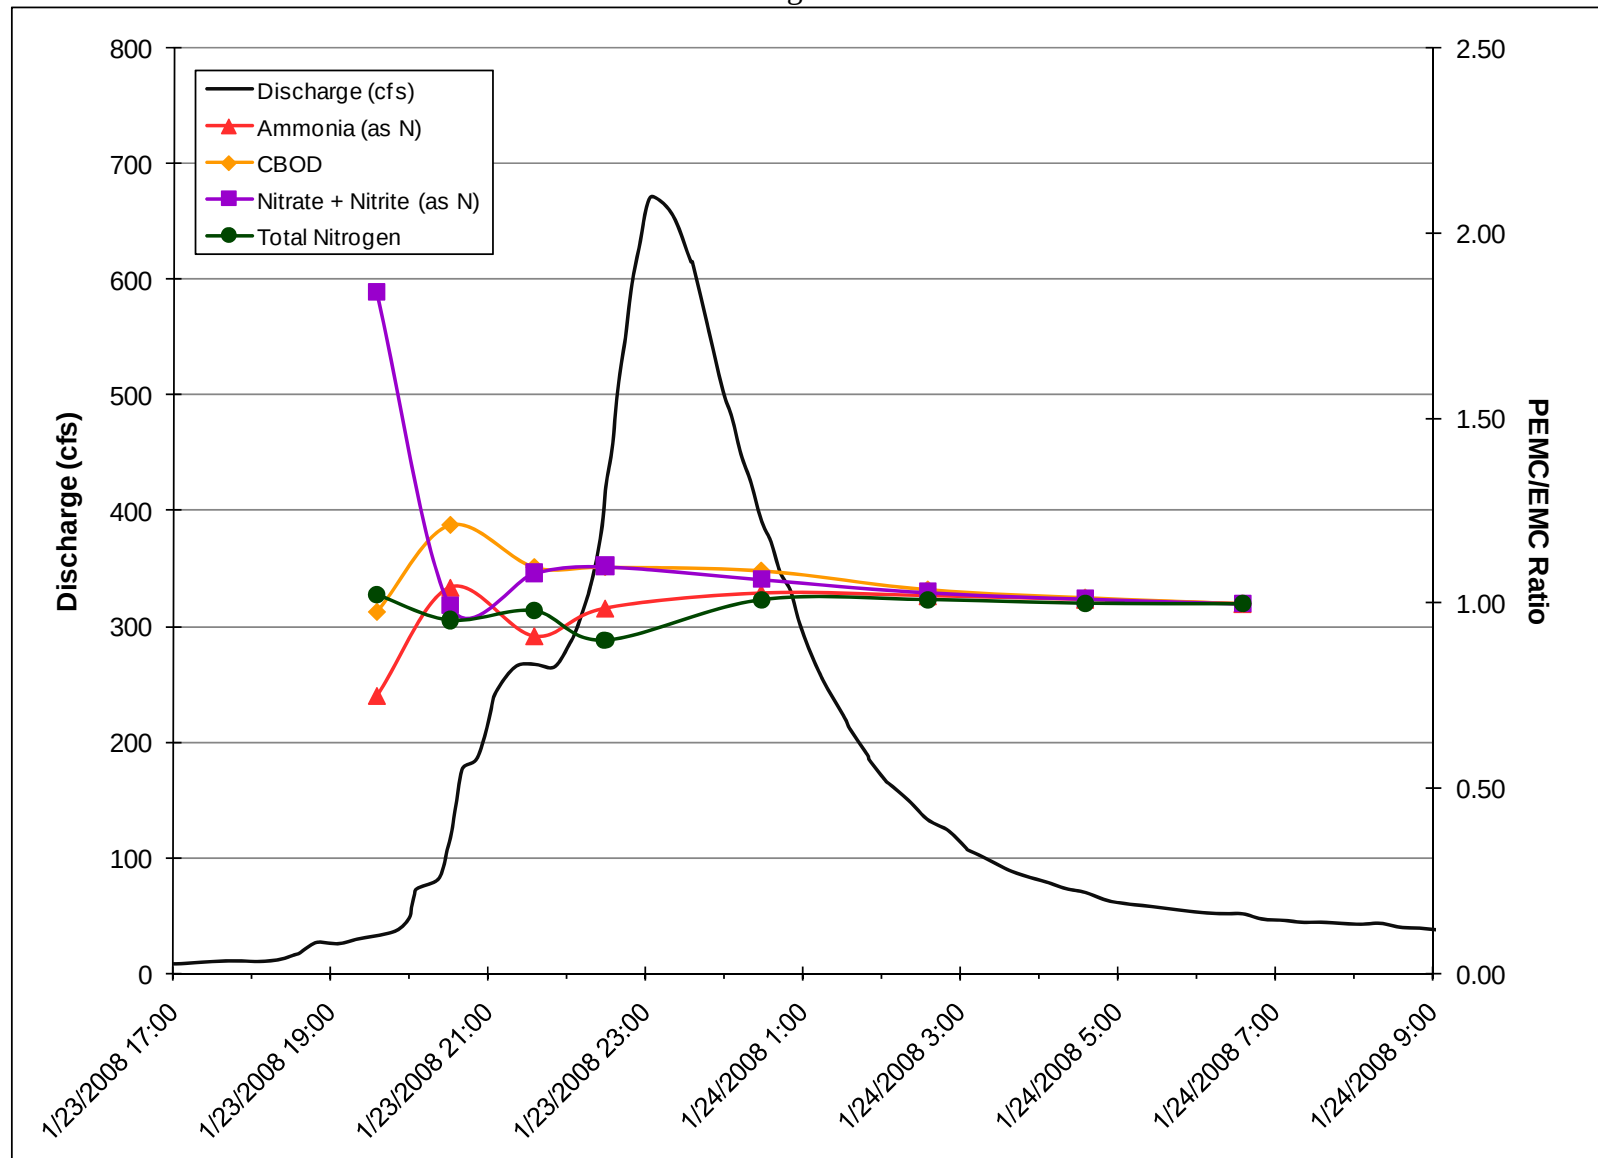
Buena Vista Mass Emission Station Wet Weather Event 2  
First Flush Ratios – Nitrogen Constituents and CBOD

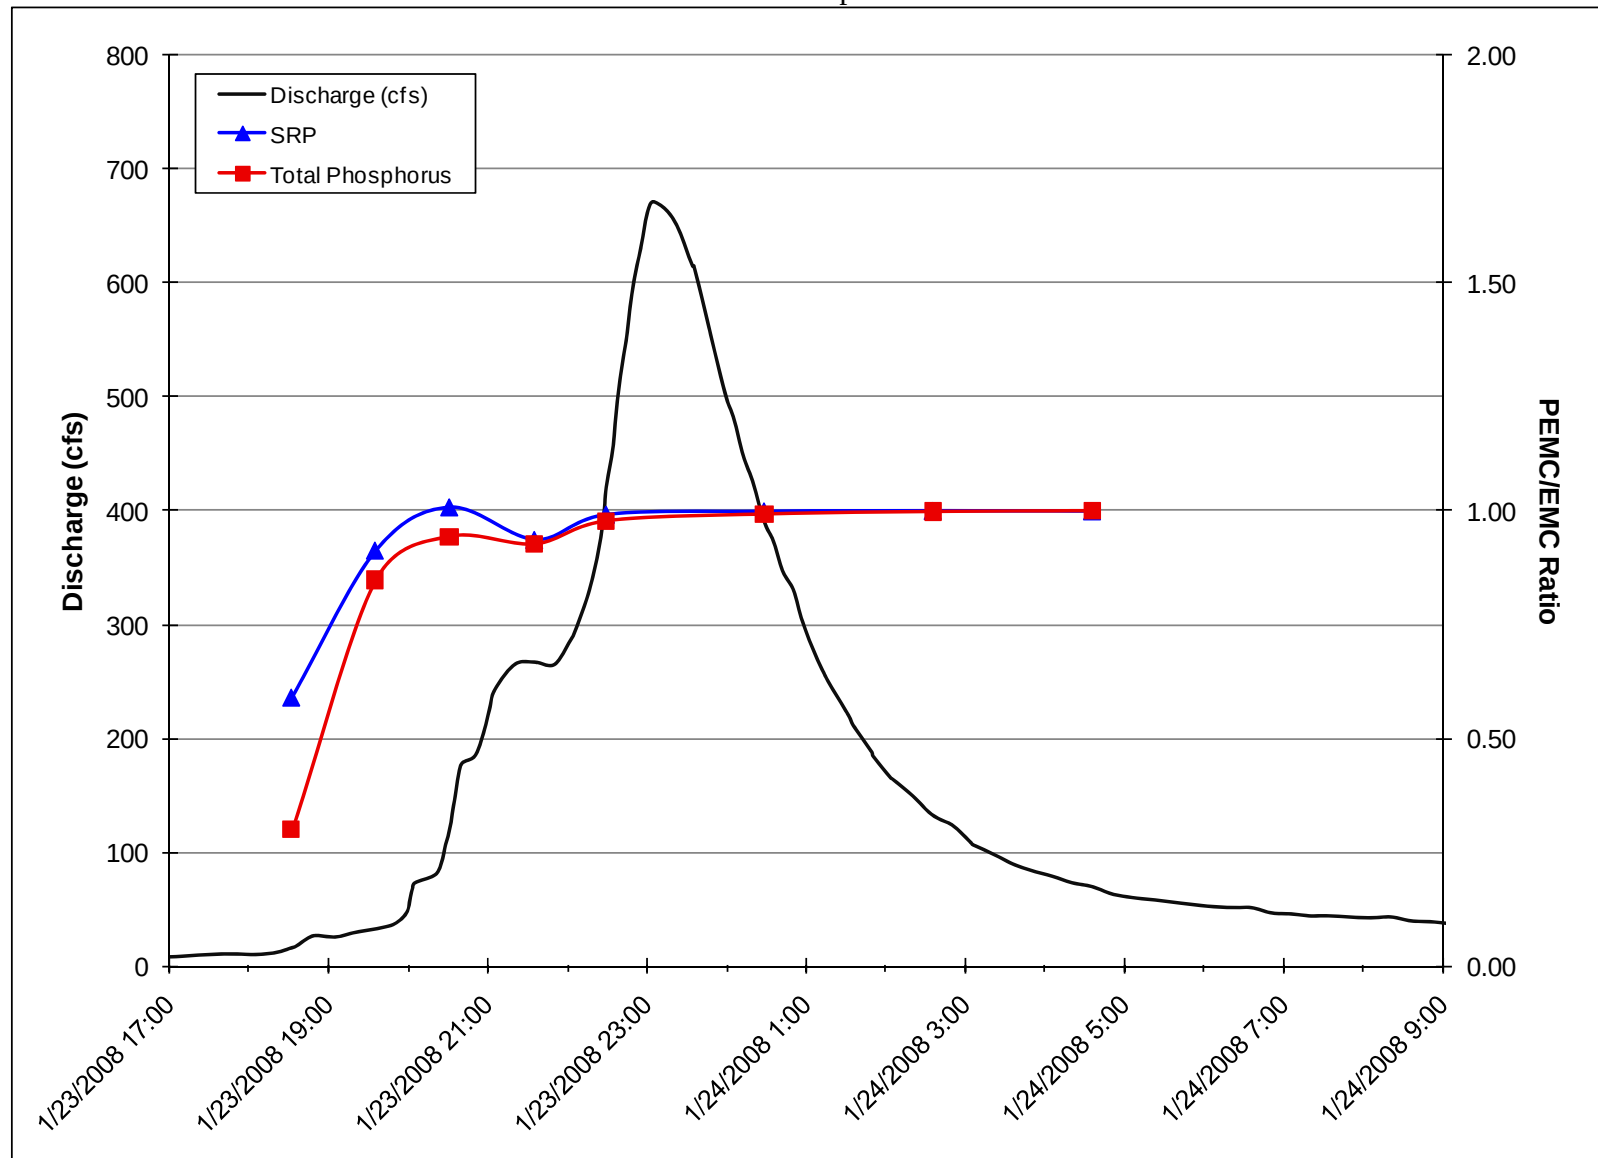
Buena Vista Mass Emission Station Wet Weather Event 2  
First Flush Ratios – Phosphorus Constituents
