**Appendix F**  
First Flush Ratio Figures

**Appendix F-1**  
Agua Hedionda Mass Emission Station  
First Flush Ratio Figures

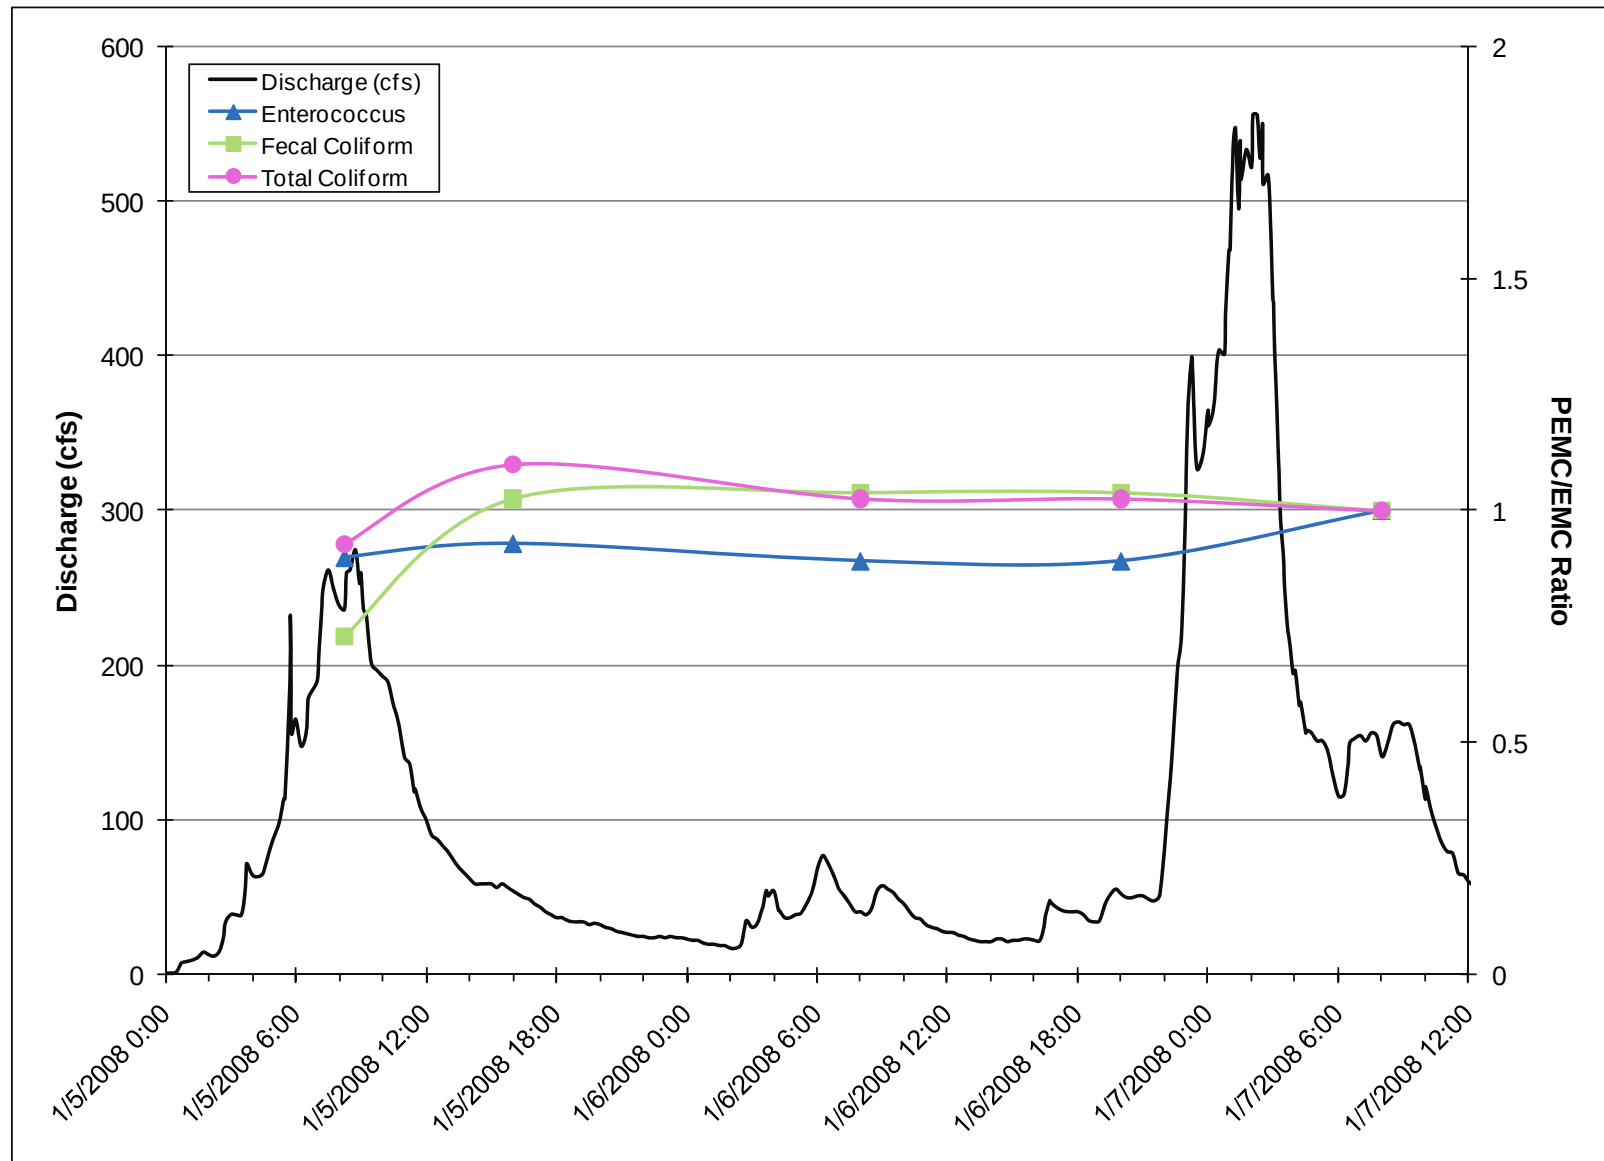
Loma Alta Mass Emission Station Wet Weather Event 1  
First Flush Ratios – Bacteria

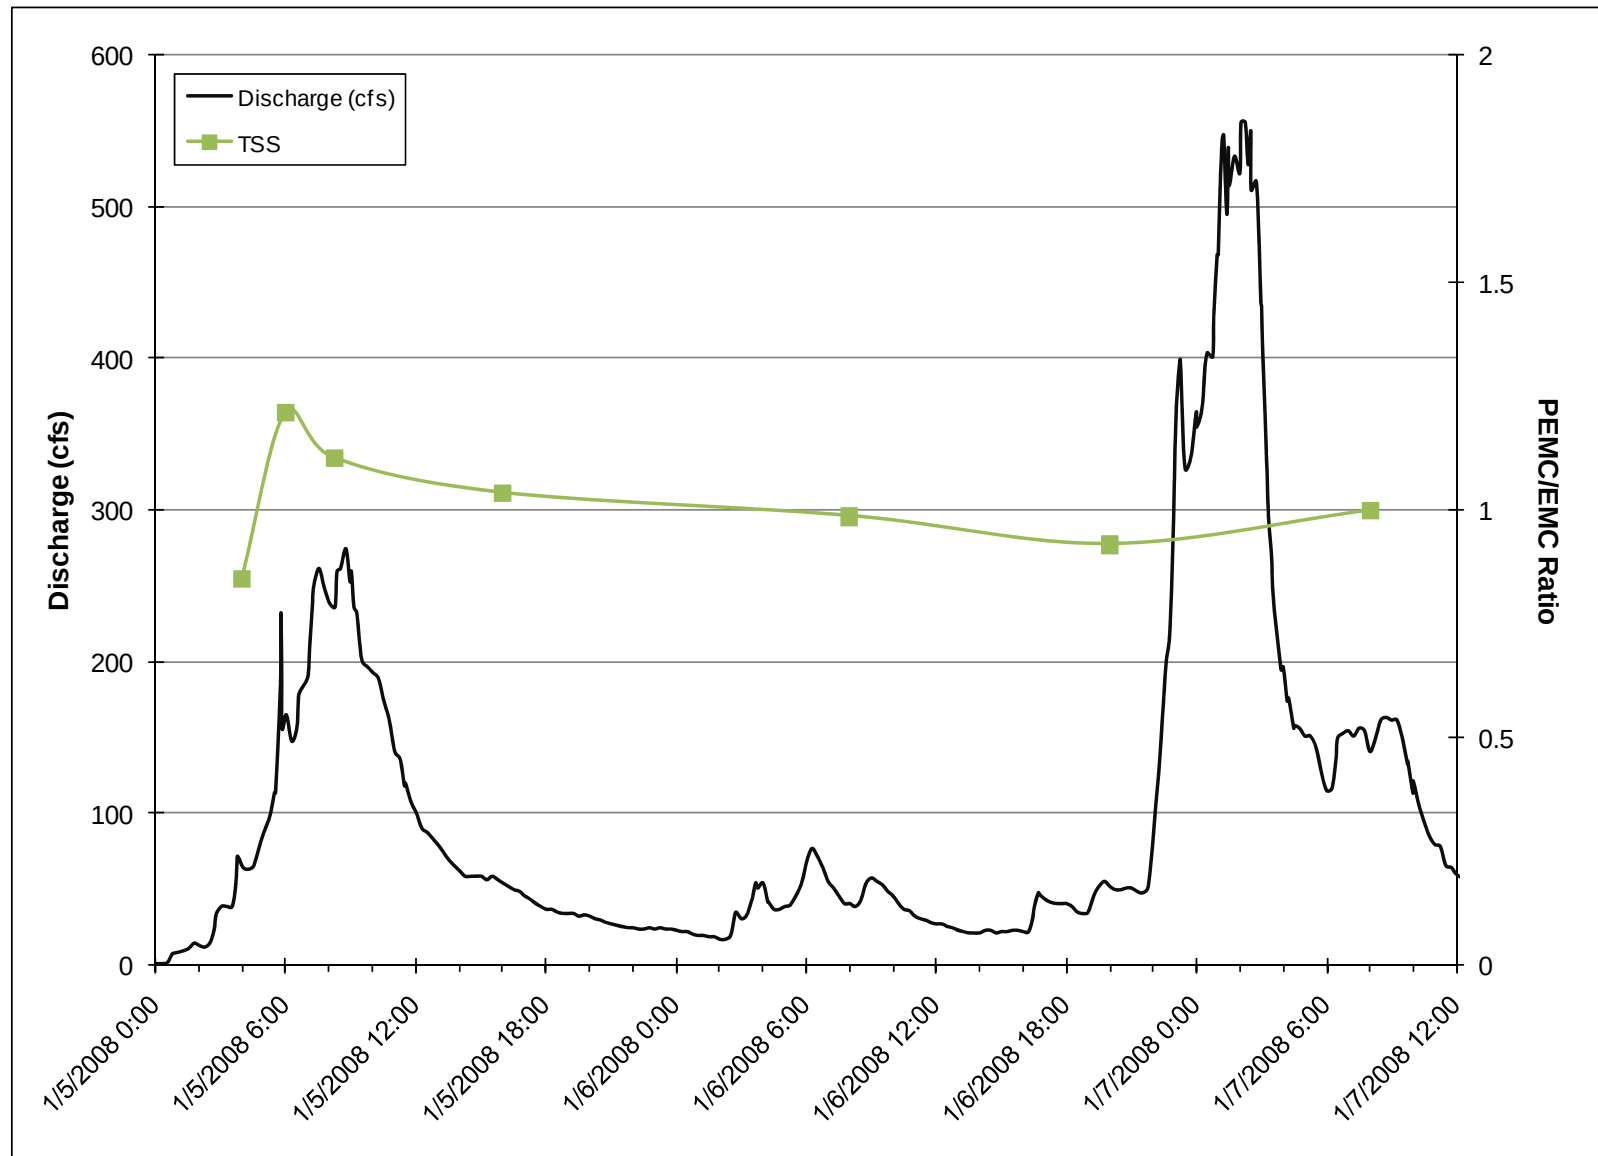
Loma Alta Mass Emission Station Wet Weather Event 1  
First Flush Ratios – Sediment

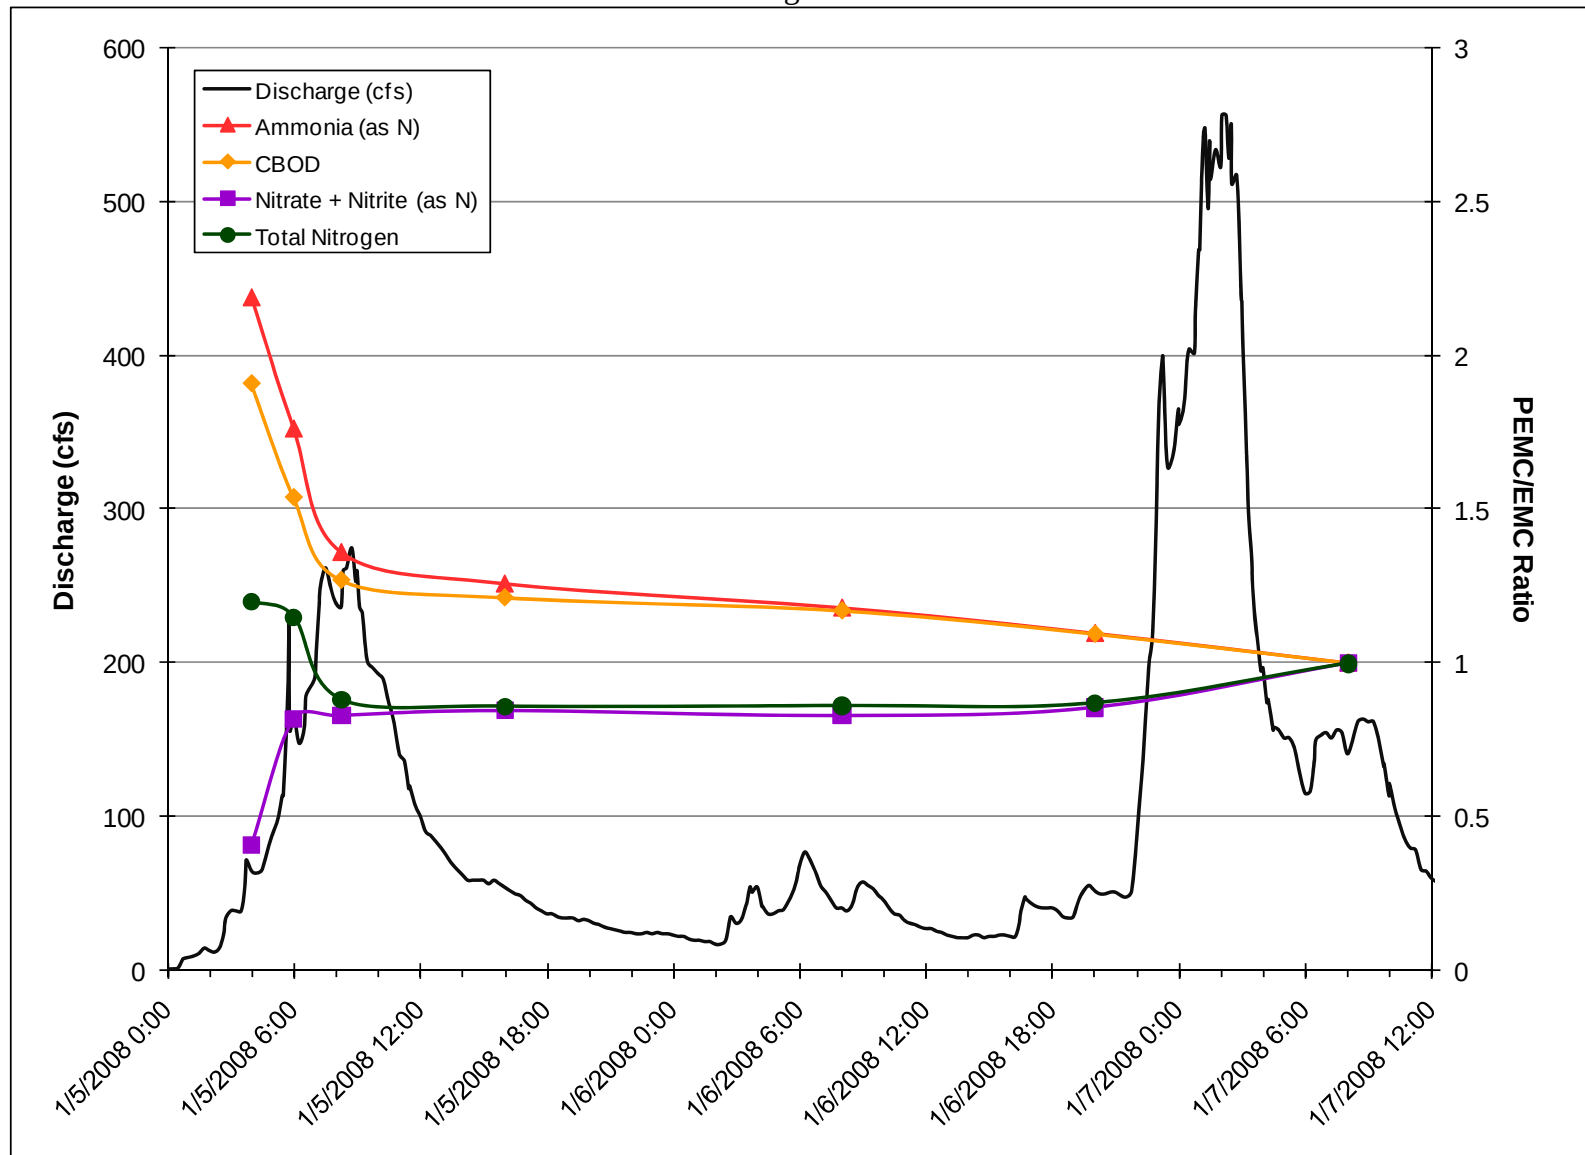
Loma Alta Mass Emission Station Wet Weather Event 1  
First Flush Ratios – Nitrogen Constituents and CBOD

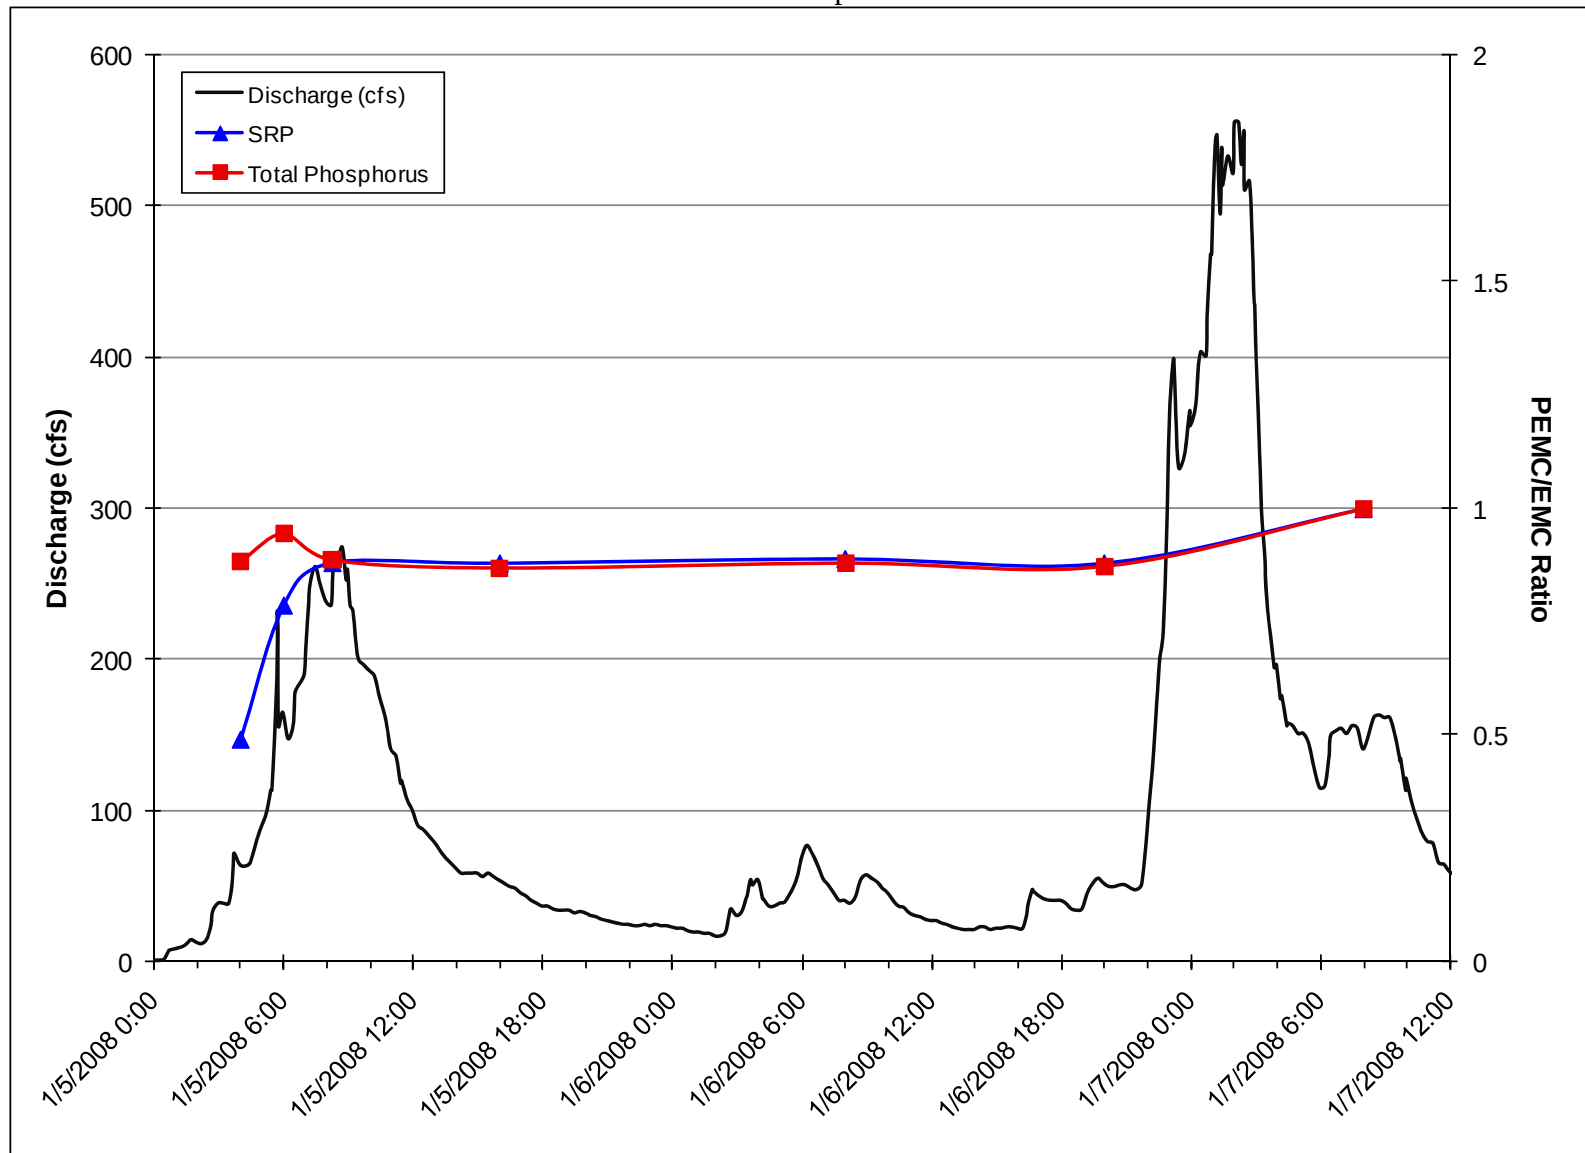
Loma Alta Mass Emission Station Wet Weather Event 1  
First Flush Ratios – Phosphorus Constituents

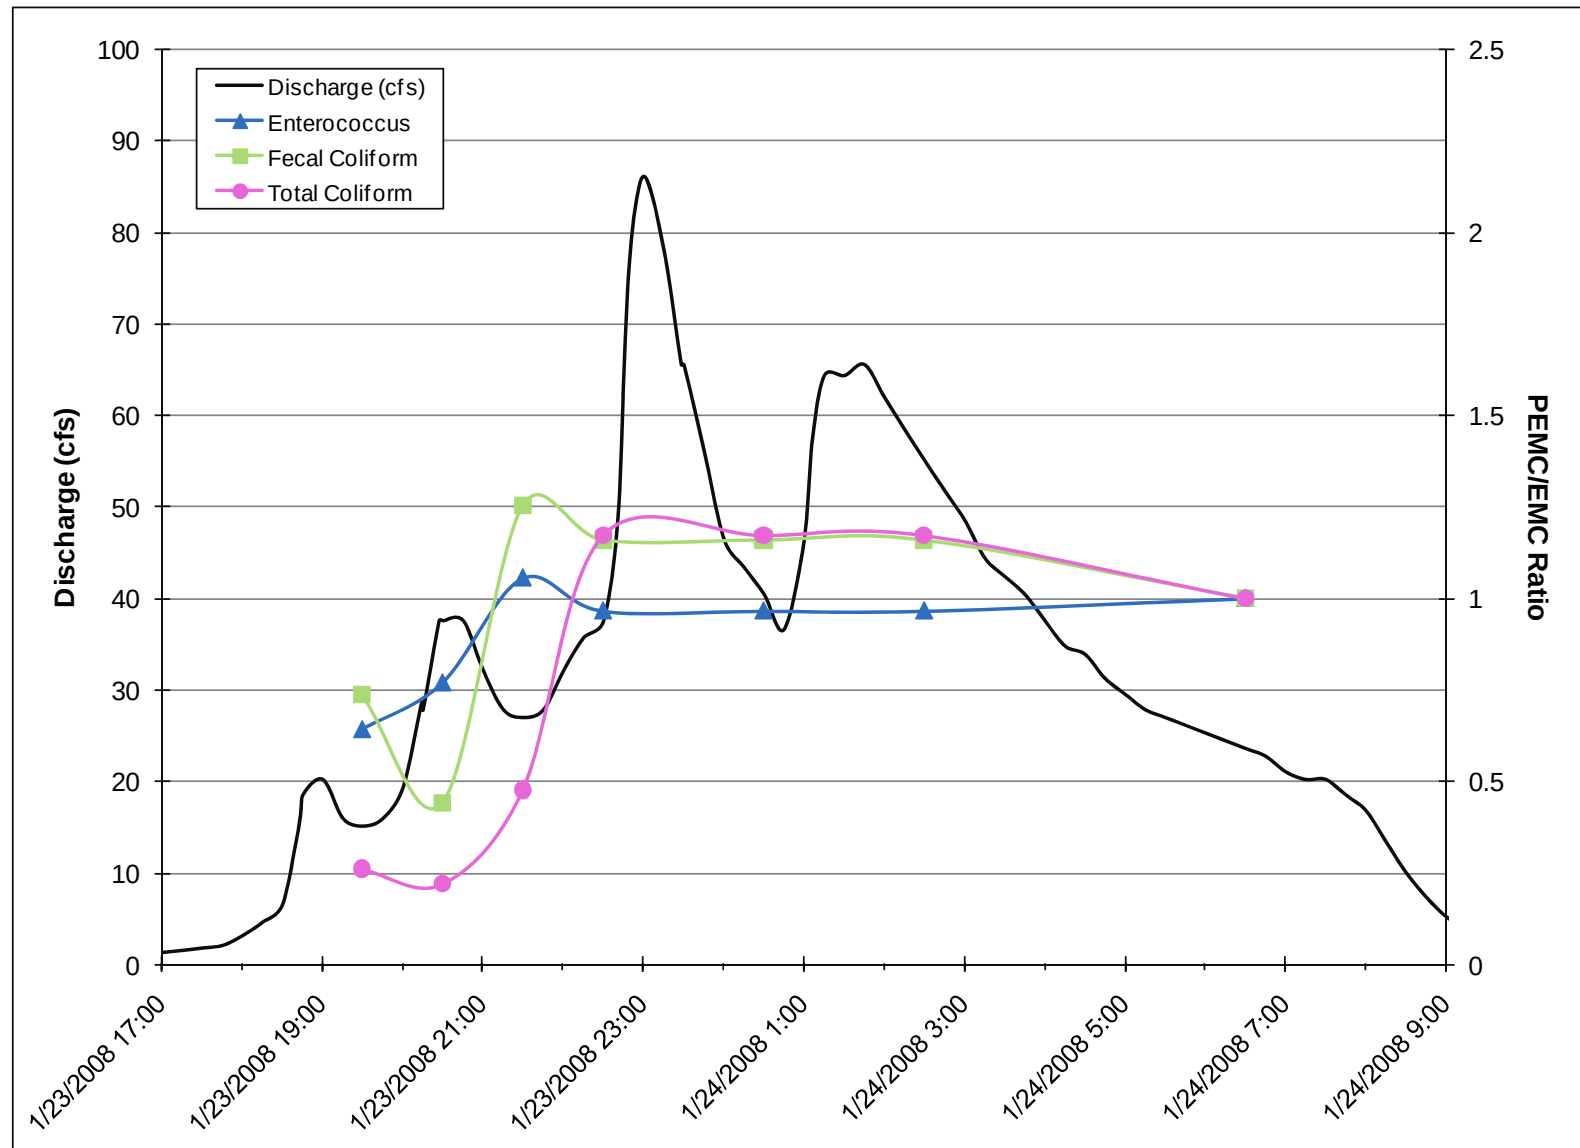
Loma Alta Mass Emission Station Wet Weather Event 2  
First Flush Ratios – Bacteria

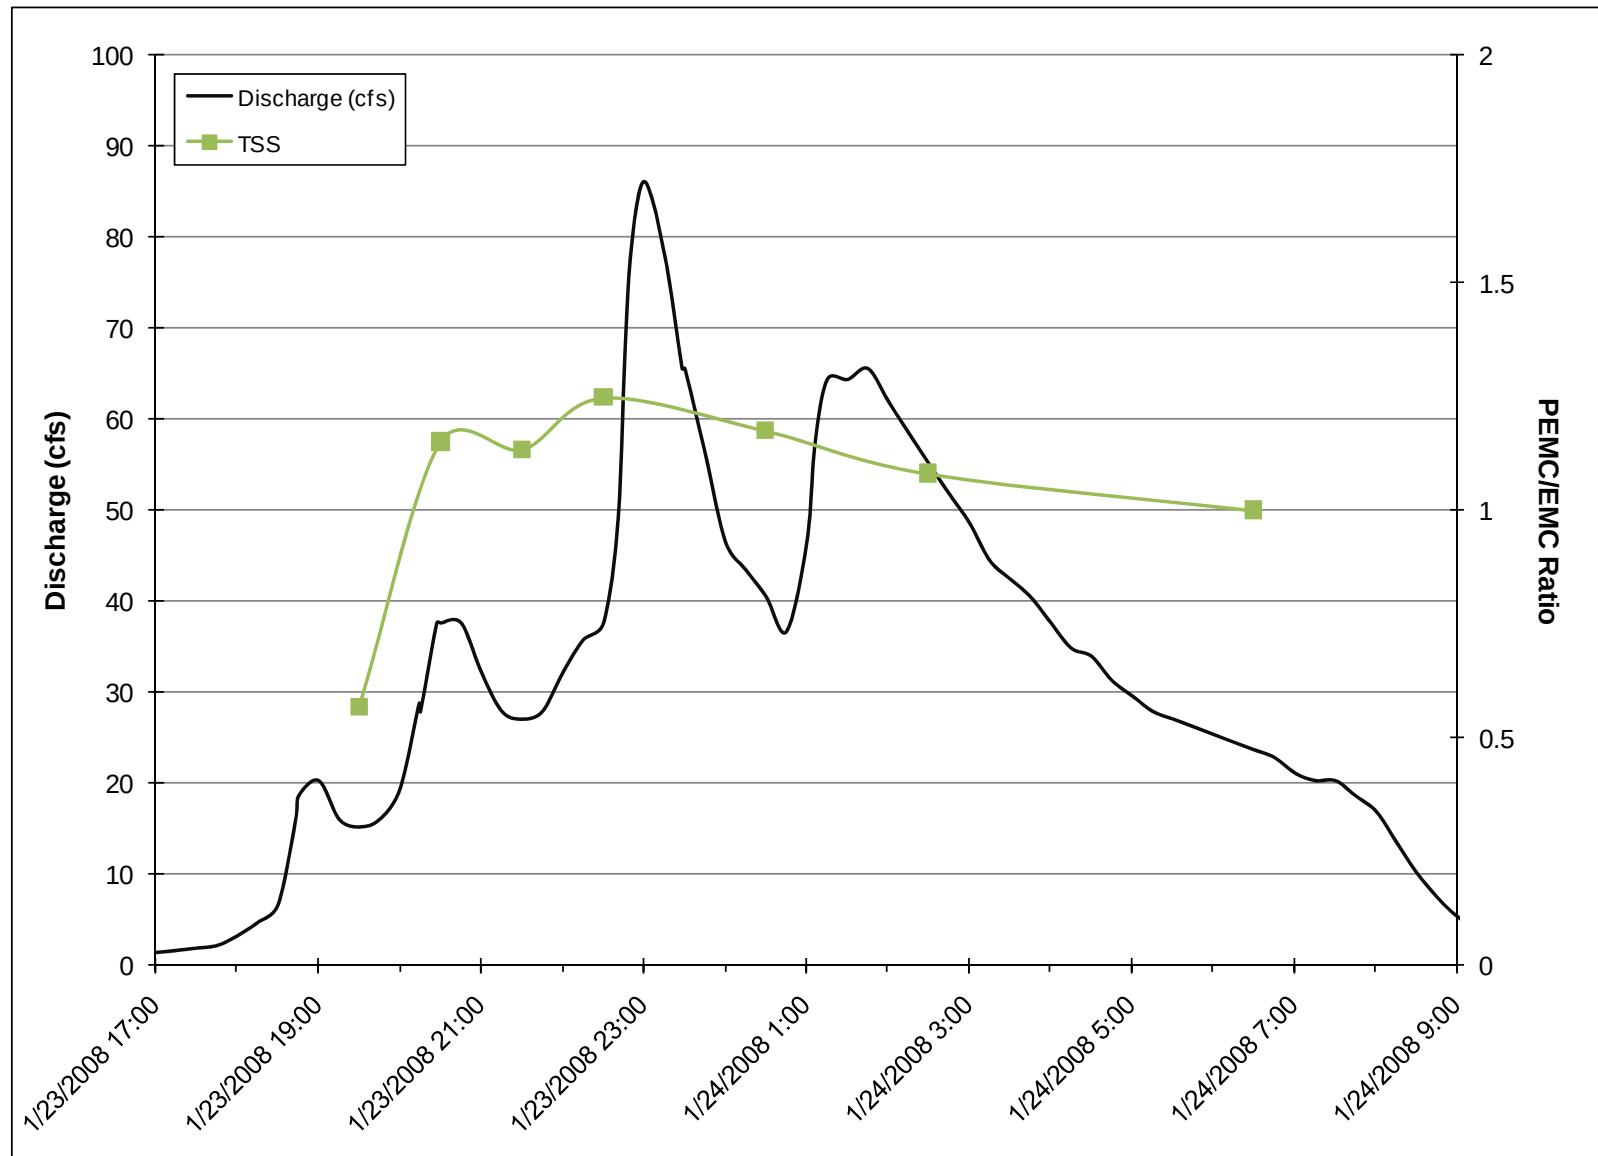
Loma Alta Mass Emission Station Wet Weather Event 2  
First Flush Ratios – Sediment

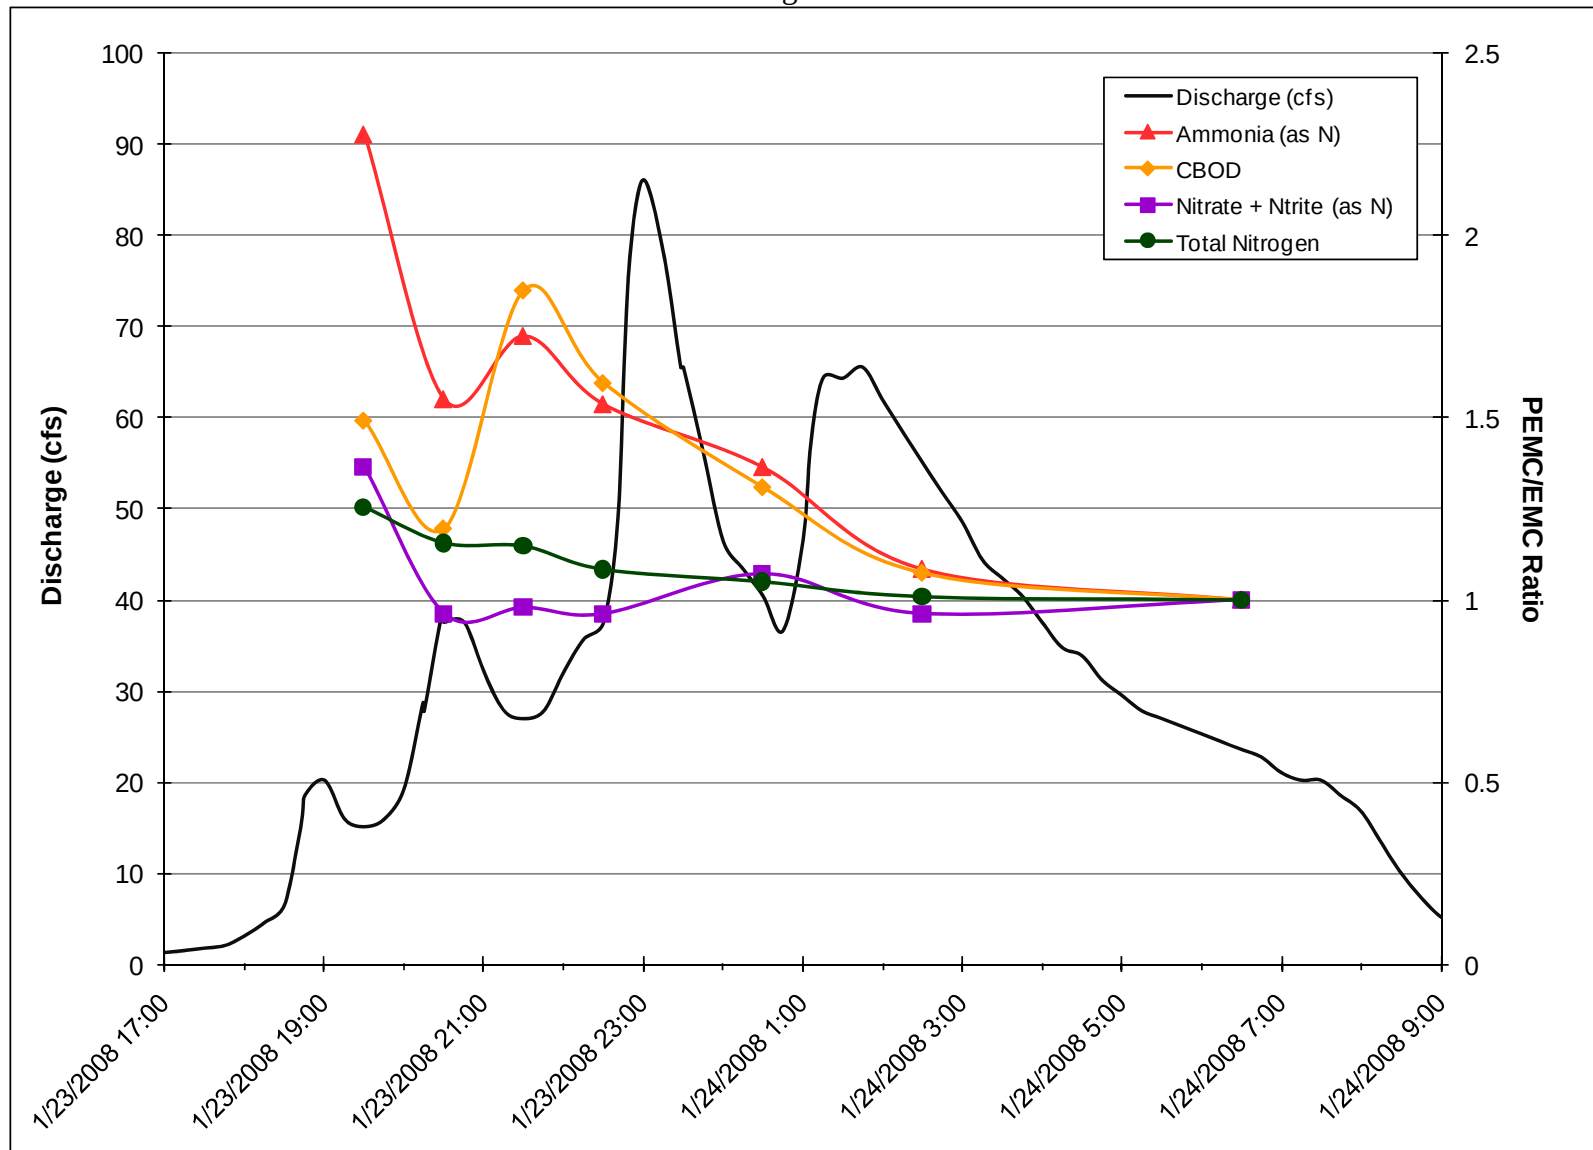
Loma Alta Mass Emission Station Wet Weather Event 2  
First Flush Ratios – Nitrogen Constituents and CBOD

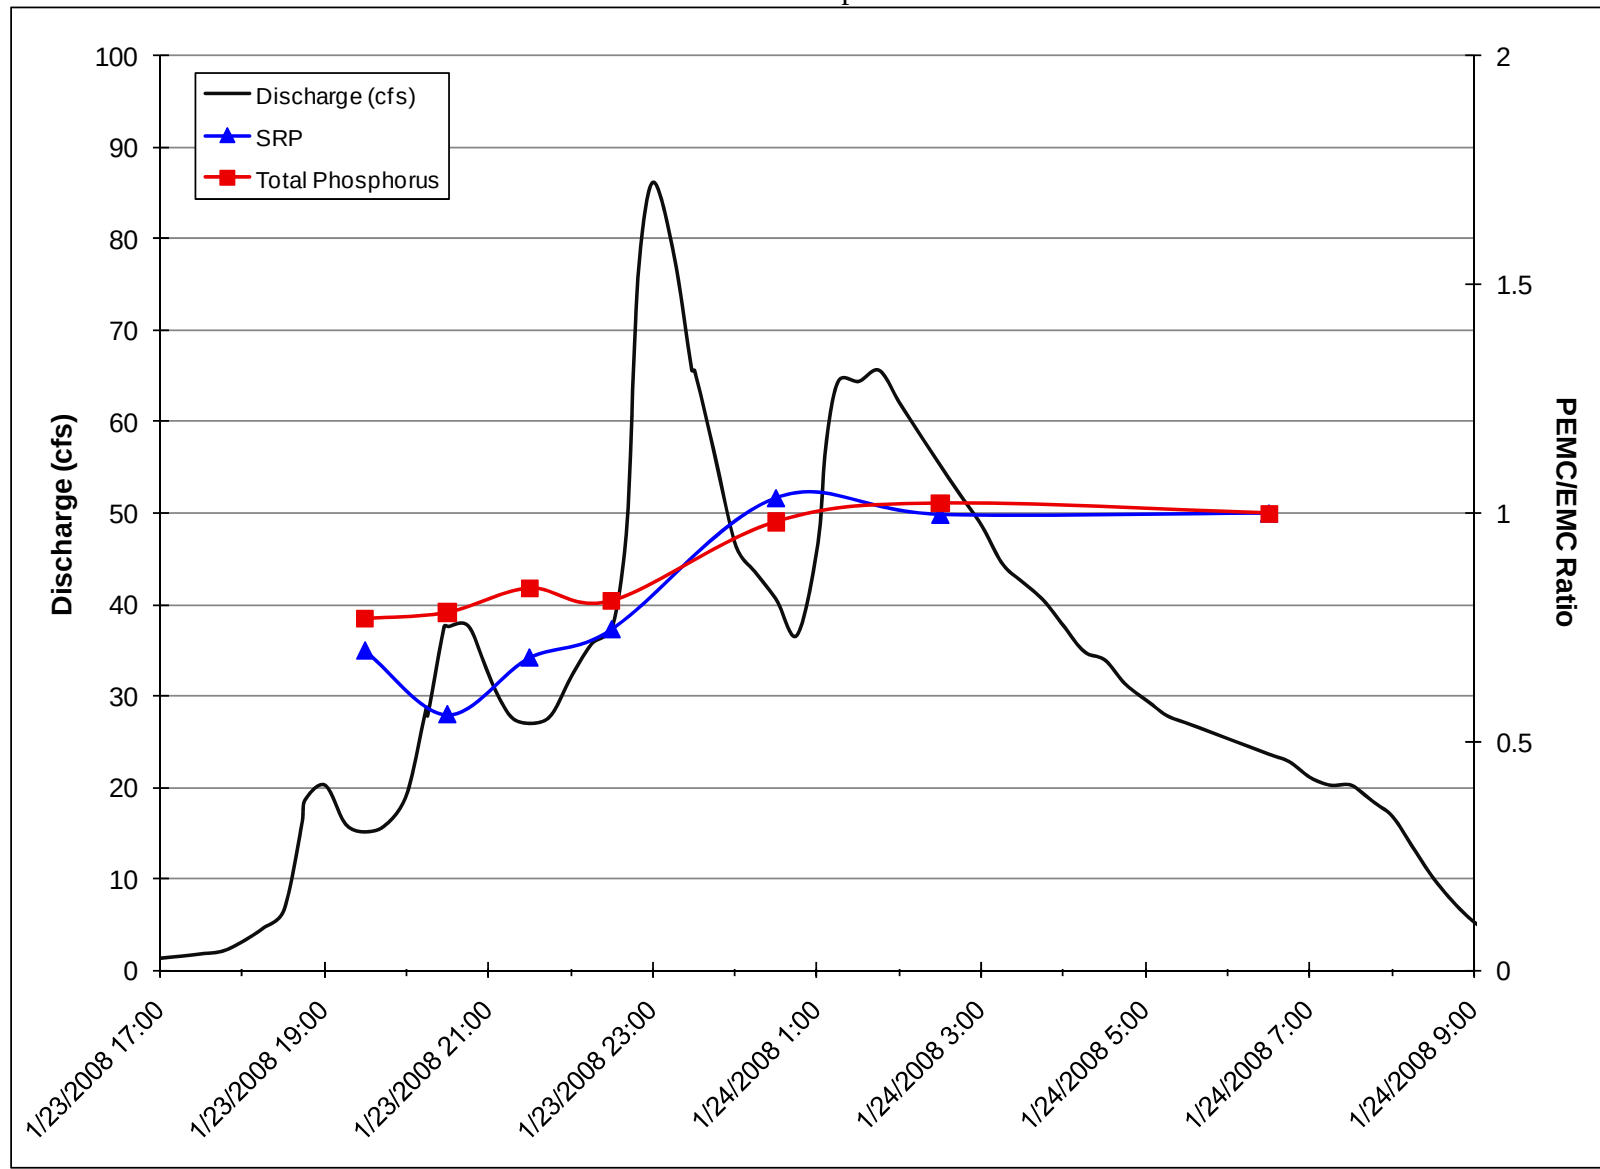
Loma Alta Mass Emission Station Wet Weather Event 2  
First Flush Ratios – Phosphorus Constituents

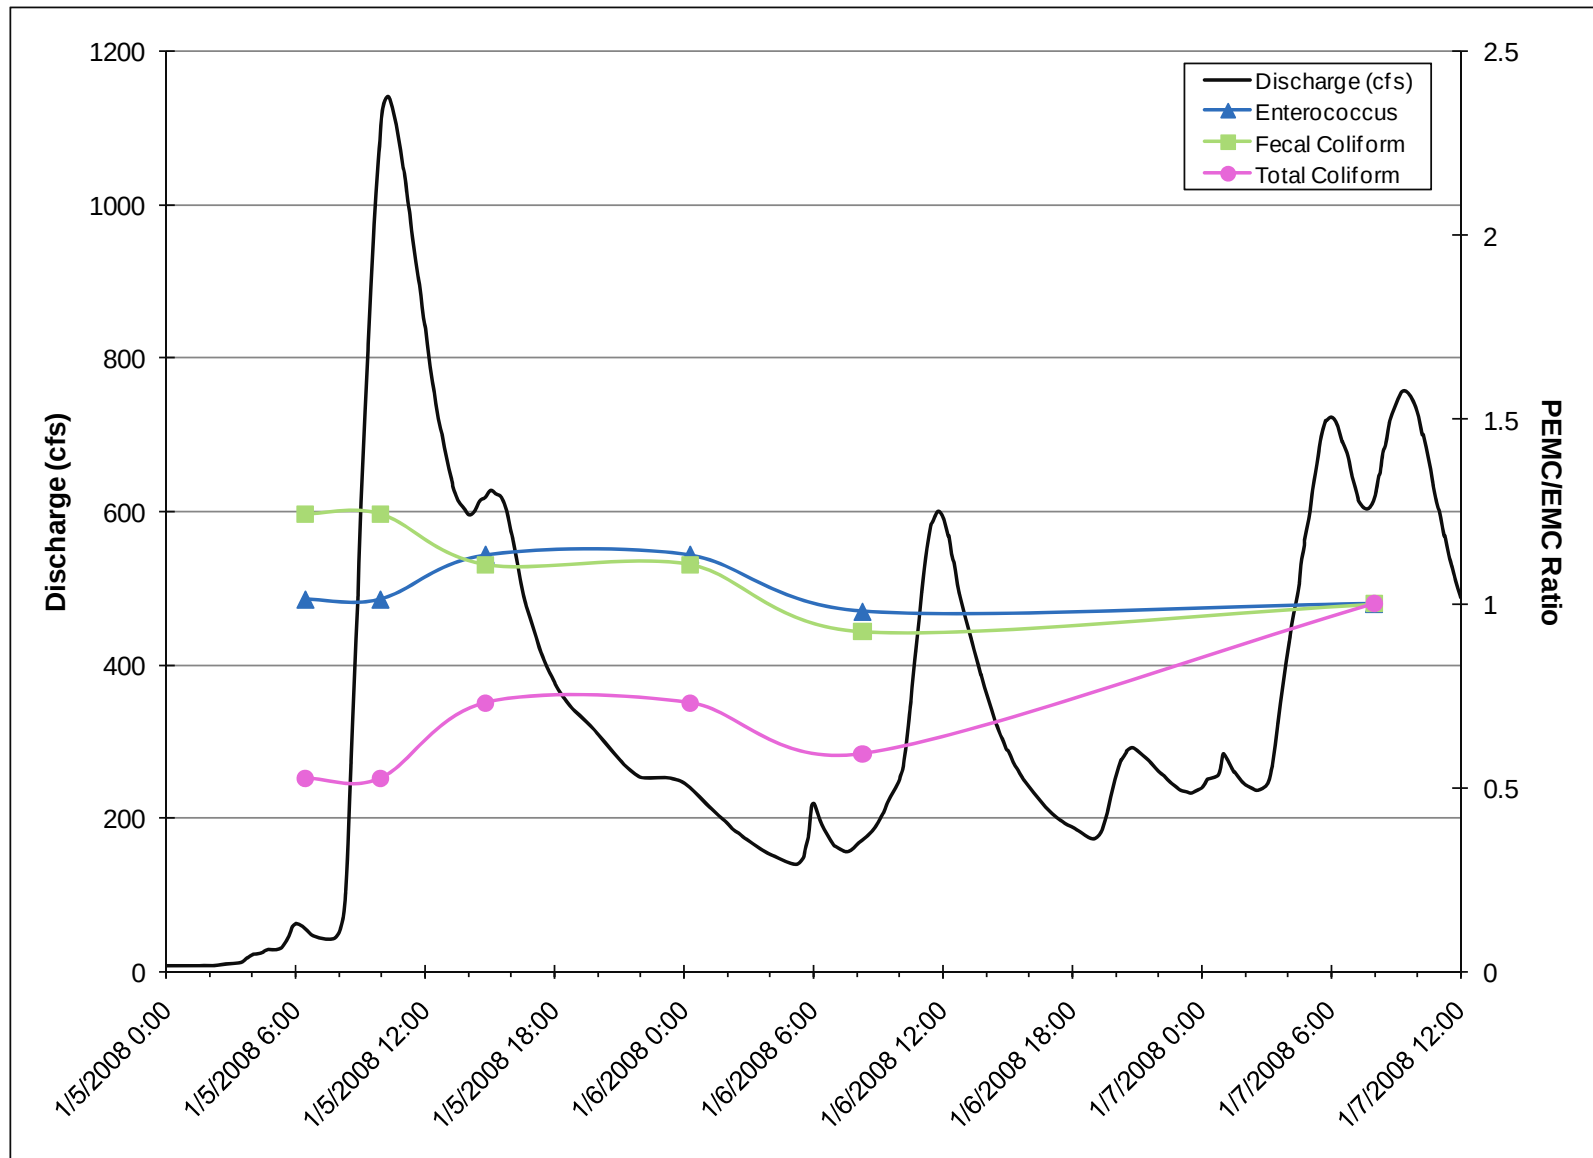
San Elijo Mass Emission Station Wet Weather Event 1  
First Flush Ratios – Bacteria

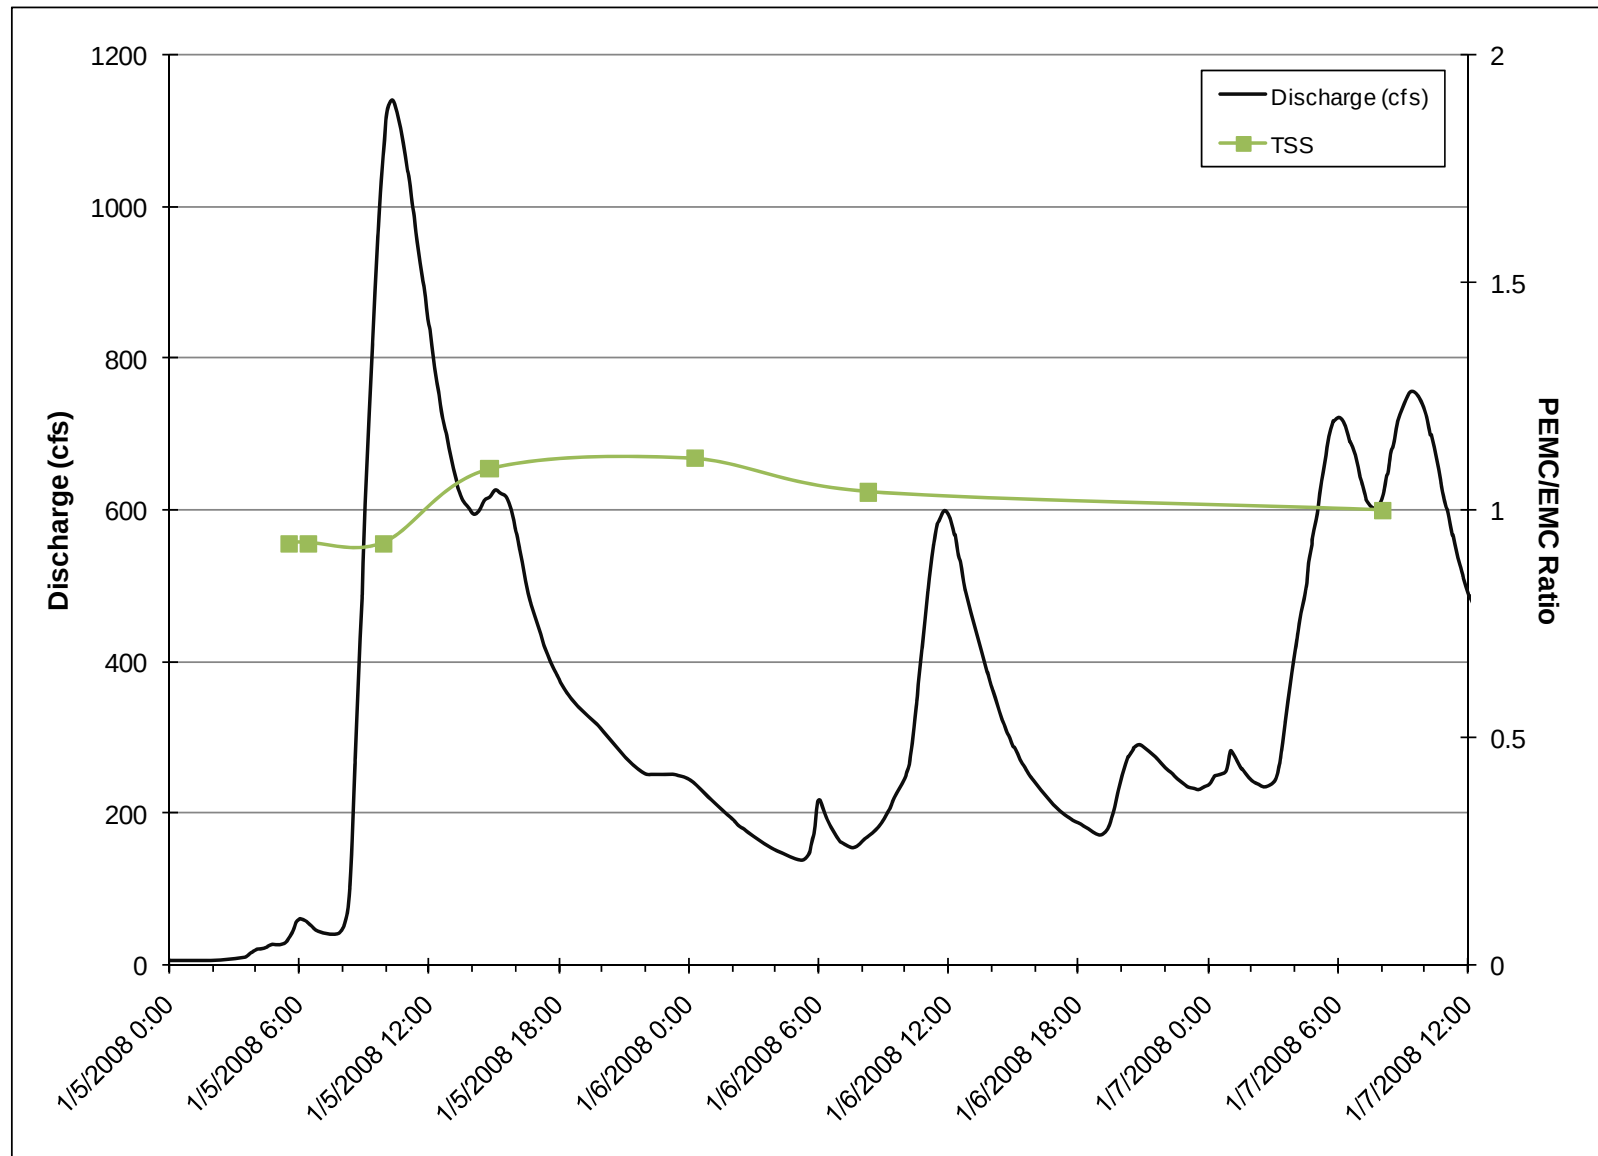
San Elijo Mass Emission Station Wet Weather Event 1  
First Flush Ratios – Sediment

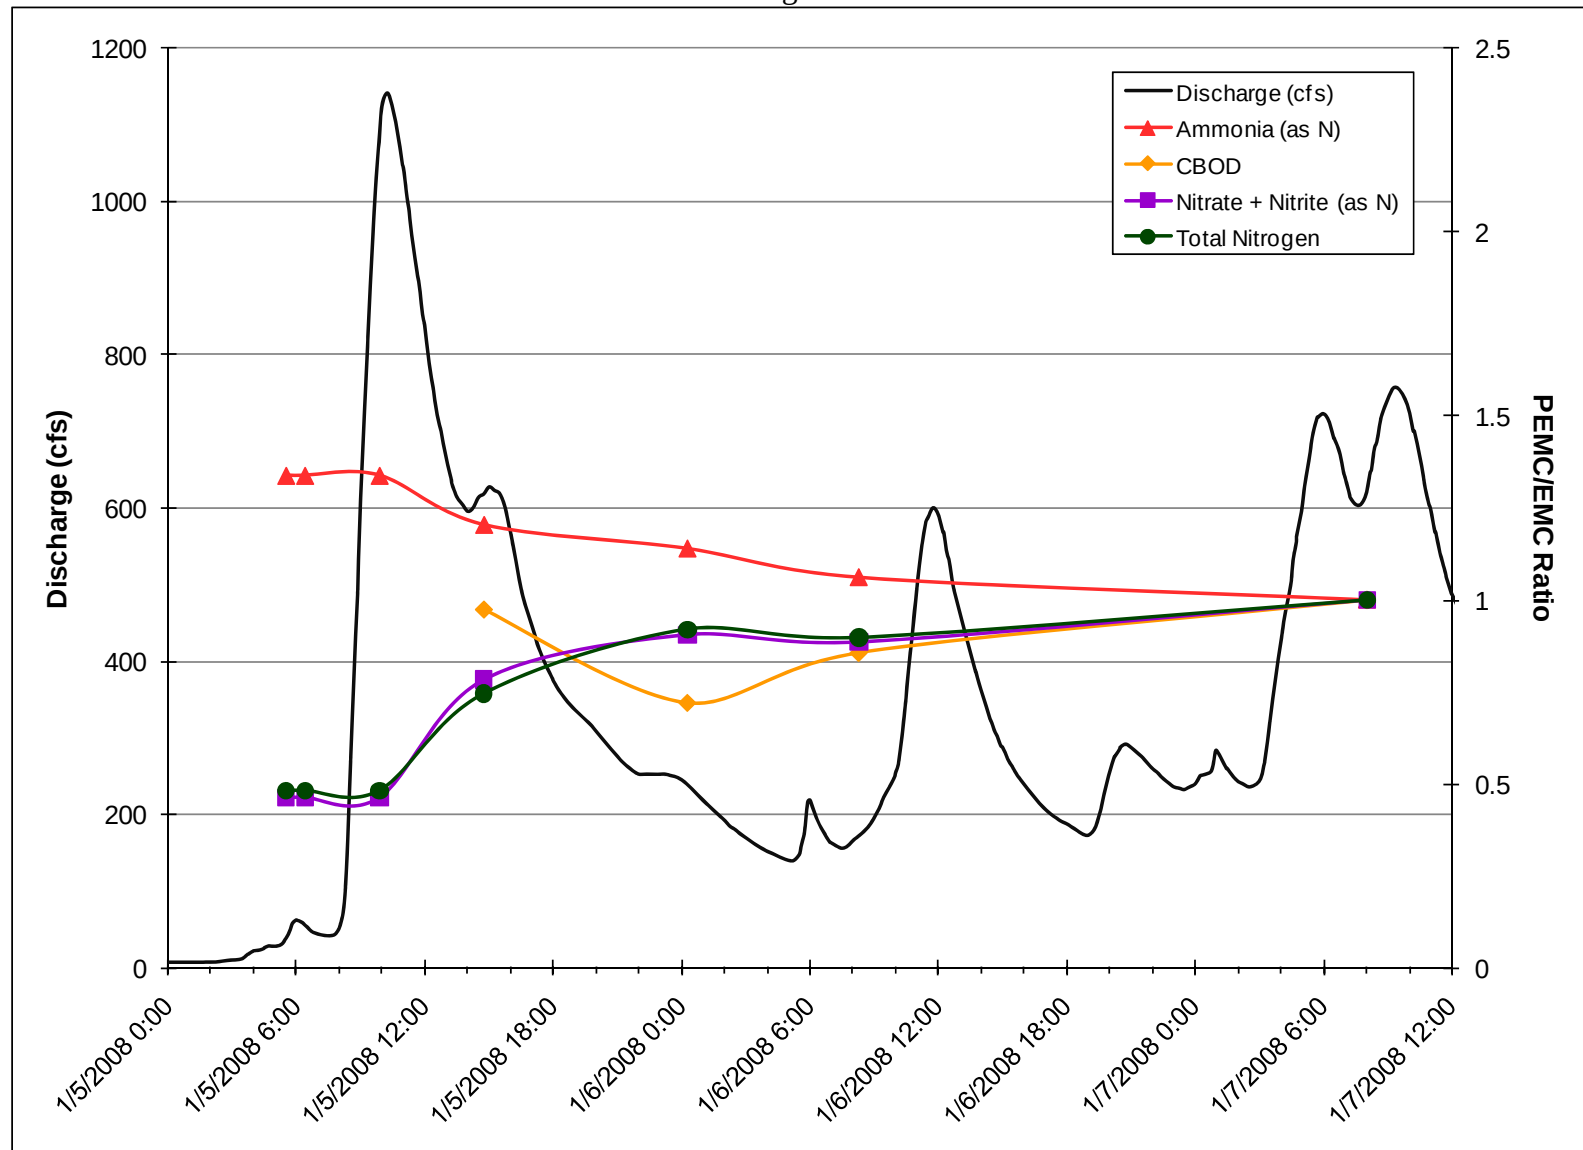
San Elijo Mass Emission Station Wet Weather Event 1  
First Flush Ratios – Nitrogen Constituents and CBOD

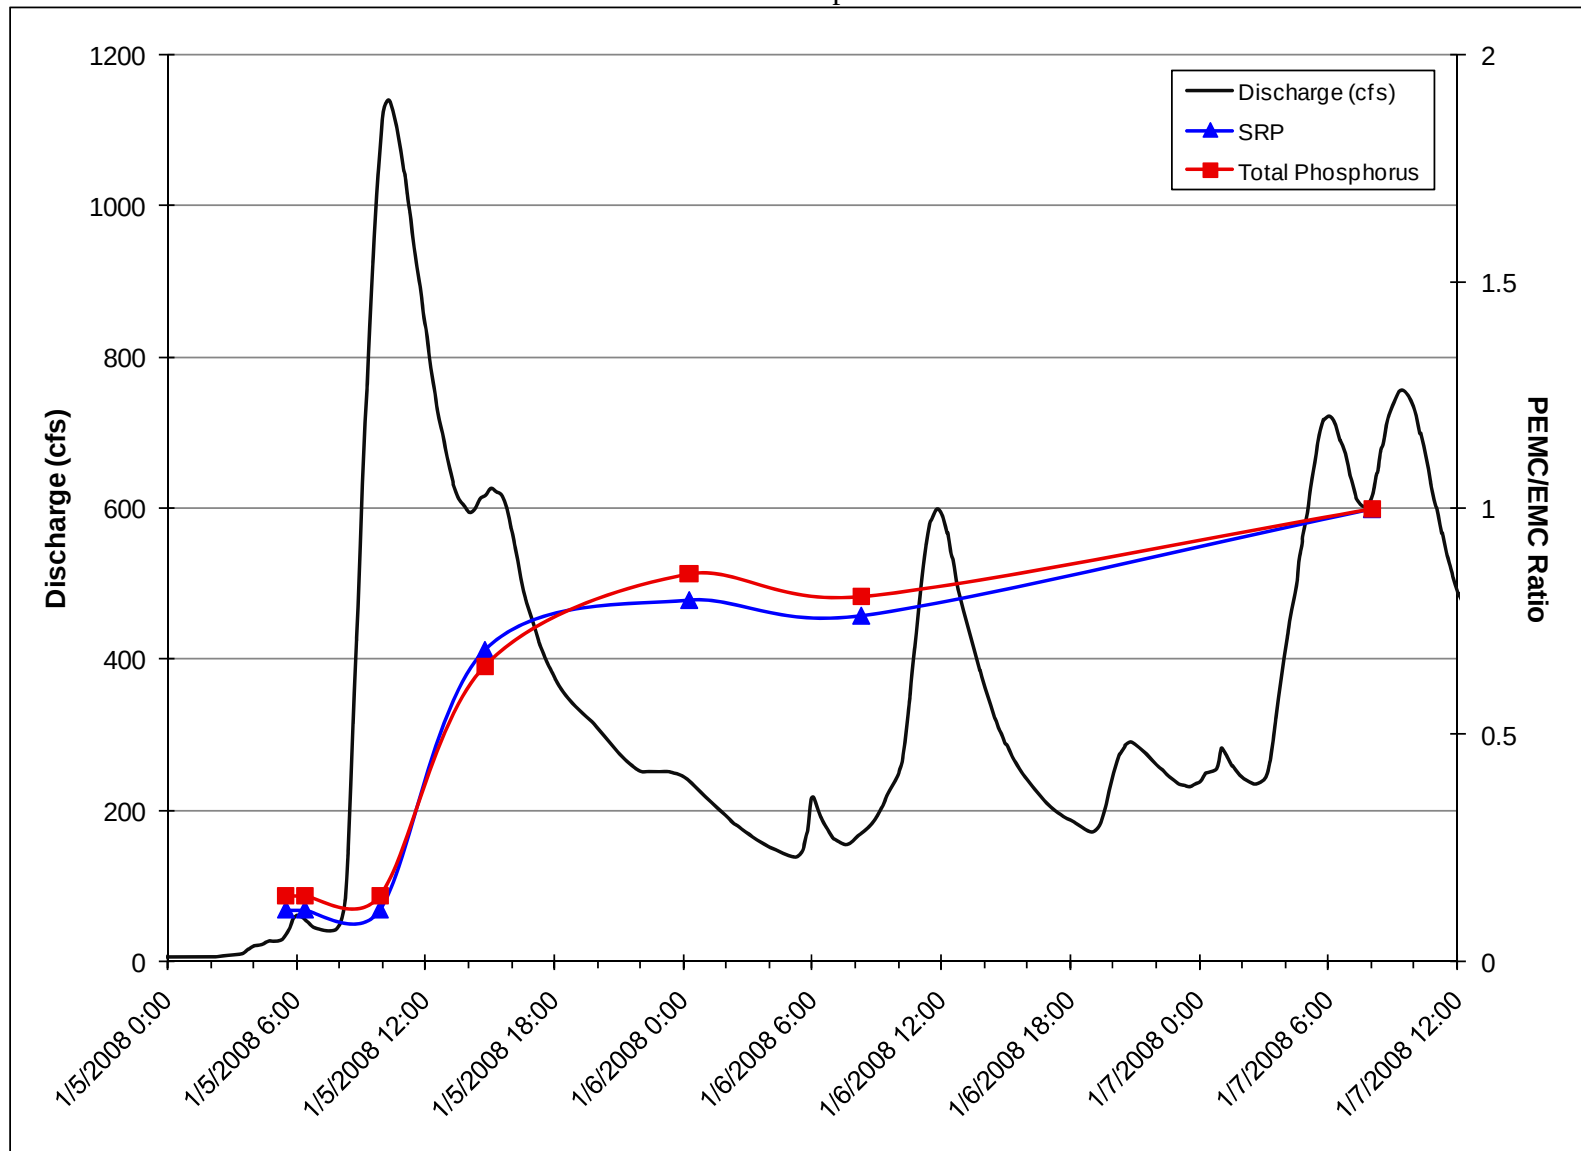
San Elijo Mass Emission Station Wet Weather Event 1  
First Flush Ratios – Phosphorus Constituents
