**Appendix F**  
First Flush Ratio Figures

**Appendix F-1**  
Agua Hedionda Mass Emission Station  
First Flush Ratio Figures

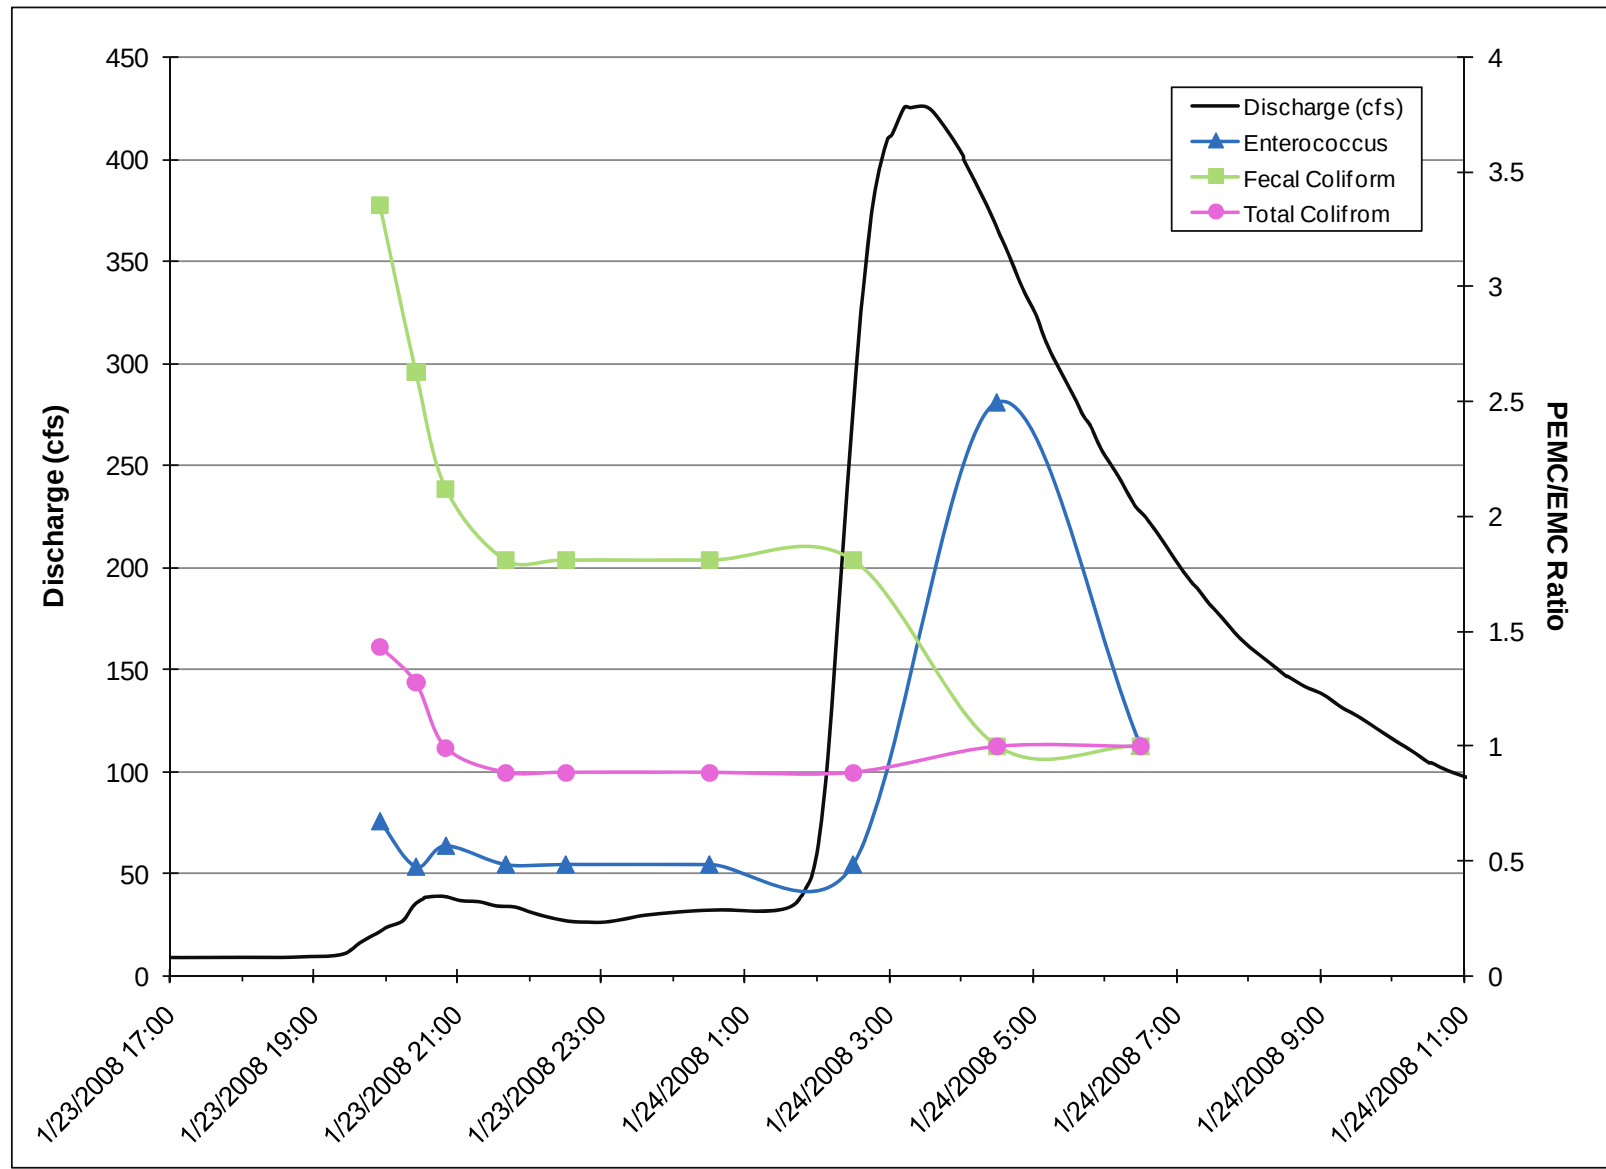
San Elijo Mass Emission Station Wet Weather Event 2  
First Flush Ratios – Bacteria

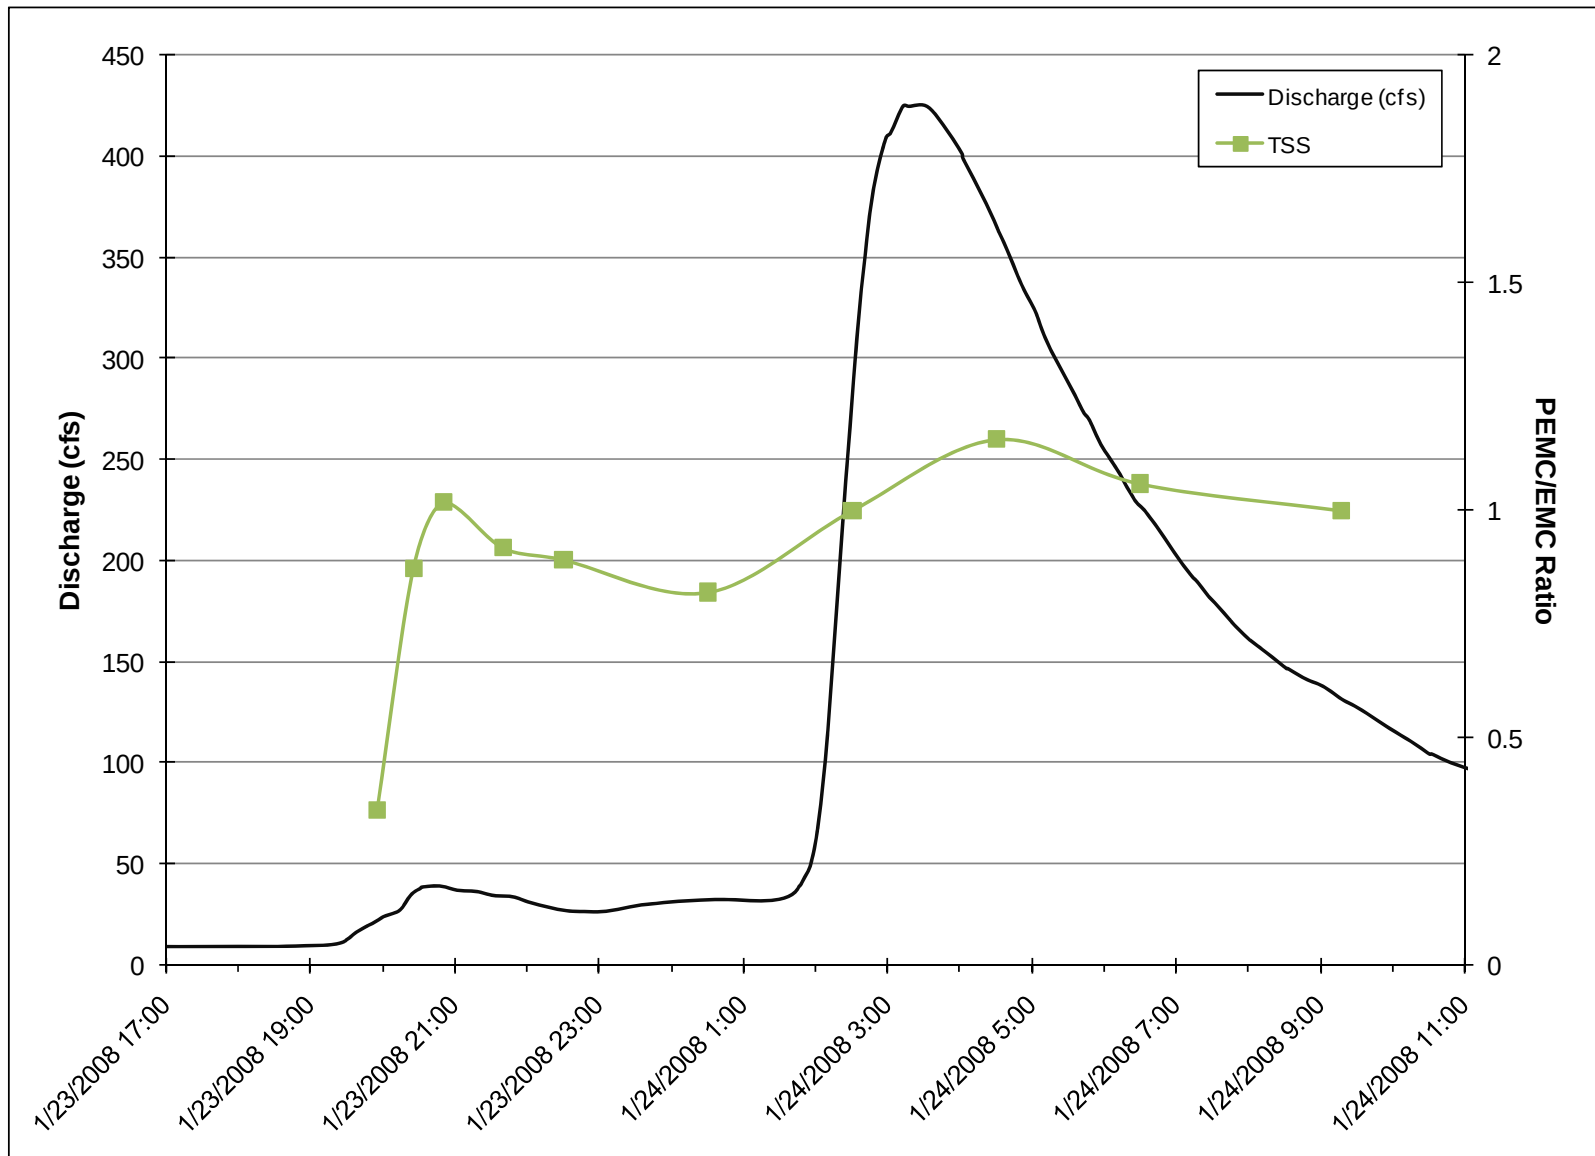
San Elijo Mass Emission Station Wet Weather Event 2  
First Flush Ratios – Sediment

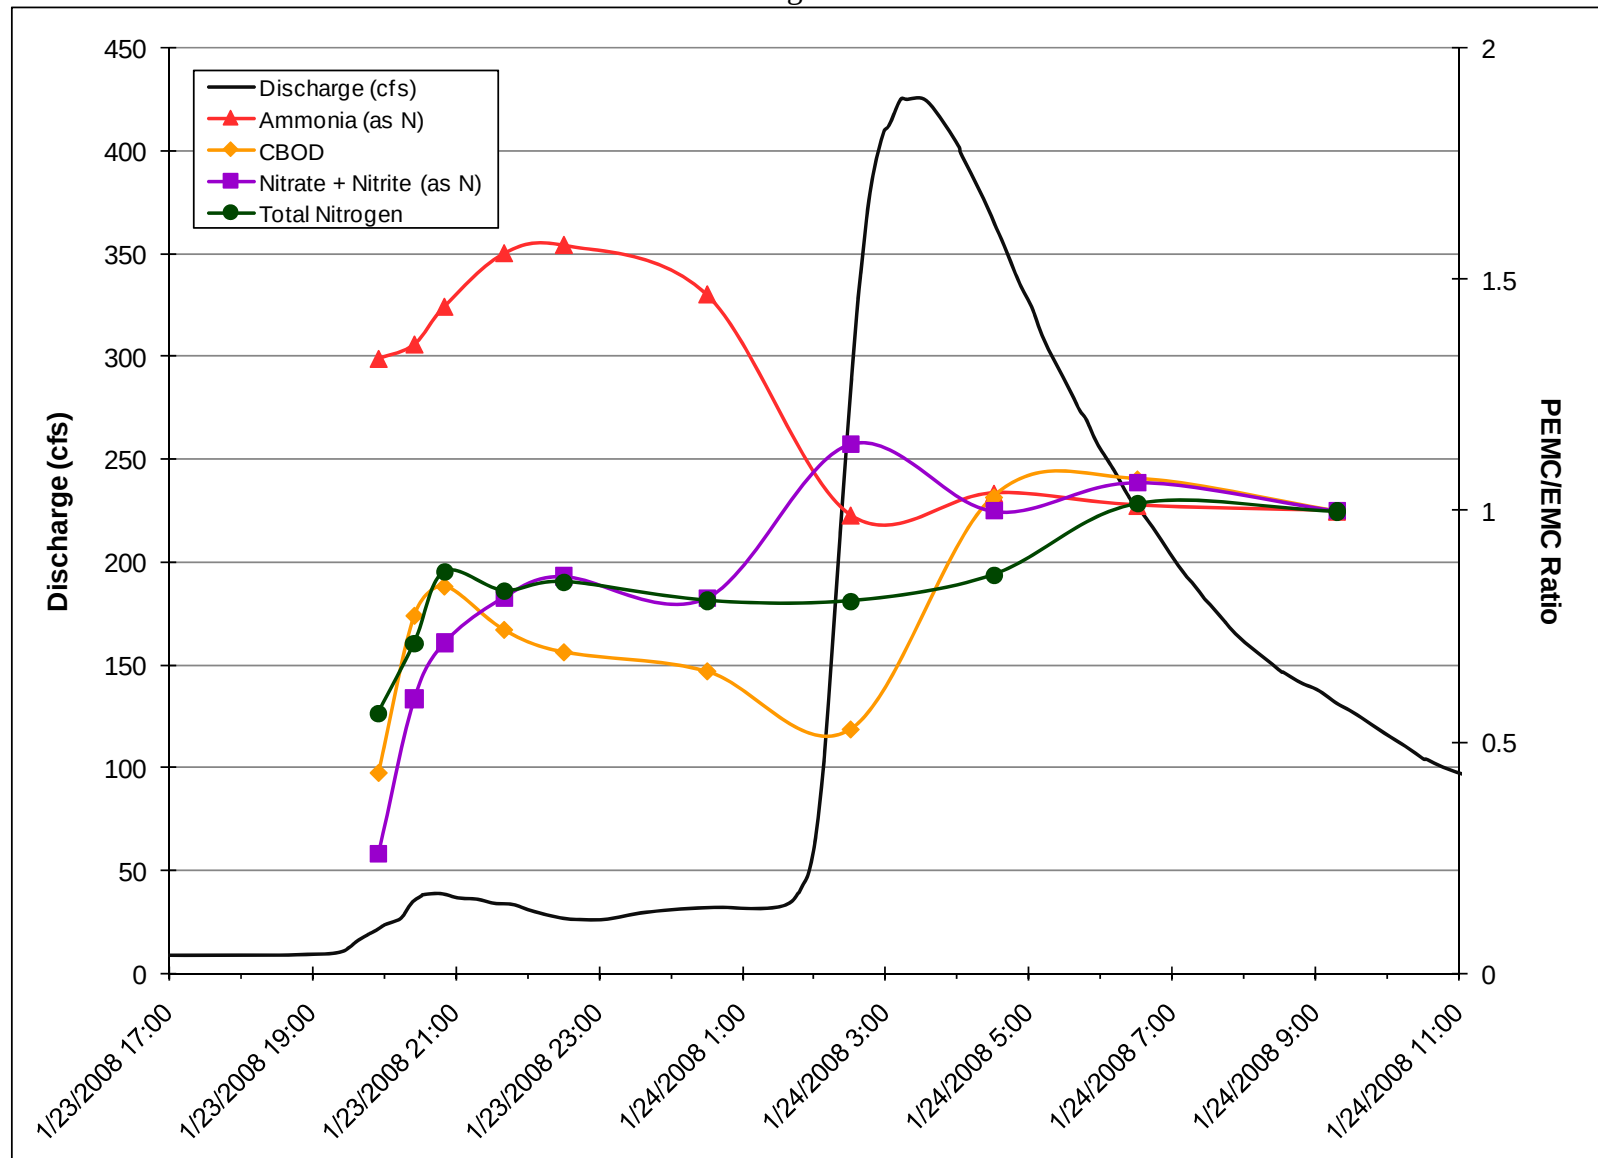
San Elijo Mass Emission Station Wet Weather Event 2  
First Flush Ratios – Nitrogen Constituents and CBOD

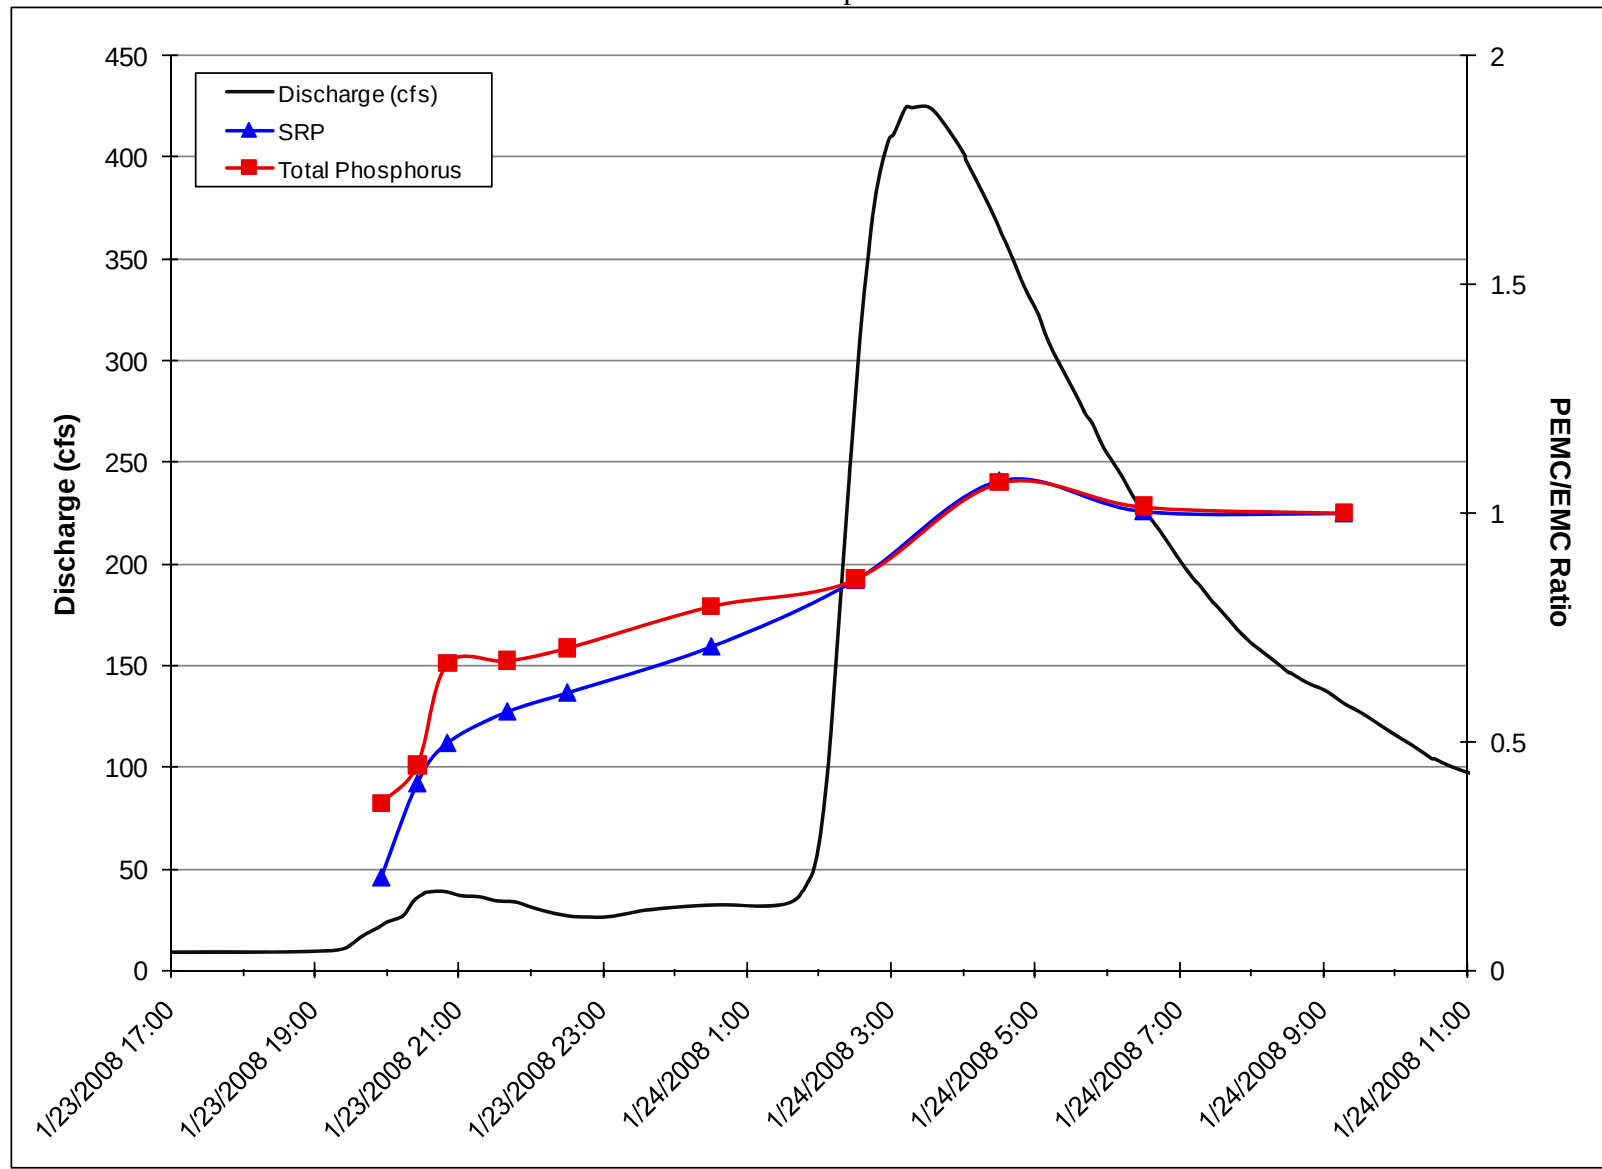
San Elijo Mass Emission Station Wet Weather Event 2  
First Flush Ratios – Phosphorus Constituents
