CLEANUP AND ABATEMENT ORDER No. R2-2017-00XX

BREMER FAMILY WINERY VINEYARD
NAPA COUNTY

INSPECTION REPORT

Subject: Inspection of the Bremer Family Winery Vineyard, Napa County

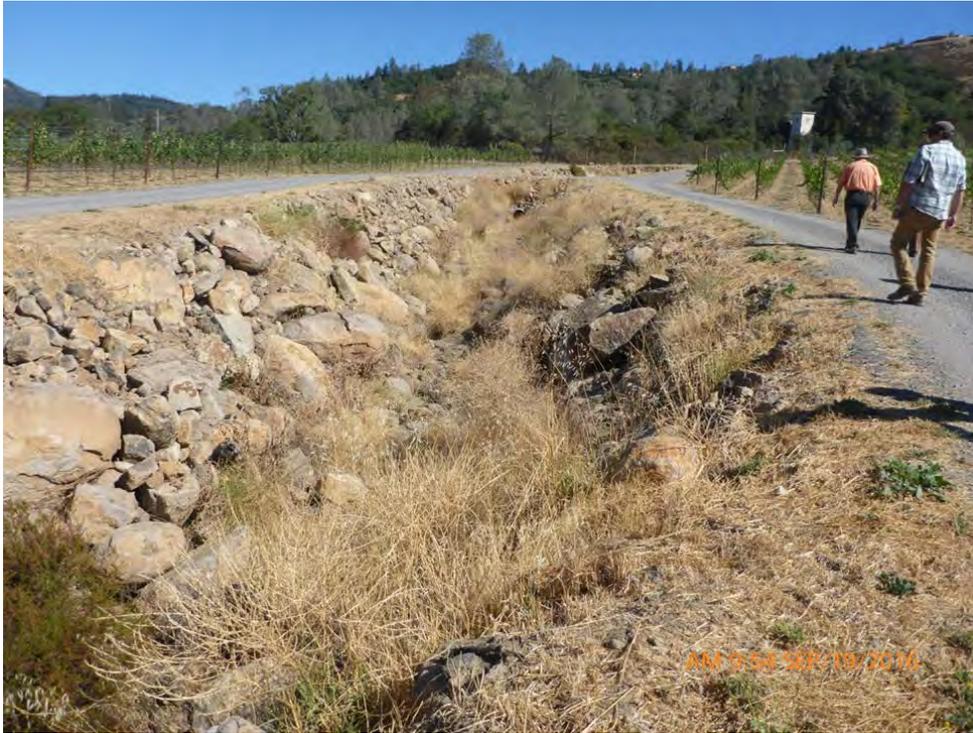
1. **An unnamed intermittent or ephemeral stream channel, that is hydrologically connected to the Napa River, was ditched and culverted during the current phase of vineyard development.** Vineyard blocks were developed directly adjacent to the channelized stream, with eight- to ten-foot-high rock walls now forming the banks of the stream. Prior to development, as evidenced by review of time-sequential aerial photographs available in Google Earth, there was a continuous physical connection between this unnamed stream and a named blue-line stream (Canon Creek), and wet-season flow was evident. Prior to development the stream alternated between single-thread and multiple-threaded reaches, cascade bedforms were common, and vegetation on the rocky floodplain for the channel was dominated by chaparral species.

Photo 1. Lower portion of unnamed intermittent stream that was channelized (looking upstream).

1. No later than May 22, 2017, the Dischargers shall submit, acceptable to the Water Board Executive Officer, the following:
 - a. A technical report providing a description of the recent unauthorized construction activities at the Site and an assessment of the impacts to the Creek and associated riparian habitat. This technical report shall describe in detail the nature and extent of the unauthorized fill and vegetation clearing activities by: providing a map illustrating the extent of unauthorized construction activities at the Site; calculations quantifying the acreage of land disturbance and linear footage of Creek impacts; calculations of the volume and types of fill placed; a detailed qualitative description of the overall project purpose and design; as-built plans for the constructed project; a jurisdictional delineation of the extent of federal and State waters at the Site prior to and following the constructed project; and all other necessary information. The impact assessment shall be completed by a licensed professional geologist or civil engineer with expertise in fluvial geomorphology and/or creek restoration, and shall, at a minimum, include a description of the pre-disturbance channel morphology, soil conditions, hydrology, and characterization of the impacted Creek and riparian habitat, as well as supporting documentation (e.g., aerial photographs, photographs, reports, topographic maps, and drawings). The technical report, including the impact assessment, shall serve as the basis for the Corrective Action Workplan described below.

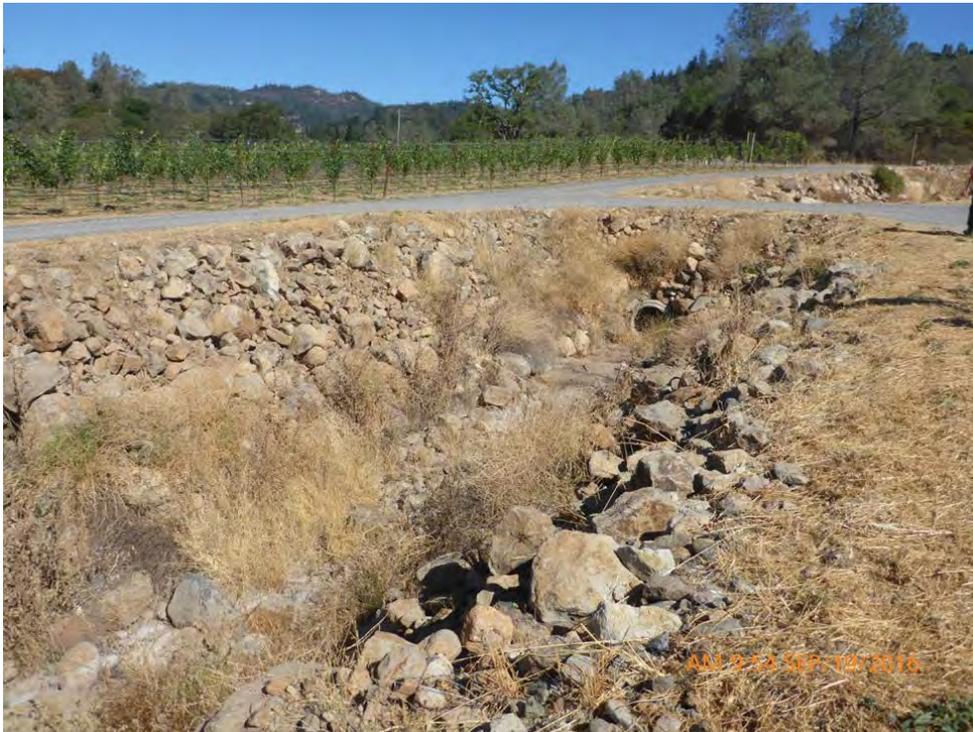
Photo 2. Lower portion of unnamed intermittent stream that was channelized (looking upstream).

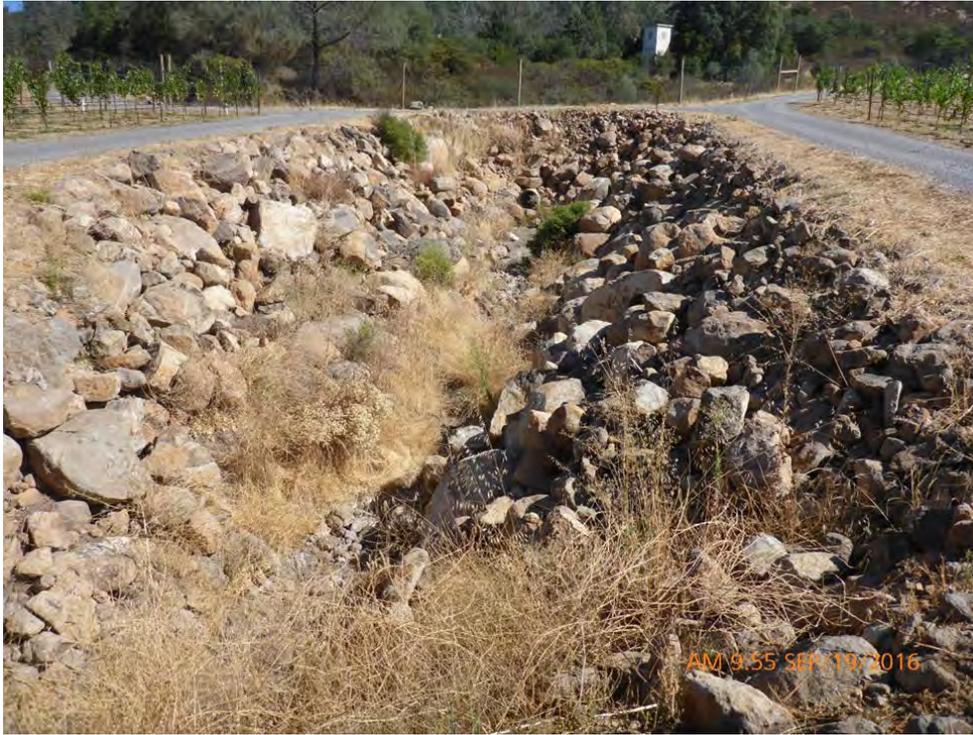
Photo 3. Upper portion of unnamed intermittent stream that was channelized (looking upstream).

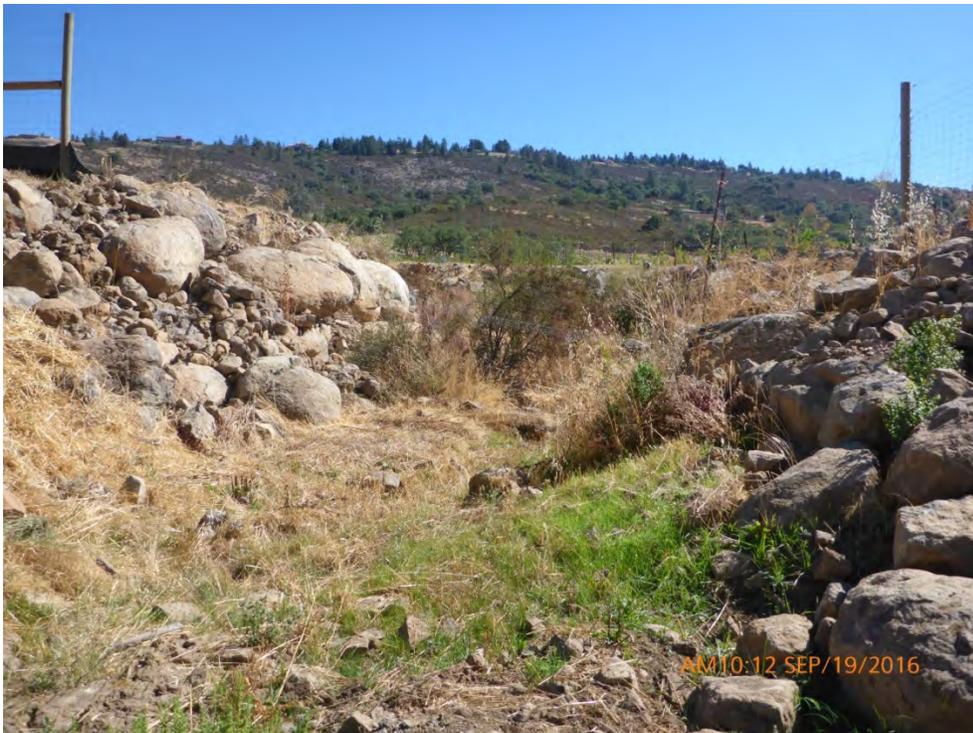
Photo 4. Confluence of channelized unnamed intermittent stream and Canon Creek (looking upstream).

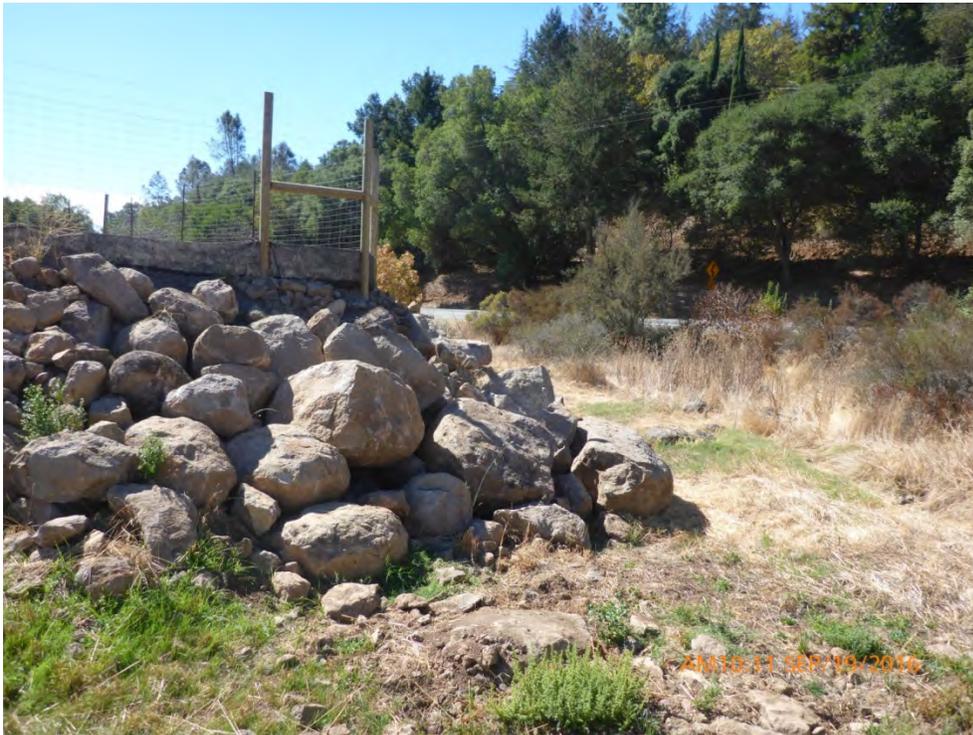
3. **No filter fabric was placed between the rock walls and fill, and the rock walls may be vulnerable to differential settlement and soil piping,** which has the potential to result in significant sediment discharge to Canon Creek. In our discussion with the project engineer, we learned that the fill is not keyed or benched except at the contact with the rock wall. There has been no engineering analysis performed to confirm that the rock walls will remain stable under expected loads. The rock walls should be subject to a design review by a qualified geotechnical engineer.

Photo 5. Example photograph of rock walls.

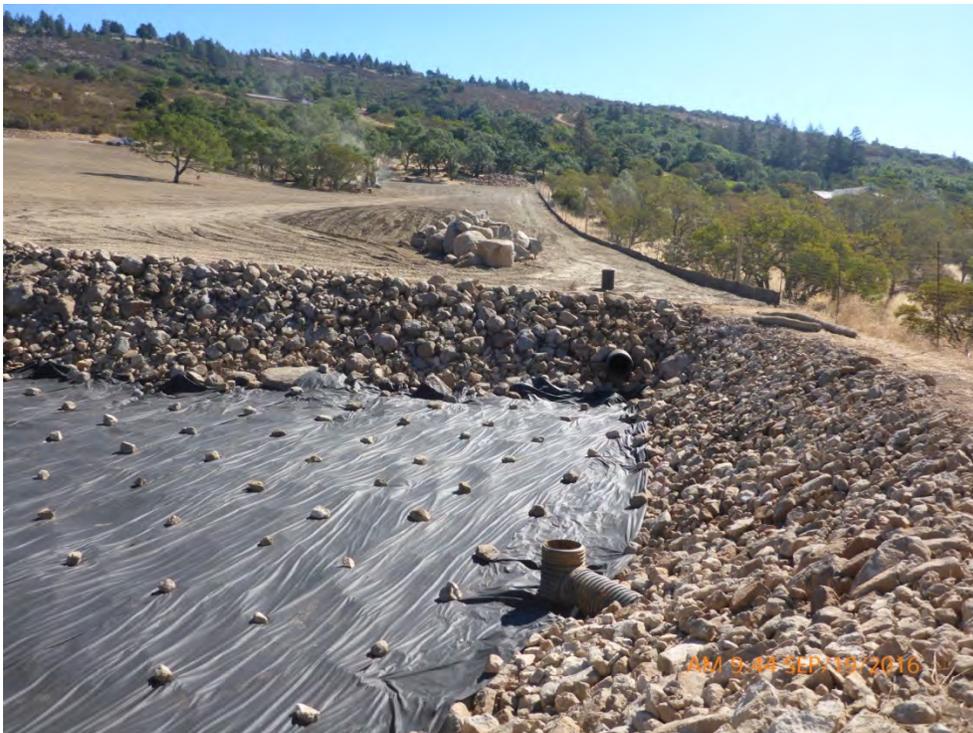
2. **Post-vineyard development increase in storm runoff peak does not appear to be fully attenuated.** Key assumptions in the original hydrologic model for the vineyard development project appear unreasonable or imprudent (e.g., a persistent improvement in soil infiltration capacity as a result of deep ripping; taking advantage of a recent fire over part of the property to assume reduced infiltration capacity under the pre-development condition; not accounting for decreases in time of concentration as a result of ditching and placement of subsurface drainage pipes, etc.). As a result, it is plausible that the constructed detention basin is significantly undersized.

Photo 6. Photograph of detention basin.
