### Sonoma Valley Fires

### Monitoring Plan

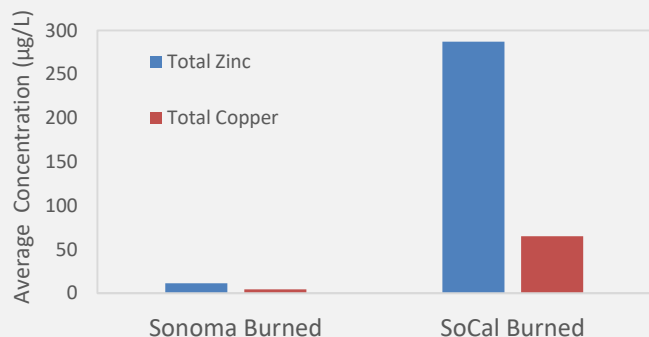
Figure 5. Comparison of metal concentrations in post-fire storm samples for Sonoma Creek and Southern California (Stein et al., 2012).

- All samples were below acute toxicity thresholds.
- Nine of 576 samples exceeded chronic objectives for selenium, mercury, dissolved oxygen, or pH. Two of these exceedances occurred at the unburned reference site.
- Increased pH at Kenwood during first storm could have been a fire signal. However, no other pH exceedances were observed in this study.
- Observed increases in metals and nutrients are likely a natural increase that occurs during storms and not related to the fire.
- The small increase in metals and nutrients between baseline and storm flows was similar for burned watersheds and the reference, unburned watershed.
- In contrast, metal concentrations from burned areas in Southern California were often hundreds of times higher than burned areas in this study (Figure 5).
