# **AQUATIC PESTICIDE APPLICATION PLAN (APAP)**

For the Statewide General National Pollutant Discharge Elimination System (NPDES) Permit for Residual Aquatic Pesticide Discharges to Waters of the United States from Algae and Aquatic Weed Control Applications, to meet the aquatic vegetation management requirements of lakes listed in Chapter 6 herein.

Prepared By:  
Waterworks Aquatic Management, Inc.  
4120 Douglas Blvd. Suite #306  
Granite Bay, CA 95746

February 2018

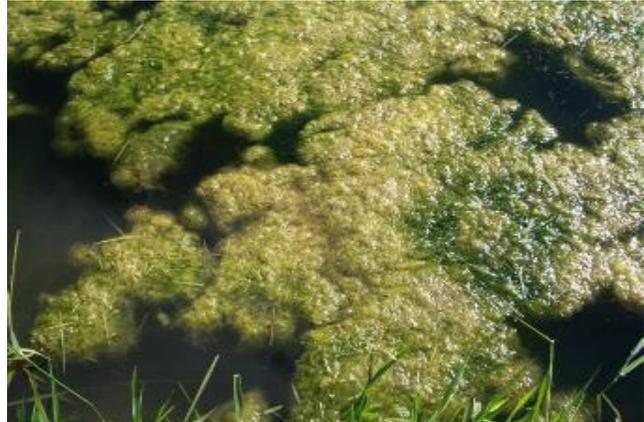
- **Filamentous Algae** (Various genera)

- Species Description: Also known as “pond scum”, or “moss”, filamentous algae form greenish mats upon the water’s surface. This alga usually begins its growth along the edges or bottom of a lake or pond and “mushrooms” to the surface buoyed by the oxygen it has produced. Individual filaments are a series of cells joined end to end which give the thread like appearance.

- Habitat: Filamentous algae grows in water of marshes, wet ditches, and along the shorelines of rivers and lakes.
- Problems: Aesthetics, clogging of irrigation systems and water intakes, mosquito habitat.

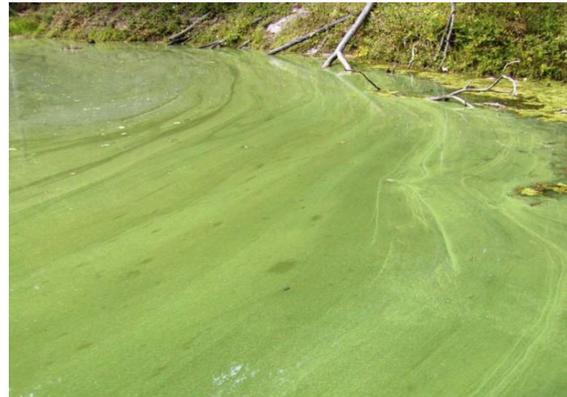
- Species Description: Planktonic algae are microscopic plants, usually suspended in the upper few feet of a waterbody, which often reach bloom proportions. Their presence will cause the water to appear pea soup green or brownish in color.
- Habitat: Planktonic algae grows in lakes, ponds, reservoirs, and backwater areas of river and stream systems.

- Problems: Aesthetics, taste and odor problems in drinking water reservoirs, natural die off may result in summer fish kills due to oxygen depletion, and some species are toxic to animals and humans.

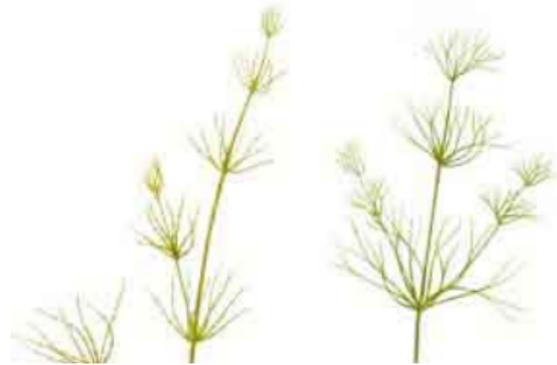
- **Attached Algae** (Various genera)

- Species Description: Attached algae are Periphyton; freshwater organisms attached to or clinging to plants and other objects projecting above the bottom sediments. It can sometimes used to assist in determining water quality, and as a useful environmental indicator for human-induced nutrient enrichment in lakes. Chara and Nitella are the most common attached algae found in these lakes. This gray-green branched algae is oftentimes mistaken for a plant because it has stem and leaf-like structures. They grow submerged, attached to the muddy bottom.
- Habitat: Attached algae grows in lakes, ponds, reservoirs, and backwater areas of river and stream systems.
- Problems: Aesthetics.

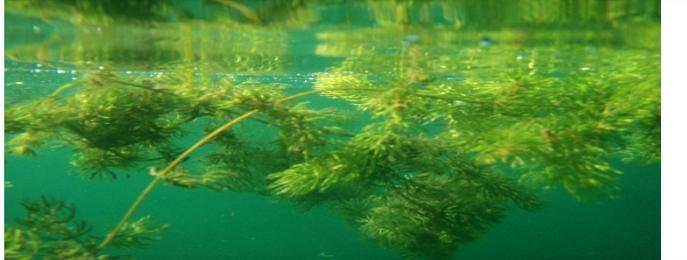
<p><b>Ranking 1</b> 0-10% Coverage Scattered Plants</p>

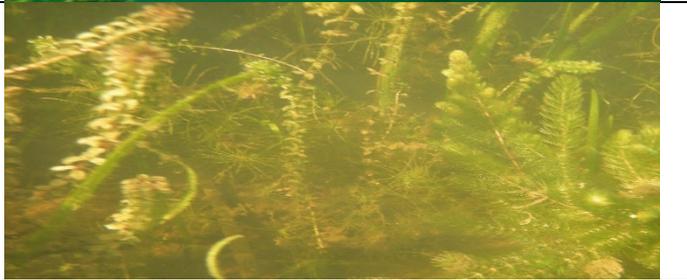
<p><b>Ranking 2</b> 30% Coverage</p>

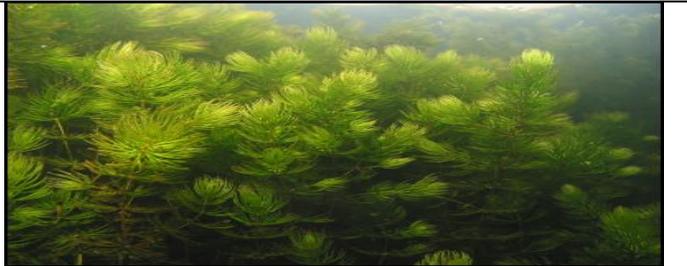
<p><b>Ranking 3</b> 50% Coverage Moderate Plant Growth</p>

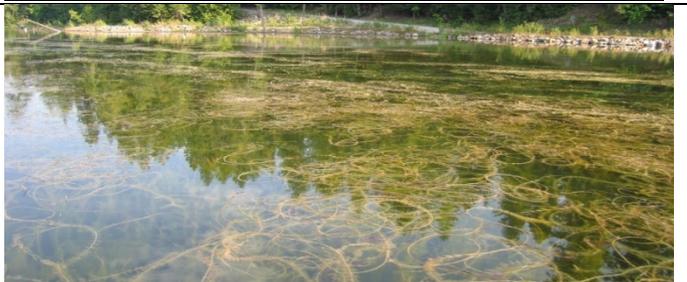
<p><b>Ranking 4</b> 70-80% Coverage Moderate to Dense Plant Growth</p>

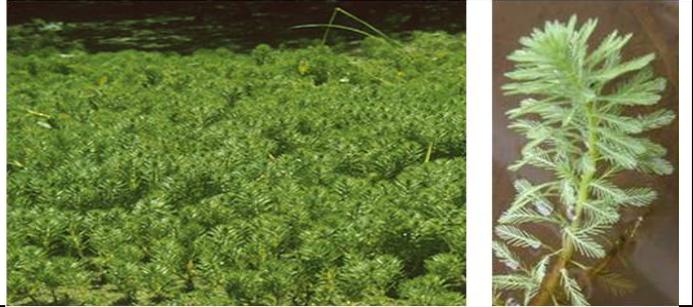
**Ranking 5**  
100% Coverage  
Dense Plant Growth

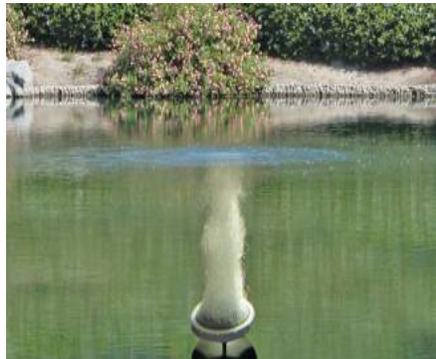
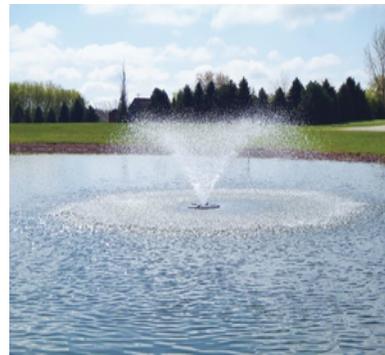
- **Aeration & Water Quality Alteration:** Aeration has been used for decades to circulate water and increase Dissolved Oxygen within lake and pond systems. In stratified lake systems where the bottom layers are anoxic during the summer months, a properly designed aeration system will limit nutrient recycling by supporting aerobic bacteria that support nutrient breakdown in bottom waters and in the hydrosol. Aeration has proven to be a successful tool for reductions in planktonic algae growth in lakes and reservoirs, and is now being studied to evaluate its efficacy on the control of submersed vegetation. Systems vary in size and style from fountains to bottom bubbler diffuser type systems to hypolimnetic units that oxygenate the lower water below the thermocline. Aeration systems have been installed in the lake systems to support water quality improvements.

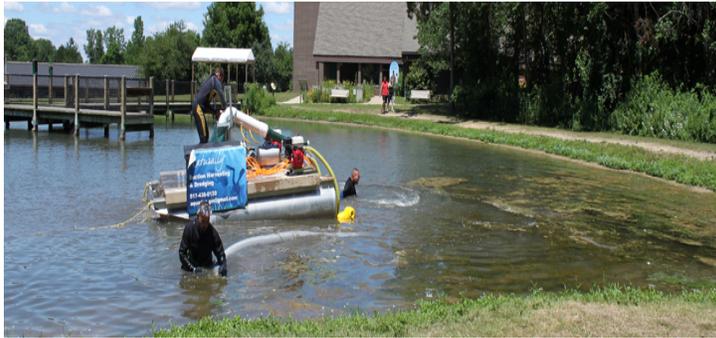
- **Diver Dredge:** The diver dredging procedure is a mechanical control technology that was pioneered by the British Columbia Ministry of Environment after Eurasian Watermilfoil invaded its waterways in the early 1970s. With only limited numbers of aquatic herbicides registered for use in Canada, the Ministry had to develop alternatives to deal with this noxious weed. Diver dredge programs were developed as an alternative method of control. In the United States, this technology has been used since the mid-1980s, and is effective at removing pioneer colonies of invasive aquatic plants.

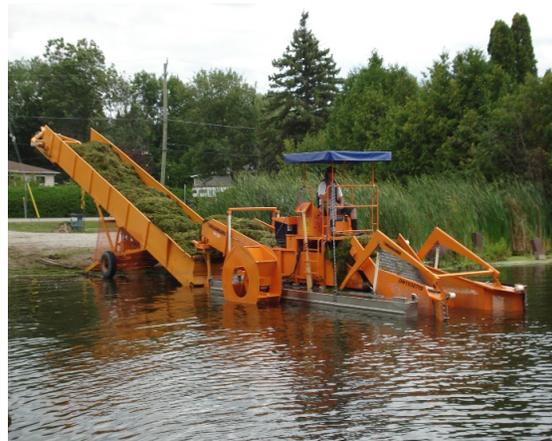
- **Harvesting:** Mechanical Harvesting utilizes specialized equipment that cuts and removes aquatic vegetation to a depth of approximately five (5) foot below the water level. When the harvester is full, it transports the harvested vegetation to an onshore unloading location where the plants are conveyed onto a Trailer Conveyor for stockpiling, or dumped on the shoreline, then taken for final disposal.

The disadvantages to mechanical harvesting are that the process is expensive, time consuming (the daily harvesting rate is 1-2 acres), and the harvested materials must be hauled away for final disposal. As such, this equipment is often used in high-use/priority areas of lakes, to clear beaches and boat lanes or to provide fishing areas within heavy weed infestations. Equipment such as the “Cookie Cutter” Harvester is utilized for the control of emergent vegetation such as cattails and bulrush. Use of harvesting equipment is limited to large lakes with boat ramp access.

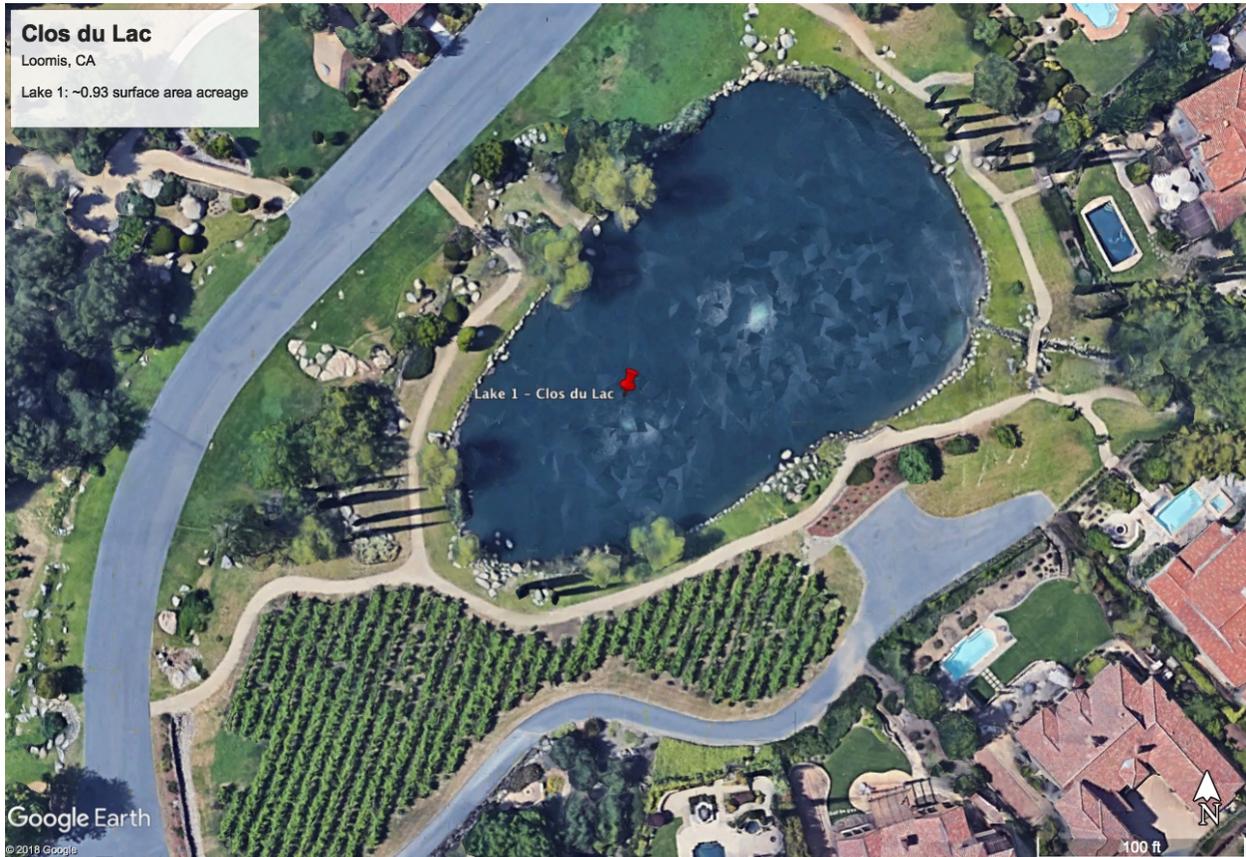
The lake has a surface area of approximately 0.93 acres, and an average depth of approximately 7 feet. Clos Du Lac Lake 1 overflows into the Miners Ravine Tributary.

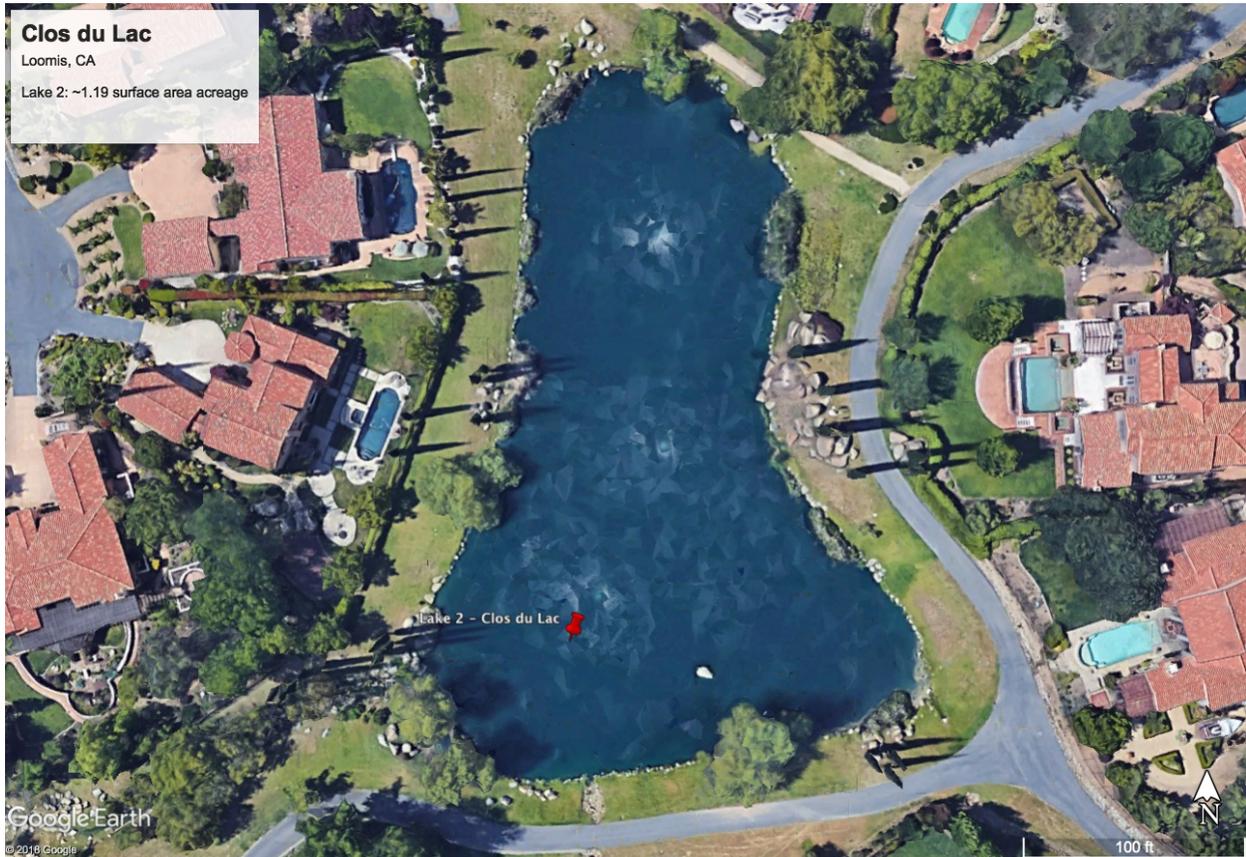
**CLOS DU LAC LAKE 2**

The lake has a surface area of approximately 1.19 acres, and an average depth of approximately 7 feet. Clos Du Lac Lake 2 overflows into Clos Du Lac Lake 1.

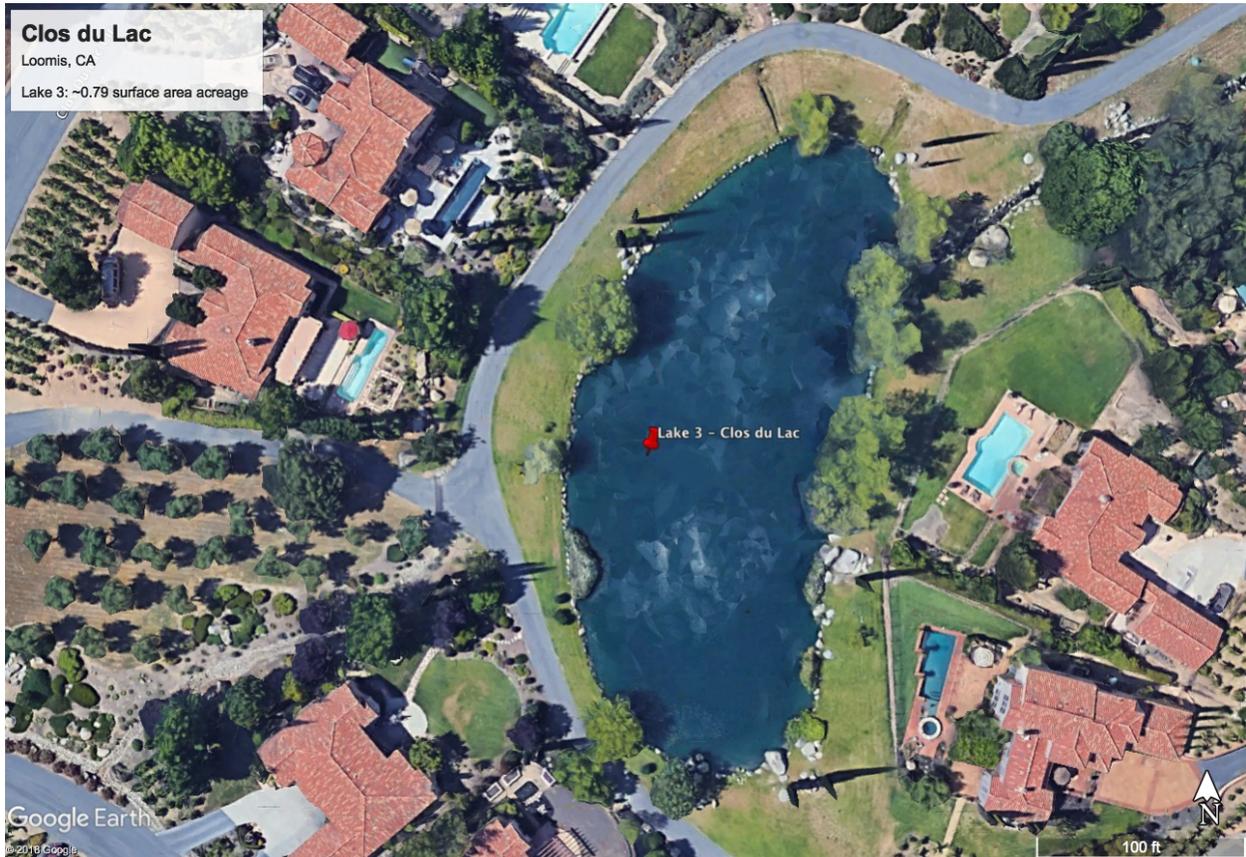
### CLOS DU LAC LAKE 3

The lake has a surface area of approximately 0.79 acres, and an average depth of approximately 7 feet. Clos Du Lac Lake 3 overflows into Clos Du Lac Lake 2.

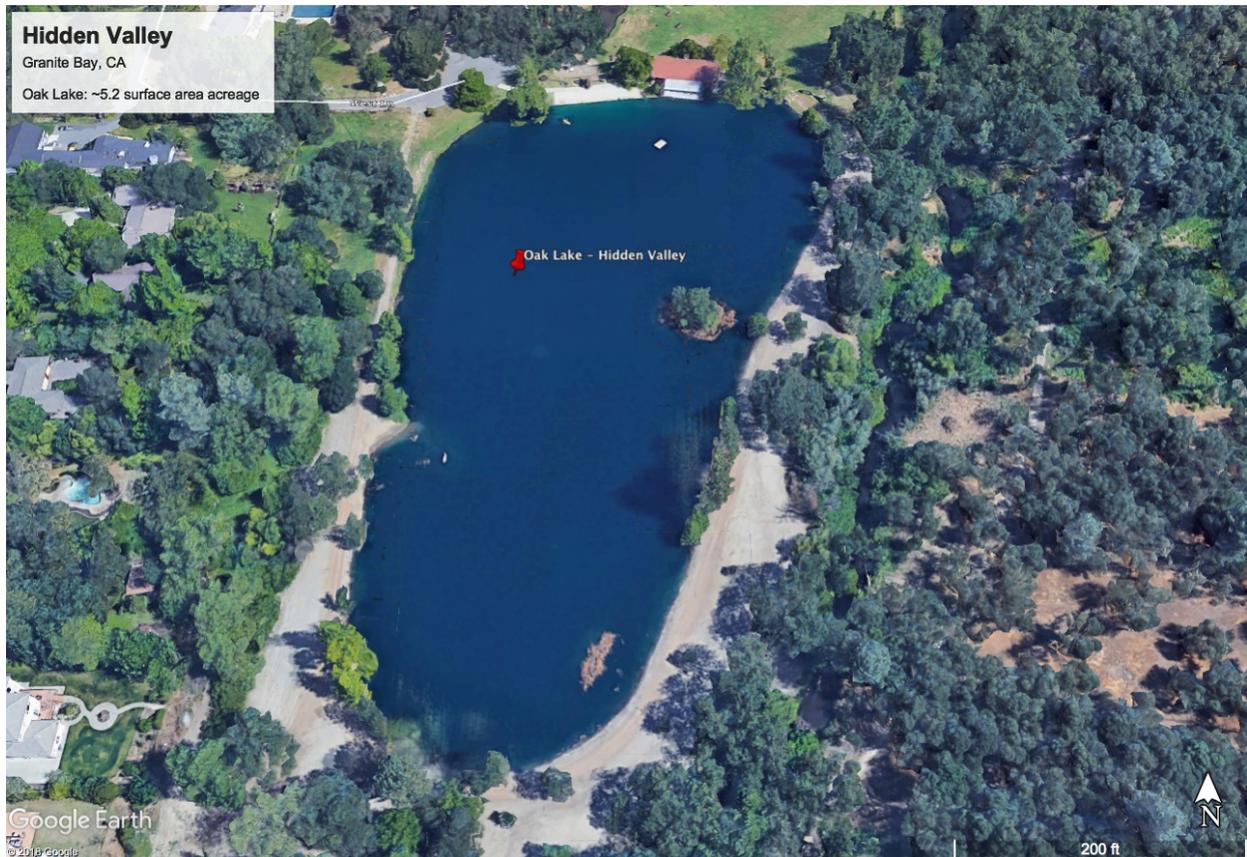
The lake has a surface area of approximately 5.2 acres, and an average depth of approximately 8 feet. Oak Lake overflows into the Miners Ravine Tributary.

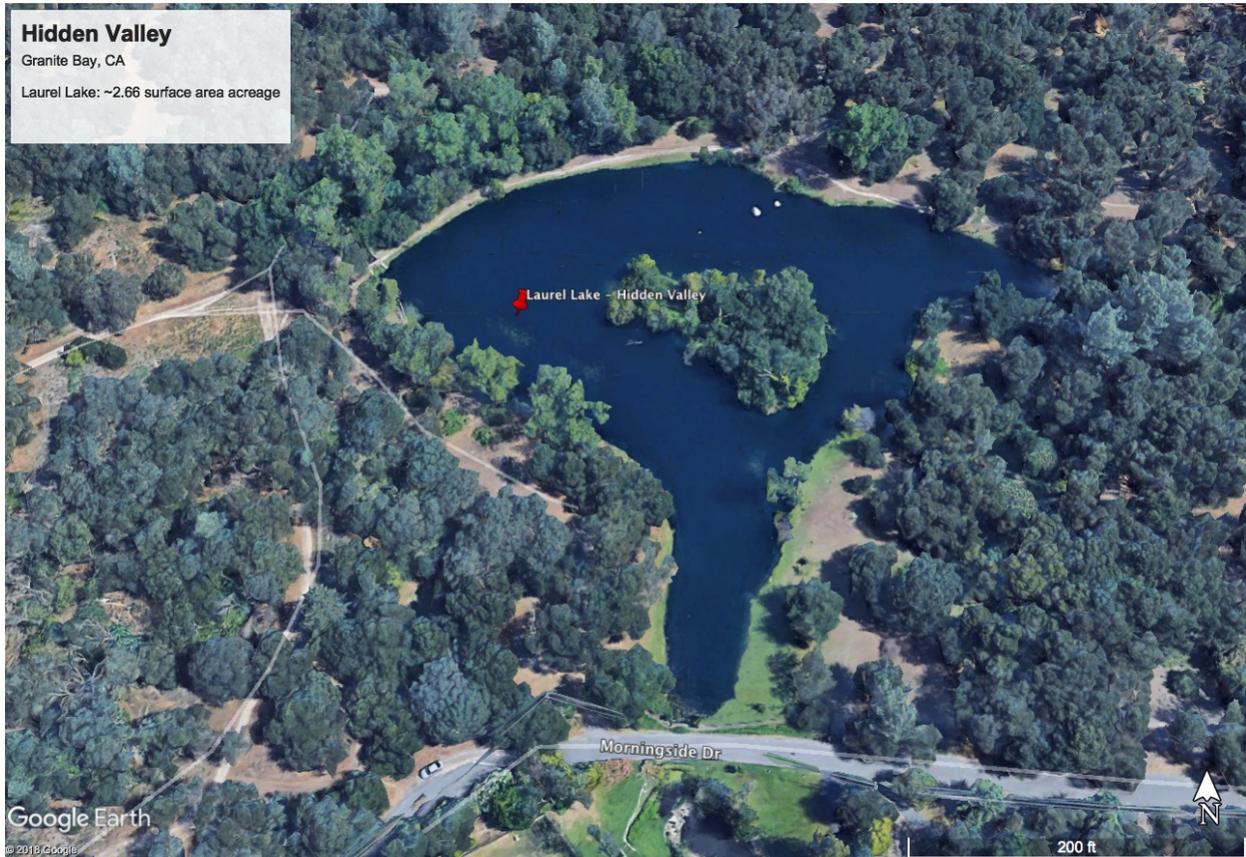
**LAUREL LAKE – HIDDEN VALLEY**

The lake has a surface area of approximately 2.66 acres, and an average depth of approximately 8 feet. Laurel Lake overflows into the Miners Ravine Tributary.

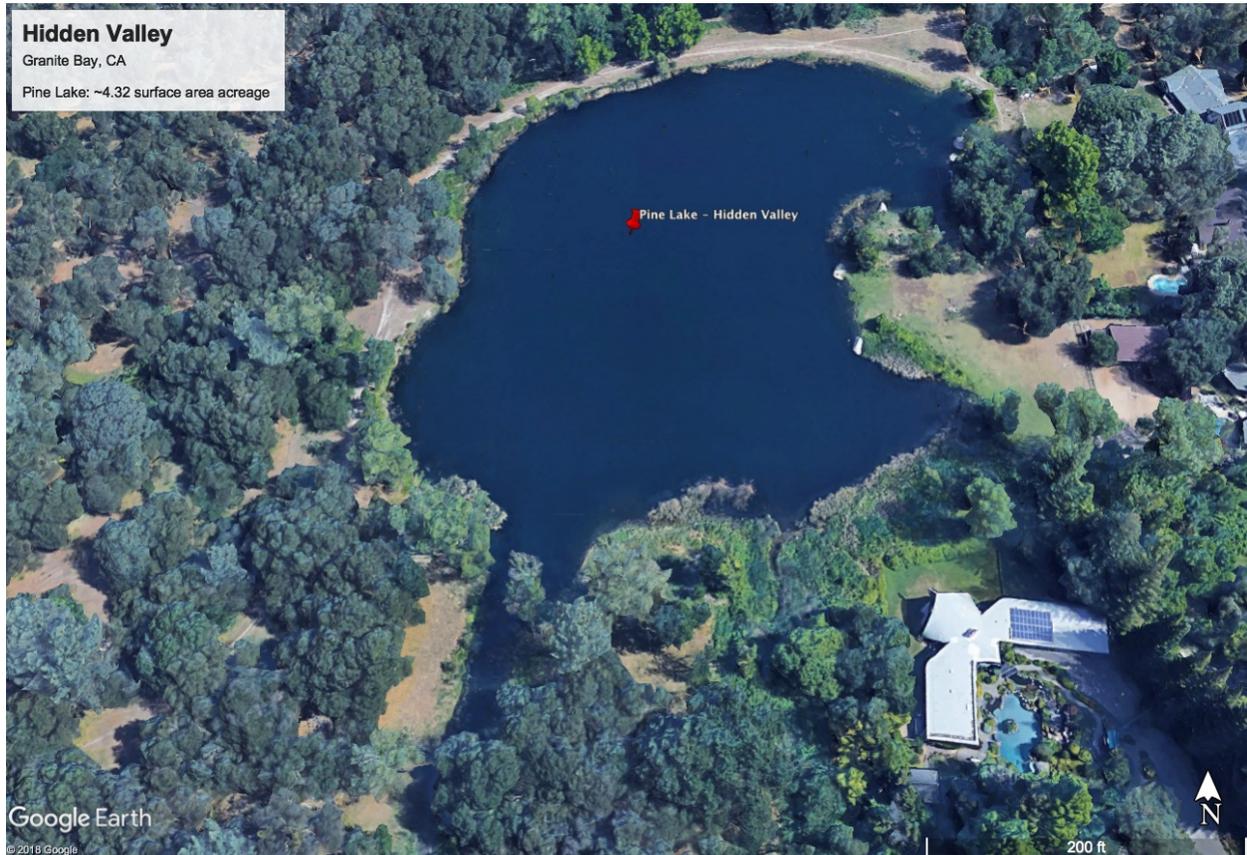
**PINE LAKE – HIDDEN VALLEY**

The lake has a surface area of approximately 4.32 acres, and an average depth of approximately 8 feet. Pine Lake overflows into the Miners Ravine Tributary.

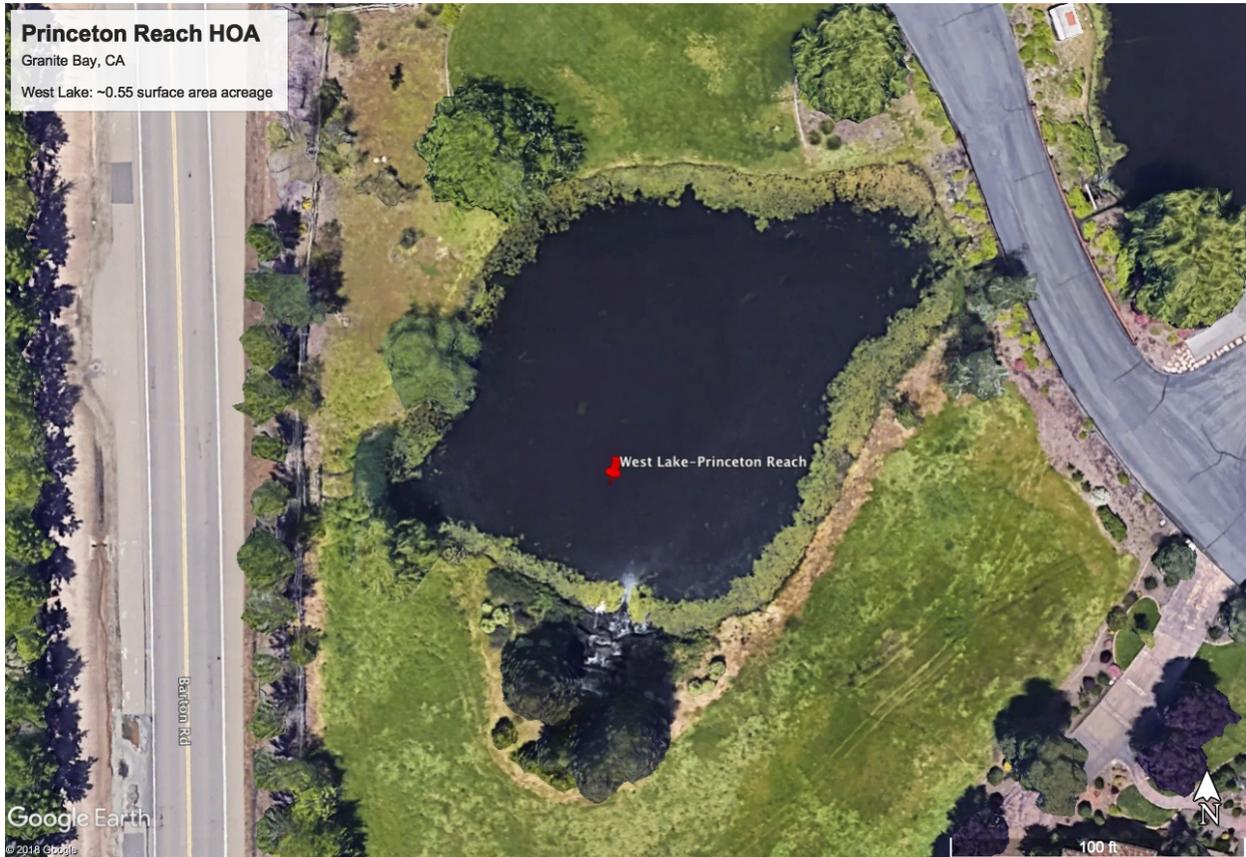
The lakes have has a surface area of approximately 0.55 acres, and an average depth of approximately 5 feet. West Lake overflows into East Lake.

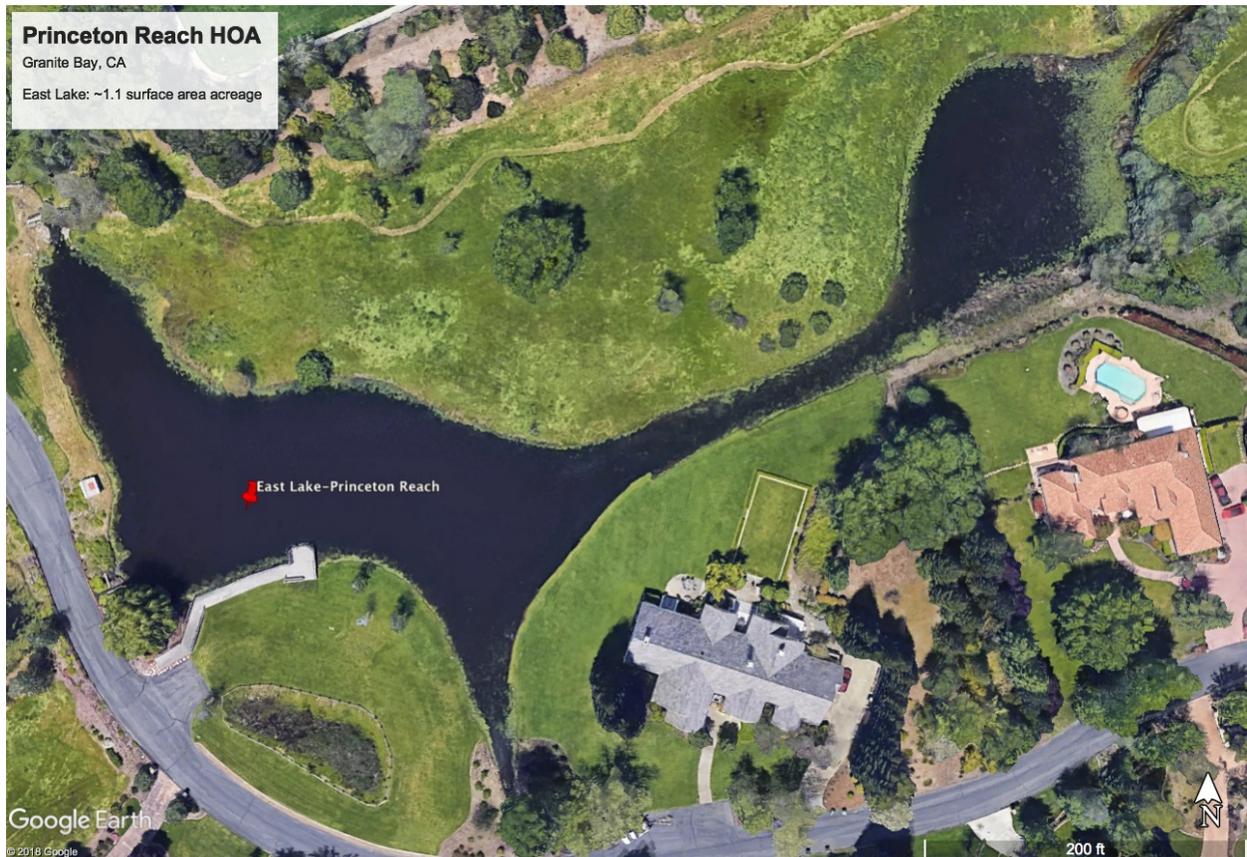
### EAST LAKE - PRINCETON REACH

The lakes have a surface area of approximately 1.1 acres, and an average depth of approximately 5 feet. East Lake overflows into Strap Ravine; part of the Dry Creek Watershed.

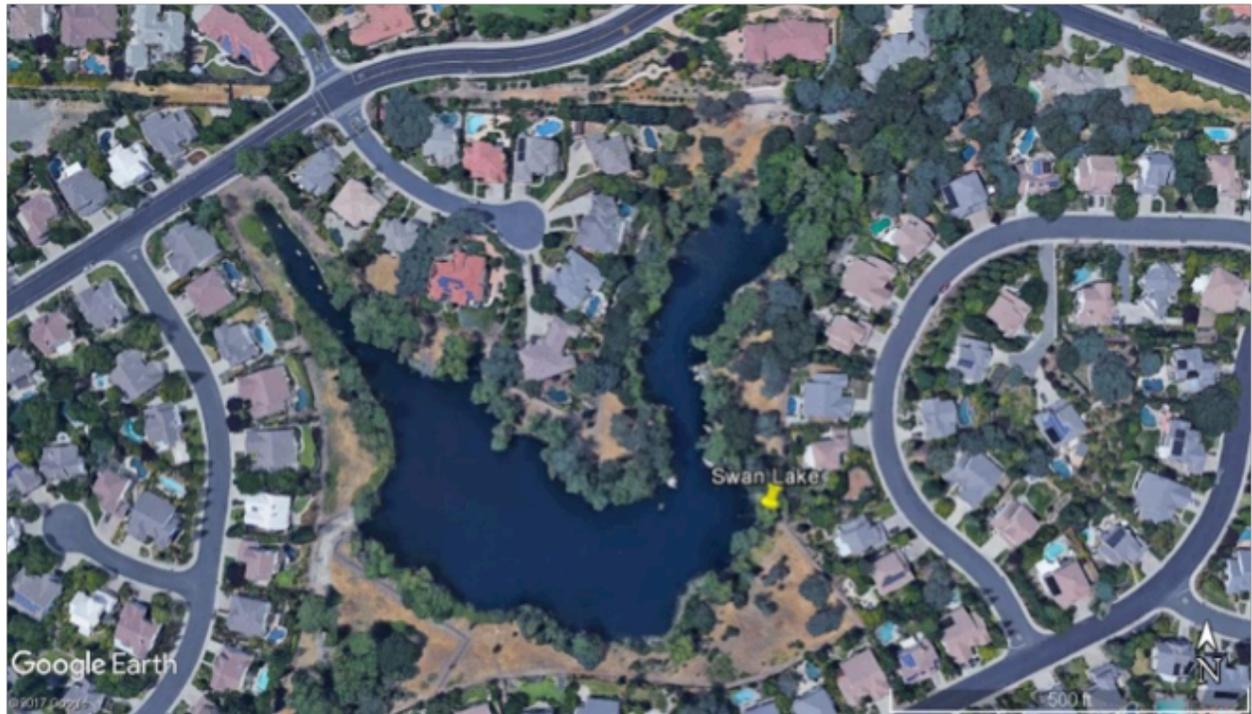
**SWAN LAKE**

Swan Lake is located off Treelake Road and Swan Lake Drive within the Treelake Village community. The lake has a surface area of approximately 5.2 acres, and an average depth of approximately 5 feet. Swan Lake is within the headwaters of Linda Creek. Water releases from Swan Lake into Upper Mill Pond, which flows to Village Center, which flows to Long Lake and then flows into the Linda Creek Tributary.

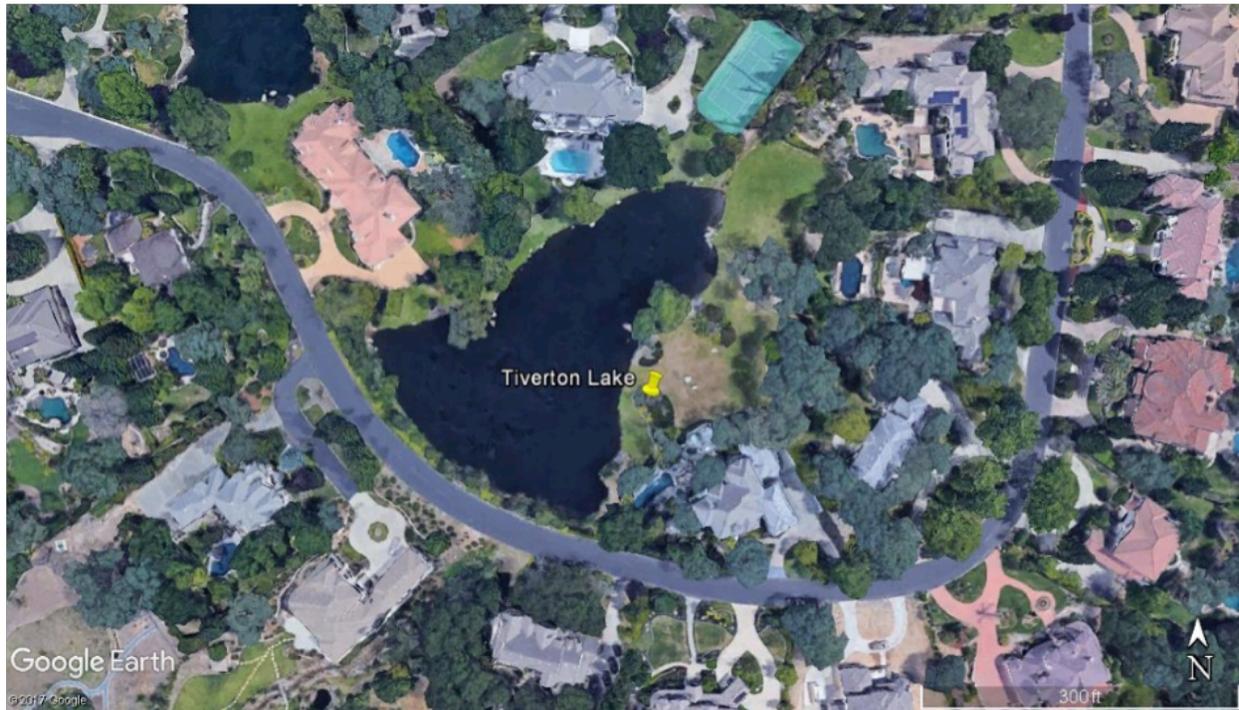
Tiverton Lake is located off Wexford Circle within the Treelake Village community. The lake has a surface area of approximately 1 acre, and an average depth of approximately 5 feet. Manor Lake is within the headwaters of Linda Creek. Water from Tiverton Lake flows into the Linda Creek Tributary.
