Restoration of a Reach of the San Diego River within the Unincorporated Community of Lakeside, San Diego County, California

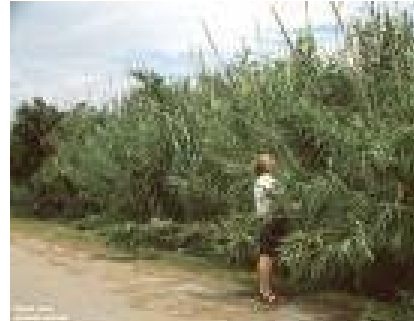
Fig. 1. Invasive, non-native *Arundo donax* (giant reed) stand before removal.

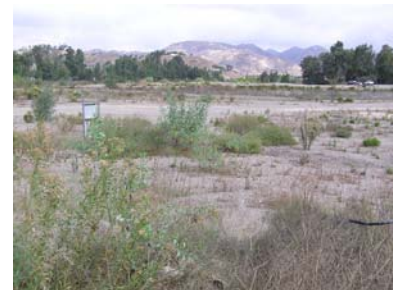
Fig. 2. First constructed wetland treatment cell before construction.

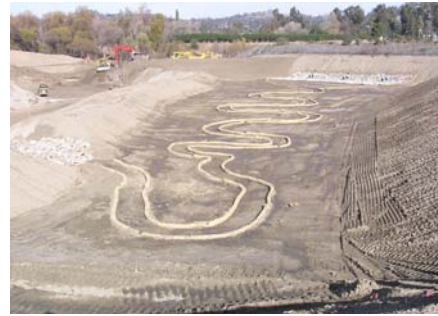
Fig. 3. First constructed wetland treatment cell after grading.

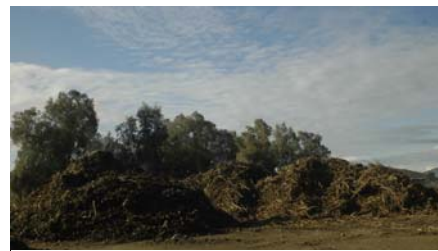
Fig. 4. Removed *Arundo donax* (giant reed) biomass stockpiled for grinding.

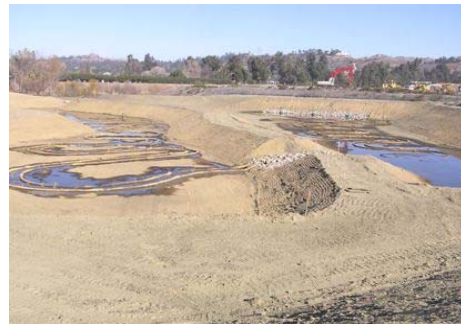
Fig. 5. Constructed wetland (1st and 2nd cells) during final grading.

Baseline water quality data has been collected since the bioswales and constructed wetland for water quality treatment were graded. However, bioswales and constructed wetlands are not functional until they are fully vegetated as designed. The baseline water quality data collected (previous and ongoing) during the vegetation planting and vegetation maturation phases will be compared to future data when the bioswales and constructed wetlands are fully vegetated as designed. It is anticipated that vegetation will be mature, as designed, by fall 2008.
