# California Regional Water Quality Control Board

### NOTICE OF VIOLATION

On July 2, 2008, you submitted a Notice of Intent to comply with the terms of the Timber Waiver for the Angora Hazard Tree Removal Project (hereafter referred to as the "Project"). The Basin Plan requires you to winterize (i.e., stabilized or protected to prevent soil movement) all project sites by October 15 as a condition of continuing work.

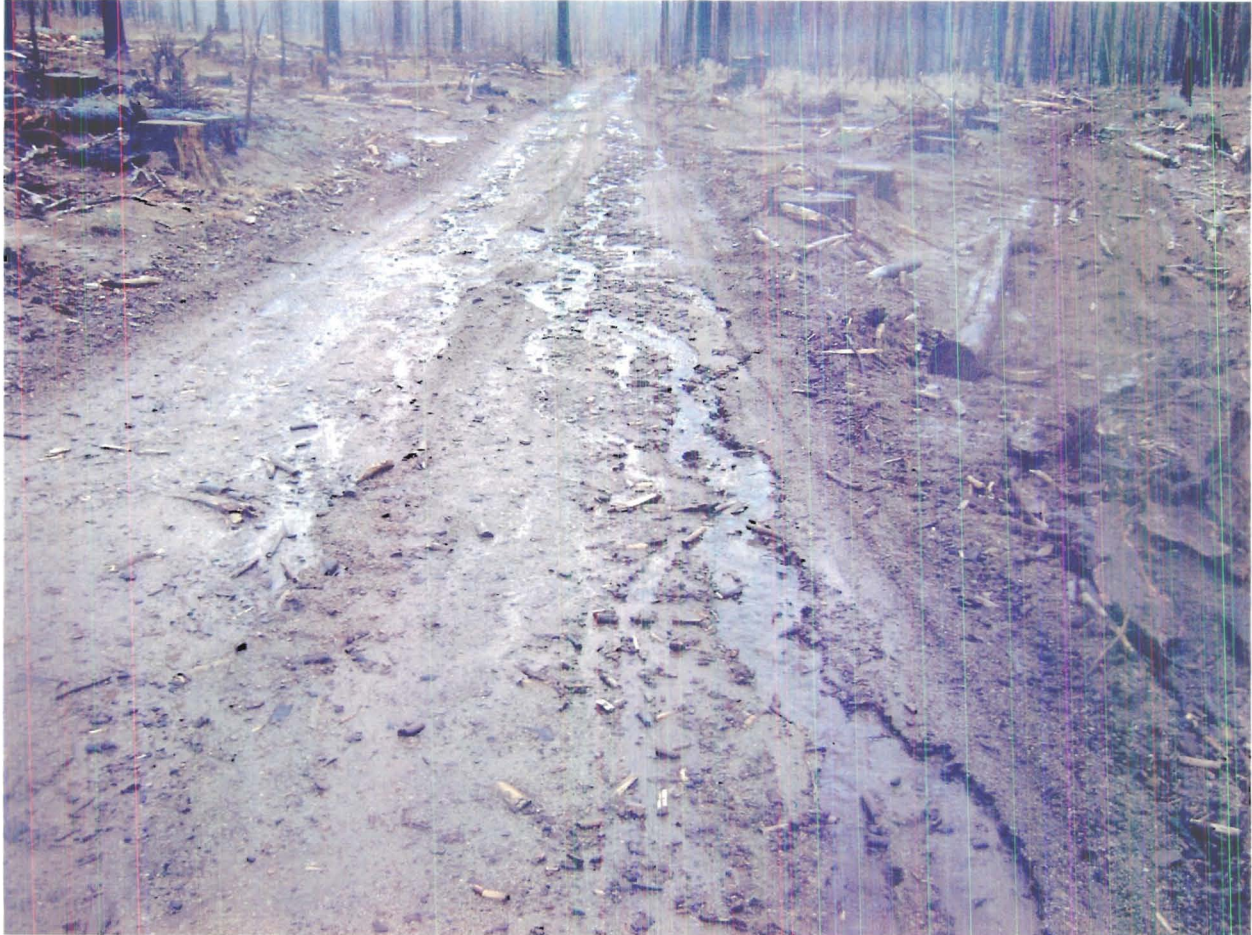
Refer to enclosed photos 1-4, showing lack of erosion control measures on Project sites on October 13, 2009. An inspection by staff members of the Water Board and the Tahoe Regional Planning Agency on October 15, 2009, revealed that the site was not winterized at that time, in violation of the Basin Plan.

**Photo 1: Forest Road 17E49, north of Seneca Pond in Unit 5 on October 13, 2009. No erosion control structures are installed.**

1. **Immediately** cease any and all new soil disturbance activities. You are only authorized to **stabilize** areas already disturbed by Project activities.
2. To completely stabilize all disturbed soils on Project sites by **October 23, 2009**, including decommissioning roads, trails, and removing temporary crossings as described in the Decision Memo and project documents which may amend the Decision Memo.
3. Decommission the former primary access road at the Seneca Drive entrance to Unit 5 by **October 23, 2009**.
4. Submit a report to the Lahontan Water Board by **October 30, 2009**, which describes and documents the completion of site stabilization activities per identified project area. Documentation must include photo documentation.

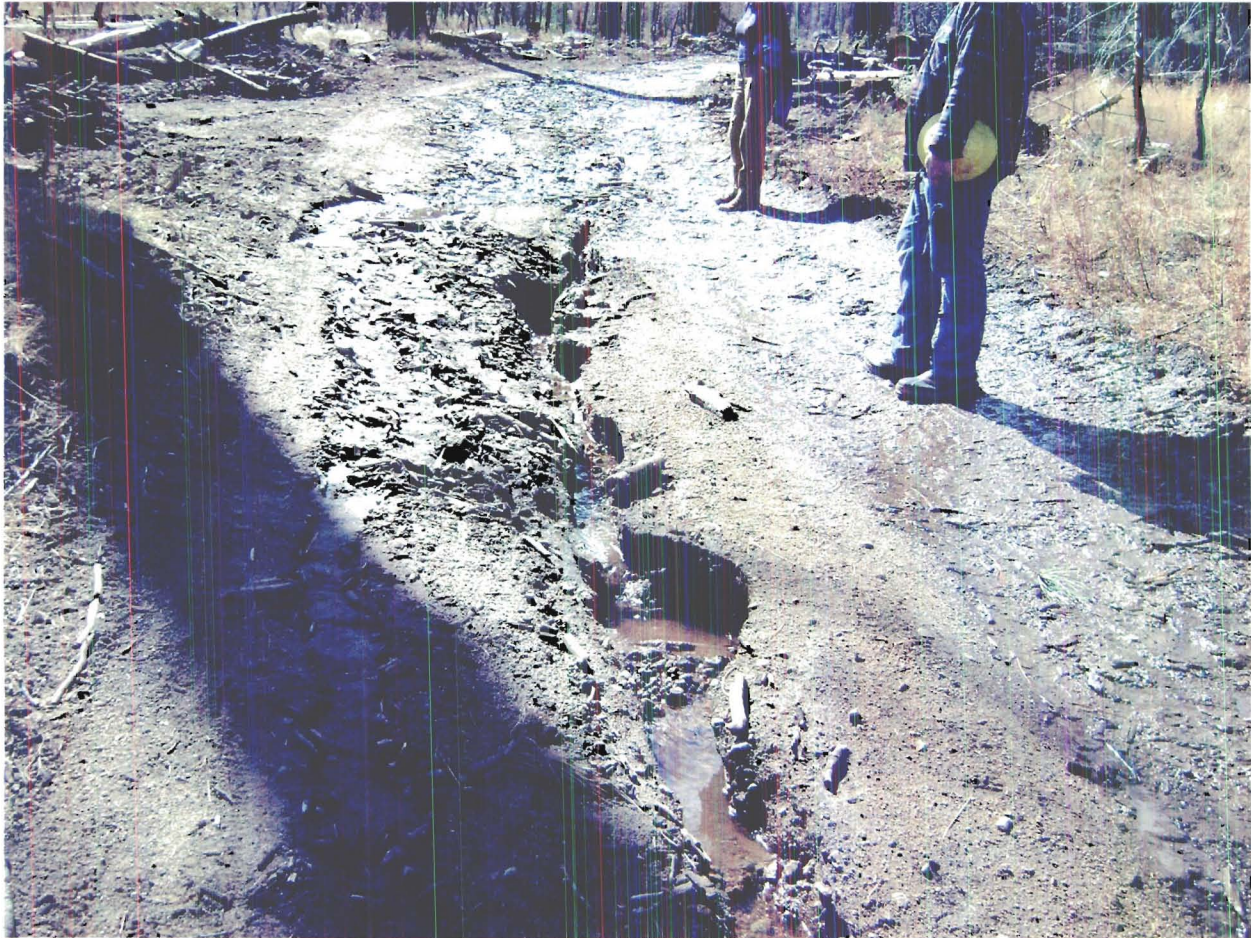
**Photo 2: Forest Road 17E49, north of Seneca Pond in Unit 5 on October 15, 2009. No erosion control structures are installed.**

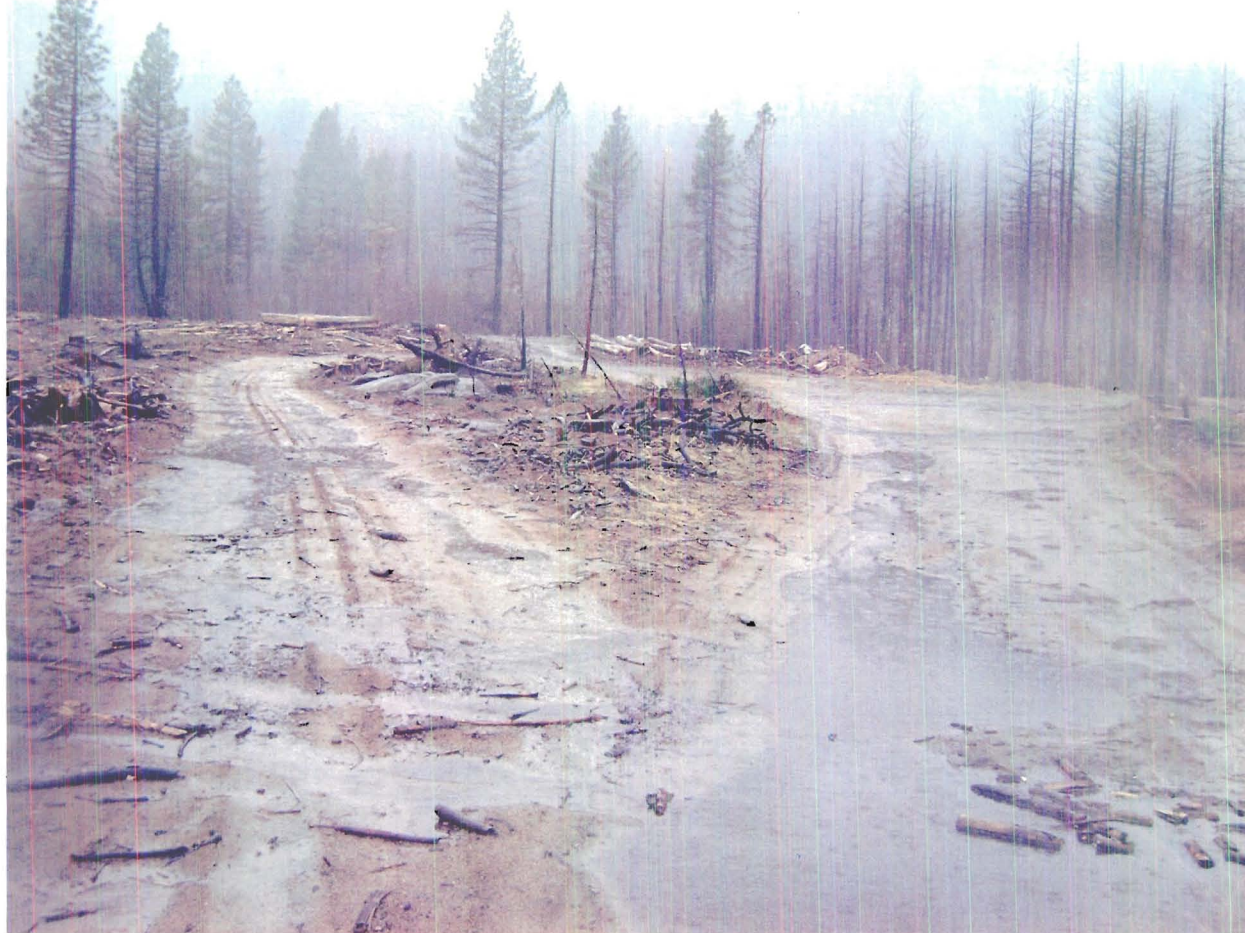
**Photo 3: Landing near Seneca Pond in Unit 5 on October 13,2009. Note lack of erosion control structures. Stormwater was running from landing, down road to discharge into Angora Creek (see Photo 4).**

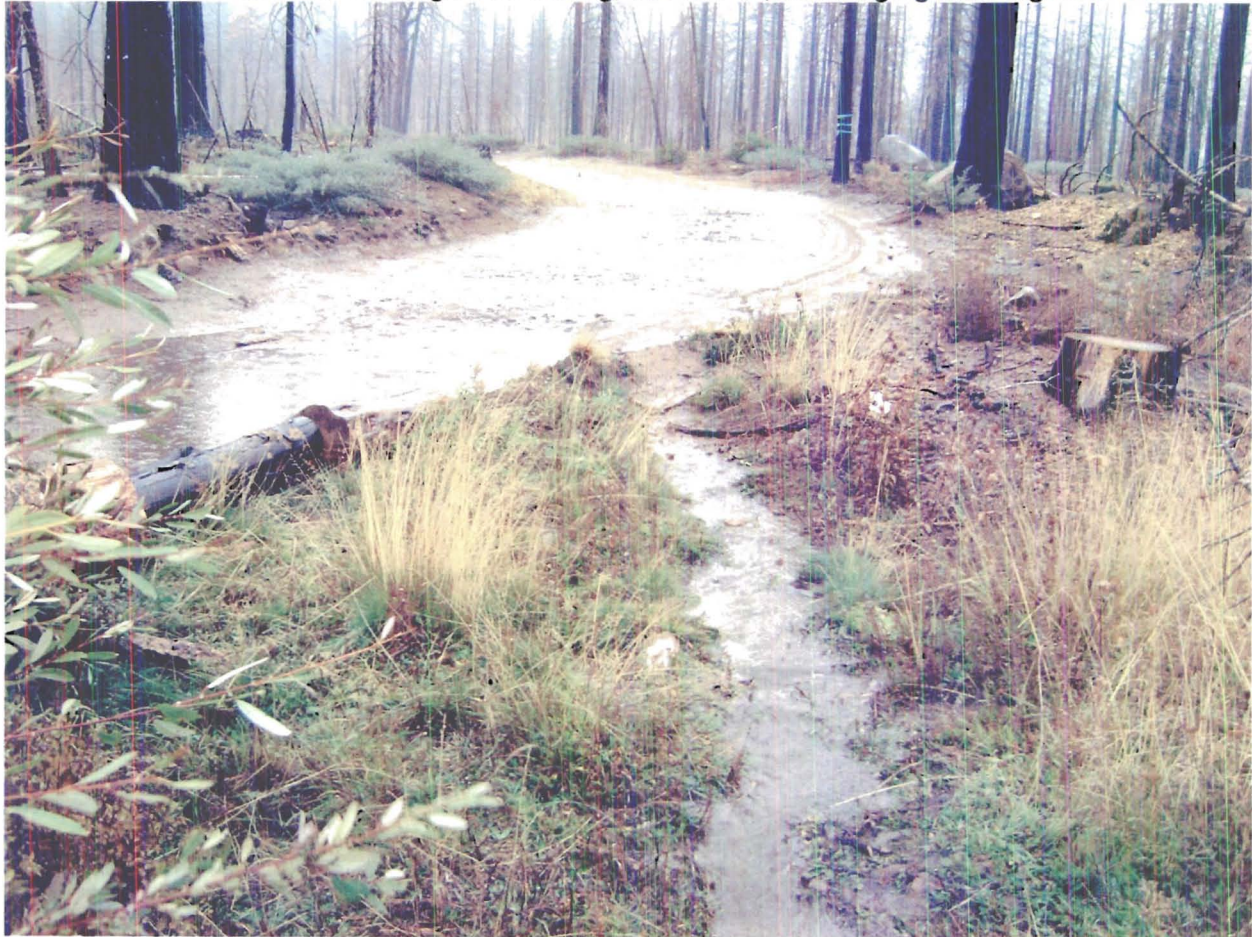
Inspections conducted on October 13 and 14 revealed sediment discharges into Angora Creek and its tributaries from roads and landings in the Project area due to lack of erosion control structures. Refer to photos 4-6 showing sediment-laden stormwater discharging into Angora Creek from a road in the Project area. No waterbars or other stormwater control measures were installed to prevent the discharge.

**Photo 4: Road downslope of landing shown in Photo 3. No erosion control structures are installed. Stormwater was running from landing, down road, discharging into Angora Creek.**

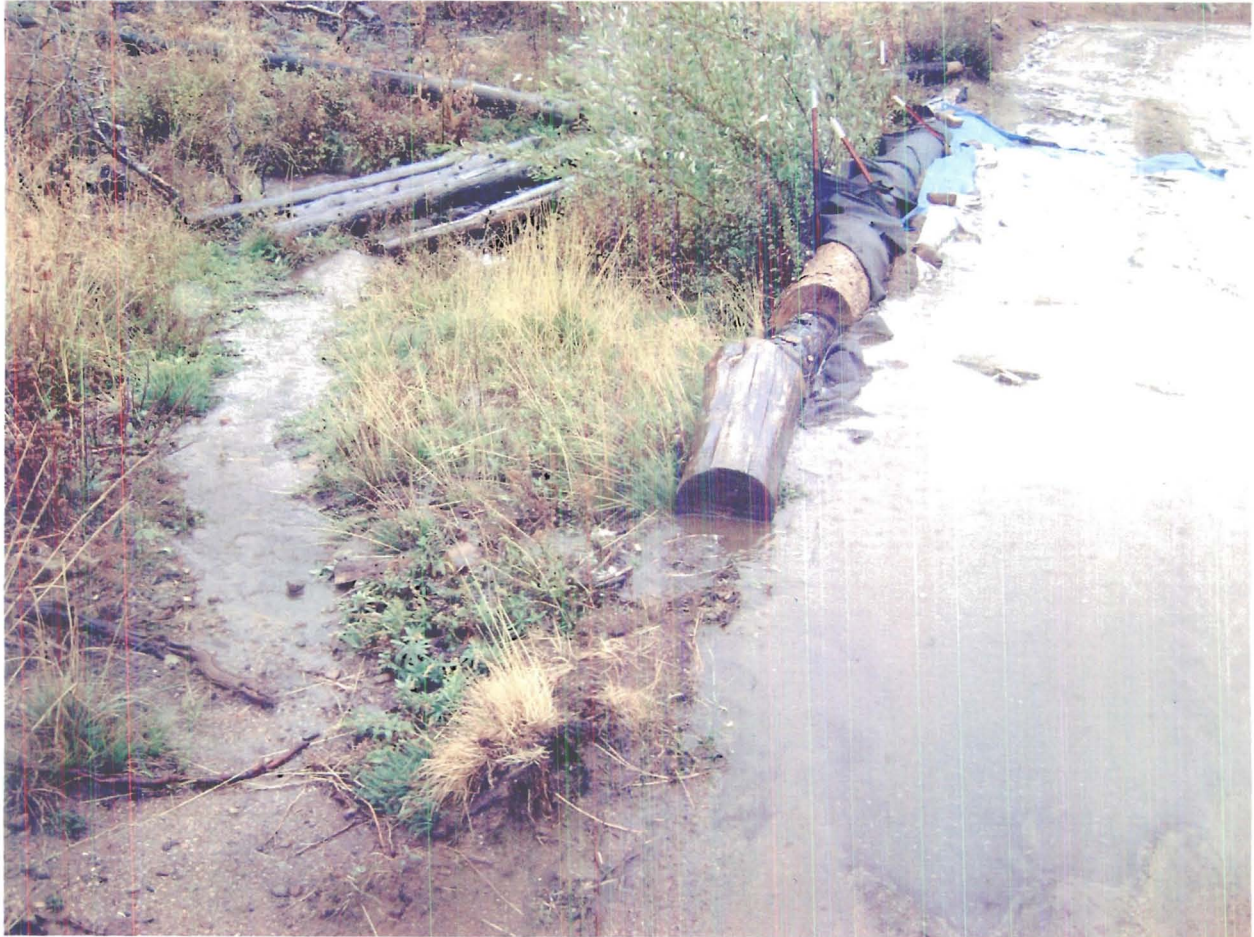
**Photo 5: Sediment-laden stormwater discharging from road and crossing 11 into Angora Creek. No erosion control structures are installed.**

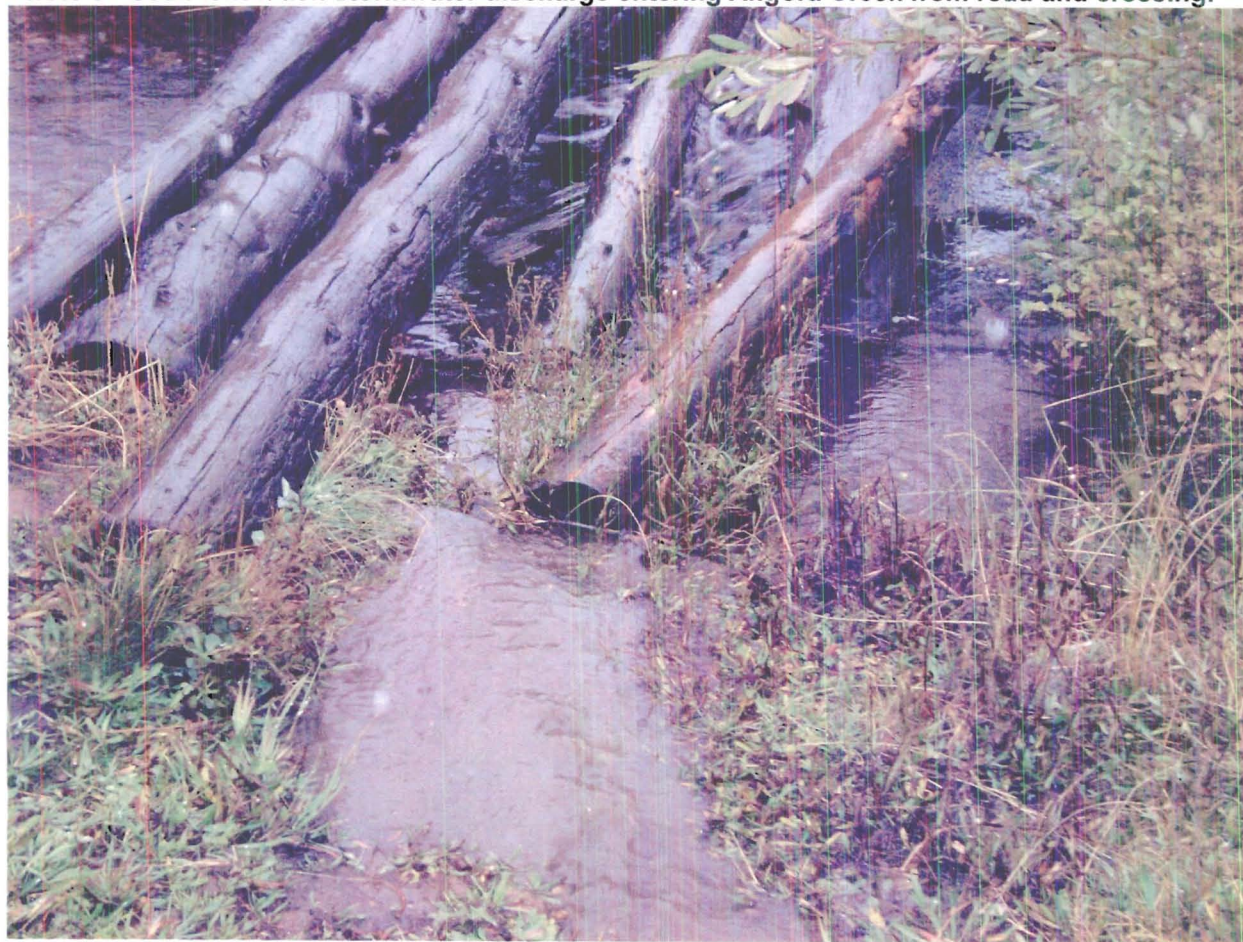
**Photo 6: Sediment-laden stormwater discharge entering Angora Creek from road and crossing.**

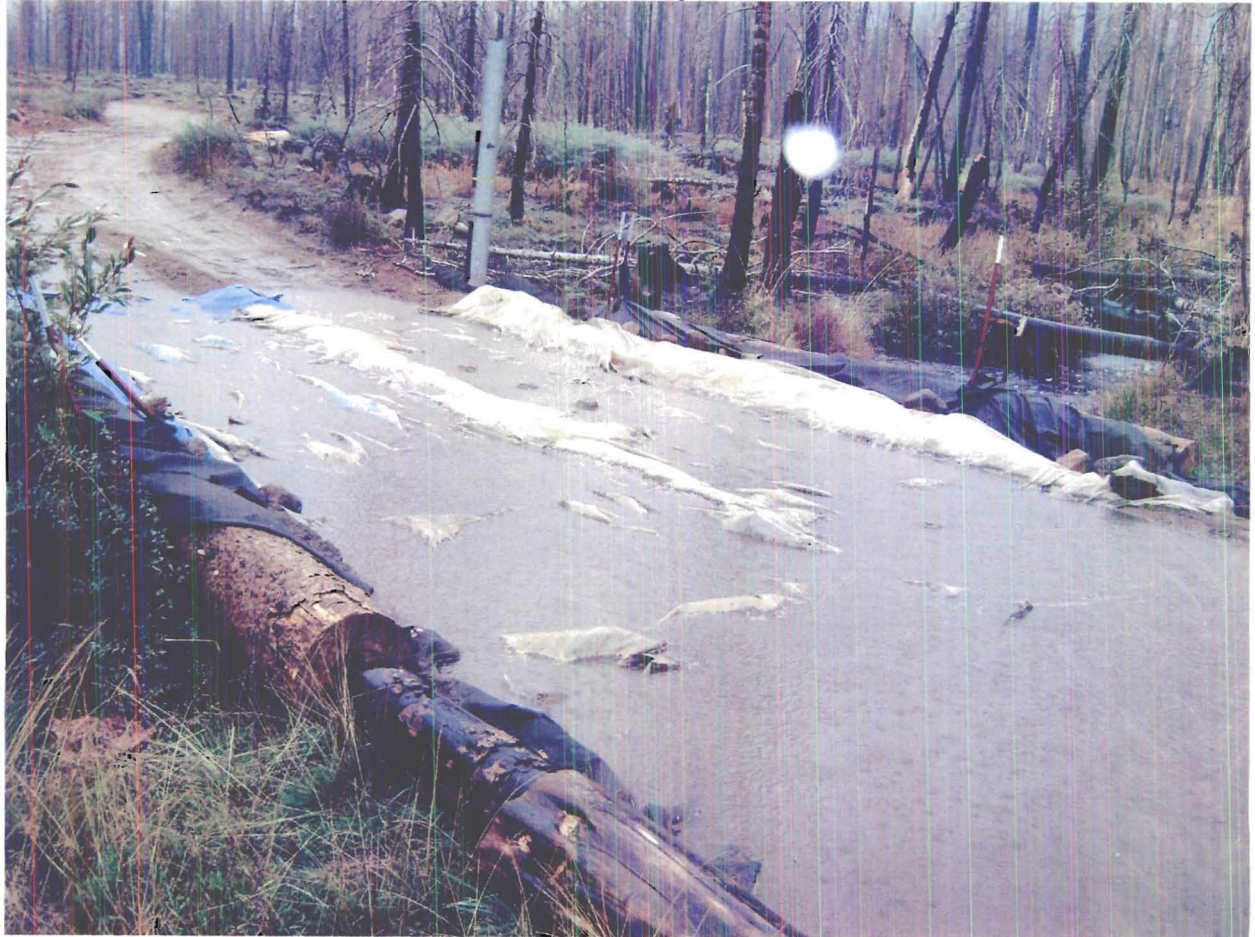
Refer to Photo 7, taken on October 15, 2009, showing the crossing 11 on Angora Creek in place. An email received on October 13, 2009 from LTBMU staff states that "Crossing 11 is still in as there are still logs in the Seneca Pond landing that still need to be chipped."

**Photo 7: Crossing 11 on Angora Creek still in place on October 13, 2009. Due to increased streamflow and saturated soils, crossing 11 is still in place on October 15, 2009.**
