**SUBJECT:** County of Marin's Draft Compliance Plan for the Duxbury Reef ASBS

# Duxbury Reef Area of Special Biological Significance (ASBS) Draft Compliance Plan

*Submitted in Compliance with State Water Resources Control Board Resolution No. 2012-0031 (Ocean Plan Special Protections for ASBS)*

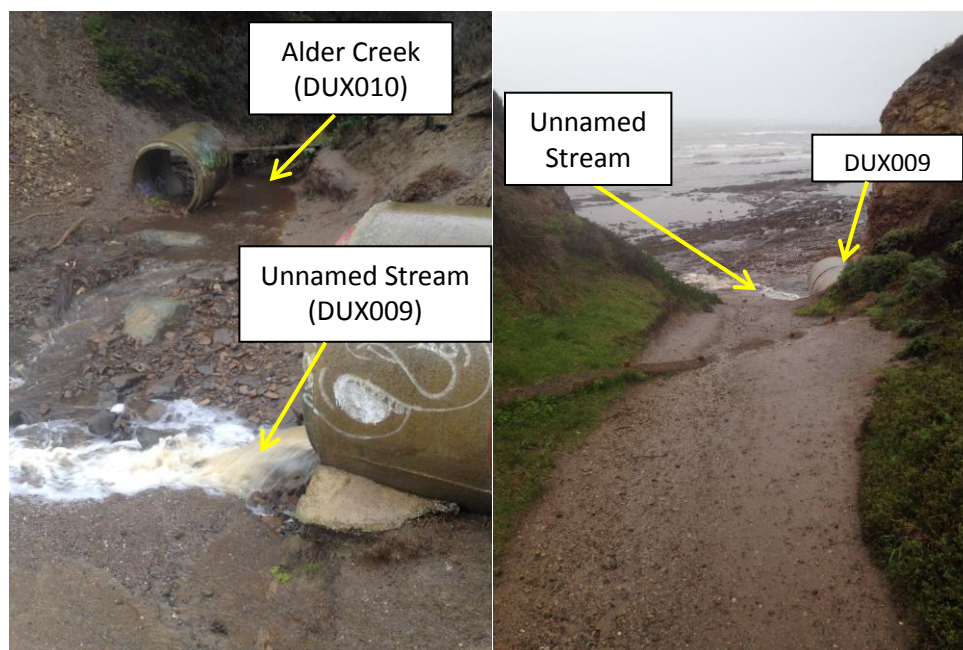
**Figure 3.3.** Alder Creek and Unnamed Stream Confluence Detail, Duxbury Reef (photo courtesy of Rob Carson, February 2014)

Stormwater runoff from Bolinas Mesa flows overland or through groundwater seepage within a system of roadside ditches and culverts to the major drainages or directly to the ocean (Figure 3.4). The largest Bolinas Mesa drainage network includes Alder Creek and several tributary drainages to the north and south. Alder Creek flows from east to west, through the rural residential neighborhoods on the Bolinas Mesa before emptying onto Agate Beach. Adjacent to where Alder Creek empties onto the beach, an unnamed seasonal stream flows through a culvert and joins Alder Creek. In typical years, both Alder Creek and the unnamed stream are completely dry between the months of April and November and therefore do not discharge into the Duxbury Reef ASBS during those months (Fall Creek Engineering and Strelow Consulting 2007). While the unnamed stream has been called a tributary that joins Alder Creek from the south, the topography on the Bolinas Mesa separates the two watersheds until stream flow converges on Agate Beach (Figure 3.3).
