## Summary for Las Tunas Beach Santa Monica Bay (TBSM)

The following graphs show trends at Las Tunas Beach Santa Monica Bay from years 1986-2009 for the following constituents: Butyltin, Chlordane, Total DDT, Dieldrin, Total PAH, PCBs, Zinc (Zn), Silver (Ag), Aluminum (Al), Arsenic (As), Cadmium (Cd) , Chromium (Cr), Copper (Cu), Iron (Fe), Mercury (Hg), Manganese (Mn), Nickel (Ni), Lead (Pb), Selenium (Se), Antimony (Sb, Silicon (Si) and Tin (Sn).

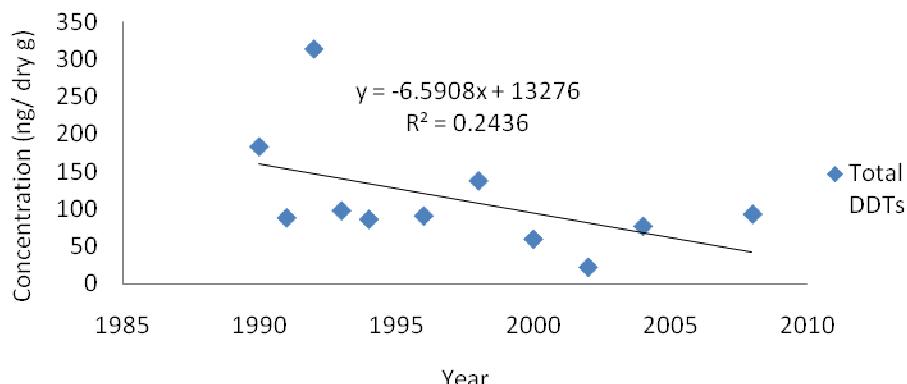
**Trend of Total  
DDTs concentration at Las Tunas Beach Santa Monica Bay**

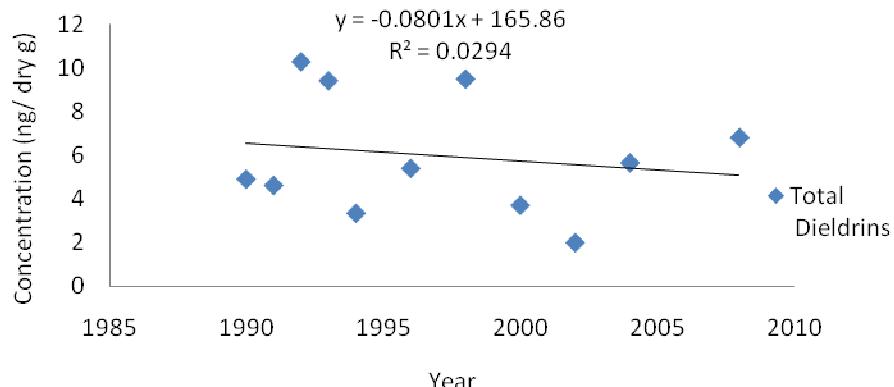
**Trend of Total  
Dieldrins concentration at Las Tunas Beach Santa Monica  
Bay**

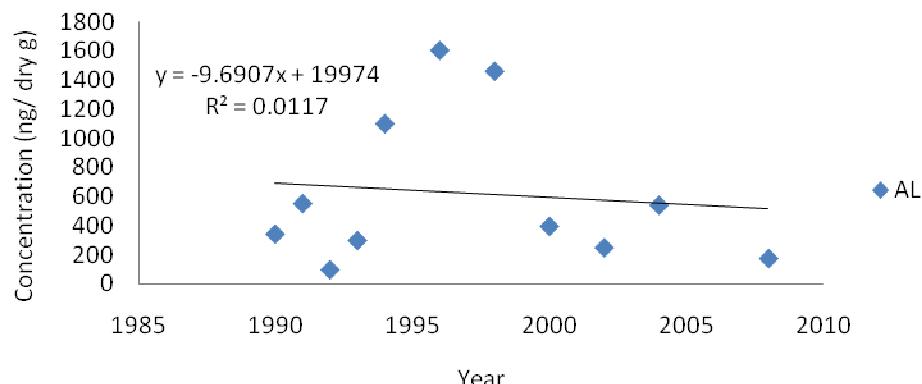
### Trend of Al concentration at Las Tunas Beach Santa Monica Bay

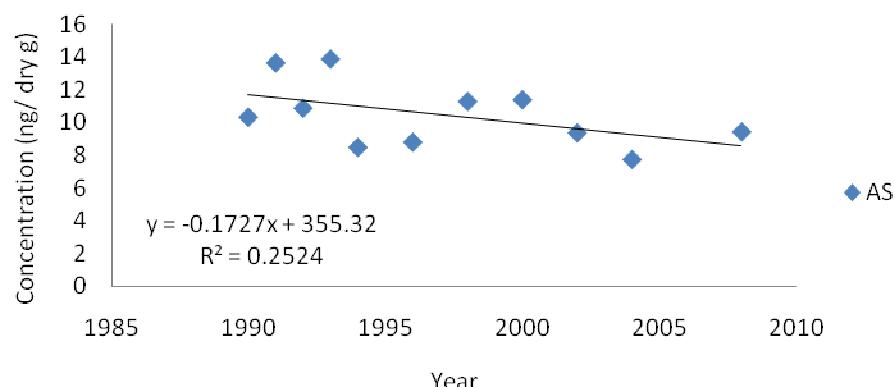
### Trend of As concentration at Las Tunas Beach Santa Monica Bay

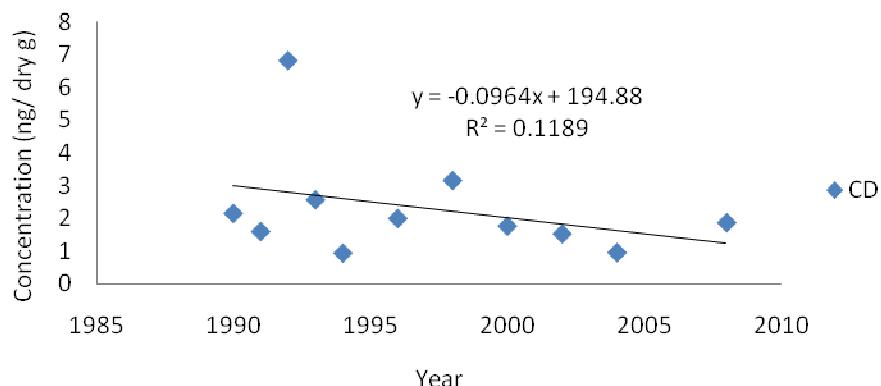
Trend of Cd concentration at Las Tunas Beach Santa Monica Bay

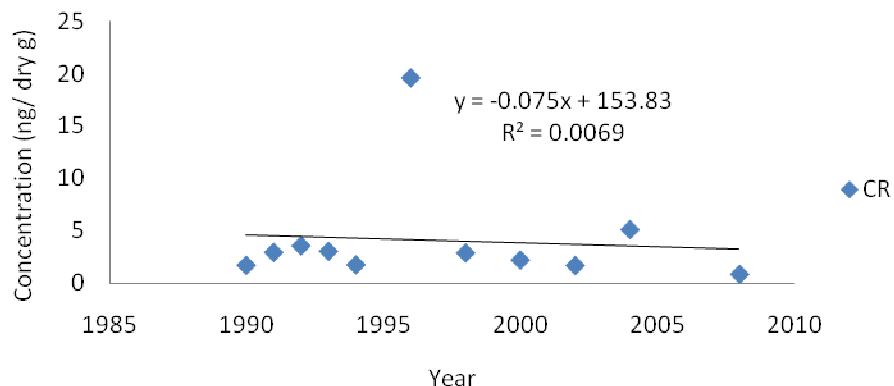
Trend of Cr concentration at Las Tunas Beach Santa Monica Bay

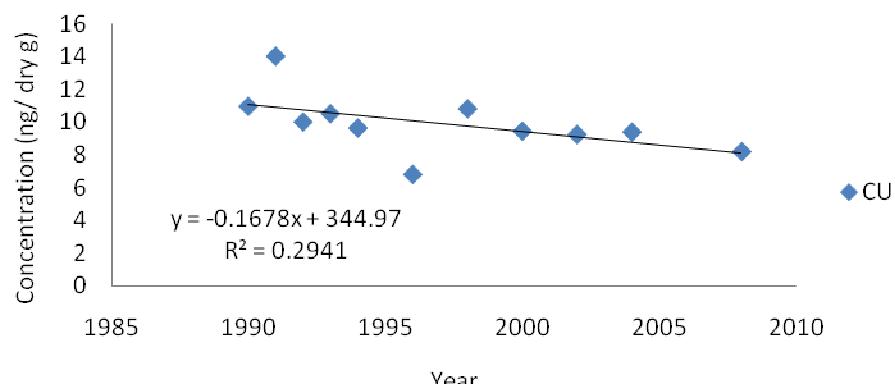
### Trend of Cu concentration at Las Tunas Beach Santa Monica Bay

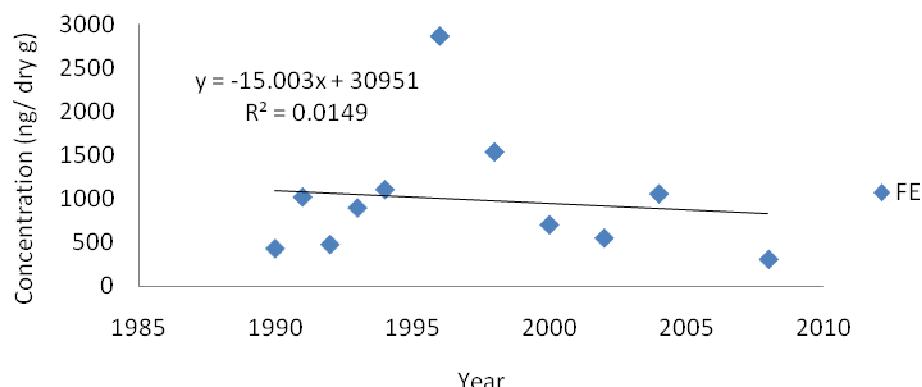
### Trend of Fe concentration at Las Tunas Beach Santa Monica Bay

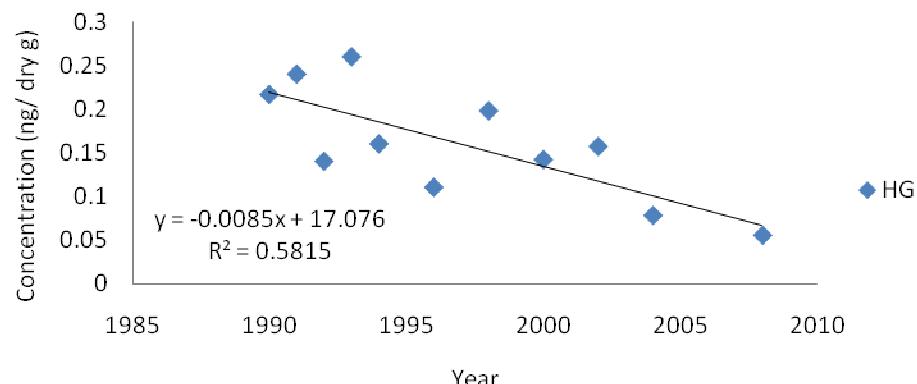
Trend of Hg concentration at Las Tunas Beach Santa Monica Bay

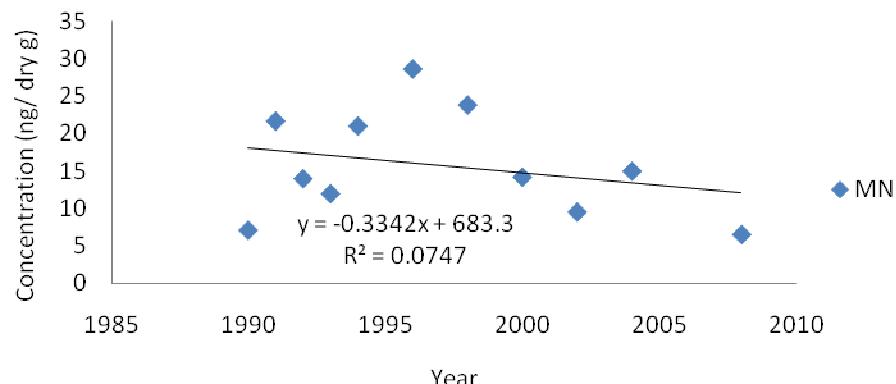
Trend of Mn concentration at Las Tunas Beach Santa Monica Bay

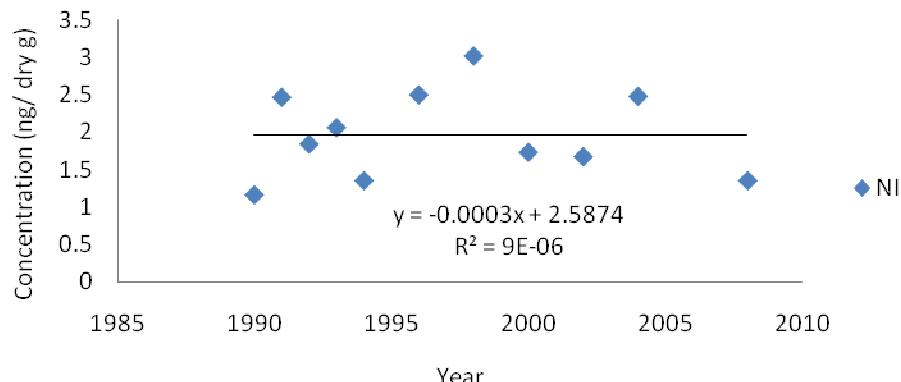
### Trend of Ni concentration at Las Tunas Beach Santa Monica Bay

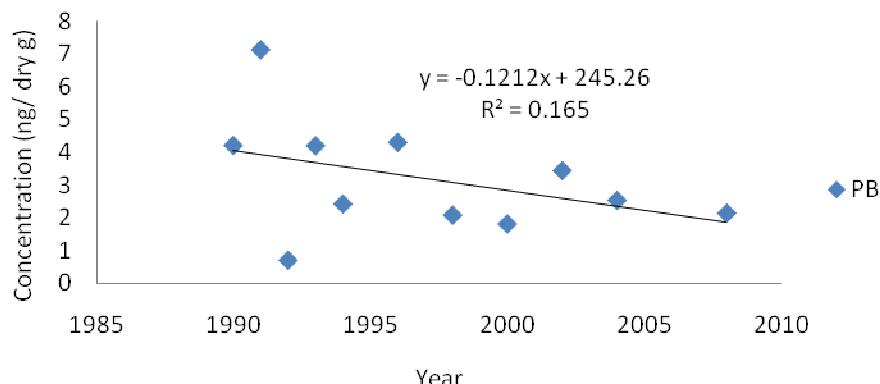
### Trend of Pb concentration at Las Tunas Beach Santa Monica Bay

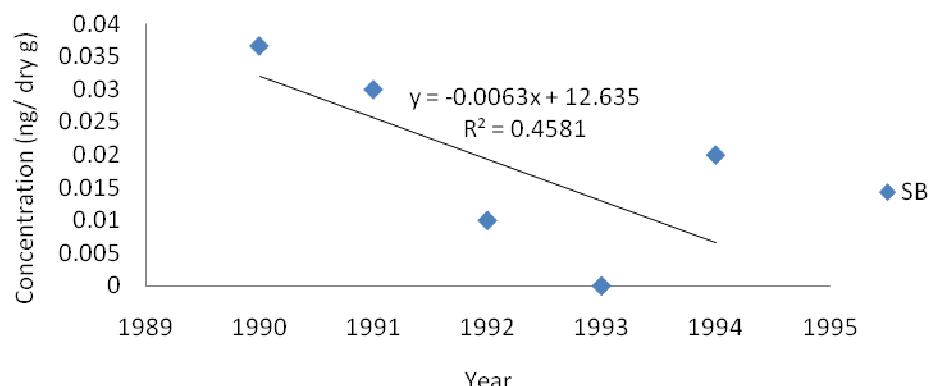
### Trend of Sb concentration at Las Tunas Beach Santa Monica Bay

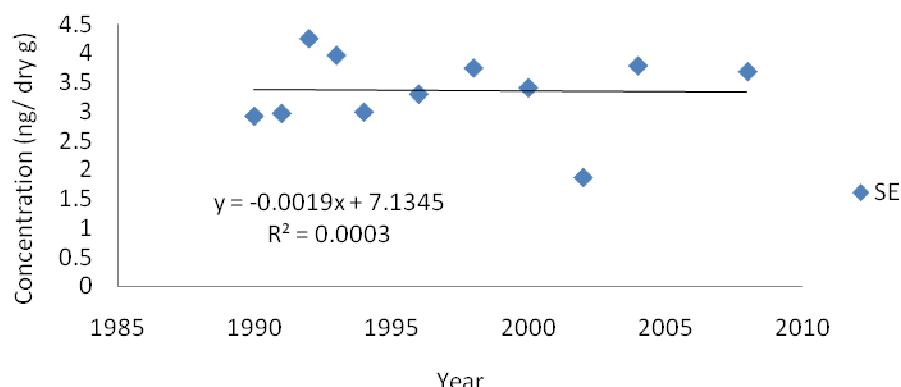
### Trend of Se concentration at Las Tunas Beach Santa Monica Bay

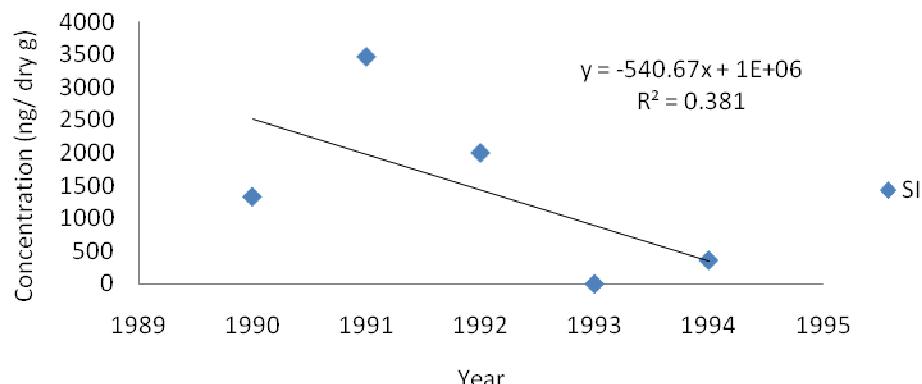
### Trend of Si concentration at Las Tunas Beach Santa Monica Bay

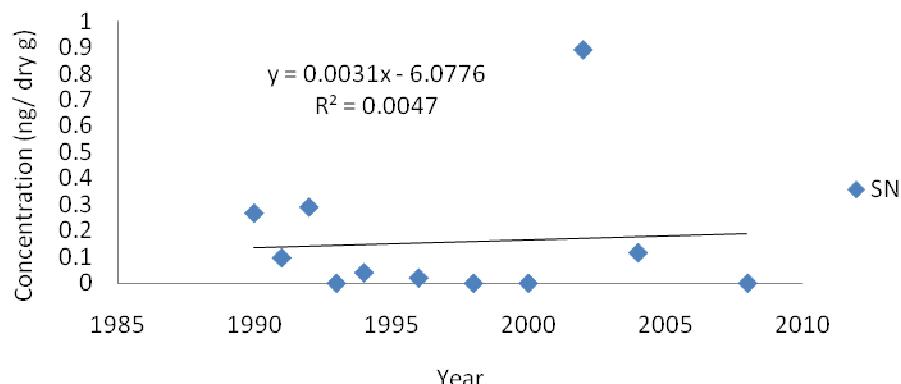
### Trend of Sn concentration at Las Tunas Beach Santa Monica Bay
