DATE: 1986

LONG TERM ON-SITE AND OFF-SITE EFFECTS OF LOGGING
AND EROSION IN THE REDWOOD CREEK BASIN, NORTHERN CALIFORNIA

Danny K. Hagans, Dr. William E. Weaver, and Mary Ann Madej,
Redwood National Park

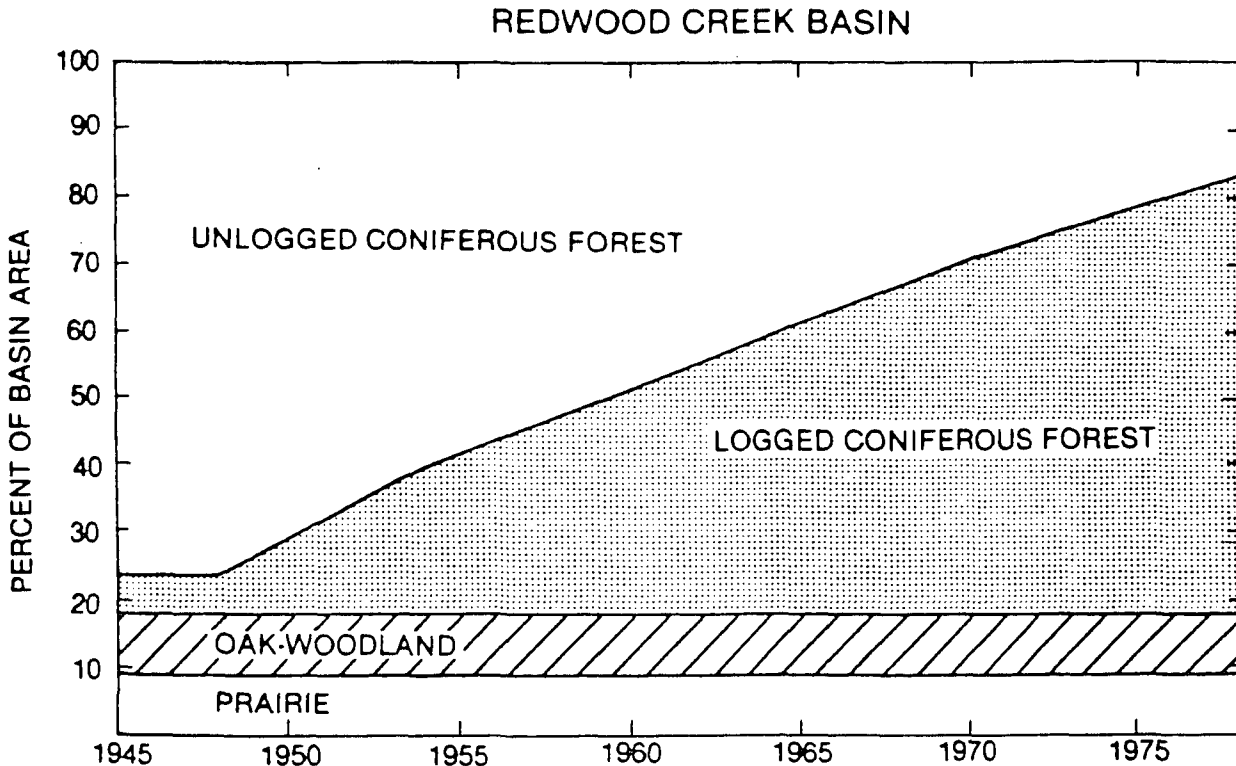
FIGURE 2

TIMBER HARVEST IN THE REDWOOD CREEK BASIN SHOWING CHANGES IN PERCENT OF BASIN LOGGED FROM 1945 TO 1978

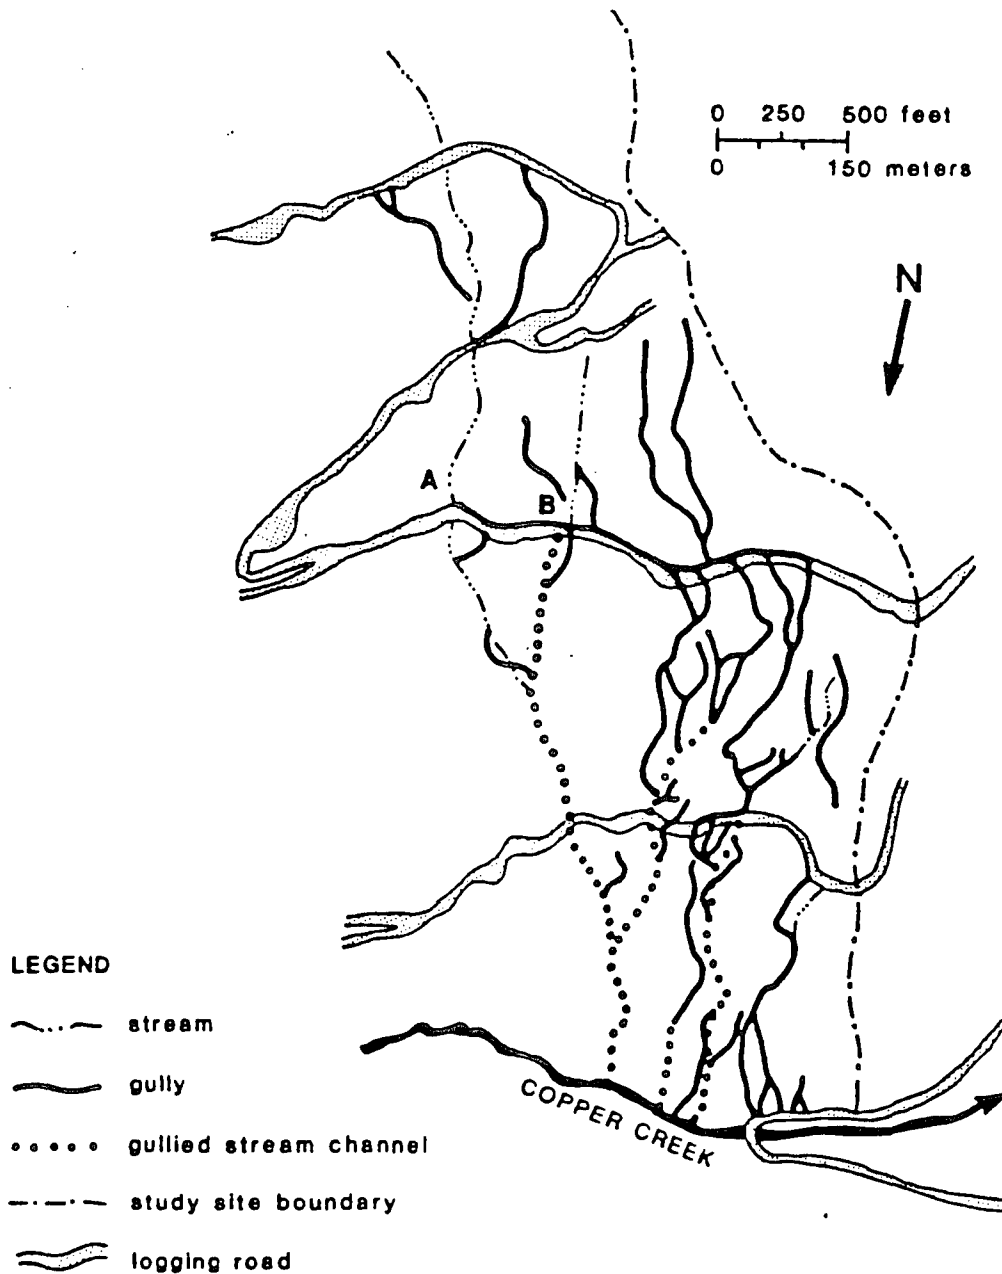
FIGURE 3

DETAILED MAP OF MEASURED GULLY NETWORK AND ENLARGED STREAM CHANNELS ON THE WESTERN SIDE OF THE SOUTH COPPER CREEK STUDY SITE. TOTAL MEASURED GULLY EROSION FOR THE MAPPED AREA IS 40,600 m³. ROAD CROSSINGS AT LOCATIONS A AND B DRAIN 29- AND 8-HECTARE WATERSHEDS RESPECTIVELY. THE DIVERSION OF STREAM FLOW TO THE INBOARD DITCH AT THESE LOCATIONS RESULTED IN THE MAJORITY OF GULLY EROSION AND ENLARGED STREAM CHANNELS SHOWN ON THE MAP

A map of the South Copper Creek site graphically shows the extent and length of gullies compared to original stream network (Figure 3). The gullies are widespread and complexly interconnected. They represent the dominant sediment source contributing to increased post-harvest sediment yield and changes in drainage density on this and all the study sites. Increased drainage densities were commonly caused by stream diversions and the resultant creation of lengthy and large hillslope gully systems (Figure 4). Stream flow was diverted onto adjacent bare hillslopes when culverts plugged or where logging roads and skid trails crossed ephemeral and intermittent streams which had not been fitted with culverts.

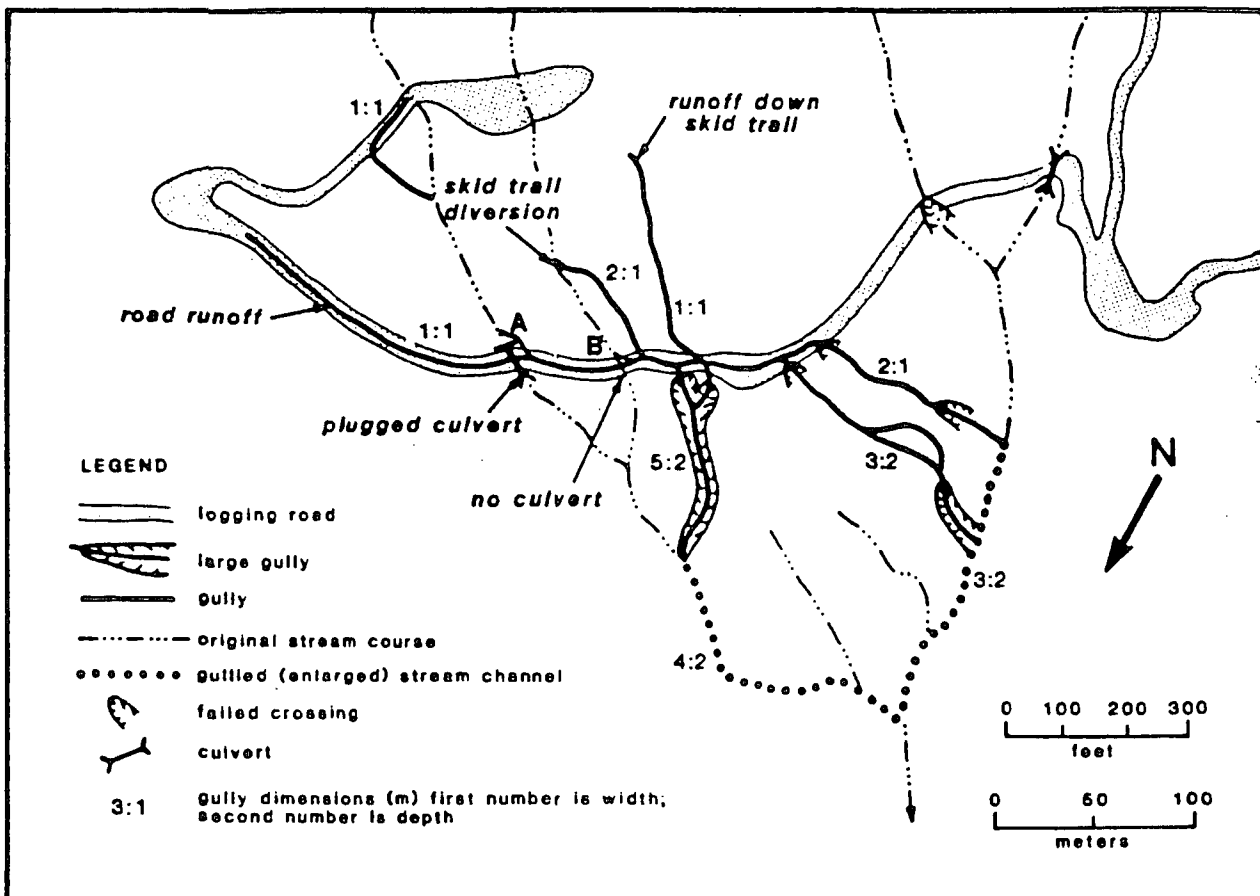
FIGURE 6

SIMPLIFIED MAP SHOWING CAUSES AND EXTENT OF GULLYING ON LOGGED LANDS IN THE REDWOOD CREEK BASIN. LOCATIONS A AND B ARE DESCRIBED IN THE TEXT

Off-site downslope effects are essentially of the same type and magnitude as the on-site effects, but the ultimate "cause" of the erosion always stems from upslope activities. For example, Figure 6 shows a portion of the existing logging road network in Copper Creek, a lower Redwood Creek tributary basin. It demonstrates how 89 percent of the lower basin gully erosion and, based on sample plots, a comparable or greater percentage in the upper and middle basin, has been caused by land use; how this erosion was preventable; and how it has resulted in long-term and persistent changes to the watershed. The region above the logging road may be thought of as the area experiencing on-site effects, and the area below the road as the off-site downslope area or area below the harvest unit. The figure shows a stream network with gullies originating from five different causes (labeled by italic print). All five causes of gullying were associated with disruption of the natural drainage pattern on the hillslope. Importantly, individual gullies resulting from most causes are generally small (less than one meter wide

and deep). However, when these gullies merge, or if streamflow is diverted out of a channel as shown at locations A and B (Figure 6), exceptionally large gullies may develop off-site and downslope from the harvest area. Their off-site impact to stream systems is nearly immediate since measured delivery ratios for the developing gully systems exceed 90 percent. Likewise, the relatively rapid creation of these new "stream channels," usually during larger storms, can also cause the gullying or enlargement of natural stream channels downslope as large volumes of sediment are routed through the stream network (Figure 6).

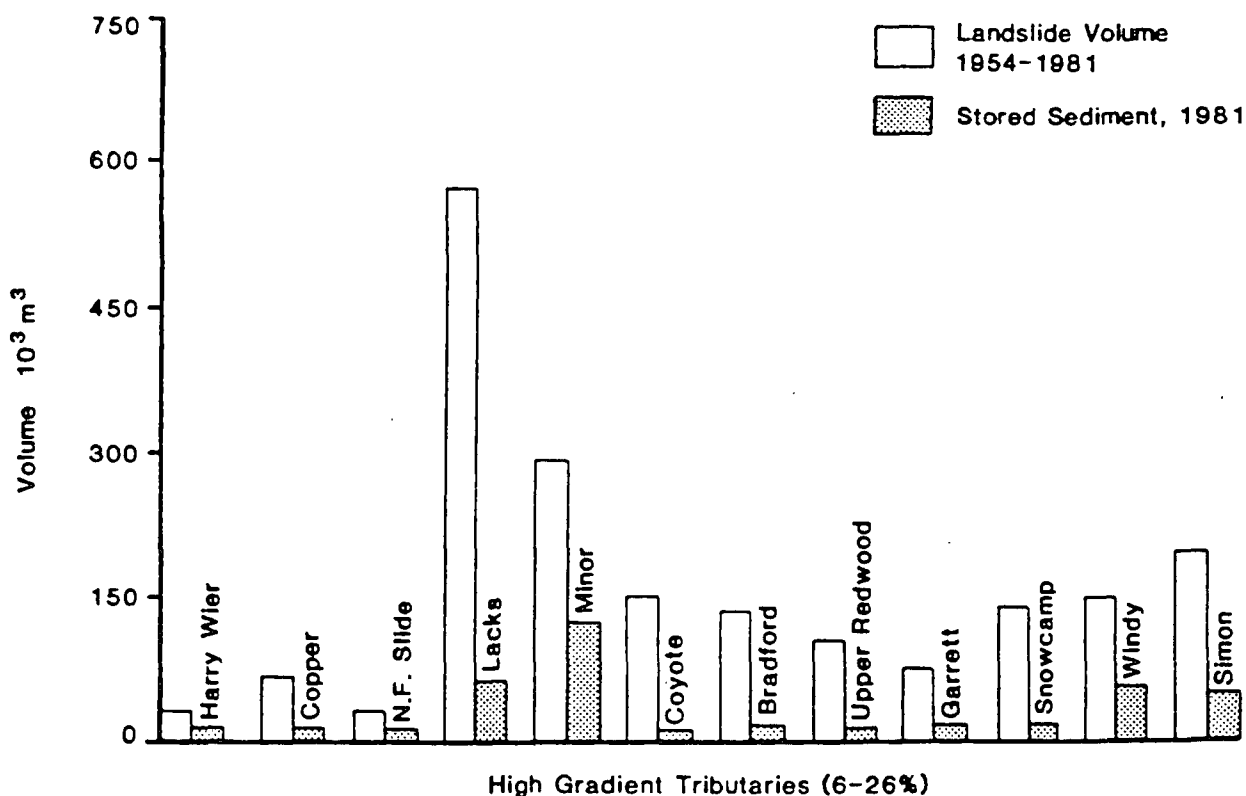
FIGURE 8

BAR GRAPH COMPARING MEASURED LANDSLIDE VOLUME FOR THE PERIOD 1954 TO 1981 TO THE AMOUNT OF SEDIMENT IN STORAGE AS OF 1981 ON 12 TRIBUTARY BASINS TO REDWOOD CREEK. TAKEN FROM PITLICK (13)

measured landslide volumes in these tributaries for comparison purposes, Figure 8 shows that while relatively large sediment volumes were introduced to these streams, very little of the introduced material was still in storage by 1981. On average, these tributaries have stored between 9 and 66 percent of the introduced material. If fluvial hillslope contributions (i.e. an additional 30 to 40 percent not shown in Figure 8) are considered together with landslide volumes, the tributaries actually store between 5 and 30 percent of the total introduced material. Thus, except where tributary gradients are naturally low, or locally reduced behind log jams, the off-site geomorphic effects of increased upstream erosion appears to be minimal. Instead, steep high order tributaries serve as corridors through which material introduced upstream and upslope is efficiently transported to lower gradient reaches in Redwood Creek.

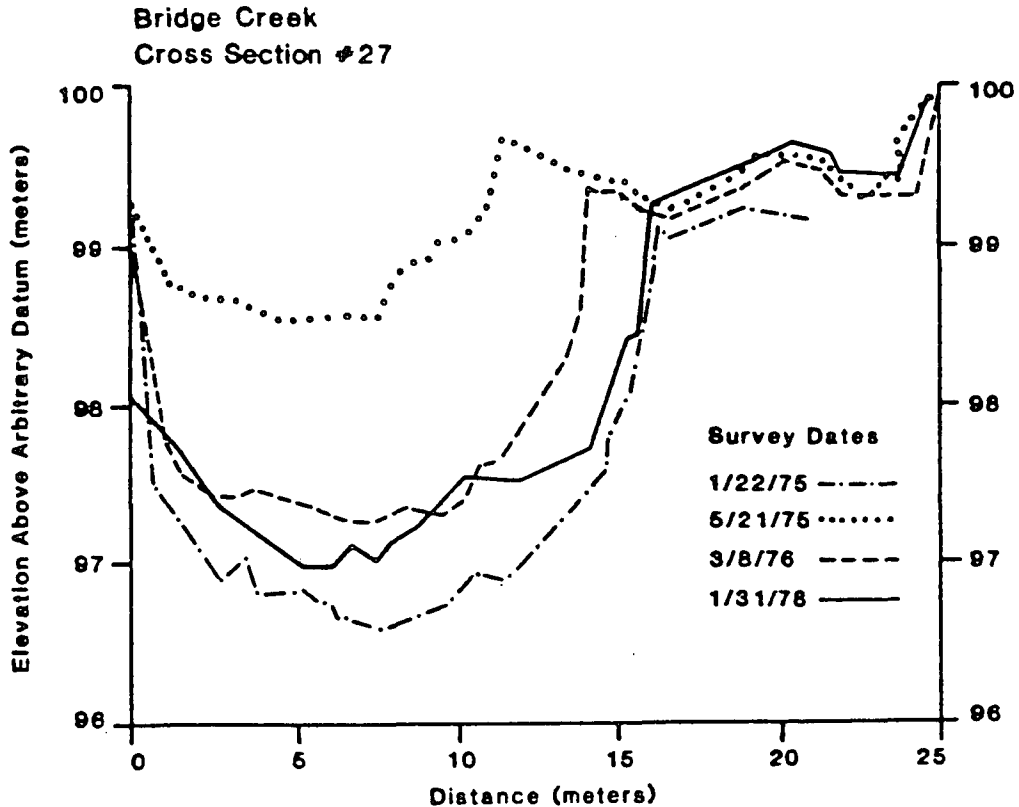
FIGURE 9

BRIDGE CREEK CHANNEL CROSS SECTIONS MEASURED OVER A THREE YEAR PERIOD ILLUSTRATE THE SHORT RESIDENCE TIME OF STORED SEDIMENT IN MANY HIGHER ORDER TRIBUTARY STREAMS OF REDWOOD CREEK

Tributary efficiency is exemplified in a series of cross-sections surveyed near the mouth of the 29.4 km² Bridge Creek watershed (Figure 9). It illustrates the exceptionally short residence time of stored sediment in many higher order tributary streams. One year after the March 1975 flood had deposited over two meters of sediment in the channel, well over one meter of degradation had occurred throughout the cross-section. Within

just three years, the channel had flushed out virtually all the introduced sediment and returned to near its original configuration with little evidence of major secondary changes in channel geometry (e.g., bank erosion).

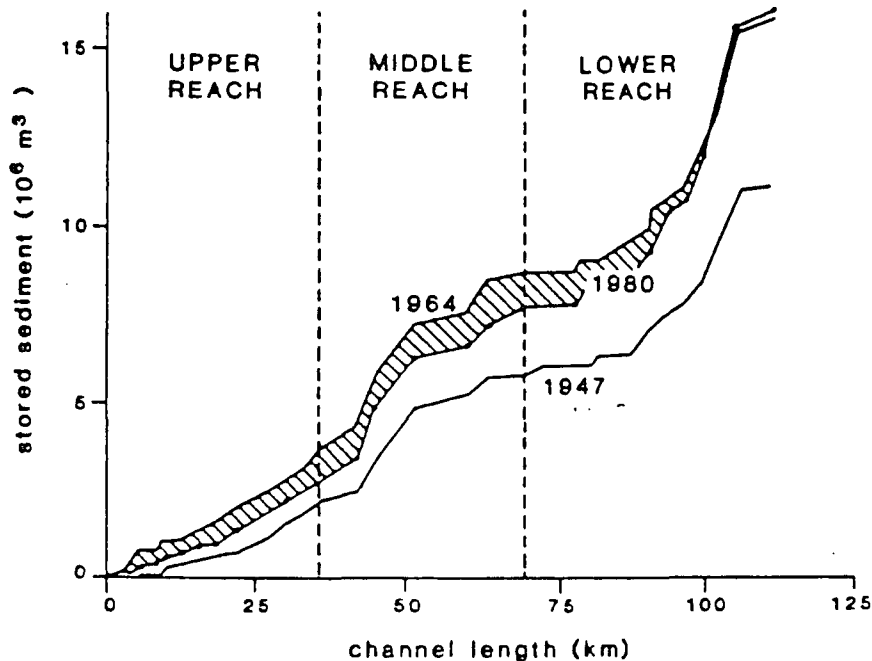
FIGURE 11

CUMULATIVE VOLUMES AND SPATIAL DISTRIBUTION OF STORED SEDIMENT IN REDWOOD CREEK AS OF 1947, 1964 AND 1980

Figure 11 shows the cumulative volume of stored sediment in the upper, middle and lower reaches of Redwood Creek plotted against the channel distance from the divide. Three distinct time markers are used to illustrate land use related effects. The 1947 line represents the amount of sediment in Redwood Creek under pre-disturbance conditions, prior to significant road construction and timber harvesting in the basin. Total sediment in the Redwood Creek channel in 1947 was about $11 \times 10^6 \text{ m}^3$. By

1964 the amount of stored sediment had increased to over $16 \times 10^6 \text{ m}^3$. The most severe aggradation occurred in the upper reach during the December 1964 flood, a flood with a local recurrence interval of about 50 years.

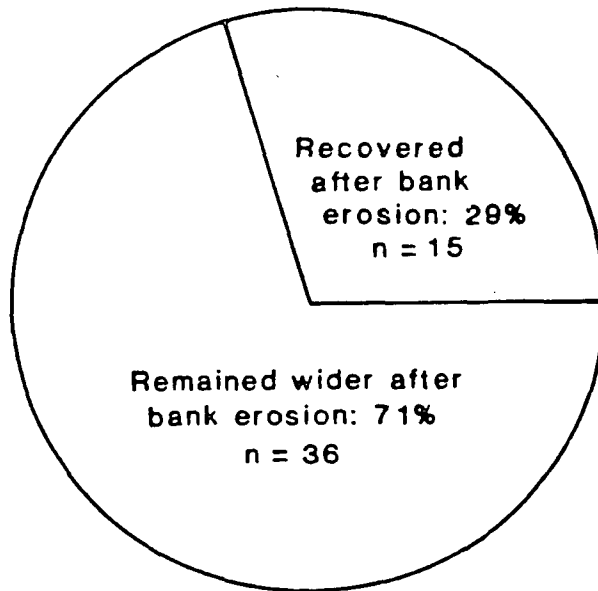
FIGURE 12

PIE DIAGRAM DEMONSTRATING PERSISTENT CHANGES IN CHANNEL WIDTH CAUSED BY MAJOR (GREATER THAN 6 METER) BANK EROSION ON A 30 km SAMPLE REACH OF REDWOOD CREEK BETWEEN 1955 AND 1978

To further illustrate the extent of off-site downstream effects, bank erosion was studied in detail using aerial photographs and survey data. For example, in a 30 km long middle reach of Redwood Creek, 51 locations of major bank erosion (greater than six meters of lateral scour) occurred between 1955 and 1978 (Figure 12). Channel widening was associated with severe channel bed aggradation of up to five meters at some locations. At 71 percent of the bank erosion locations, the channel remained wider for decades following initial erosion and has not recovered to its pre-disturbance channel configuration. Figure 13 dramatically illustrates the lack of recovery of original channel width during 12 years of record at a cross section in the lower reach of Redwood Creek, where major bank erosion is also occurring. Between 1973 and 1985, the right

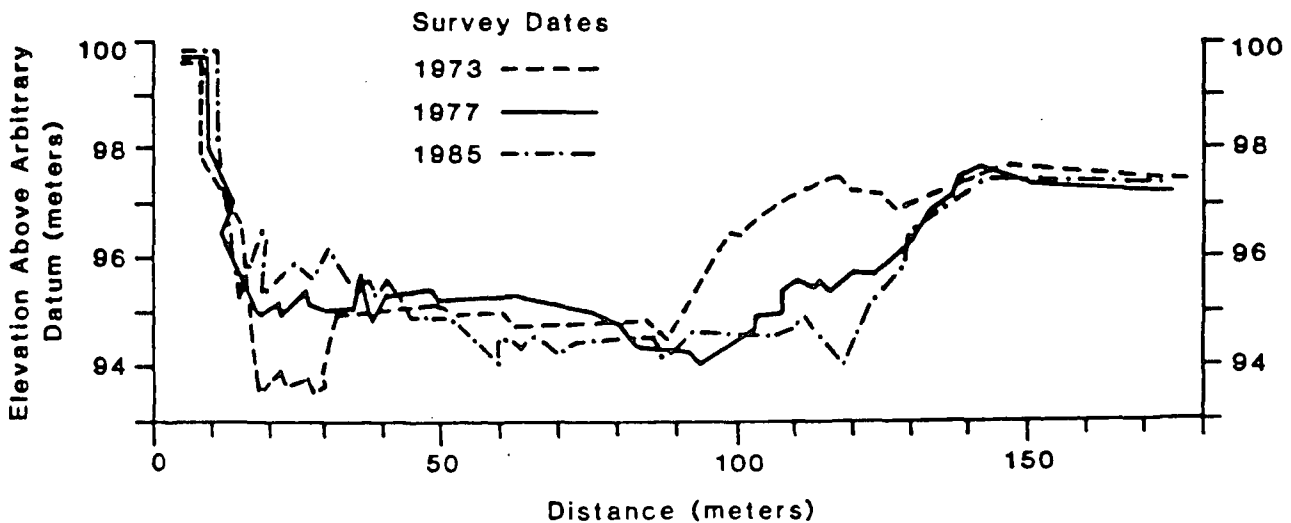
FIGURE 13

Redwood Creek Near Orick
Cross Section #3

CROSS-SECTION #3, LOCATED ON REDWOOD CREEK NEAR THE MOUTH OF HAYES CREEK (NEAR ORICK), ILLUSTRATES LACK OF RECOVERY OF ORIGINAL CHANNEL WIDTH DURING 12 YEARS OF SURVEY RECORD. BANK EROSION CONTINUES AS A RESULT OF SEVERE BED AGGRADATION IN THIS REACH

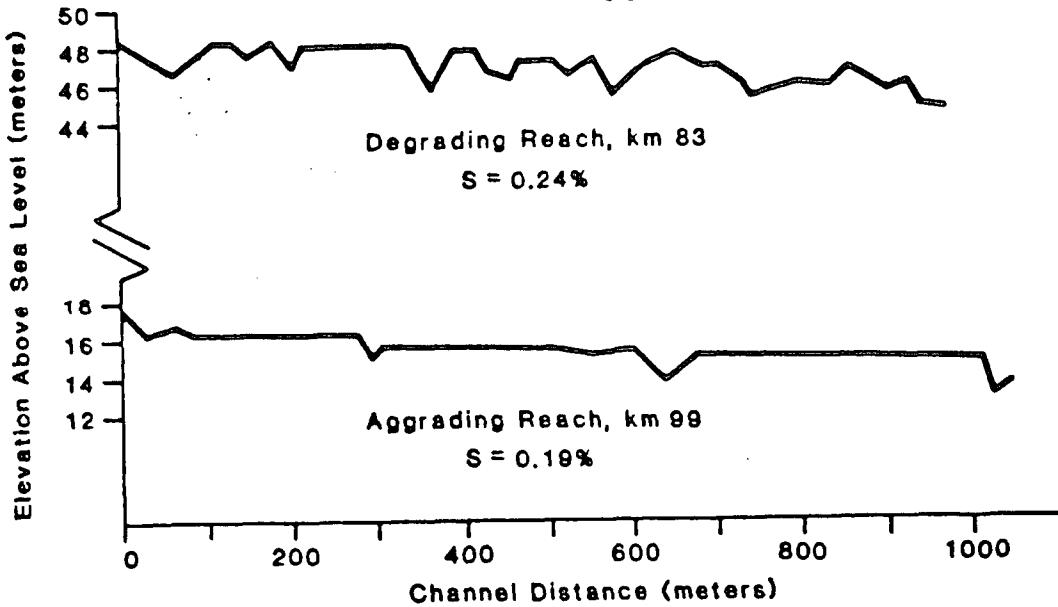
FIGURE 14

A COMPARISON OF LONGITUDINAL PROFILES FOR TWO SEPARATE 1000 METER REACHES WITH SIMILAR CHANNEL GRADIENTS IN THE LOWER REDWOOD CREEK BASIN. THEODOLITE AND ELECTRONIC DISTANCE METER SURVEYS WERE PERFORMED DURING THE SUMMERS OF 1977 AND 1983

Varnum and Ozaki (14) have shown that in reaches where stream recovery has occurred since aggradation, pool numbers have increased again. A comparison of two reaches, one where aggradation is actively occurring and one that is recovering, illustrates this fact. Longitudinal profiles were surveyed for two 1000-meter long reaches about 16 km apart, with similar channel gradients (Figure 14). The amount of large organic debris and exposed bedrock in the two reaches were essentially the same. Based on cross section surveys, the upper reach has been degrading over the last seven years and the thalweg has remained entrenched in the same location through runoff events for this time period. The lower reach is still actively aggrading. Over a six year period, the mean depth of degradation in the upper reach (based on profile surveys in 1977 and 1983) is 1.1 m; whereas the mean depth of aggradation for the lower reach is 0.4 m (14).

Thalweg slopes were calculated by regression analysis of theodolite surveys and the associated coefficients of determination (r^2) were calculated for the reaches. The r^2 value associated with the upstream reach (0.62) is lower than that for the downstream reach (0.93). The lower r^2 value in the upstream channel segment reflects the increase in bed variation seen in recovering reaches, where the most well defined pool-riffle sequence occurs (Figure 14). Conversely, the higher values of r^2 are associated with aggrading reaches of Redwood Creek where pools are not as deep or frequent (14). Presently, there are 15 km of channel in lower Redwood Creek that are actively aggrading. Thus, in reaches where Redwood Creek stores increased amounts of sediment, and streambeds are aggraded to higher than pre-disturbance elevations, pool frequencies are reduced.

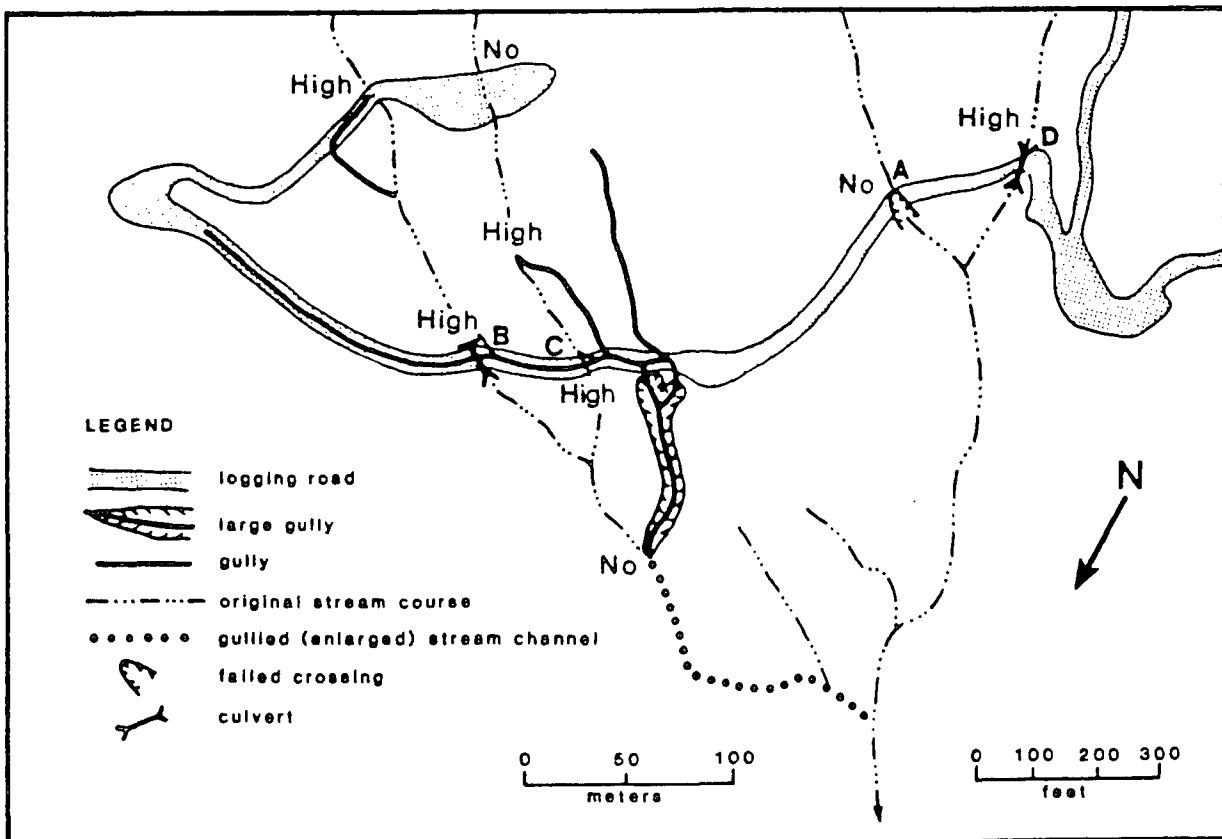
FIGURE 15

DIVERSION POTENTIAL RATINGS APPLIED TO ROAD AND SKID TRAIL CROSSINGS IN A PORTION OF THE COPPER CREEK DRAINAGE BASIN. THE RATING IS BASED SOLELY ON THE GRADIENT OF THE ROAD AS IT CROSSES THE STREAM. "HIGH" RATINGS INDICATE DIVERSIONS OF STREAMFLOW COULD OCCUR, "NO" RATINGS INDICATE STREAMFLOW WILL ALWAYS BE CONFINED TO THE CROSSING, EVEN IF THE CULVERT PLUGS. LOCATIONS A, B, C AND D ARE DESCRIBED IN THE TEXT

To describe this situation, a diversion potential rating system, based solely on the gradient of the road as it crosses a stream channel, was developed. In the example diagram of a road system in the lower Redwood Creek basin (Figure 6), each crossing was examined in the field and assigned one of two potentials (Figure 15). For the three crossings with no diversion potential, the road gradient on both approaches dips into the stream

There are many stream crossings throughout the Redwood Creek watershed which exhibit high diversion potentials but whose culverts have not yet plugged (Location D, Figure 15). Many other crossings have already experienced stream diversions at least once. For example, seventy percent of the logging road stream crossings surveyed in the lower Redwood Creek basin were constructed with a high diversion potential (Table 6). Of these, 56 percent have experienced diversions at least once, only to be reconstructed again with a high diversion potential.

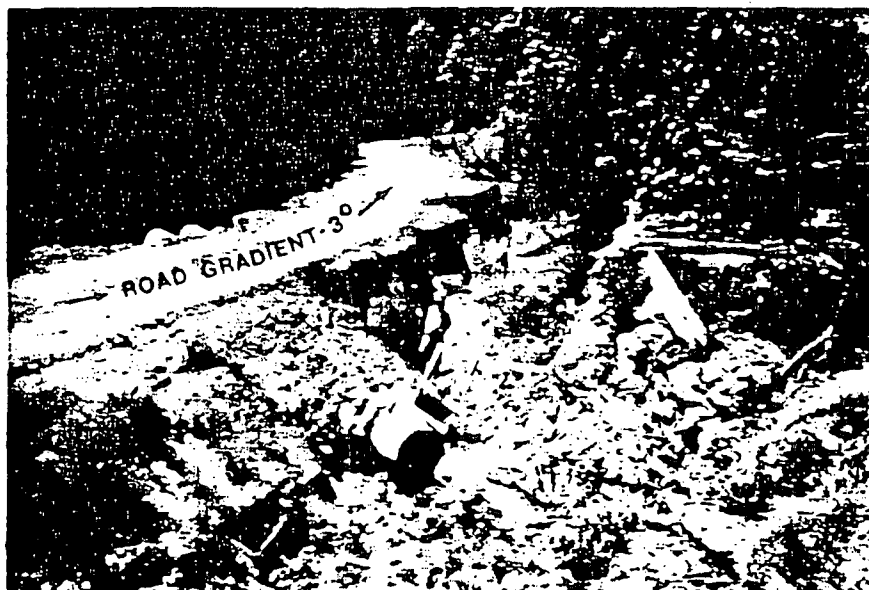
FIGURE 17

LOGGING ROAD STREAM CROSSING CONSTRUCTED WITH A HIGH DIVERSION POTENTIAL. CULVERTS SHOW ORIGINAL ORIENTATION OF STREAM CHANNEL IN RELATION TO ROAD. NOTE GULLIED INBOARD DITCH DOWN ROAD FROM POINT OF STREAM DIVERSION (CULVERT INLET). STREAM DIVERSIONS IN THE REDWOOD CREEK BASIN FREQUENTLY CREATE GULLY NETWORKS ON ADJACENT HILLSLOPES WHICH MAY YIELD 2,000 TO 4,000 m³ OF ERODED SEDIMENT

channel at the crossing (Figure 16). Even if the culvert plugs, flow cannot escape the drainage system. For the five crossings with high diversion potentials, the road surface was found to slope away (down) from the stream crossing in at least one direction (Figure 17).
